Contract No. HY/2010/02

**Hong Kong – Zhuhai – Macao Bridge
Hong Kong Boundary Crossing
Facilities –
Reclamation Works**

Monthly EM&A Report for December 2014

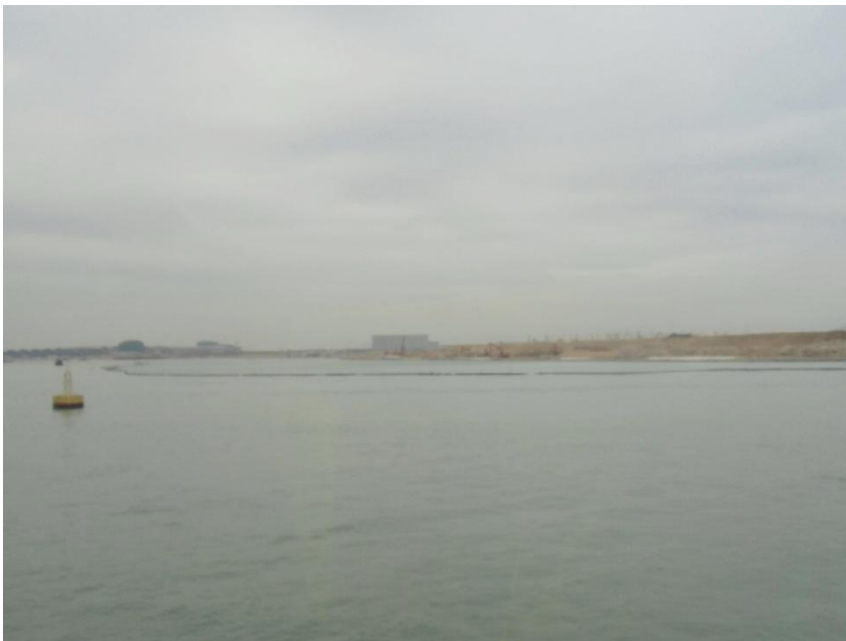
4.7.2.6 In addition, with referred to monitoring record, no sediment plume has been observed to flow from the inside of the perimeter silt curtain to the outside of the perimeter silt curtain during ebb tide on 5 December 2014. (Please refer to photo record taken during ebb tide on 5 December 2015)

4.7.2.7 Photo record which shows the sea condition near Portion B, the southeast part of the HKBCF reclamation works at ebb tide on 5 December 2014.

4.7.2.13 Nevertheless, the Contractor was reminded to ensure provision of ongoing maintenance to the silt curtains and to carry out maintenance work once defects were found.

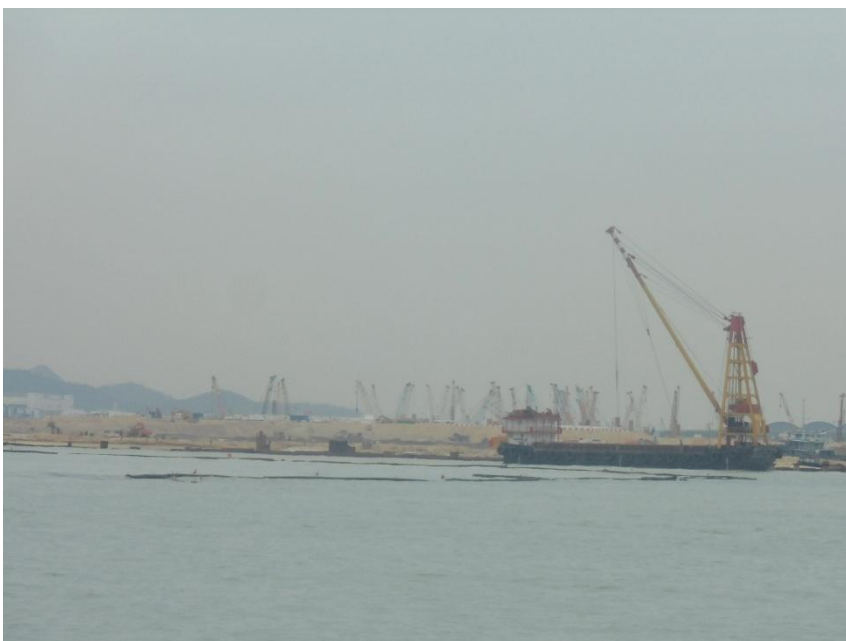
4.7.2.8 Photo record which shows the sea condition near Portion E, the northeast part of the HKBCF reclamation works at ebb tide on 5 December 2014

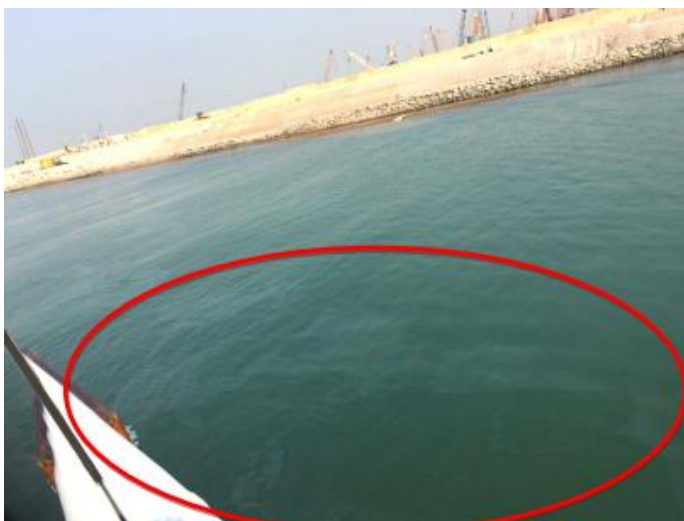
6.4.7 As informed by the Contractor via email at 15:06 on 8 December 2014, oil was observed at sea area near western waters within the silt curtain at 15:00 on 8 December 2014. Following the spill response plan ET, IEC and the RSS were informed of the incident by the Contractor.

6.4.7.2 The oil spill was visually identified by the Contractor and RSS on 8 December 2014 as discrete, non-continuous source with approximately 25m² spread. (Also refer to photo record below)

6.4.7.7 The contractor was reminded to continue to follow the spill response plan in the event of accidental oil spillage.

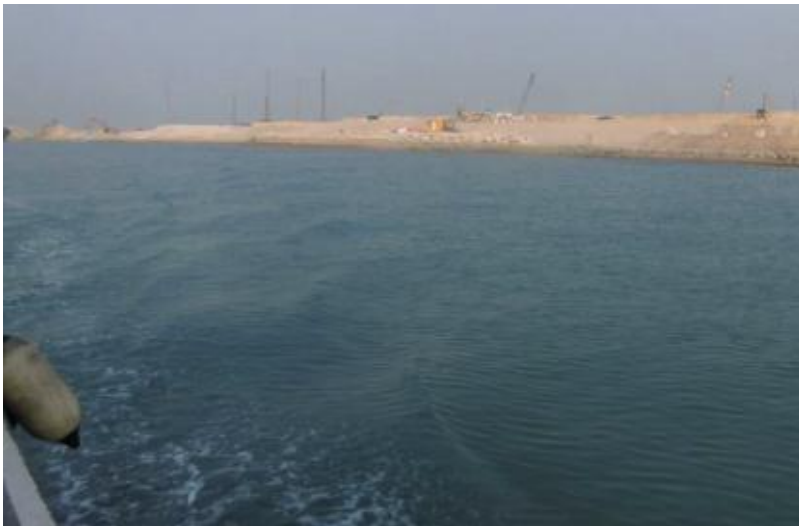
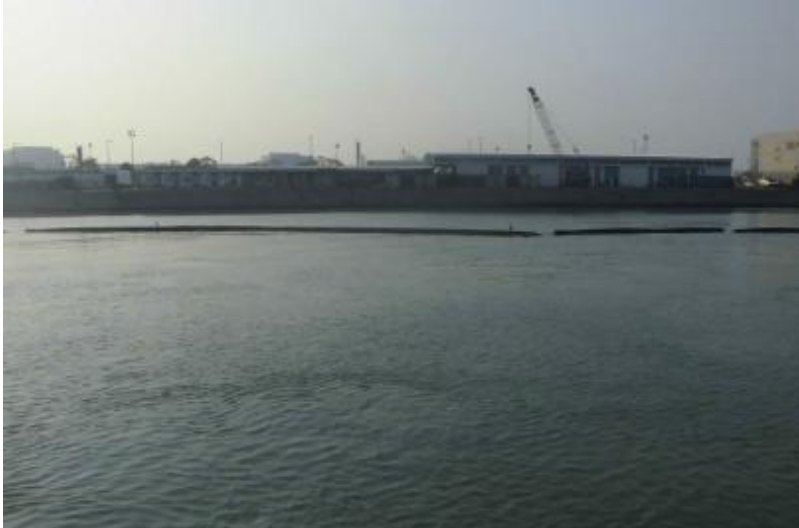
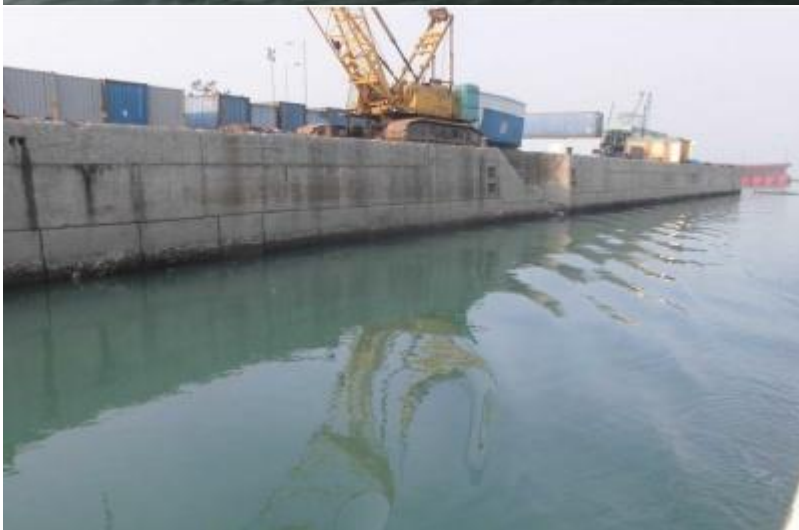
6.4.7.3 The oil stain was no longer found when the emergency boat arrived the area about 15mins after the observation. And no sign of oil spillage was found on the nearby waters after. (Please see below photo record for reference)

6.4.7.4 The oil stain observed was limited at nearby western sea area within the silt curtain.

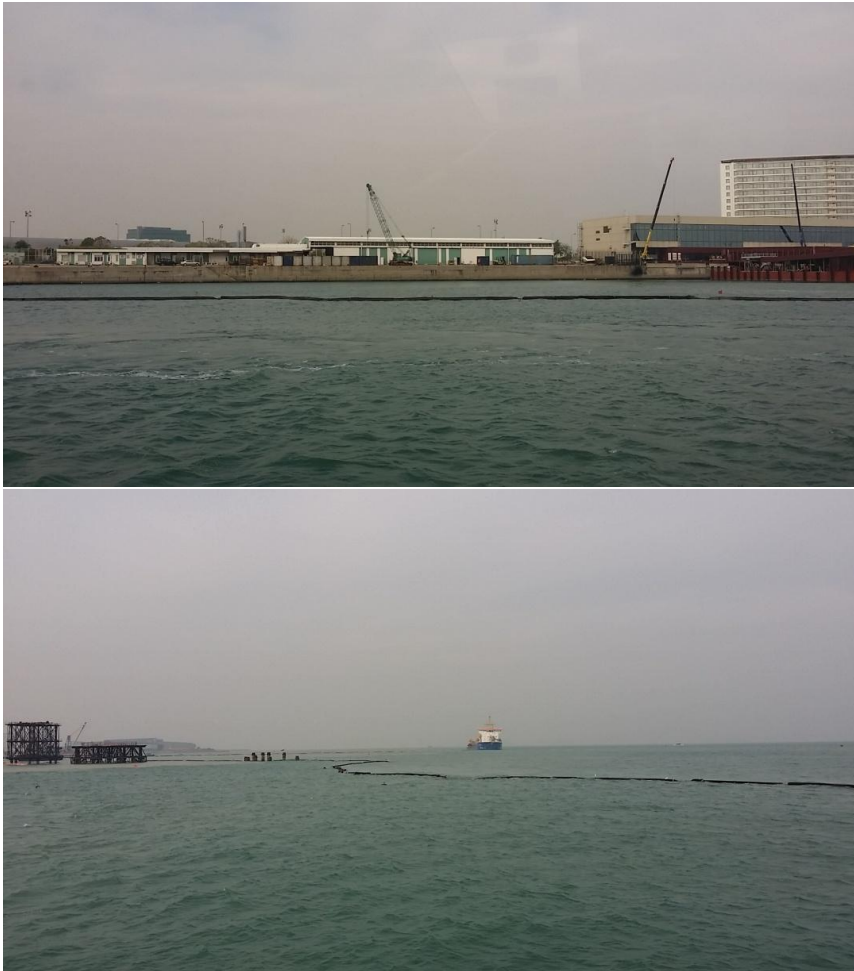
6.4.7.5 An joint site inspection was conducted with ET, Contractor and RSS on 11 December 2014 at perimeter of HKBCF Reclamation Works and no oil spillage was observed on site. (Also refer to photo record below).
