**Hong Kong – Zhuhai – Macao Bridge
Hong Kong Boundary Crossing
Facilities –
Reclamation Works**

Monthly EM&A Report for February 2015

**Contract No. HY/2010/02 HZMB HKBCF – Reclamation Works
Monthly Environmental Monitoring & Audit Report for February 2015**

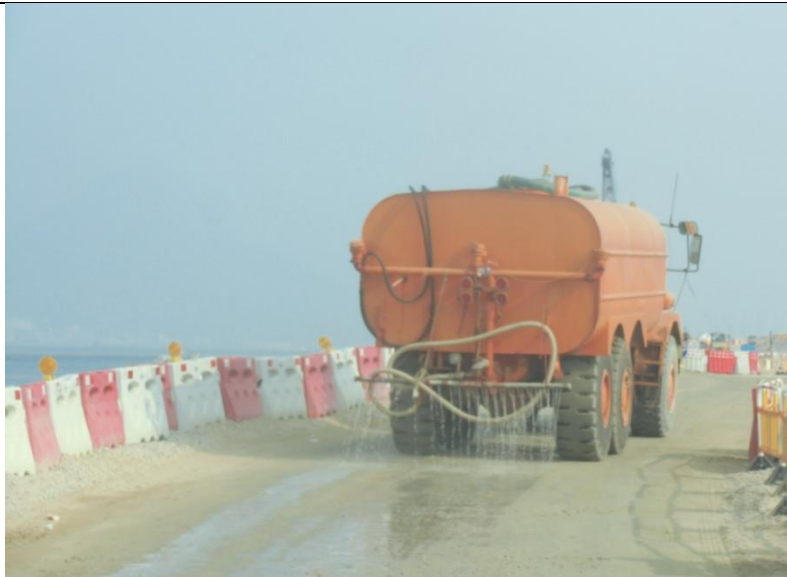
2.7.3.5 Photo record taken on 5 February 2015 showed that the Contractor implemented dust control measures at HKBCF reclamation works such as watering on exposed soil. The Contractor was reminded to continue to provide such dust control measure.

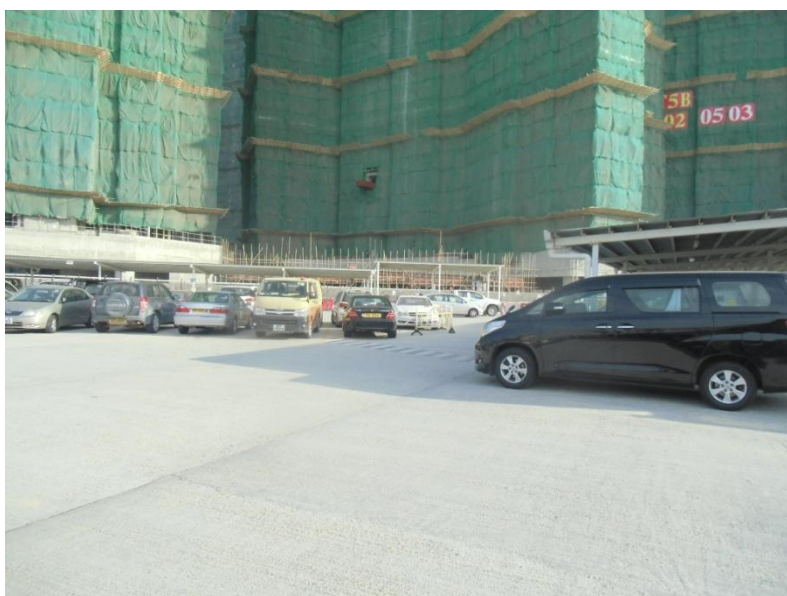
2.7.3.6 Photo record taken on 12 February 2015 showed that the Contractor implemented dust control measures such as hard paved roads at WA2. The Contractor was reminded to continue to provide such dust control measure.

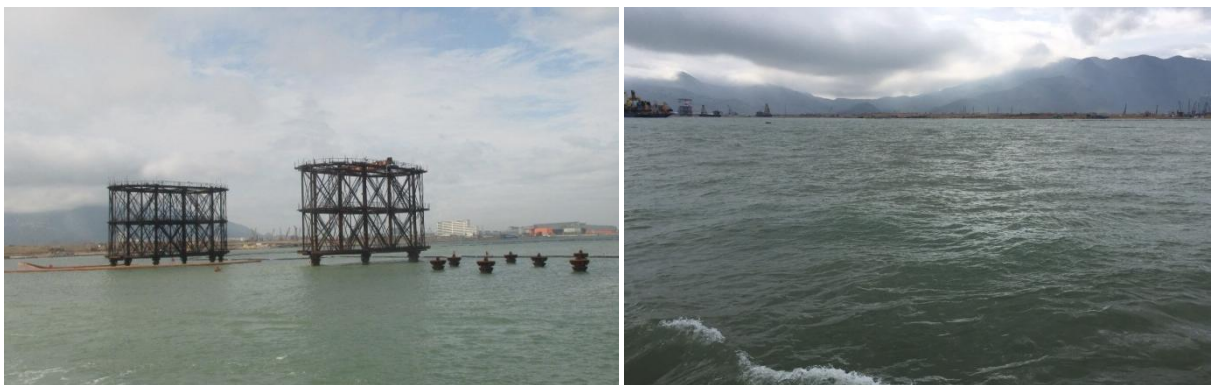
4.7.2.4 Photo record which shows the sea condition at north part of the HKBCF reclamation works during flood tide on 23 February 2015:

4.7.2.5 Also, turbidity level recorded at IS(Mf)11, SR7, IS10 and IS17 were 24.9(NTU), 14.7(NTU), 5.7(NTU) and 23.9(NTU) respectively; Suspended solids level recorded at IS10 and IS17 were 23.2mg/L and 7.9mg/L respectively, which were all below the action and limit level. This indicates the turbidity level at or near IS(Mf)11 and SR7 and Suspended Solids level near IS(Mf)11 and SR7 were not adversely affected.

4.7.2.6 The exceedances were likely due to local effects in the vicinity of IS(Mf)11 and SR7.
