Contract No. HY/2010/02

**Hong Kong – Zhuhai – Macao Bridge
Hong Kong Boundary Crossing
Facilities –
Reclamation Works**

Monthly EM&A Report for April 2015

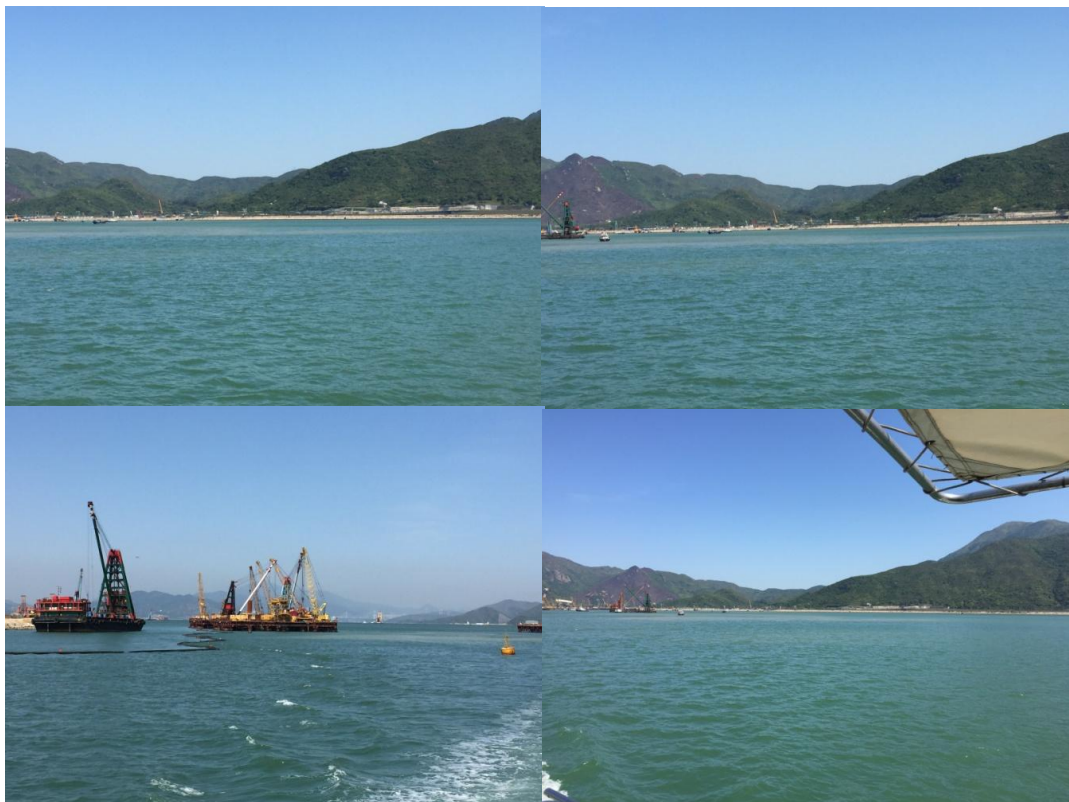
6.4.7 There is a report of silt plume observed near the silt curtain for HZMB HKBCF Project maintained by Contract No. HY/2010/02 during a site visit conducted by HyD on 15 April 2015. The location is near the eastern part of HKBCF reclamation works (portion B and E), near the silt curtain for HZMB HKBCF Project maintained by Contract No. HY/2010/02

6.4.7.4 Photo record taken on 15 April 2015 shows that silt plume was observed near the silt curtain for HZMB HKBCF Project maintained by Contract No. HY/2010/02 during a site visit conducted by HyD on 15 April 2015:

6.4.7.3 Nevertheless, the Contractor was reminded to continue to properly and implement all water quality mitigation measure.

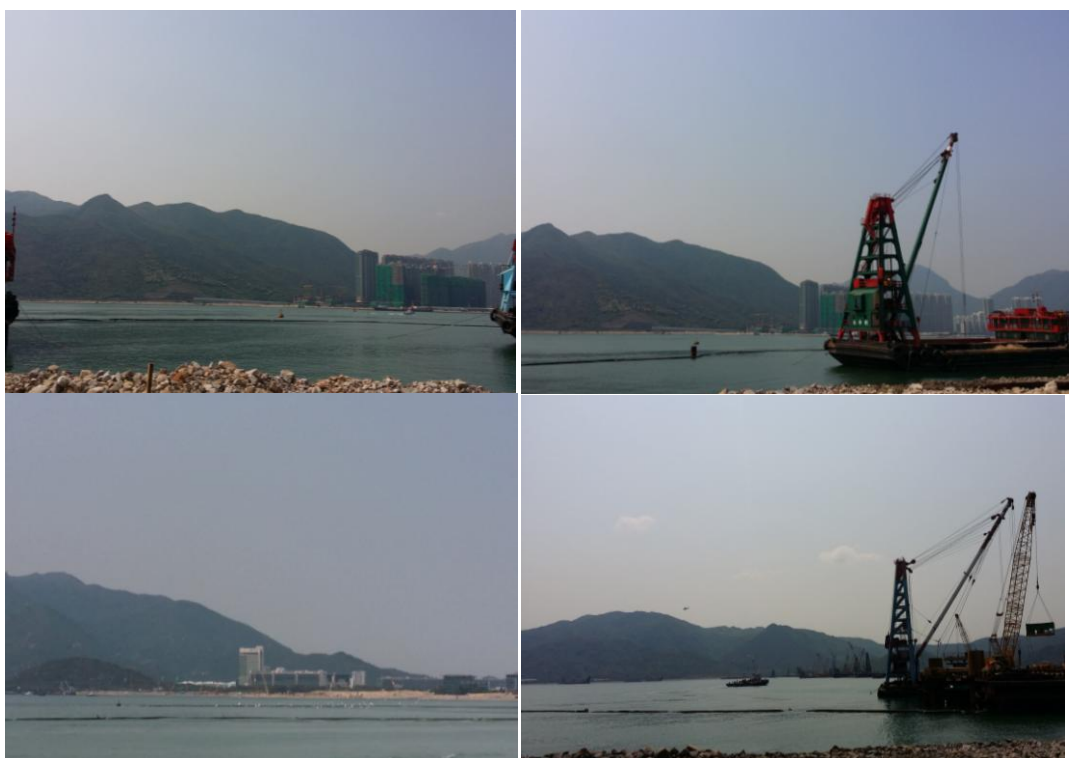
- No silt plume around the Portion B and Portion E2 of HKBCF reclamation works were observed during the joint site inspection conducted jointly with the Contractor, RSS and ESS on 16 April 2015. Photos were taken and please see below photo record for reference

- No disconnection of silt curtain was observed during the joint site inspection conducted jointly with the Contractor, RSS and ESS on 16 April 2015.
- Works activity such as deep cement mixing on land was observed at the Portion B and Portion E2 of HKBCF reclamation works and relocating rock material of cellular structure was observed at the Portion B of HKBCF reclamation works during the joint site inspection conducted jointly with the Contractor, RSS and ESS on 16 April 2015, however, silt plume or discharge of silt plume was not observed.

6.4.7.5 Photo record taken on 16 April 2015 shows that no silt plume around the Portion B and Portion E2 of HKBCF reclamation works were observed during the joint site inspection conducted jointly with the Contractor, RSS and ESS on 16 April 2015.
