Contract No. HY/2010/02

**Hong Kong – Zhuhai – Macao Bridge
Hong Kong Boundary Crossing
Facilities –
Reclamation Works**

Monthly EM&A Report for May 2015

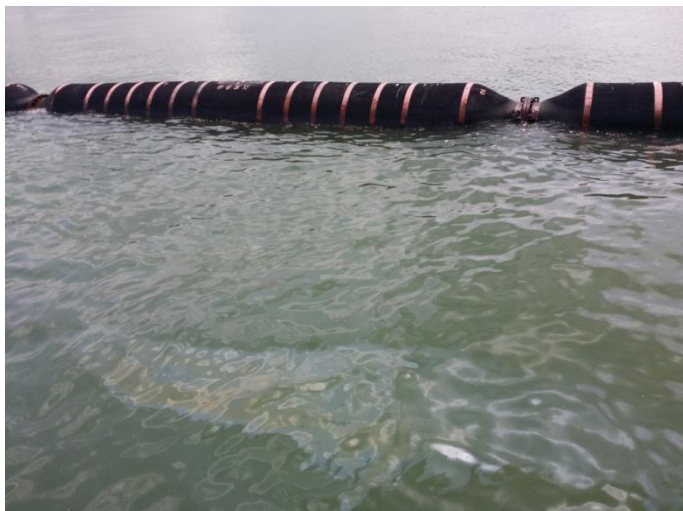
- Oil was observed on sea next to Northeastern of Portion C2c within silt curtain at 10:45 a.m. on 14 May 2015 during joint inspection conducted by Contractor, ET, ESS and the RSS. The following actions was taken by the Contractor:
- The Contractor organised manpower to identify the spill source, the vessel (Evershin no.8) located close to the oil spill was inspected but the source of oil spill was not identified.
- The oil spill was identified during join site inspection conducted by the Contractor, ET, ESS and RSS on 14 May 2015 as discrete, non-continuous source with approximately 10m² spread. Also refer to photo below:

6.4.7.3 The contractor was reminded to continue to follow the spill response plan when oil is observed on sea.

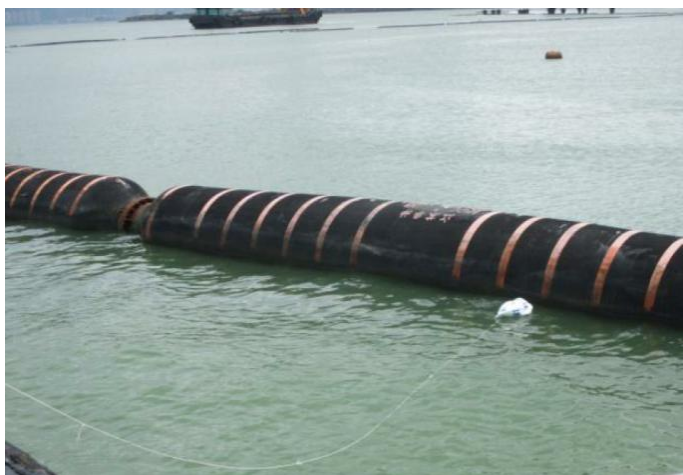
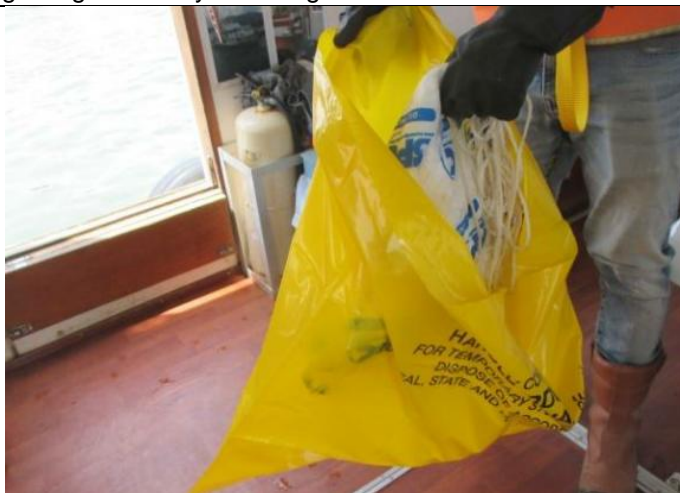
- The Contractor deployed absorption booms to remove the floating oil from water and the used absorption booms were collected using disposal bags as part of the spill kits item. The used absorption booms were disposed of as chemical waste by the Contractor. (Also refer to photo record below).

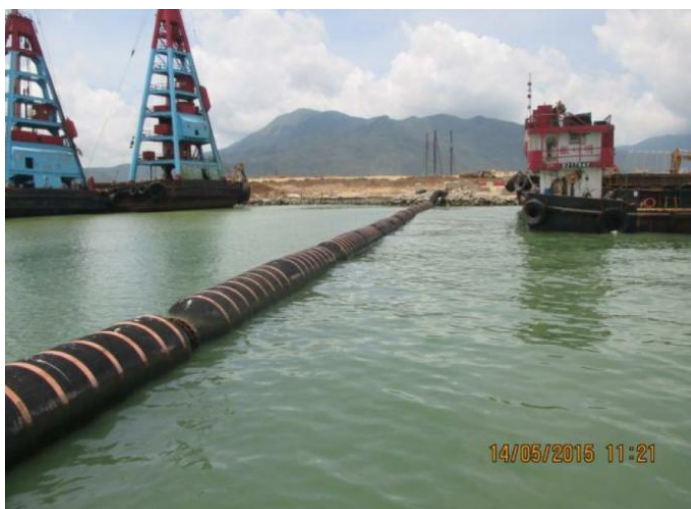
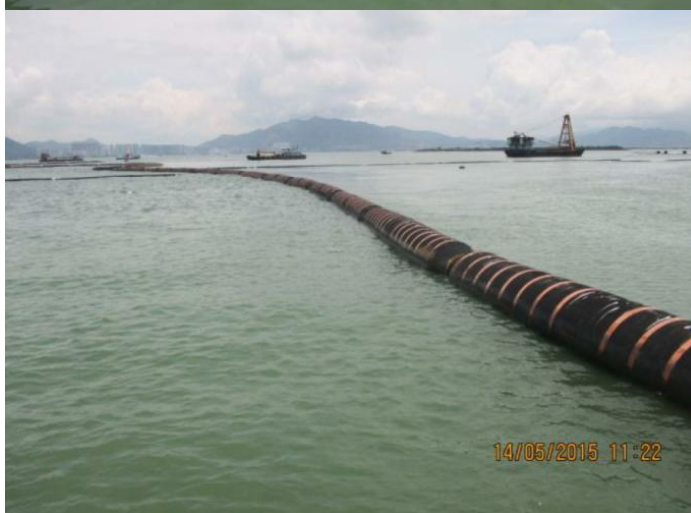
- The oil stain observed was limited at nearby Northeastern sea area within the silt curtain.
- Photo record shows that oil on sea was no longer observed at sea area near Northeastern of Portion C2c. (Also refer to photo record below)
