Contract No. HY/2010/02

**Hong Kong – Zhuhai – Macao Bridge
Hong Kong Boundary Crossing
Facilities –
Reclamation Works**

Monthly EM&A Report for June 2015

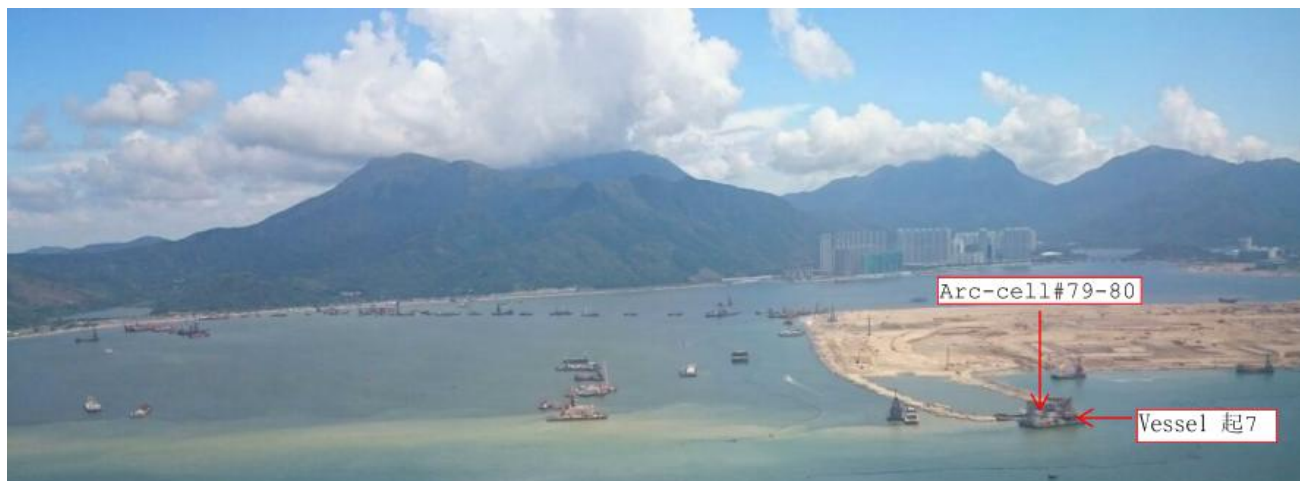
6.4.15 Photo record taken on 20 June 2015 at about 15:00 shows that silt plume was observed near the silt curtain for HZMB HKBCF Project maintained by Contract No. HY/2010/02.

6.4.14 Nevertheless, the Contractor was reminded to regularly check the performance of the silt curtain and ensure swift provision of maintenance to the perimeter silt curtains once defects of the perimeter silt curtain were observed.

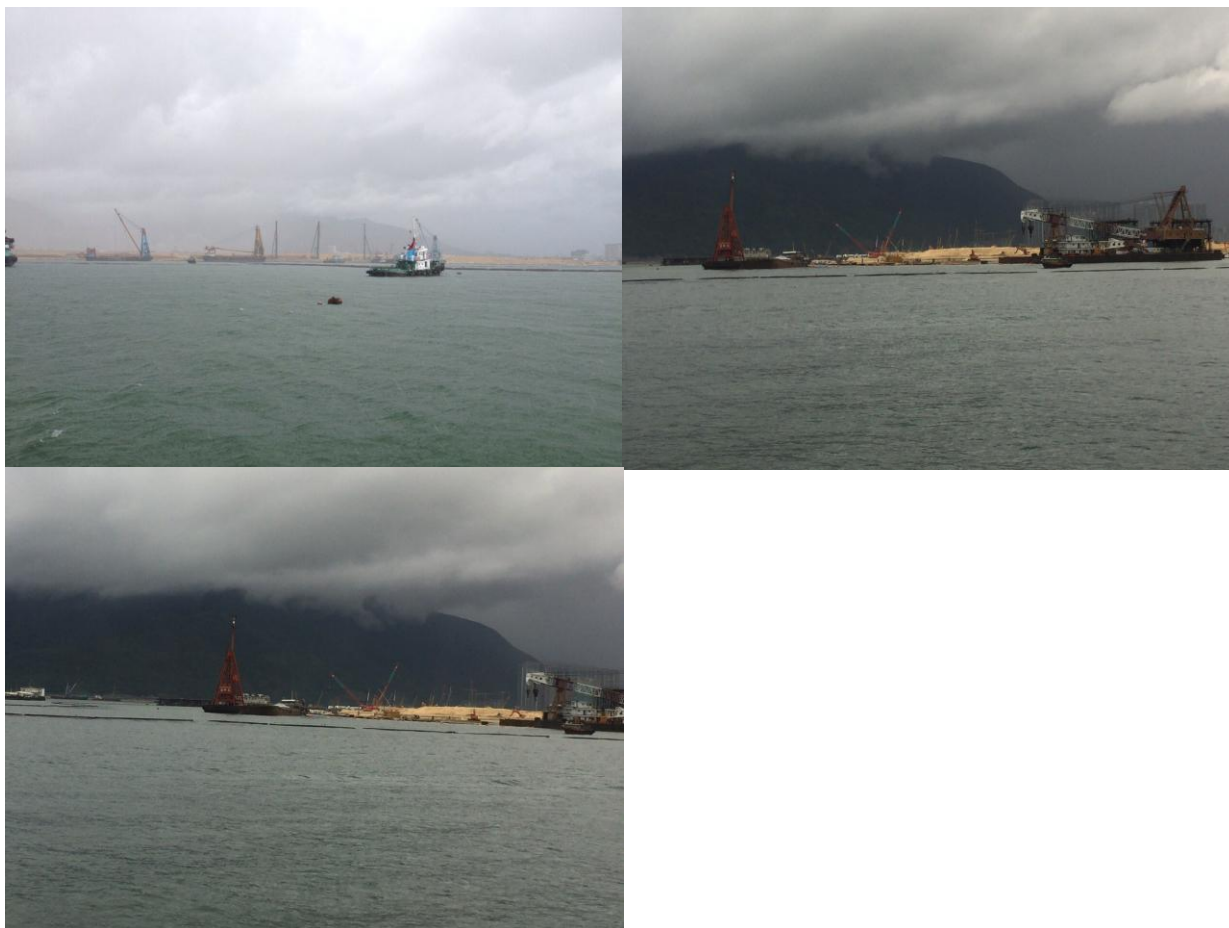
6.4.16 Photo record taken on 22 June 2015 shows that no silt plume around Portion E1 of HKBCF reclamation works were observed during the site inspection conducted on 22 June 2015.

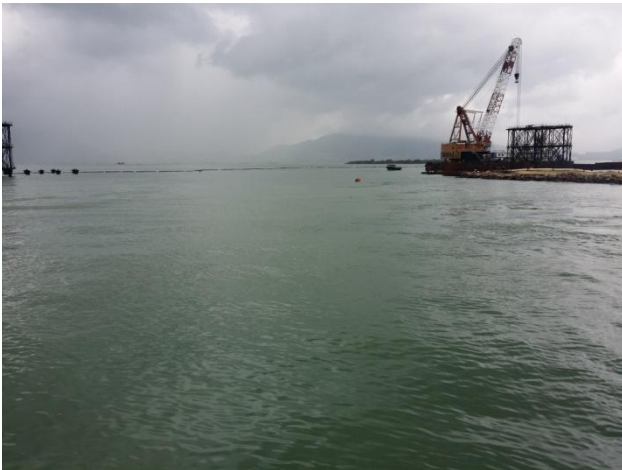
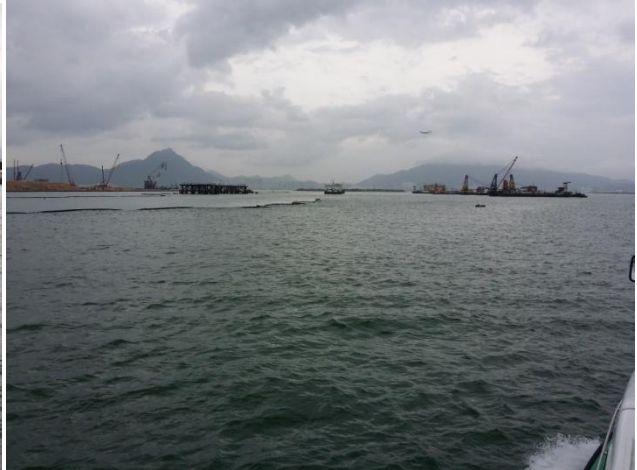
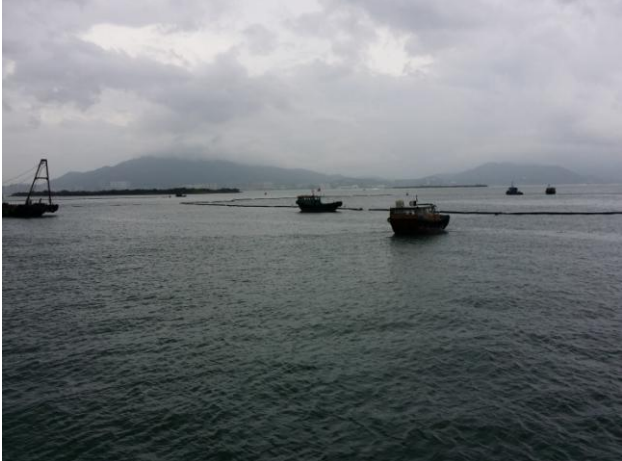
Photo record taken on 25 June 2015 shows that no silt plume around Portion E1 of HKBCF reclamation works were observed during the site inspection conducted on 25 June 2015.

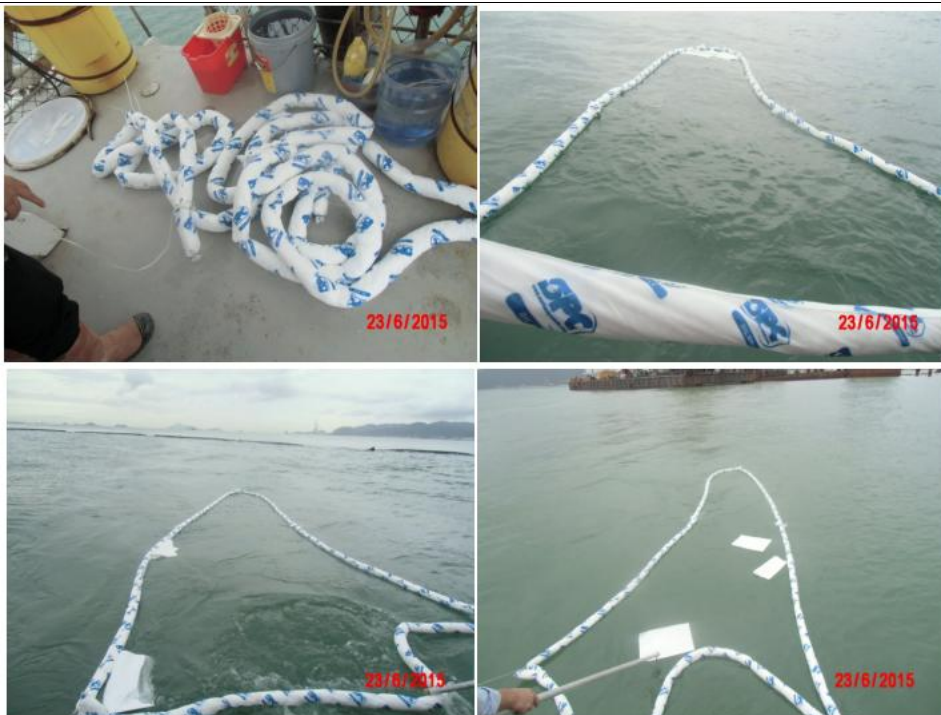
6.4.21 The oil spill was identified during join site inspection conducted by the Contractor and RSS on 23 June 2015 as discrete, non-continuous source with approximately 10m2 spread. Also refer to photo below:

6.4.22 The oil spill was identified during join site inspection conducted by the Contractor and RSS on 23 June 2015 as discrete, non-continuous source with approximately 10m2 spread. The below photo shows that the Contractor deployed absorption booms to remove the floating oil from water.

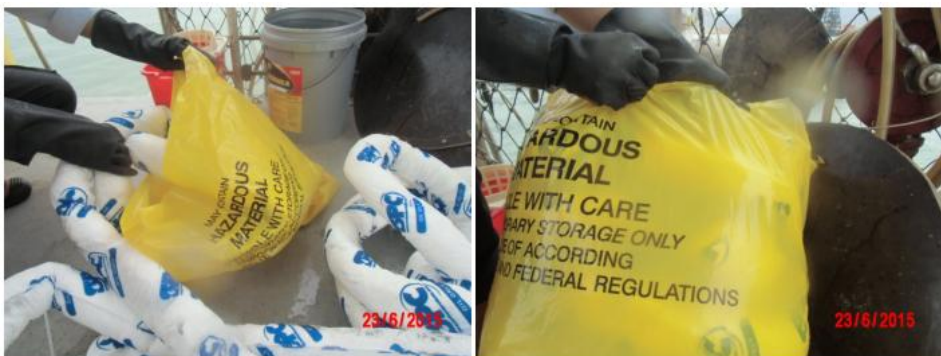
6.4.23 The used absorption booms were collected using disposal bags as part of the spill kits item. The used absorption booms were disposed of as chemical waste by the Contractor. (Also refer to photo record below)

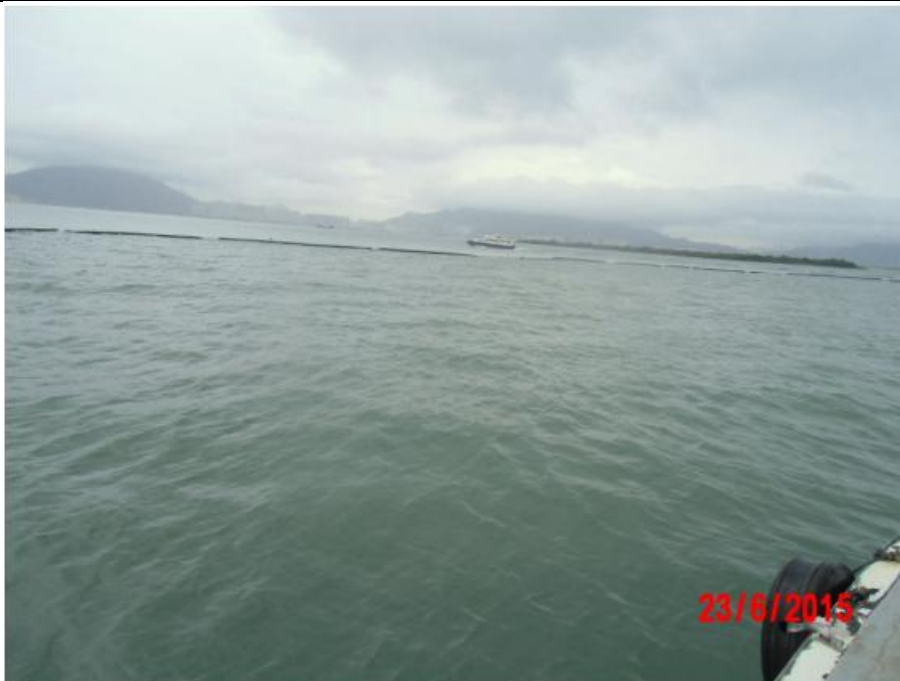
6.4.25 Photo record shows that oil on sea was no longer on sea area near Cell No. 78. (Also refer to photo record below)
