Contract No. HY/2010/02

## Hong Kong – Zhuhai – Macao Bridge Hong Kong Boundary Crossing Facilities – Reclamation Works

Monthly EM&A Report for October 2015

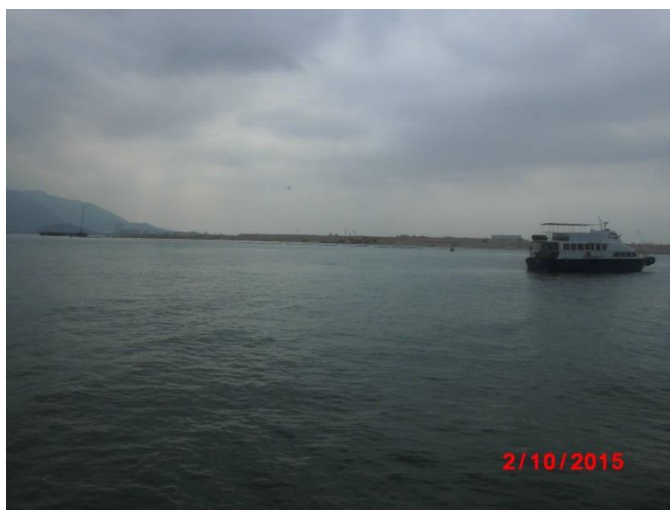
4.6.4.3 With reference to the silt curtain checking record of 02 October 2015, defects such as missing segment or disconnection of the perimeter silt curtain were not observed at north part of the perimeter silt curtain.

4.6.4.5 Photo record which shows the sea condition at north part of the HKBCF reclamation works during flood tide on 02 October 2015

4.6.4.11 Nevertheless, the Contractor was reminded to ensure provision of ongoing maintenance to the silt curtains and to carry out maintenance work once defects were found.
