Contract No. HY/2010/02

**Hong Kong – Zhuhai – Macao Bridge  
Hong Kong Boundary Crossing  
Facilities –  
Reclamation Works**

**Monthly EM&A Report for December 2015**

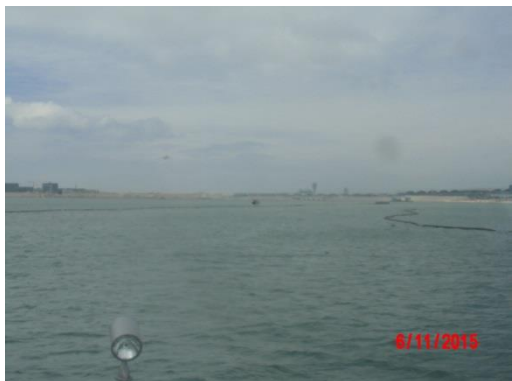
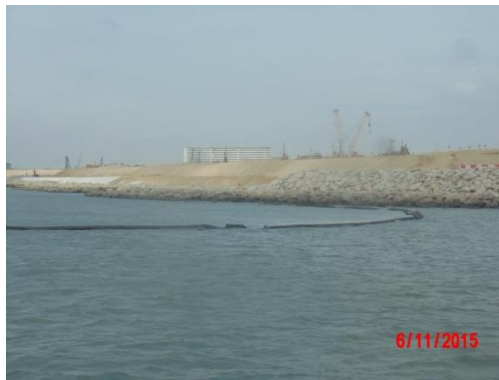
4.6.4.4 Furthermore, no filling activities was observed in progress at the sea area north to HKBCF reclamation works and no silt plume was observed to flow from the inside of the perimeter silt curtain to the outside of the perimeter silt curtain when monitoring was conducted at IS(Mf)11. Also refer to the attached photo record taken at sea area located north of HKBCF reclamation works on 28 December 2015 for reference of sea condition on 28 December 2015, which shows that no silt plume was observed.

4.6.4.5 Photo record which shows the sea condition at southern part of the HKBCF reclamation works on 28 December 2015. No silt plume was observed.

4.6.4.9 Nevertheless, the Contractor was reminded to ensure provision of ongoing maintenance to the silt curtains and to carry out maintenance work once defects were found.

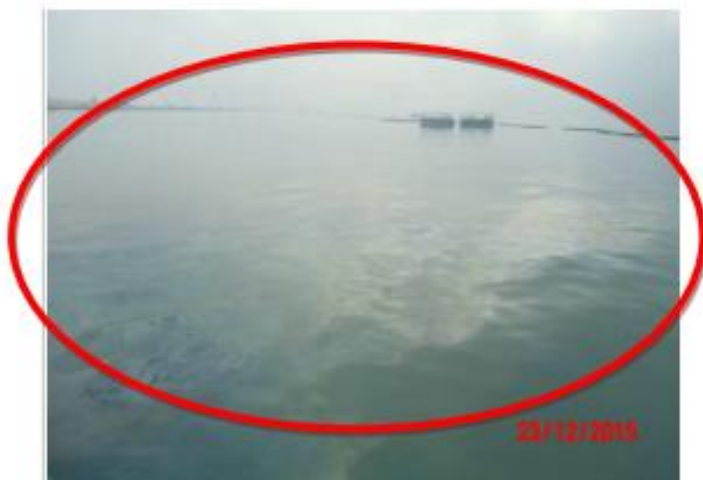
- Oil on sea was observed on sea area near Cell No. 28 within perimeter silt curtain at 09:30 a.m. on 23 December 2015 by the Contractor and RSS (also refer to above layout map).
- The following photo record shows the sea condition when the oil spillage on sea was observed.

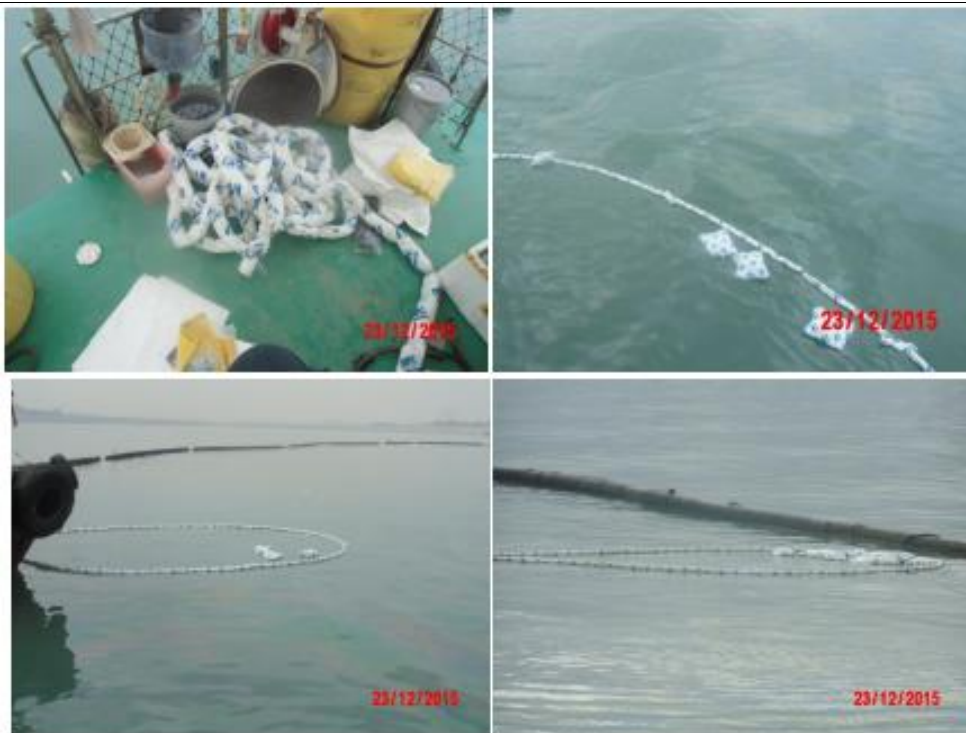
- The Contractor organized manpower to identify the spill source. During inspection, no construction vessel was observed around the concerned area and the source of oil spill was not identified.
- The oil spill was identified during inspection conducted by the Contractor and RSS on 23 December 2015 as discrete, non-continuous source with approximately 50m<sup>2</sup> spread. The below photo shows that the Contractor deployed absorption booms to remove the floating oil from water.

6.4.7.10 The Contractor was reminded to continue to follow the spill response plan when oil is observed on sea.

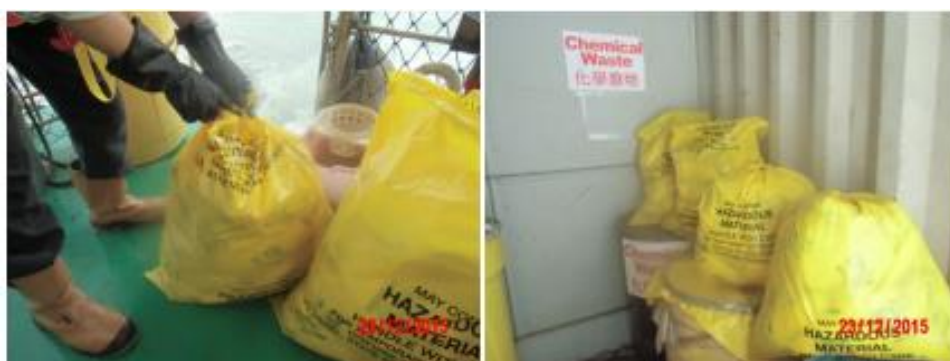
6.4.7.5 The below photos shows that the used absorption booms were collected using disposal bags as part of the spill kits item. The used absorption booms were disposed of as chemical waste by the Contractor.
