Contract No. HY/2010/02

Hong Kong – Zhuhai – Macao Bridge Hong Kong Boundary Crossing Facilities – Reclamation Works

Monthly EM&A Report for February 2016

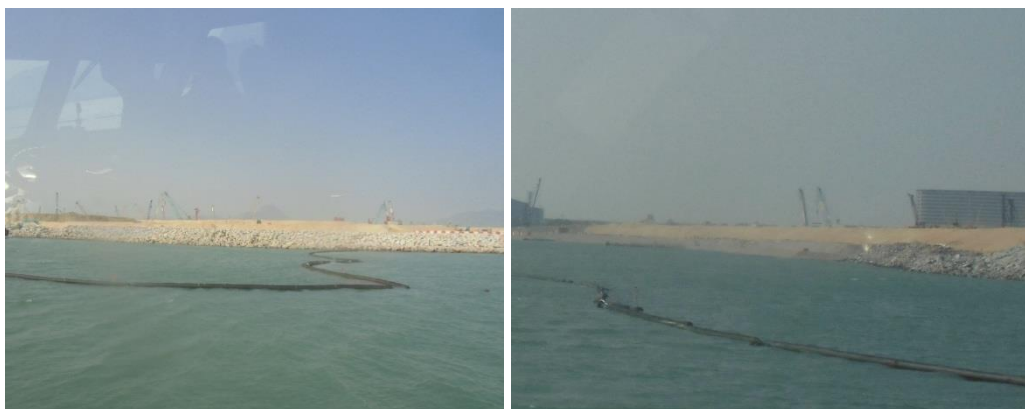
4.6.5.4 Photo record below which shows the sea condition at southern and southeastern part of the HKBCF reclamation works during flood tide on 5 February 2016.

4.6.5.5 Also, turbidity and suspended solids levels recorded at IS7, IS(Mf)9 and IS(Mf)16 were below the action and limit level. This indicates that the turbidity and suspended solids levels recorded at monitoring stations closer to the active works, were not adversely affected. As such, the exceedances recorded at SR4(N) and IS8 were unlikely attribute to the active works of this Contract.

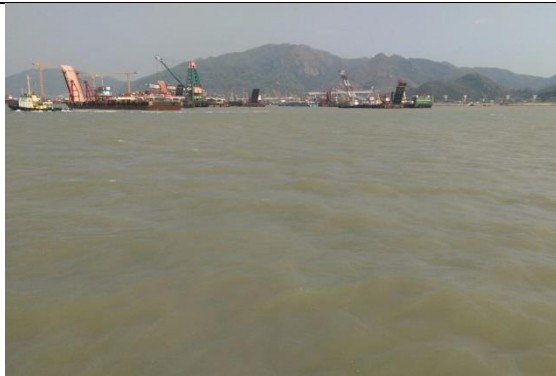
4.6.5.6 With referred to the photo record taken at monitoring station IS8 on 5 February 2016 (also see attached photo record) turbid water was observed at this area. However, with referred to the below photo record taken at southern and southeastern part of the HKBCF reclamation works during flood tide on 5 February 2016, turbid water was not noted. The photo record below shows that vessel activities was observed when monitoring was conducted at monitoring location IS8, as confirmed with the Contractor of HY/2010/02, this Contract did not have any construction vessels working outside the site boundary of Contract HY/2010/02 on 5 February 2016 (also refer to the below layout map).

4.6.5.7 Photo record below shows the sea condition taken on 5 February 2016 at monitoring location IS8 and facing monitoring station SR4(N), turbid water was observed at this area.

4.6.5.9 The exceedances were likely due to local effects in the vicinity of SR4(N) and IS8.

4.6.5.12 Nevertheless, the Contractor was reminded to ensure provision of ongoing maintenance to the silt curtains and to carry out maintenance work once defects were found.

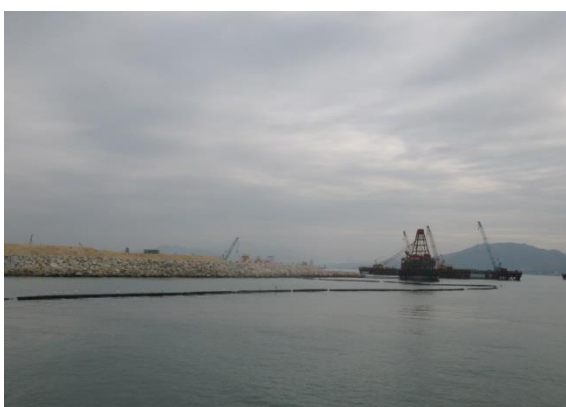
4.6.5.8 As shown below by the photo record taken on the 16 February 2016, the latest silt curtain position is within the area of the complete seawall and no more reclamation filling will be conducted by this Contract at the concerned area.

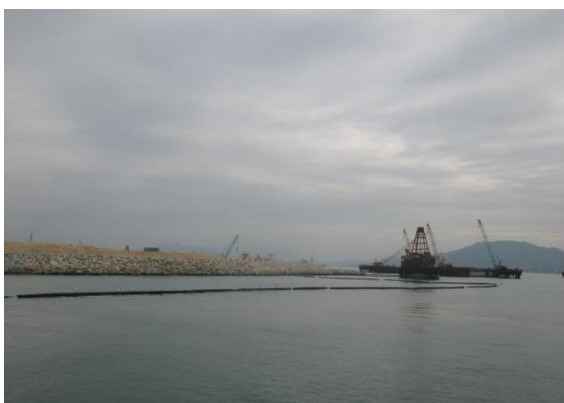
- 6.4.7.2 The impact water quality monitoring data obtained after 3 February 2016 was reviewed and no project related exceedance was observed.
- 6.4.7.3 As shown below by the photo record taken on the 16 February 2016 and it shows that the latest silt curtain position is within the area of the complete seawall. As informed by the Contractor, no more reclamation filling will be conducted by this Contract at the concerned area.

6.4.7.4 The situation is under ET's further review in the reporting period and a notification on the concerned site arrangement of the perimeter silt curtain of Contract HY/2010/02 will be given to the authority when the review is completed.

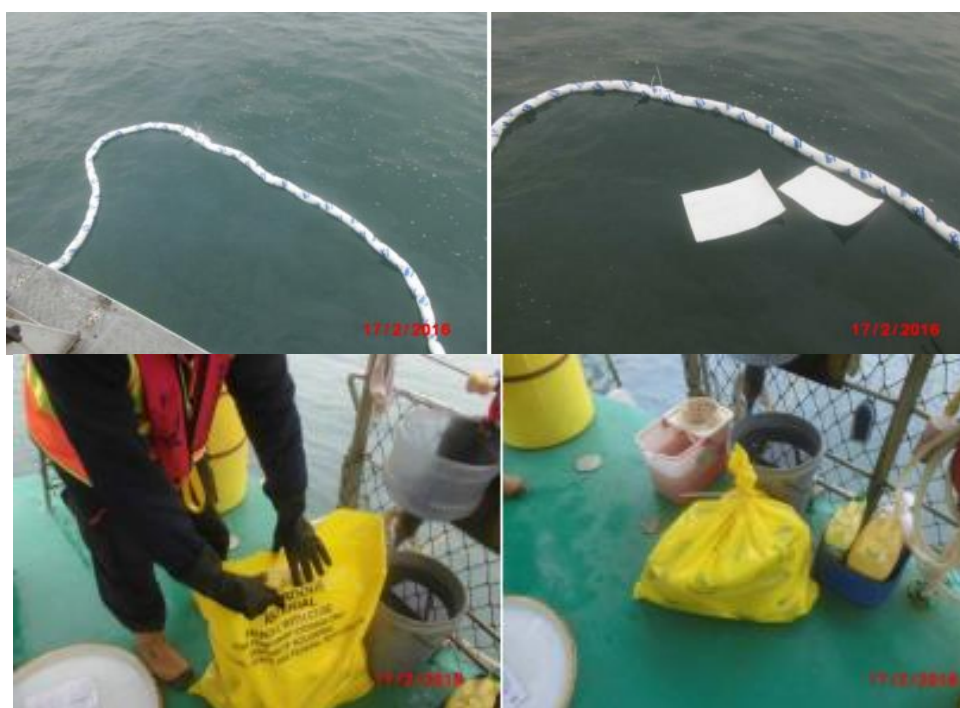
6.4.8.3 Oil was observed on sea surface near steel cell no.109 within silt curtain at 11:00 a.m. on 17 Feb 2016 by the Contractor and the RSS. The following actions was taken by the Contractor:

6.4.8.5 The oil spill was identified during join site inspection conducted by the Contractor and RSS on 17 Feb 2016 as discrete, non-continuous source with approximately 20m² spread. Also refer to photo below:

6.4.8.6 The Contractor deployed absorption booms to remove the floating oil from water and the used absorption booms were collected using disposal bags as part of the spill kits item. The used absorption booms were disposed of as chemical waste by the Contractor. (Also refer to photo record below).

6.4.8.9 The contractor was reminded to continue to follow the spill response plan when oil is observed on sea.

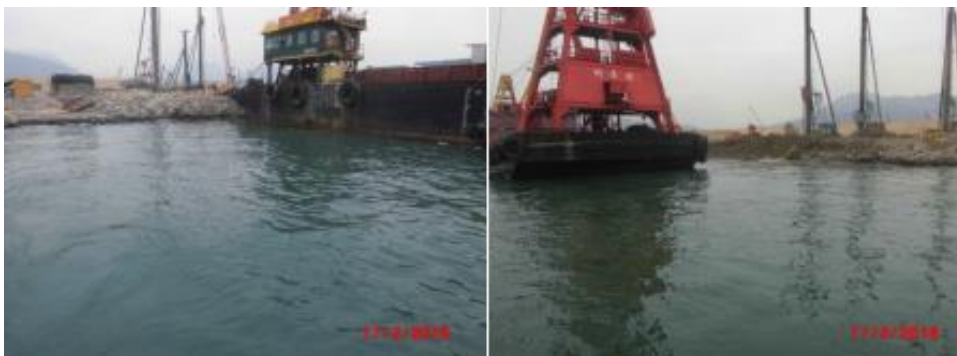
6.4.8.7 Photo record shows that oil on sea was no longer observed at sea area near Cell 109. (Also refer to photo record below)
