Contract No. HY/2010/02

## Hong Kong – Zhuhai – Macao Bridge Hong Kong Boundary Crossing Facilities – Reclamation Works

Monthly EM&A Report for July 2016

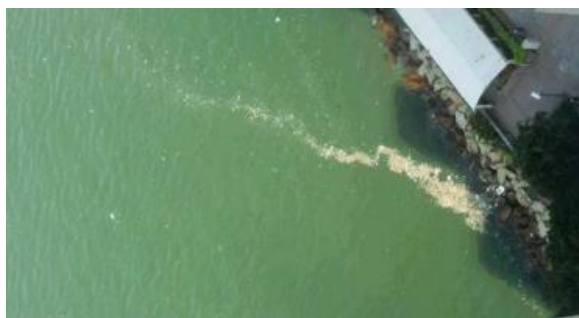
- 6.6.1 The Environmental Complaint Handling Procedure is annexed in Figure 6.
- 6.6.2 A complaint about marine litter near Tuen Mun Ferry Pier was received on 16 Jul 2016, 9:19am, also refer to below photo. The complainant complained that pollution was observed at Tuen Mun Ferry Pier and queried whether the pollutant came from the construction sites of the Lantau area or bridge construction.

- The photo provided by the complainant was reviewed and it shows that marine litter floating on sea near Tuen Mun Ferry Pier.
- Information provided by the Contractor was checked, marine activities being conducted by Contract HY/2010/02 on 16 July 2016 were accropode/rock-fill placement for the construction of the seawall by using a pelican with mechanical grab. In addition, since the location of Tuen Mun Ferry Pier is approximately 5km away from the active works contract HY/2010/02, these construction activities are unlikely related to the floating litter on sea observed near Tuen Mun Ferry Pier on 16 July 2016.
- Joint site inspection was also conducted on 21 July 2016 with the Contractor, IEC, ET and RSS. No litter was observed on sea during the inspection of the perimeter of HKBCF reclamation works.
