Contract No. HY/2010/02

Hong Kong – Zhuhai – Macao Bridge Hong Kong Boundary Crossing Facilities – Reclamation Works

Monthly EM&A Report for September 2016

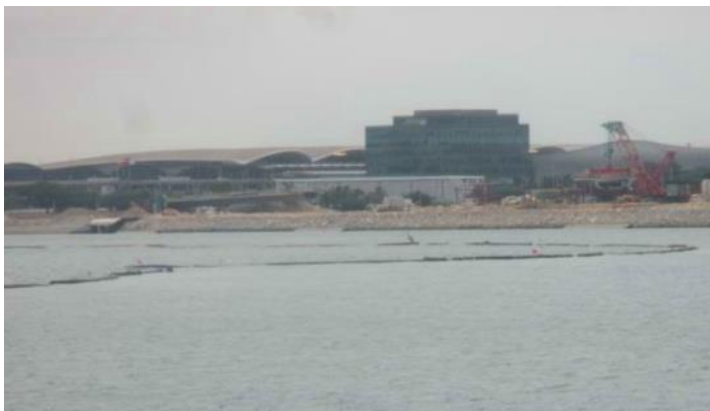
4.7.2.3 With reference to the silt curtain checking record, no defect was observed at southern part of the perimeter silt curtain which is facing IS5.

of the perimeter silt curtain to the outside of the perimeter silt curtain when monitoring was conducted during ebb tide. (Also see blow Photo record 1 for sea condition observed on 2 September 2016 during ebb tide)

4.7.2.8 Nevertheless, the Contractor was reminded to ensure provision of ongoing maintenance to the silt curtains and to carry out maintenance work once defects were found.

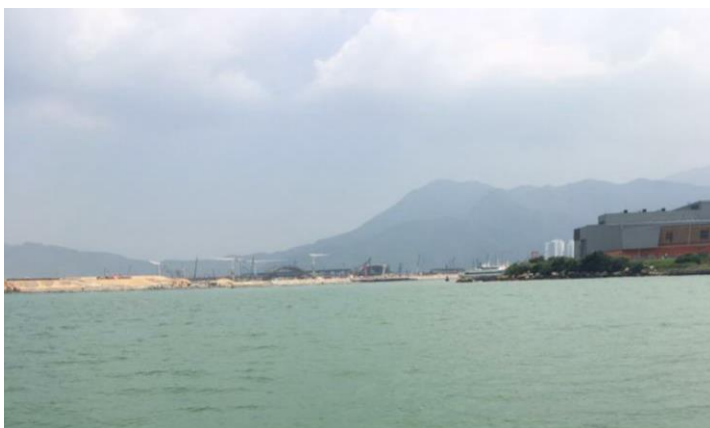
4.7.3.3 With reference to the silt curtain checking record, no defect was observed at northern part of the perimeter silt curtain which are facing SR5 and SR7

4.7.3.4 With referred to the above layout map, no marine based construction work of this Contract was conducted at the north side of HKBCF reclamation work. In addition, no silt plume was observed to flow from the inside of the perimeter silt curtain to the outside of the perimeter silt curtain when monitoring was conducted during flood tide. (Also see below Photo record 1 for sea condition observed on 19 September 2016 during flood tide.)

4.7.3.9 Nevertheless, the Contractor was reminded to ensure provision of ongoing maintenance to the silt curtains and to carry out maintenance work once defects were found.
