Contract No. HY/2010/02

Hong Kong – Zhuhai – Macao Bridge Hong Kong Boundary Crossing Facilities – Reclamation Works

Monthly EM&A Report for November 2016

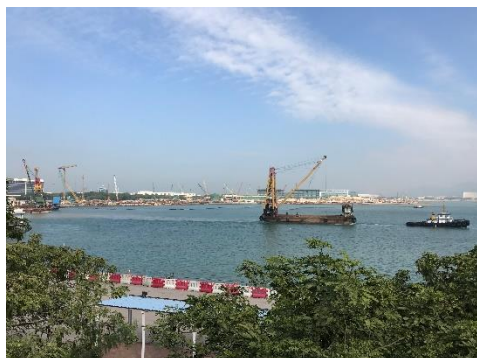
- 6.6.1 The Environmental Complaint Handling Procedure is annexed in Figure 6.
- 6.6.2 An environmental complaint was referred to the ENPO at 14:49 on the 9 November 2016 by EPD; ENPO referred this complaint to this Contract on 10 November 2016. With referred to the information provided. With referred to description provided by the complainant, with reference to a photo taken at 09:26 am on 7 November 2016 on a footbridge near Tung Chung Pier, muddy water was observed when a construction vessel 『長盛 308』 travelled from inside the works area of HZMB project - Scenic Hill section to Tung Chung Pier.

- 6.6.2.1 Below is the photo record provided by the complainant:
