Contract No. HY/2010/02

**Hong Kong – Zhuhai – Macao Bridge
Hong Kong Boundary Crossing
Facilities –
Reclamation Works**

Monthly EM&A Report for January 2017

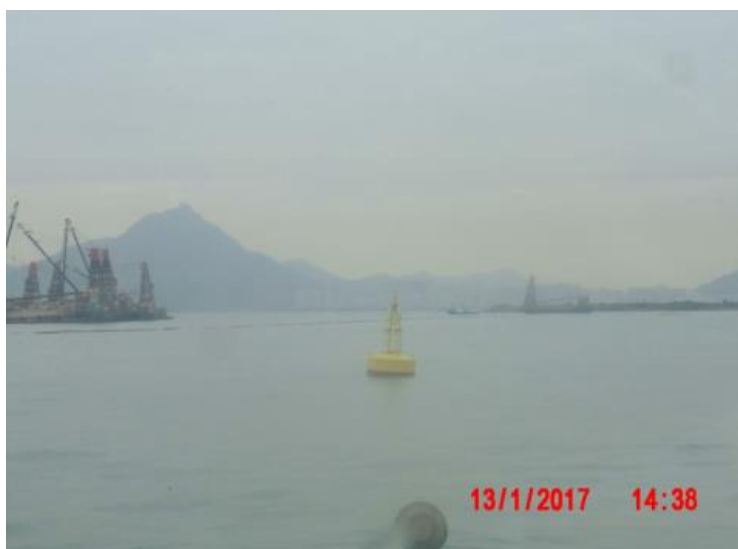
- After review of the information provided by the Contractor, seven out of twenty two vessels observed on 4 and 5 Jan 2017 worked for HY/2010/02.
- Photo below shows that no more vessel observed in the concerned area on 13 Jan 2017 at 14:38

- After investigation, it is noted that the observed vessel were removed by the Contractor on 13 January 2017 from the concerned area, and with referred to the photo record shown below, vessel under Contract no. HY/2010/02 no longer anchored at within the area of the Brothers Marine Park (BMP).

- The Contractor was informed and reminded that their vessel should no longer be anchored in the BMP after Brothers Marine Park was designated on 30 Dec 2016.
- In addition, as informed by the Contractor, the silt curtain had been deployed there since the commencement of the project. The silt curtain need to cater the movement of the water current and tidal movement and therefore may be shifted to area inside the concerned area.
- According to the available information the Contractor had already arranged the silt curtain realignment works after receiving notification of the incident by the authority, and photo record above shows that the silt curtain do not encroach the boundary of BMP on 13 January 2017.

- The Contractor was informed and reminded that their vessel should no longer be anchored in the BMP after Brothers Marine Park was designated on 30 Dec 2016.
- The Contractor was reminded that the perimeter silt curtain under Contract HY/2010/02 should be aligned to avoid encroaching the boundary of BMP at all time.
- The Contractor was recommended to carry out alignment check during regular silt curtain visual inspection, if silt curtain encroachment of the BMP was observed, the Contractor shall immediately review the situation and carry out silt curtain realignment to rectify the encroachment.

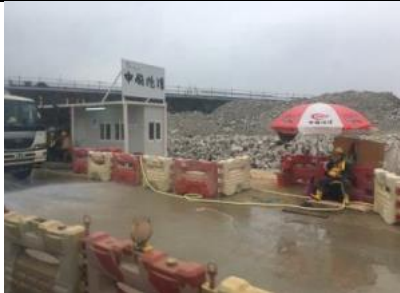
- East Coast Road (東岸道) is located near the only land-based site access of HKBCF Reclamation Works which utilised by Contract HY/2010/02, wheel washing facilities and wheel washing were provided by responsible Contractor which do not belongs to contract no. HY/2010/02:

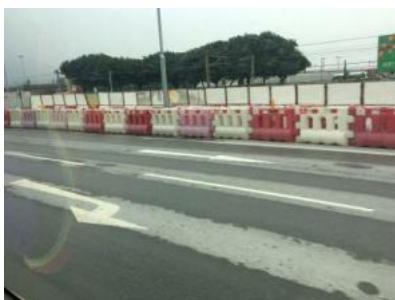
- Mud, dusts and slurry spills were not observed to be brought away from the construction sites by tippers and lorries under Contract HY/2010/02 during the site inspection on 12 January 2017

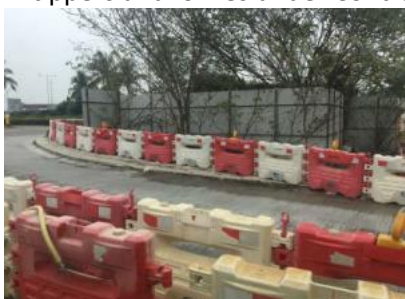
- Mud, dusts and slurry spills were not observed to be brought away from the construction sites by tippers and lorries under Contract HY/2010/02 during the site inspection on 12 January 2017.

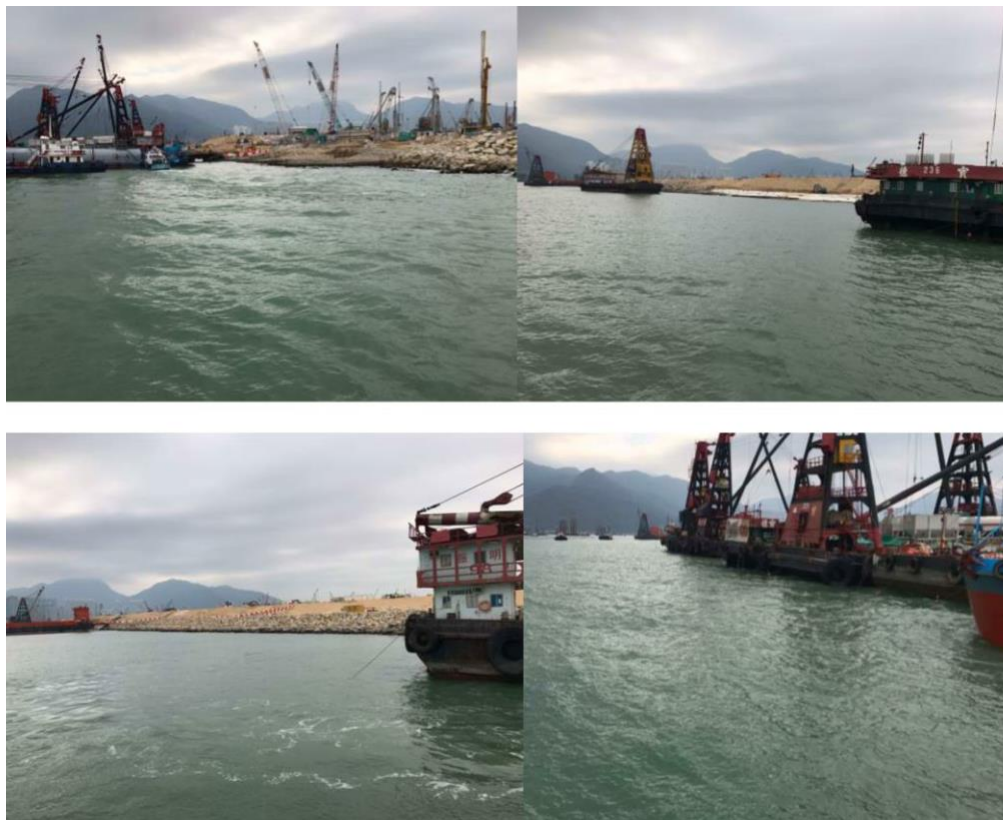
- With referred to the information provided by the Contractor, the Contractor has no activities which involve handling of sewage. Photo record taken by ET on 17 January 2017 shows that no discharge of muddy water was observed at east side of Tung Chung Artificial Island near Dragages’s construction site.

6.6.4.3 After investigation, there is no adequate information to conclude the complaint is related to this Contract.

6.6.4.4 Nevertheless, the Contractor was reminded to continue to fully and properly implement all water quality mitigation measures i.e. wastewater from temporary site facilities should be controlled to prevent direct discharge to surface or marine waters.
