**CONTRACT NO.: HY/2013/02
HONG KONG – ZHUHAI- MACAO BRIDGE
HONG KONG BOUNDARY CROSSING
FACILITIES – INFRASTRUCTURE
WORKS STAGE I
(WESTERN PORTION)
MONTHLY EM&A REPORT
NO. 40
(01 MARCH – 31 MARCH 2018)**

Report No.: ENA82215

**Contract No. HY/2013/02 – HZMB HKBCF – Infrastructure Works Stage I
(Western Portion)
Monthly Environmental Monitoring & Audit Report for March 2018**

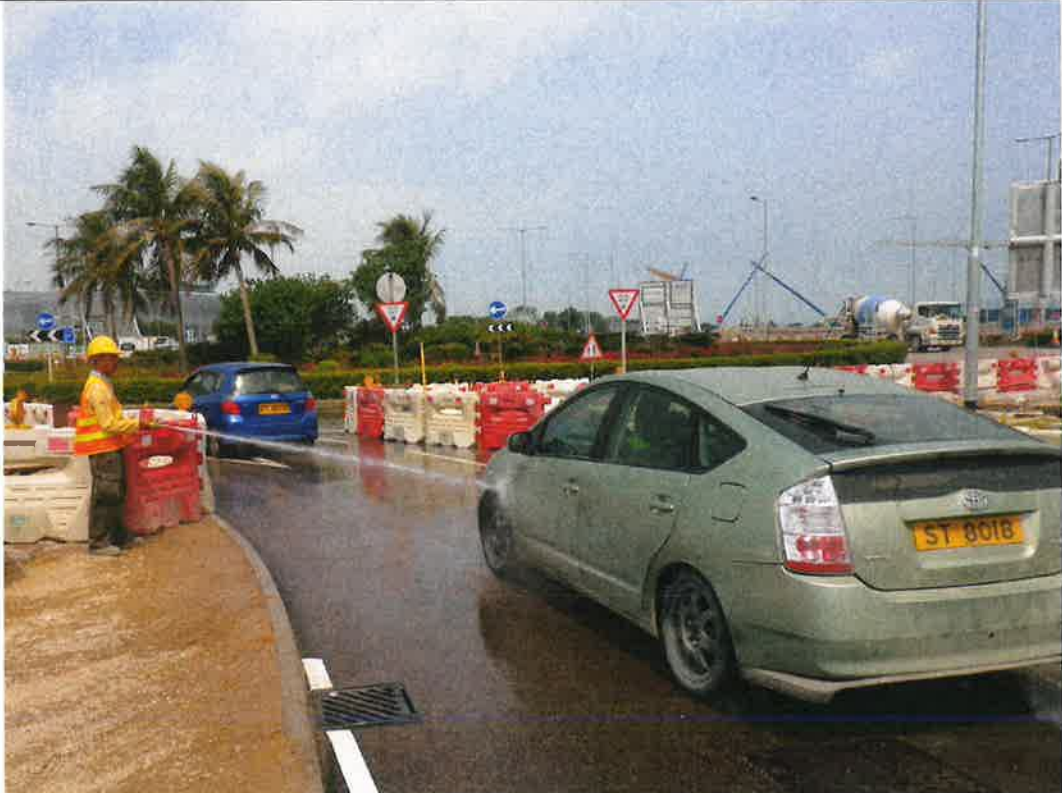
Photo 180315_003 & 004 –Washing facilities with high pressure water jet at the intersection with other contract and the site exit

Refer to the above mentioned inspection, washing facilities were provided after 19:00. Mitigation measures under the item A2 and W2 of EMIS were implemented including provide vehicle washing facilities with high pressure water jet at the intersection with other contract and the site exit (East Coast Road gate), all vehicles and plant were cleaned before they leave the construction site, provide notice to remind the vehicles to pass through the washing facilities before leaving the site. Hence, the complaint was found non-related to Contract No. HY/2013/02.
