**CONTRACT NO.: HY/2013/02
HONG KONG – ZHUHAI- MACAO BRIDGE
HONG KONG BOUNDARY CROSSING
FACILITIES – INFRASTRUCTURE
WORKS STAGE I
(WESTERN PORTION)**

**QUARTERLY EM&A REPORT
NO. 8**

(01 SEPTEMBER – 30 NOVEMBER 2016)

Report No.: ENA67142

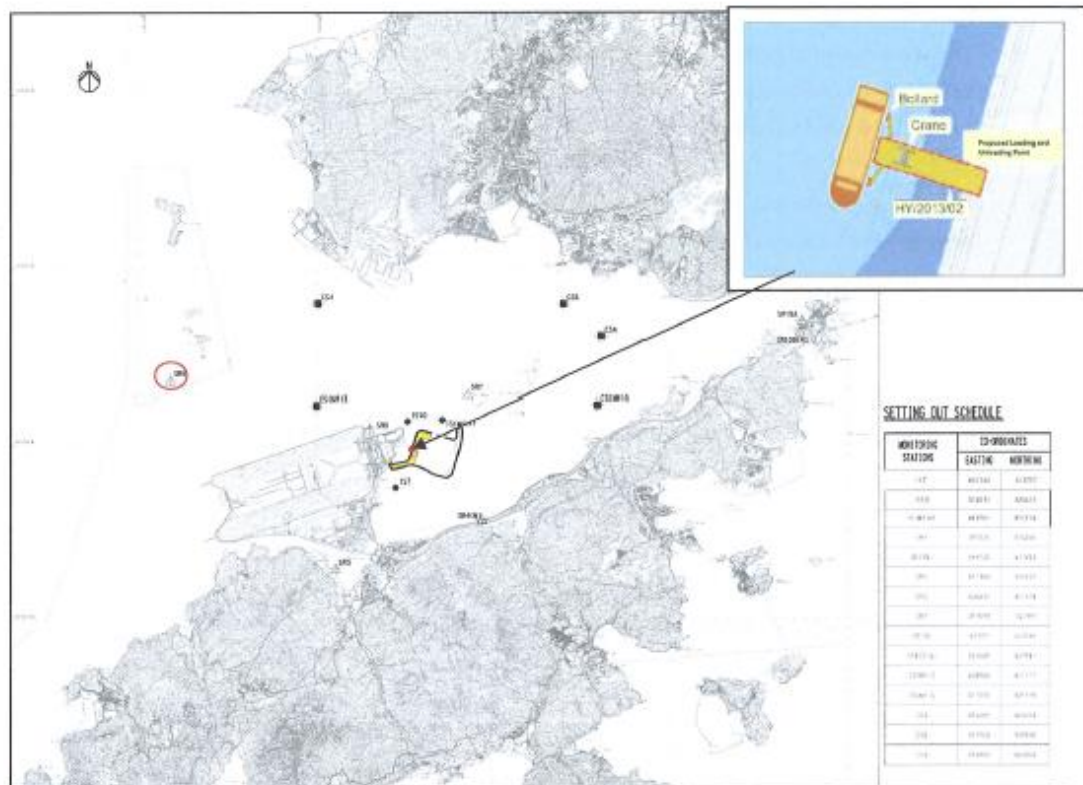
Figure 1 Location of Water Quality Monitoring Stations

Monitoring Station	Monitoring time	Measured depth averaged	Level Exceeded
SR6	08:45	24.2	Action

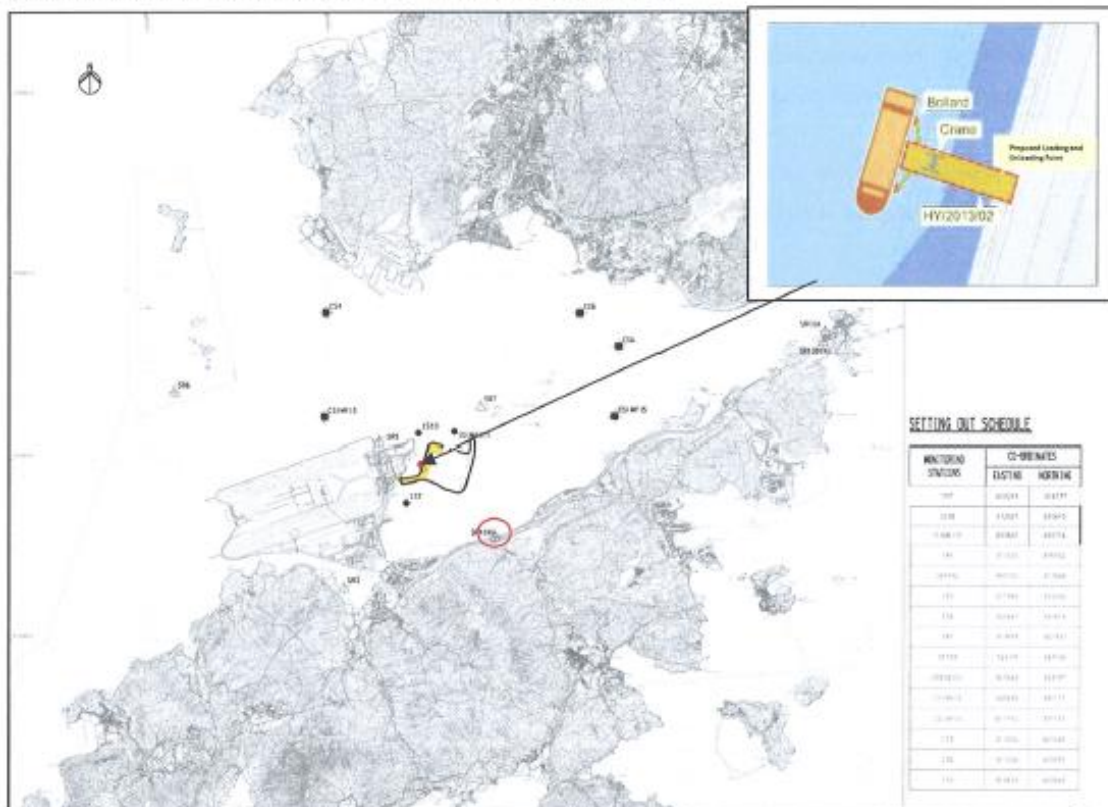
Figure 1 Location of Water Quality Monitoring Stations

Monitoring Station	Monitoring time	Measured depth averaged	Level Exceeded
SR4(N)	17:26	25.6	Action

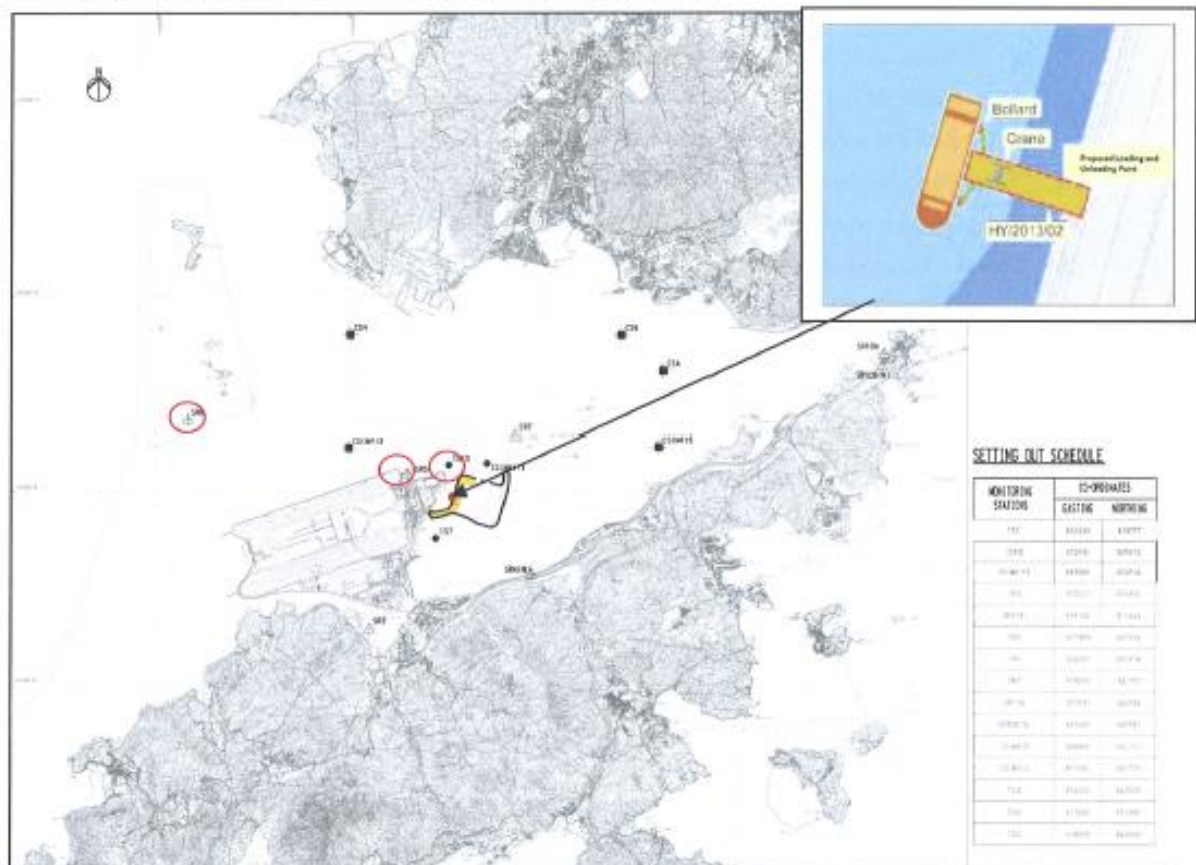
Figure 1 Location of Water Quality Monitoring Stations

Monitoring Station	Monitoring time	Measured depth averaged	Level Exceeded
IS10	8:38	31.4	Action
SR5	8:51	28.8	Action
SR6	9:47	35.8	Limit

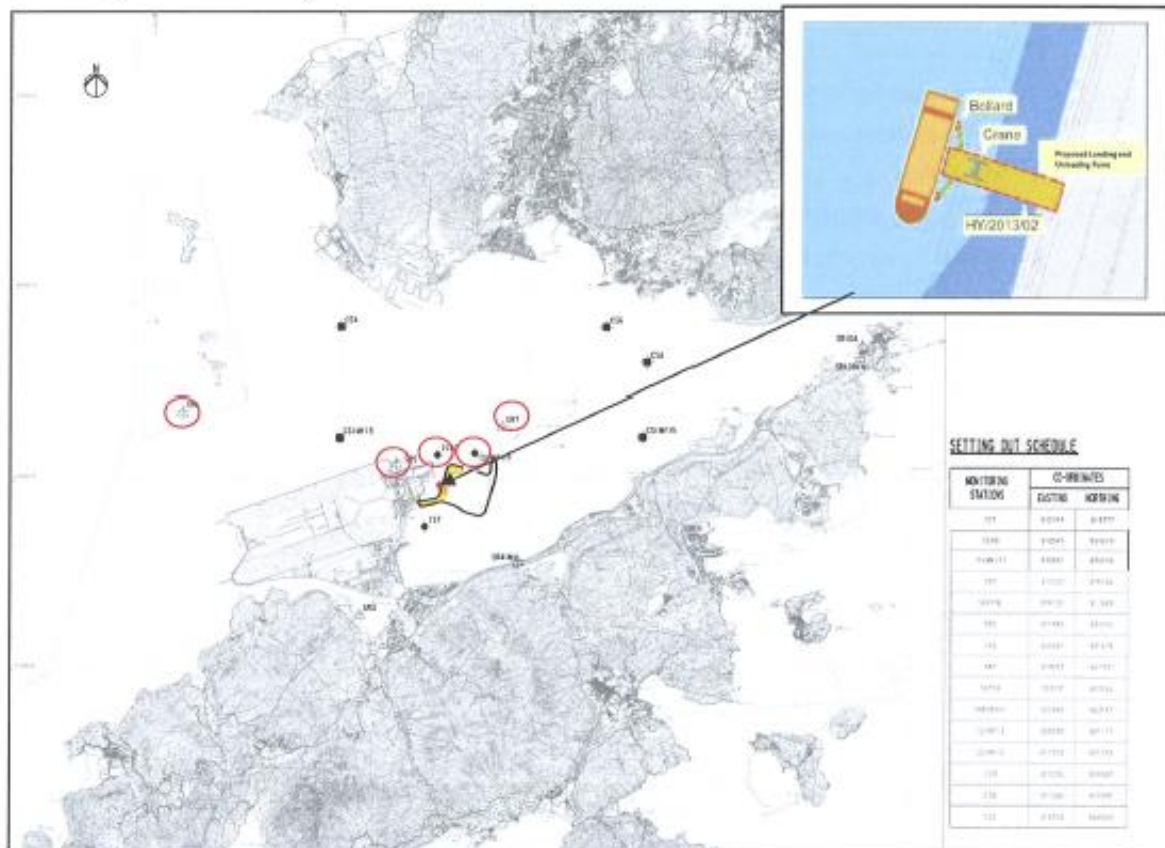
Figure 1 Location of Water Quality Monitoring Stations

Monitoring Station	Monitoring time	Measured depth averaged	Level Exceeded
IS(Mf)11	10:13	31.8	Action
IS10	10:25	28.8	Action
SR5	10:33	33.4	Action
SR6	11:22	25.1	Action
SR7	10:04	24.5	Action

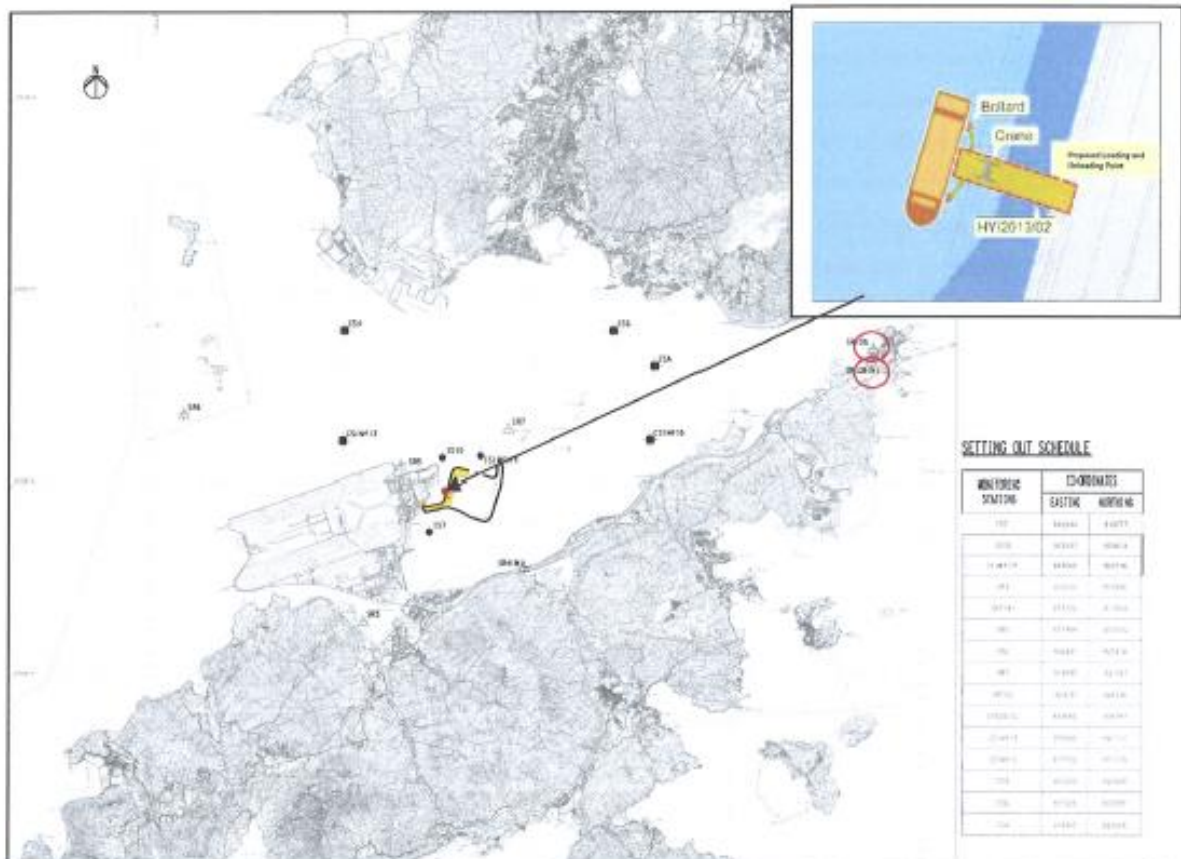
Figure 1 Location of Water Quality Monitoring Stations

Monitoring Station	Monitoring time	Measured depth averaged	Level Exceeded
SR10A	07:16	25.9	Action
SR10B(N)	07:07	24.5	Action
