### **Complaint Investigation Report**

### Complaint Investigation Report

**Contract No. HY/2013/02 -  
Hong Kong- Zhuhai- Macao Bridge  
Hong Kong Boundary Crossing Facilities –  
Infrastructure Works Stage I (Western Portion)**

**Log No. : 018**

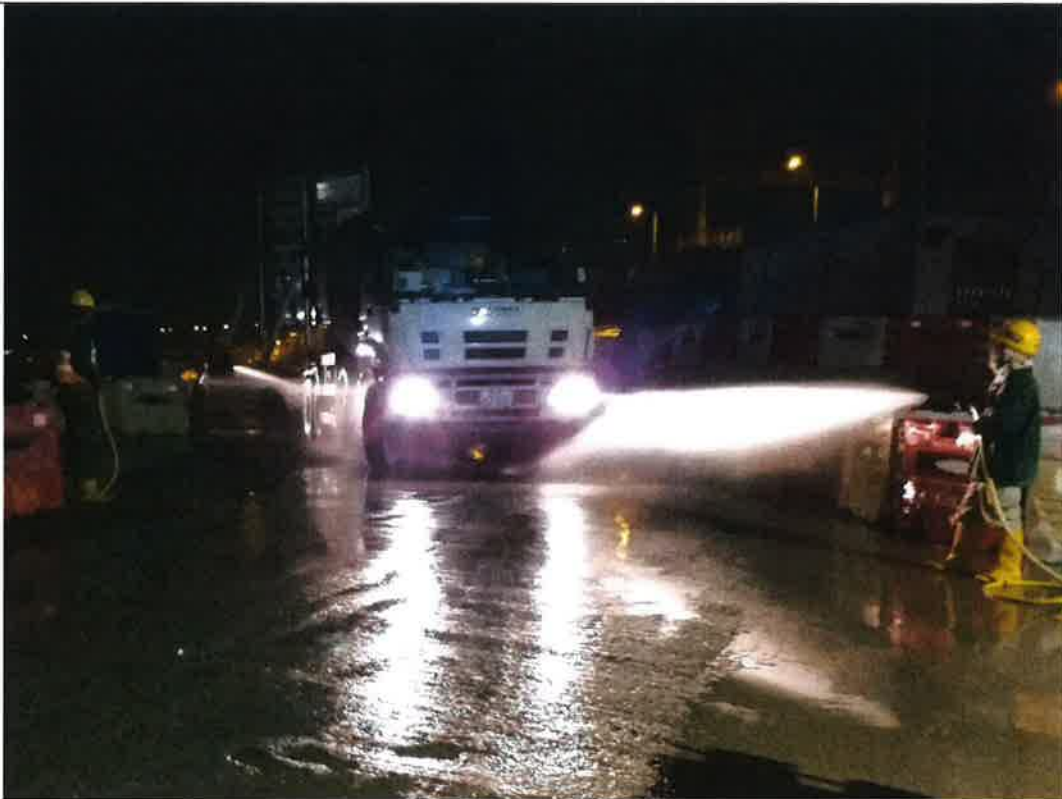
Photo 180208\_001 – Photo taken on 06 February 2018 at the site exit

After received the details of the complaint from the ENPO on 05 February 2018, a related follow-up inspection was conducted by ET and the Contractor of Contract No. HY/2013/02 to investigate this event. The inspection was concentrated to check if washing facilities provided after 19:00. After checked with the Contractor of Contract No. HY/2013/02, the washing facilities were provided after 19:00 and vehicles were cleaned before leaving the construction site (see attached photo 180208\_001). Besides, the washing facilities were also provided before receiving the complaint (see attached photo 180208\_002 & 180208\_003). Hence, the complaint received on 05 February 2018 was found non-related to Contract No. HY/2013/02.

Although these complaints were non-related to Contract No. HY/2013/02, the Contractor of HY/2013/02 was reminded to prohibit any un-cleaned vehicles from leaving the construction site, provide wheel washing facilities if there were night works of Contract No. HY/2013/02, keep the reminders at the wheel washing basin and exit to remind all Contract(s) vehicles using the site exit for proper wheel washing for the proper implementation of environmental mitigation measures associated with the site exit.

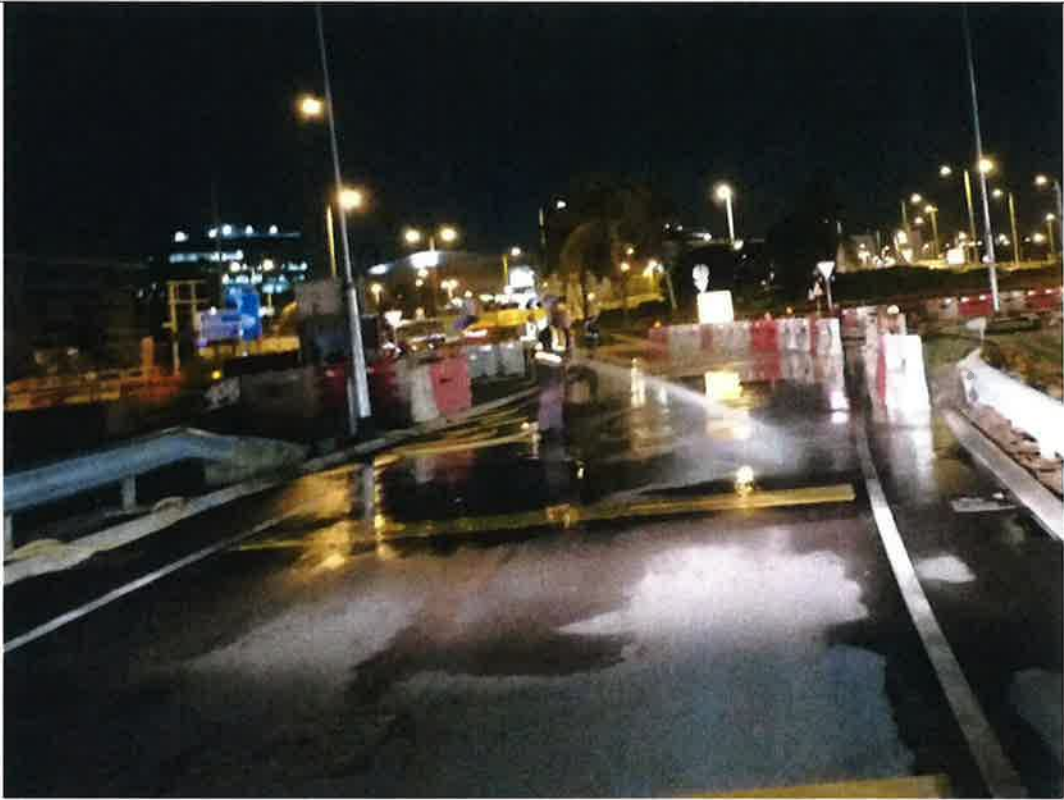
Photo 180312\_001 – Photo taken on 12 March 2018 at the site exit

For the follow up complaint received on 09 March 2018, a related follow-up inspection was conducted on 12 March 2018 to investigate this event. The washing facilities were provided after 19:00 during inspection (see attached photo 180312\_001). Besides, the washing facilities were also provided before receiving the follow up complaint (see attached photo 180224\_001 & 180307\_001). After checking with the contractor of Contract No. HY/2013/02, there were no night works after 19:00 by Contract No. HY/2013/02 on 08 March 2018. The wheel washing facilities would only be provided if there were works conducted within the site area of Contract No. HY/2013/02. Hence, the follow up complaint received on 09 March 2018 was found non-related to

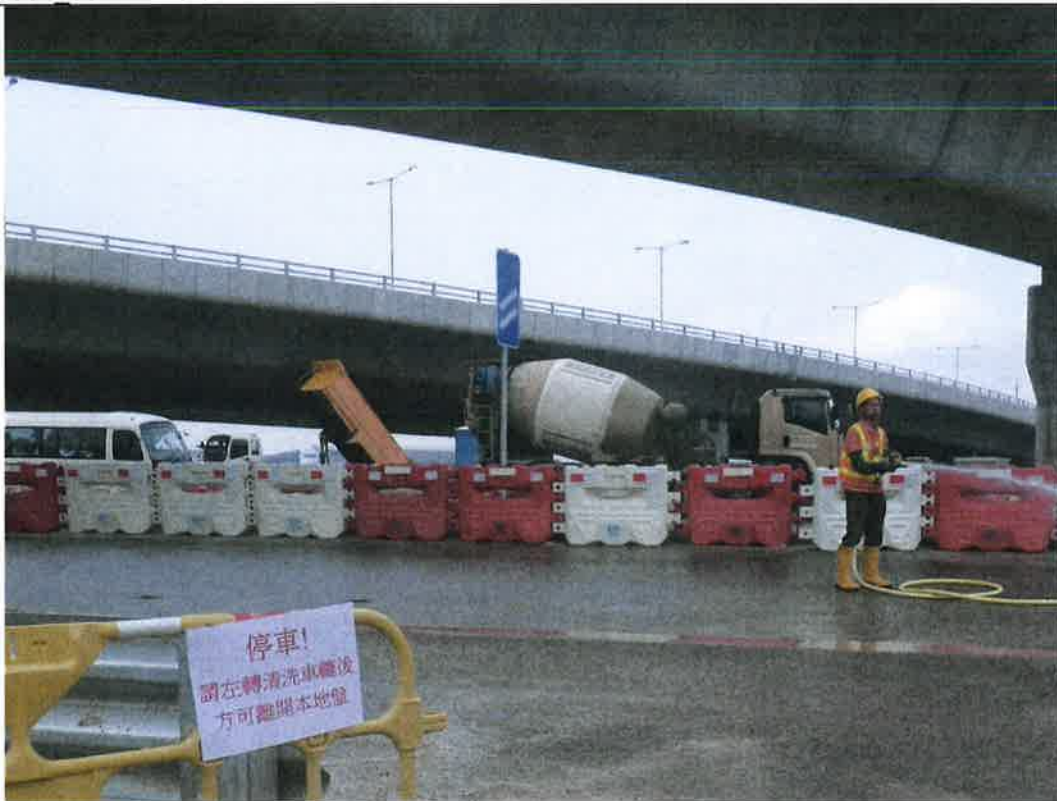
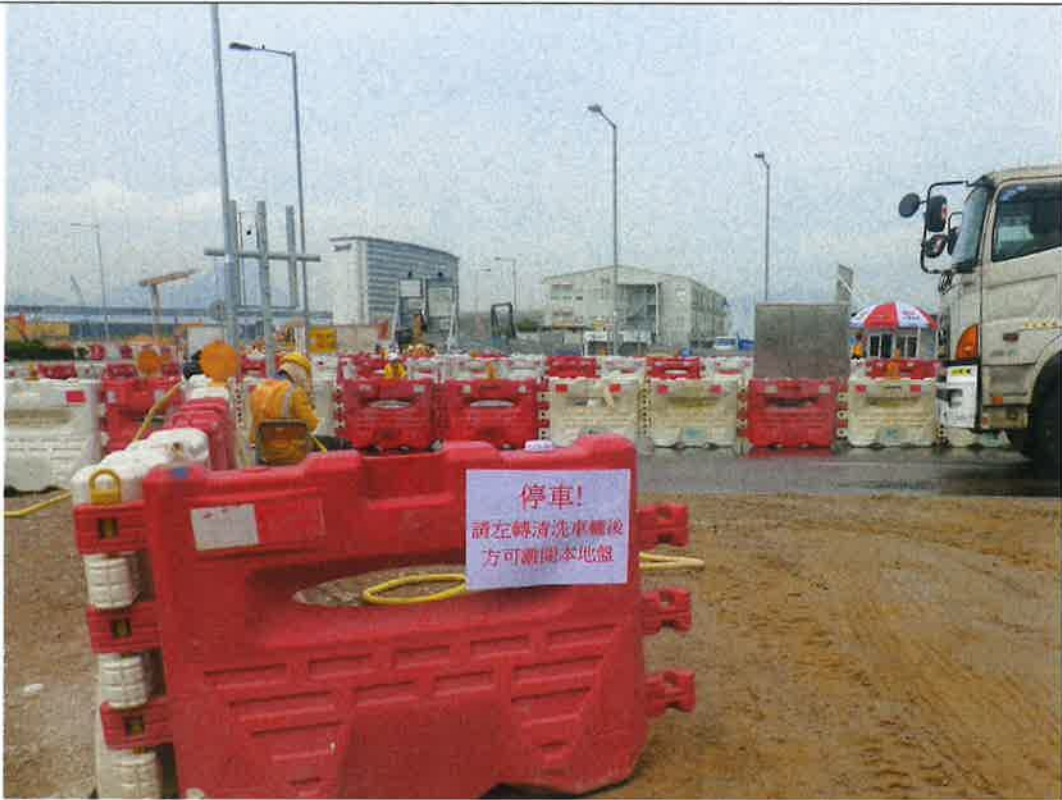
In order to assort with the new arrangement of washing facilities, follow-up site inspections were performed. Washing facilities with high pressure water jet at the intersection with other contract and the site exit (East Coast Road gate) was provided. The road section between the washing facilities and the exit point was hard paved and water lorries were arranged regularly to clean the road section between washing facilities and site exit. Notices were adhered at the intersection between muddy area and haul roads in order to remind the vehicles to pass through the washing facilities before leaving the site. The photos taken during the follow-up inspections were attached (photo 180315\_001, 002, 003 & 004).

Photo 180315\_001 & 002 – Notices for reminding the vehicles to pass through the washing facilities before leaving the site

1. Provide notices at the intersection between muddy area and haul roads in order to remind the vehicles to pass through the washing facilities before leaving the site;
2. Provide wheel washing facilities with high pressure water jet at the intersection with other contract and the site exit (East Coast Road gate) in order to prohibit any un-cleaned vehicles from leaving the construction site;
3. Arrange water lorries regularly to clean the road section between washing facilities and site exit

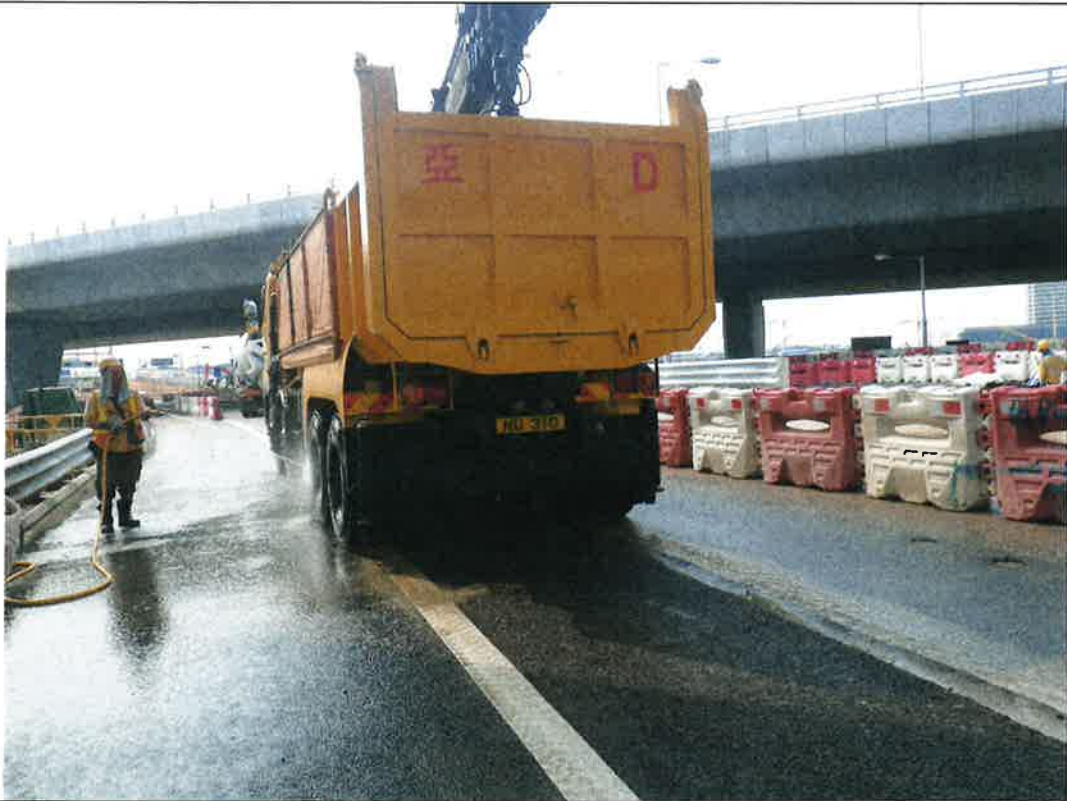
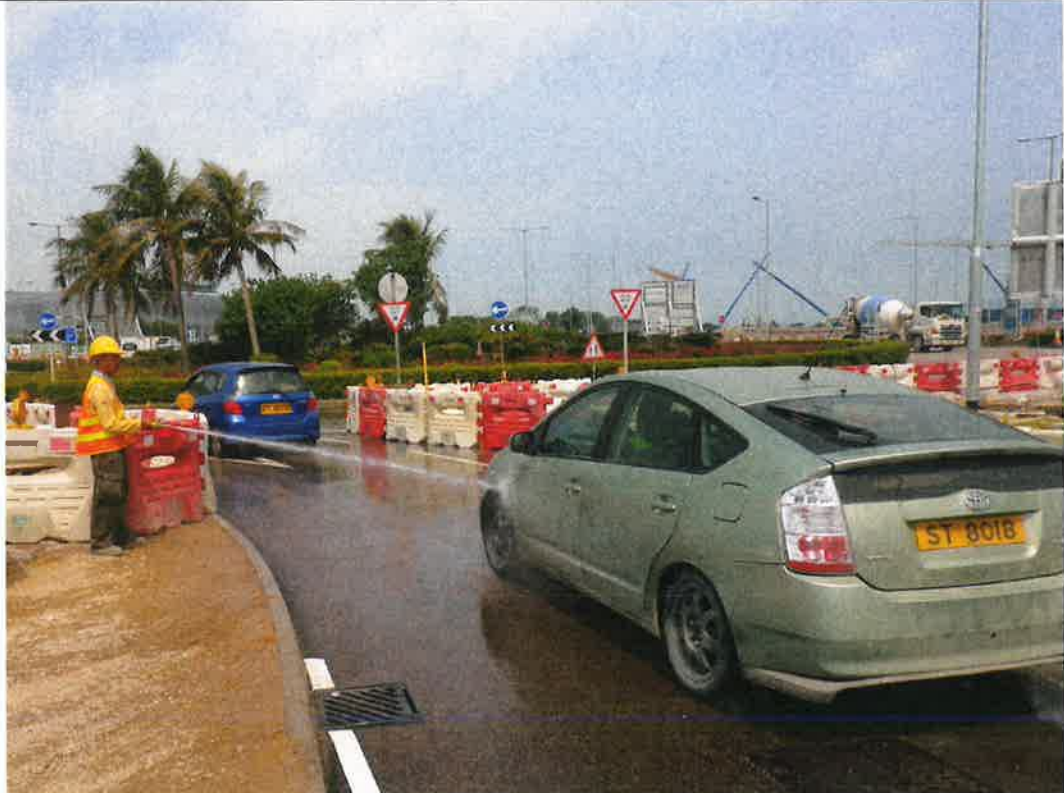
Photo 180315\_003 & 004 –Washing facilities with high pressure water jet at the intersection with other contract and the site exit

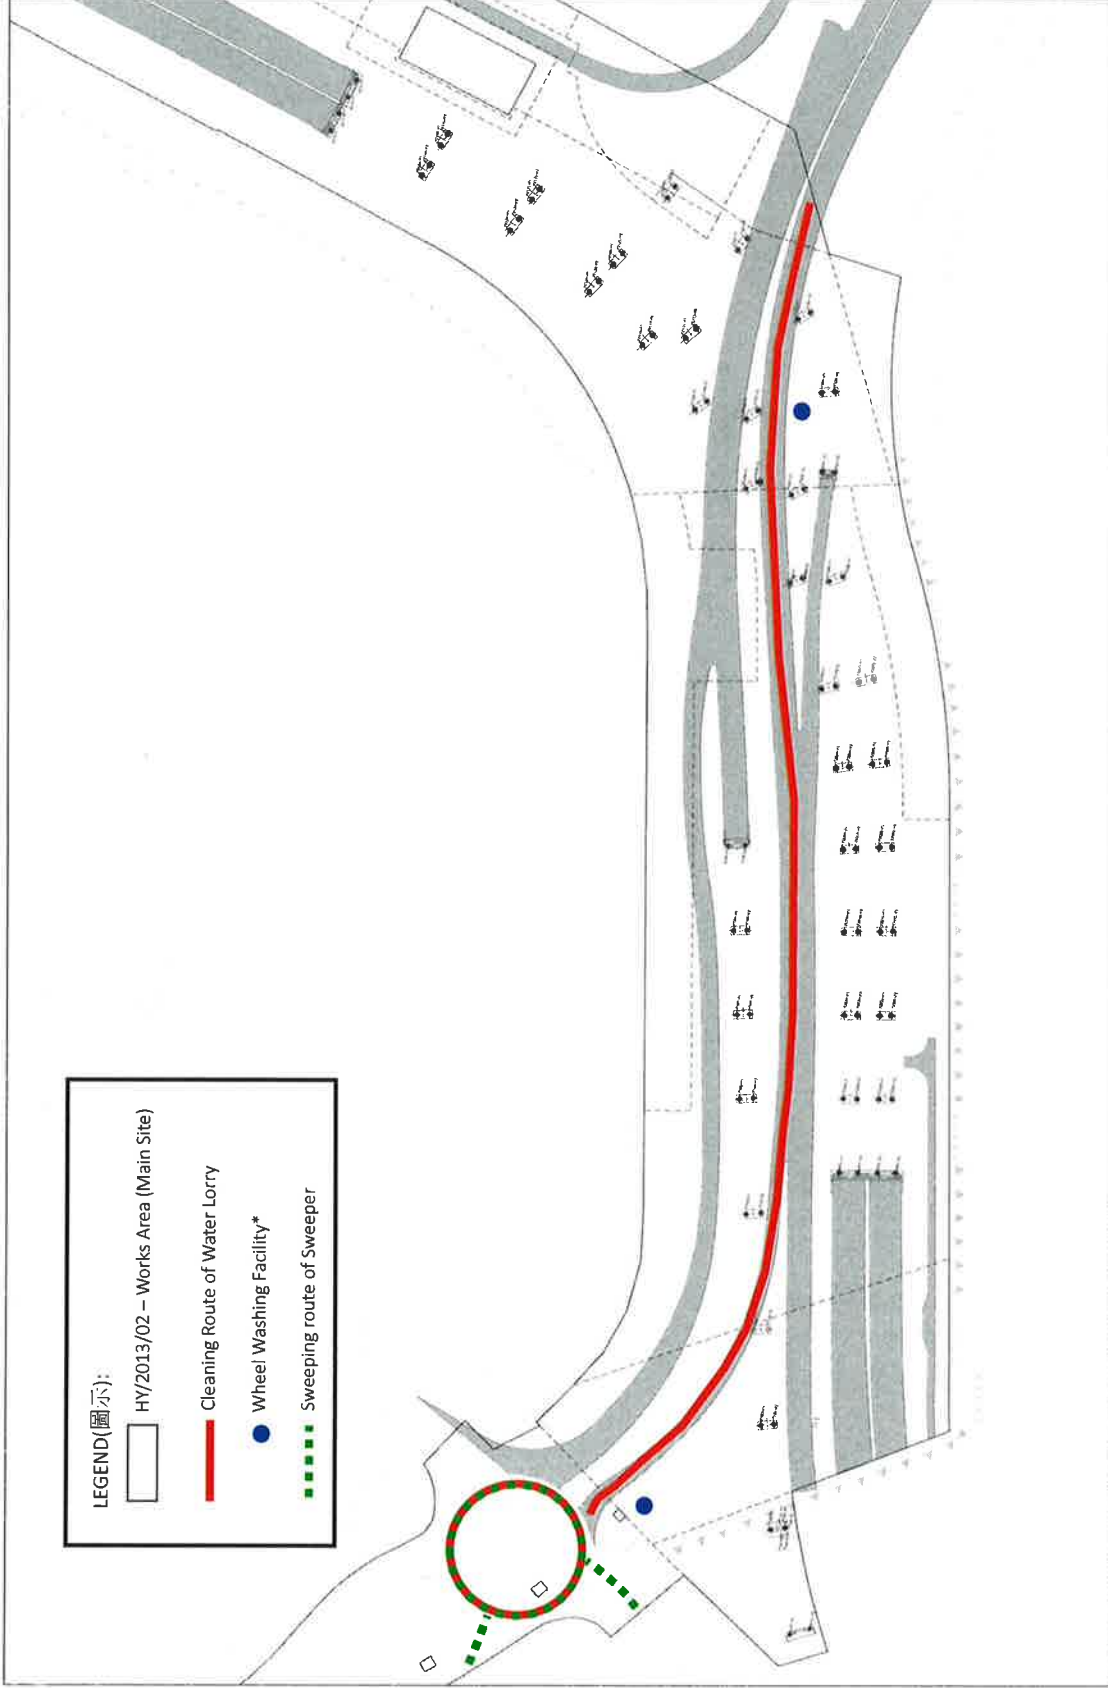
### Haul road cleaning route

1:2500 - Construction Road and Site Boundary, 1:2500 - Construction Road and Site Boundary, 1:2500 - Construction Road and Site Boundary

- One worker is deployed for each wheel washing facility and available when vehicle depart from that intersection.
- The Wheel Washing Facilities will be removed when the intersections are closed (tentatively scheduled at the end of April 2018).

In between these two complaints, there were some adjustments of the wheel washing facilities. Due to the diversion of traffic, the vehicles under Contract No. HY/2013/02 would only pass through the paved haul road and thus wheel washing facilities would only be provided at the intersection with other contract and the site exit (East Coast Road gate) since 01 March 2018. Haul road cleaning was provided at the site exit for 24 hours if any muddy condition was found. All vehicles of other contracts from entering the site area of Contract No. HY/2013/02 should be cleaned and all the haul roads are hard paved and thus self wheel washing facilities were not required. Haul road cleaning would be carried out at site exit to ensure the paved roads leading to site entrance are clean. The RSS's agreed updated wheel washing facilities plan and road washing / cleaning plan was attached below. The Wheel Washing Facilities will be removed when the intersections are closed (tentatively scheduled at the end of April 2018).
