<b>Contract No. HY/2014/05 -  Hong Kong- Zhuhai- Macao Bridge  Hong Kong Boundary Crossing Facilities – Remaining Ancillary Buildings and Facilities</b> <b>Notifications of Environmental Quality Limits Exceedances</b> <span style="float: right;">Notification No.: 20171223_Air_24hr</span>				
<b>Date of Investigation Report:</b> 10 January 2018				
<b>Date of Environmental Quality Limit Exceedance:</b> 23 December 2017 and the results were issued on 5 January 2018				
<b>Monitoring Location:</b> AMS3B – Site Boundary of Site Office Area at Work Area WA2 (The air quality monitoring station for the Contract is covered by Contract No. HY/2013/01 HZMB HKBCF – Passenger Clearance Building)				
<b>Monitoring Date:</b> 23 December 2017 <b>Start Time:</b> 08:00				
<b>Action &amp; Limit Level (AL &amp; LL) / Measured Level:</b>				
PARAMETER	STATION	AL (µg/m <sup>3</sup> )	LL (µg/m <sup>3</sup> )	MEASURED LEVEL, µg/m <sup>3</sup>

**Contract No. HY/2014/05  
Hong Kong – Zhuhai – Macao – Bridge  
Boundary Crossing Facility – Remaining Ancillary Buildings and Facilities**

**Watering Plan for December 2017**

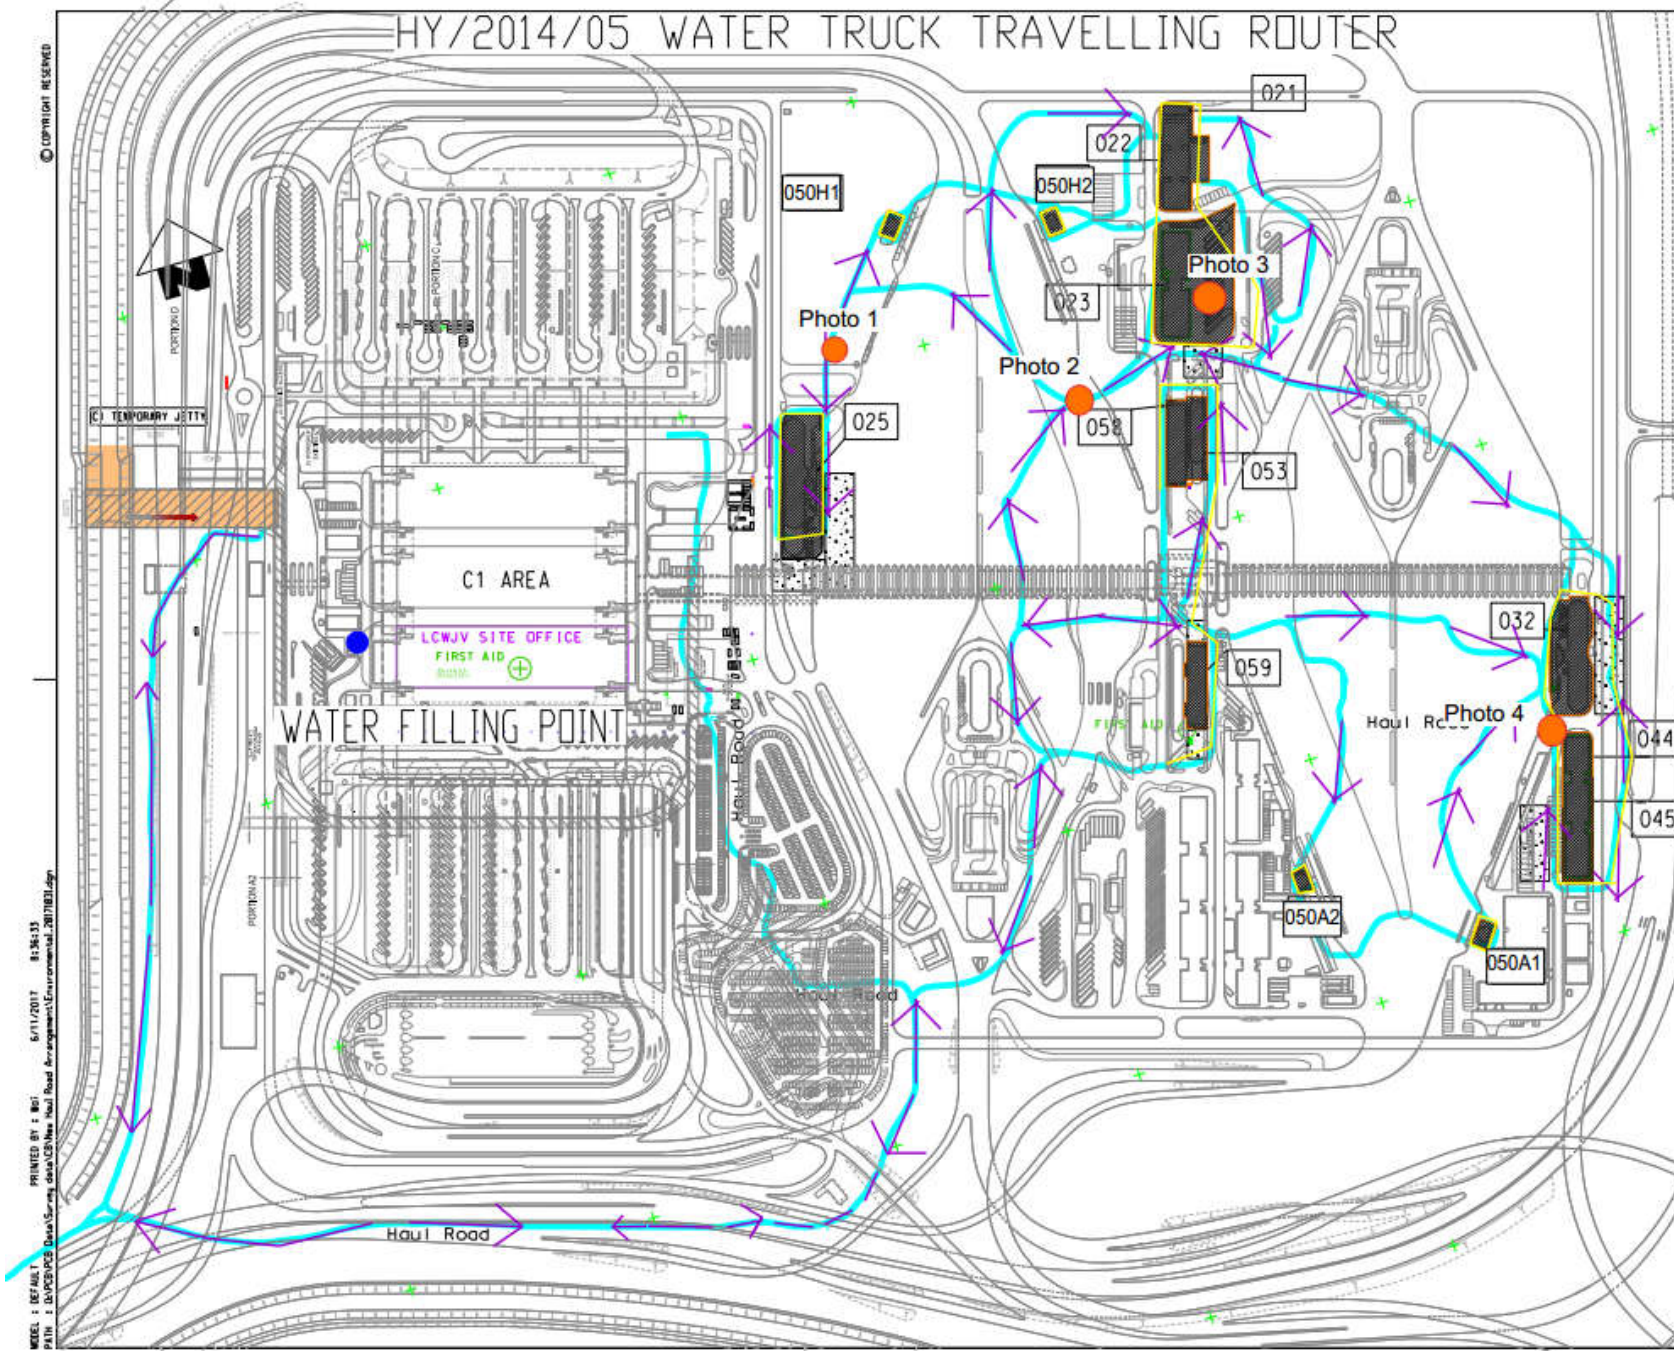
# HY/2014/05 WATER TRUCK TRAVELLING ROUTER

- LEGEND**
- WATER FILLING POINT
  - WORKING SPACE
  - TRAVEL ROUTE
  - ROAD WITH WATER SPRAYING BY HY/2014/05
  - HAUL ROAD OF HKBCF

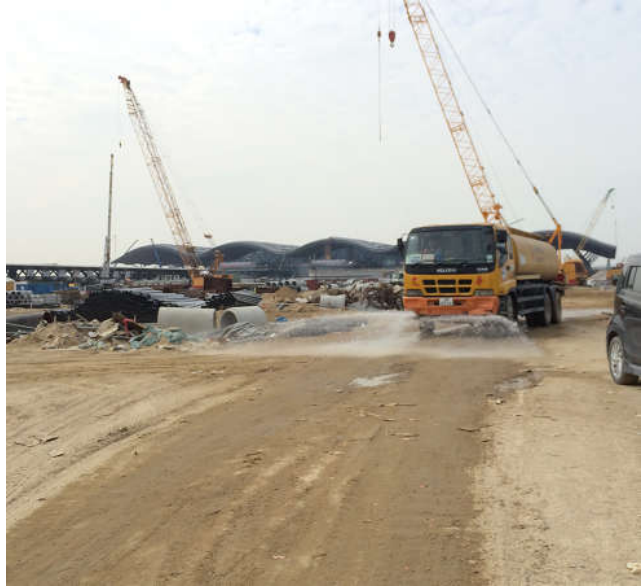
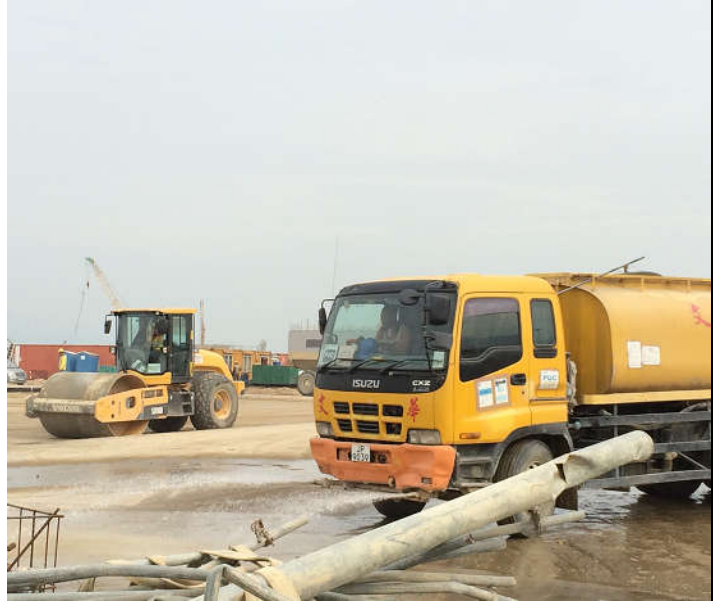
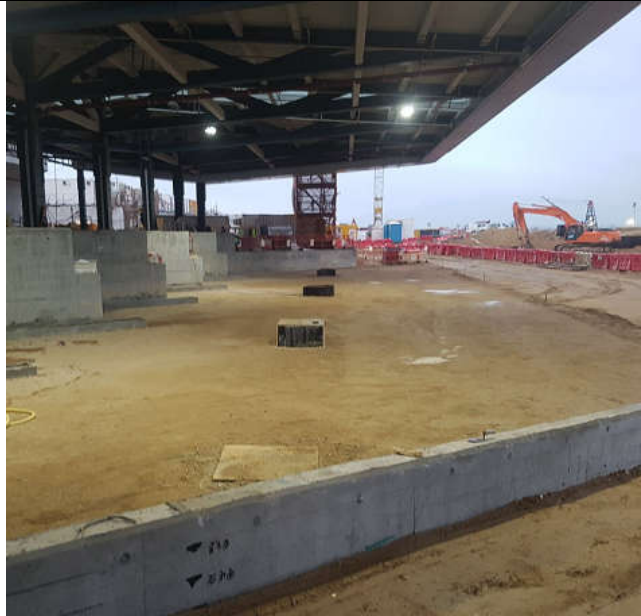
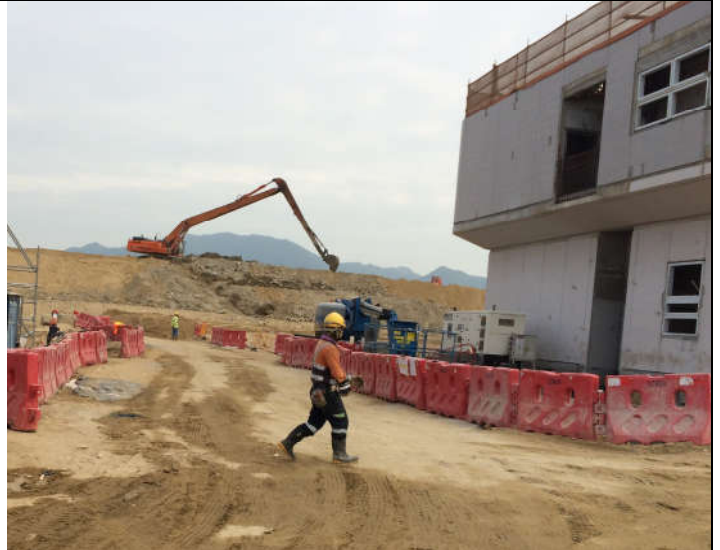
Water spraying record during TSP 24-hr monitoring on 23 and 24 December 2017

The Contractor confirmed that the mitigation measures according to Water Spraying Plan in December 2017 (Appendix A) are implemented to avoid dust emission. Photos of haul road condition and dust suppression are included in Appendix A. The Contractor has provided the guideline to remind the site vehicles travel within speed limit of 8km/hr. According to site inspection which conducted on 4, 13, 18 and 27 December 2017, no dusty activities and dry condition in haul road were observed.

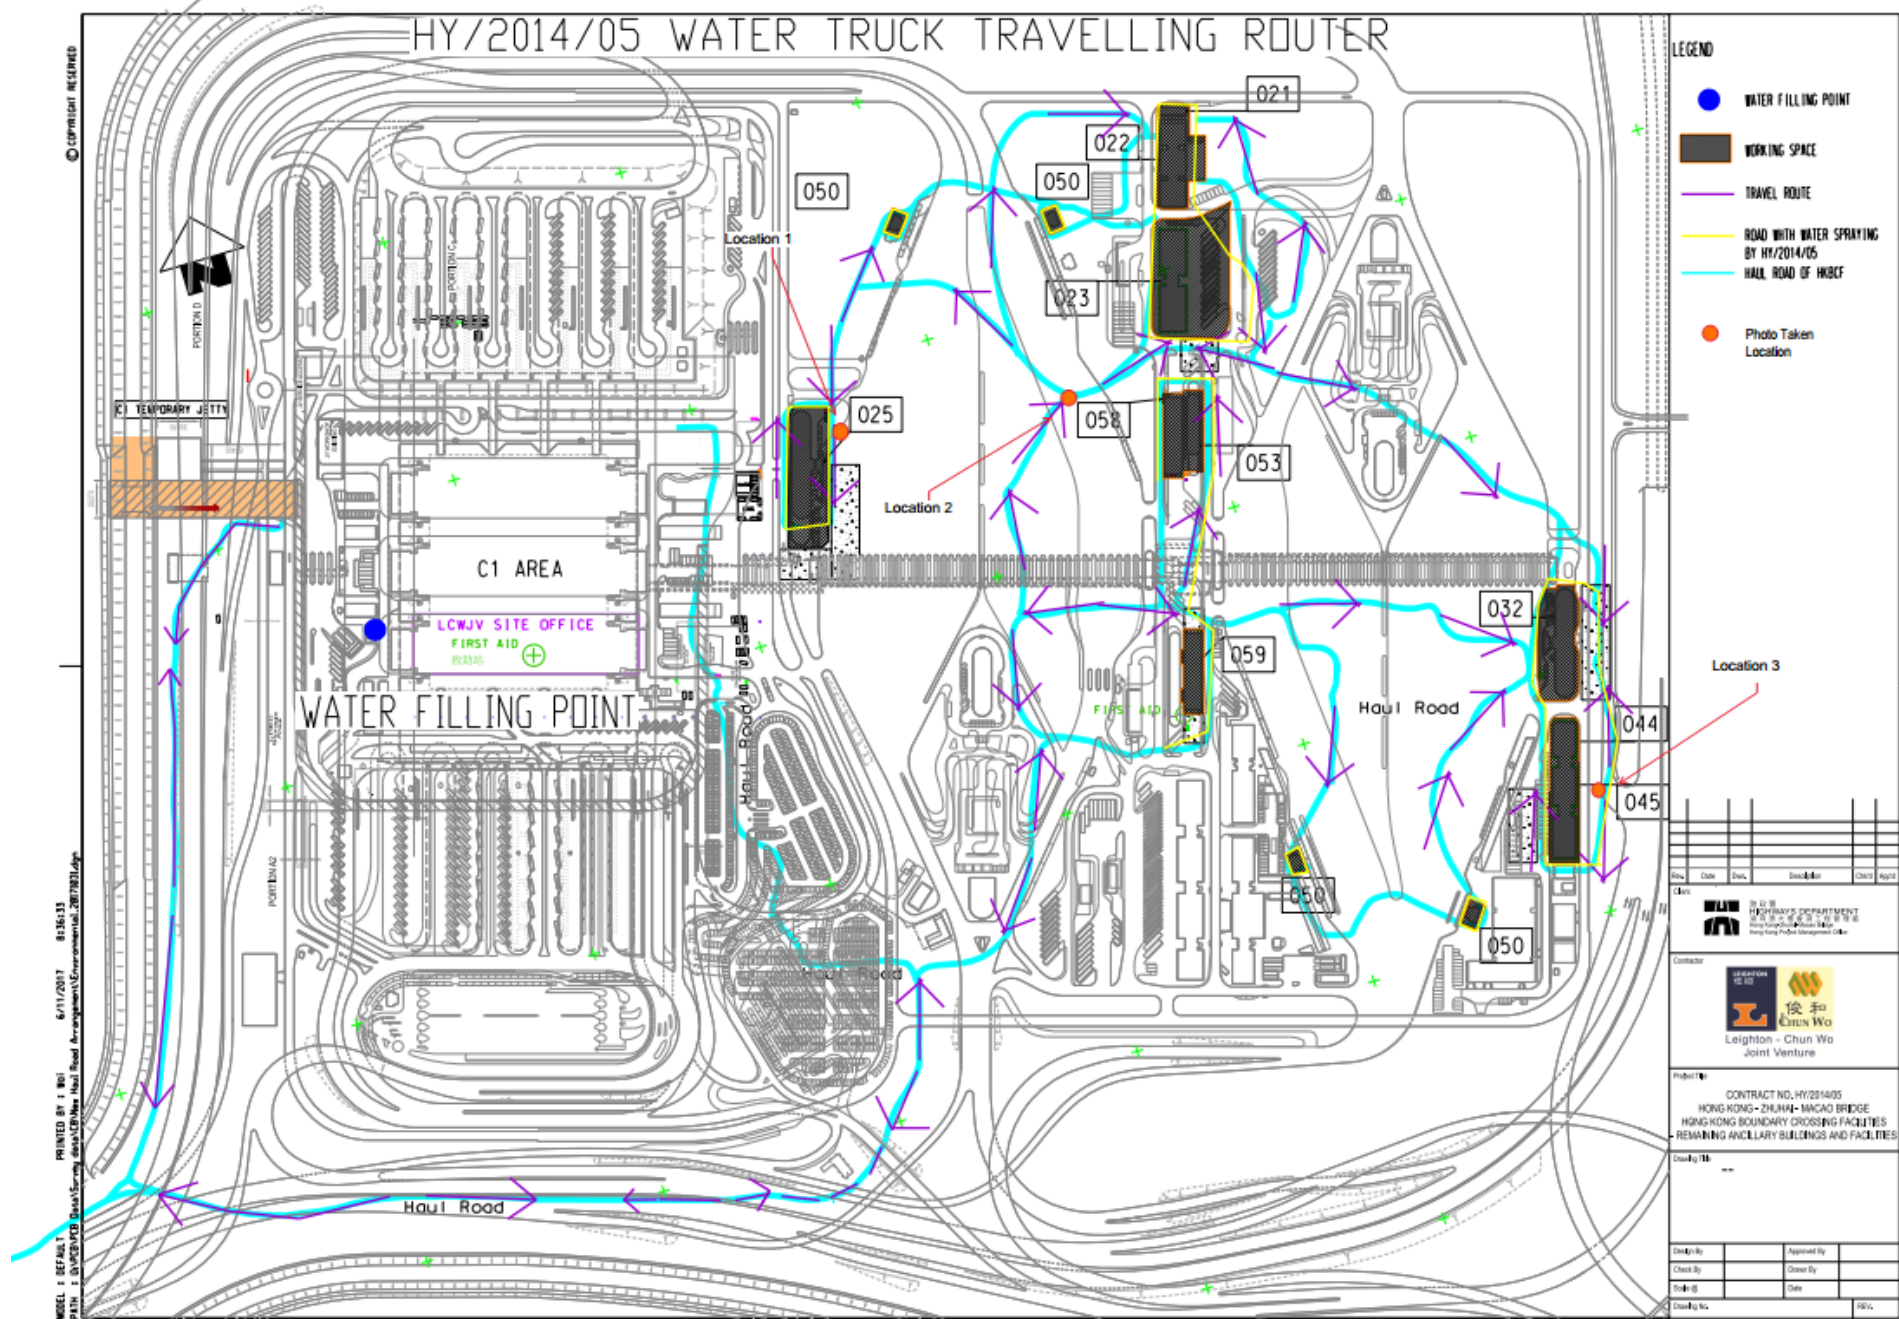
# HY/2014/05 WATER TRUCK TRAVELLING ROUTER

- LEGEND**
- WATER FILLING POINT
  - WORKING SPACE
  - TRAVEL ROUTE
  - ROAD WITH WATER SPRAYING BY HY/2014/05
  - HAUL ROAD OF HBCF
  - Photo Taken Location

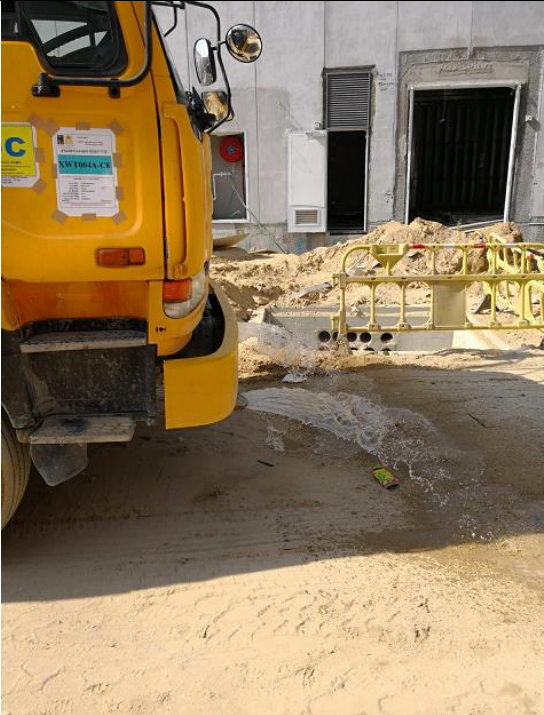
Location 1	Location 2

A close-up photograph of the rear of a yellow truck. The truck is parked on a dirt surface. A stream of water is being sprayed from the rear of the truck, creating a misty spray. In the background, there is a concrete structure with an open doorway and some construction materials.

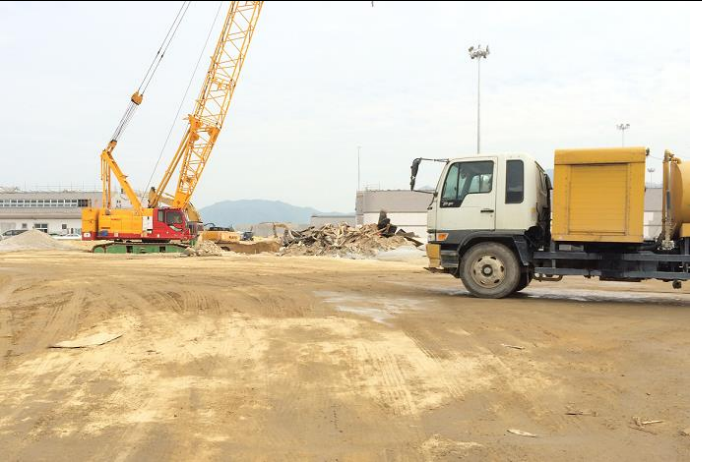
A wide-angle photograph of a construction site. In the foreground, there is a large, flat, dirt-covered area. In the background, a yellow crane is visible, along with a white truck with a yellow container. The sky is clear and blue.
Location 3

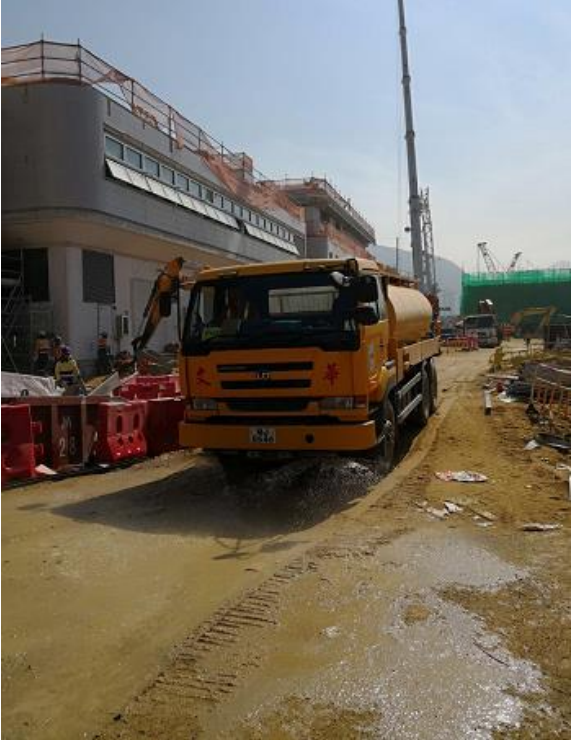
A photograph of a yellow truck driving on a dirt road at a construction site. The truck is moving towards the camera, and there is a large puddle of water on the road in front of it. In the background, there is a large building under construction and other construction equipment.
