## Monthly EM&A Report (April 2022)

**Contact No. HY/2019/01 Hong Kong-Zhuhai-Macao Bridge Hong Kong Boundary Crossing Facilities – Phase 2 and Other Works**

**EP Condition 5.4 – Monthly EM&A Report for  
Hong Kong-Zhuhai-Macao Bridge Hong Kong Boundary Crossing Facilities – Phase 2 and  
Other Works (Contract No. HY/2019/01)**

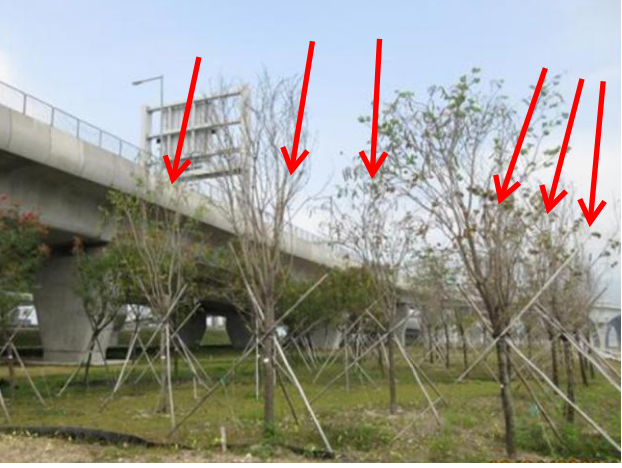
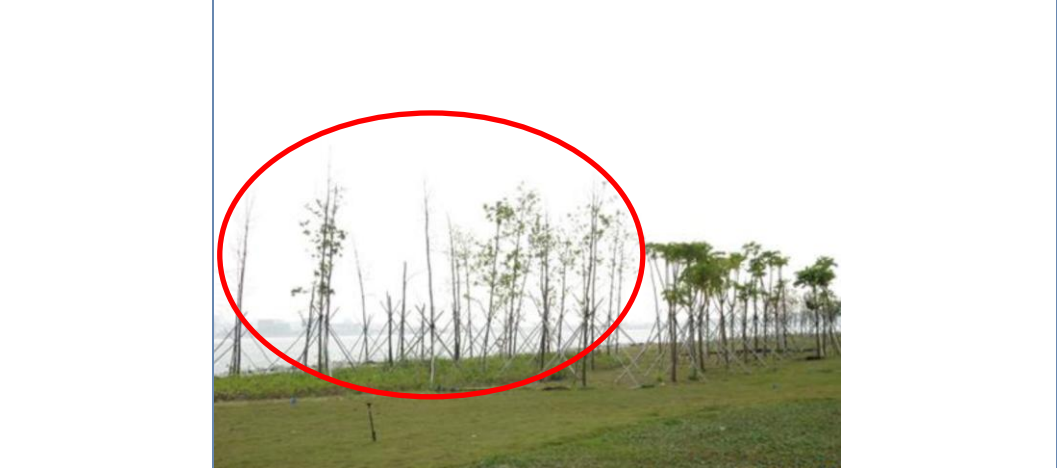
Location	Photo Record	
<p><b>Portion A-1</b></p>

- TG46: 2 *Grevillea banksii* (GB) and 4 *Bauhinia variegata* (BV) are found dead, replacements are necessary.
- TG47: 20 *Grevillea robusta* (GR) are found dead/poor conditions, replacements are necessary. 1 GR is found missing.
- TG48: 18 *Grevillea banksii* (GB) are found on site. To be replaced by 18 *Plumeria rubra* (PR).
- TG49: 1 *Grevillea robusta* (GR) is found dead, replacement is necessary.

<p>TG46: 2 <i>Grevillea banksii</i> (GB) and 4 <i>Bauhinia variegata</i> (BV) are found dead, replacements are necessary.</p>	<p>TG47: 20 <i>Grevillea robusta</i> (GR) are found dead/poor conditions, replacement is necessary. 1 GR is found missing.</p>

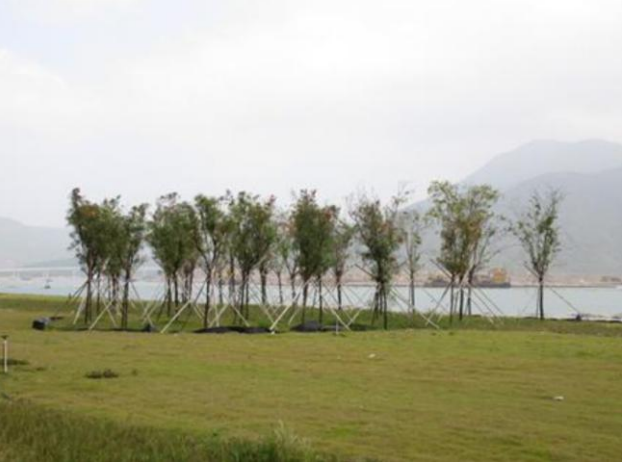
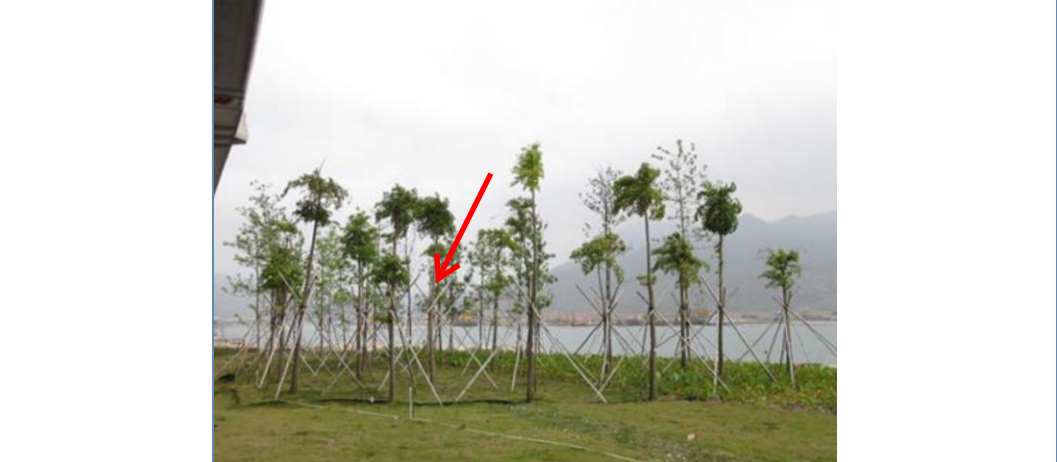
<p>TG48: 18 <i>Grevillea banksii</i> (GB) are found on site. To be replaced by 18 <i>Plumeria rubra</i> (PR).</p>	<p>TG49: 1 <i>Grevillea robusta</i> is found dead, replacement is necessary.</p>

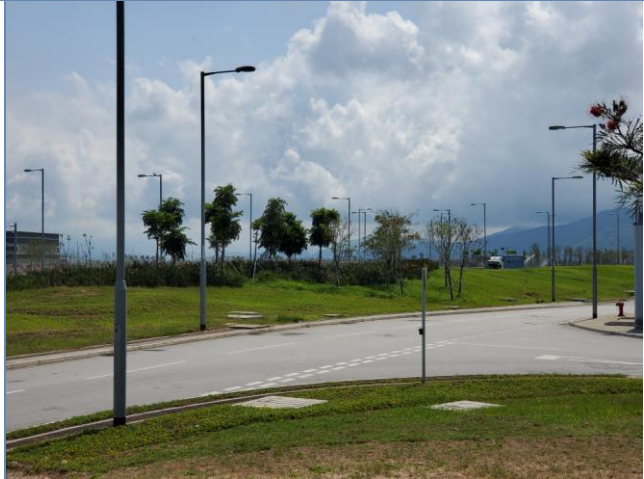
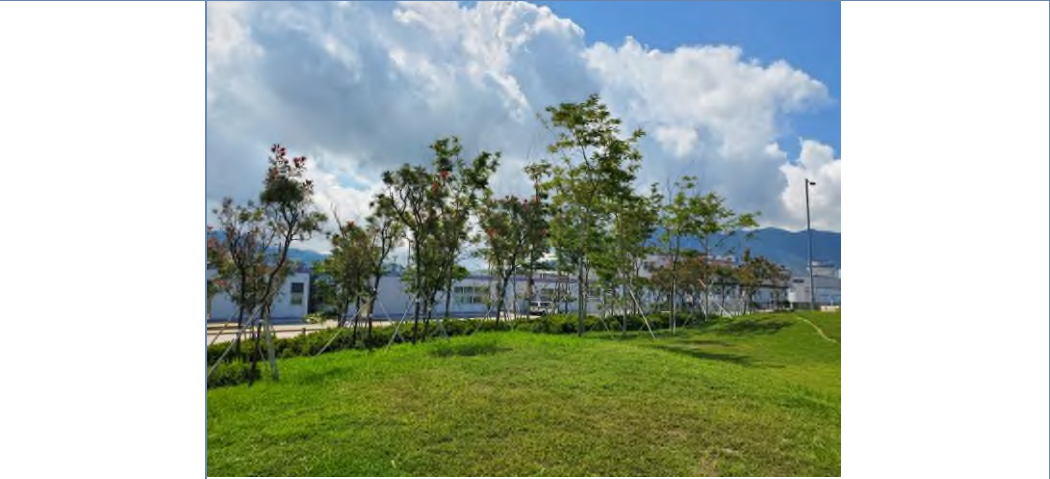
Location	Photo Record	
<p><b>Portion C</b></p>

- TG20: 2 *Heteropanax fragrans* (HF) are found missing.
- TG22: 2 *Cassia siamea* (GS) is found missing.; 2 *Grevillea banksii* (GB) are found missing.

<p>TG20: 2 <i>Heteropanax fragrans</i> (HF) are found missing.</p>	<p>TG22: 2 <i>Cassia siamea</i> (CS) are found missing. 2 <i>Grevillea banksii</i> (GB) are found missing</p>
<p><b>Portion D</b></p>

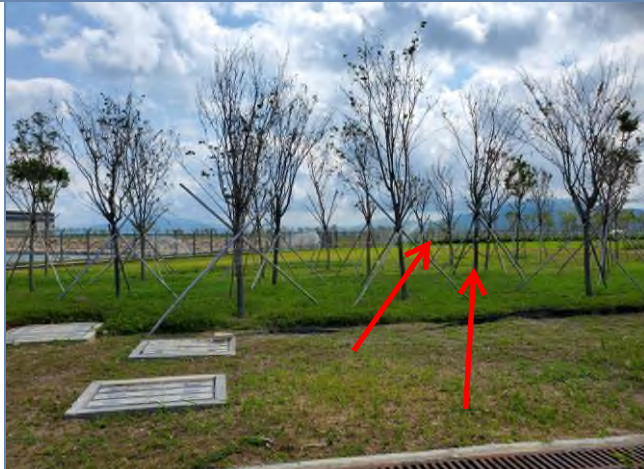
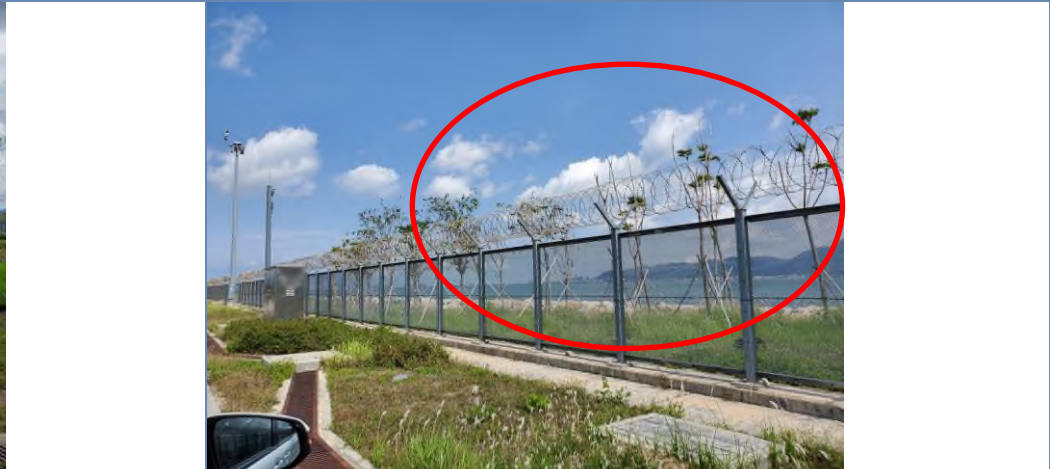
- TG02: 2 *Heteropanax fragrans* (HF) are found dead, replacements are necessary.
- TG03: 3 *Heteropanax fragrans* (HF) are found missing; 8 *Heteropanax fragrans* are dead/poor conditions, replacements are necessary.
- TG05: 3 *Bauhinia variegata* (BV) are found dead, replacements are necessary.
- TG06: 1 *Bauhinia variegata* (BV) and 1 *Cassia siamea* (CS) are found dead, replacement is necessary.
- TG07: 2 *Cassia siamea* (CS) are found dead, replacements are necessary.
- TG12: 14 *Heteropanax fragrans* (HF) are found dead, replacements are necessary. 1 HF is found missing
- TG13: 1 *Bauhinia variegata* (BV) is found dead, replacement is necessary.
- TG15: 10 *Heteropanax fragrans* (HF) are found dead, replacements are necessary.
- TG16: 3 *Bauhinia variegata* (HF) are found dead, replacements are necessary.

<p>TG02: 2 <i>Heteropanax fragrans</i> (HF) are found dead.</p>	<p>TG03: 3 <i>Heteropanax fragrans</i> (HF) are found missing; 8 <i>Heteropanax fragrans</i> (HF) are dead/poor conditions, replacements are necessary</p>

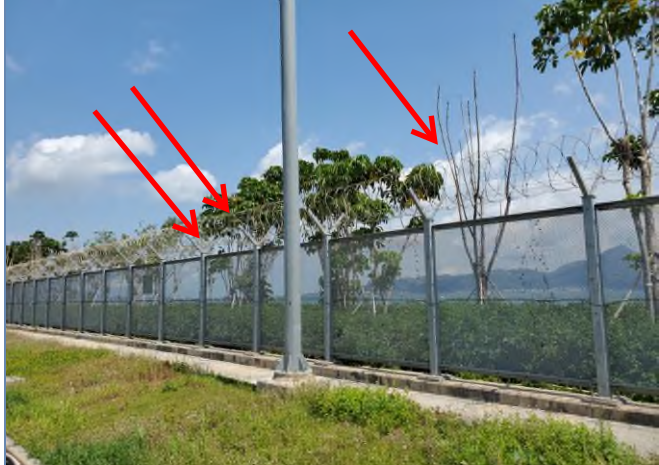
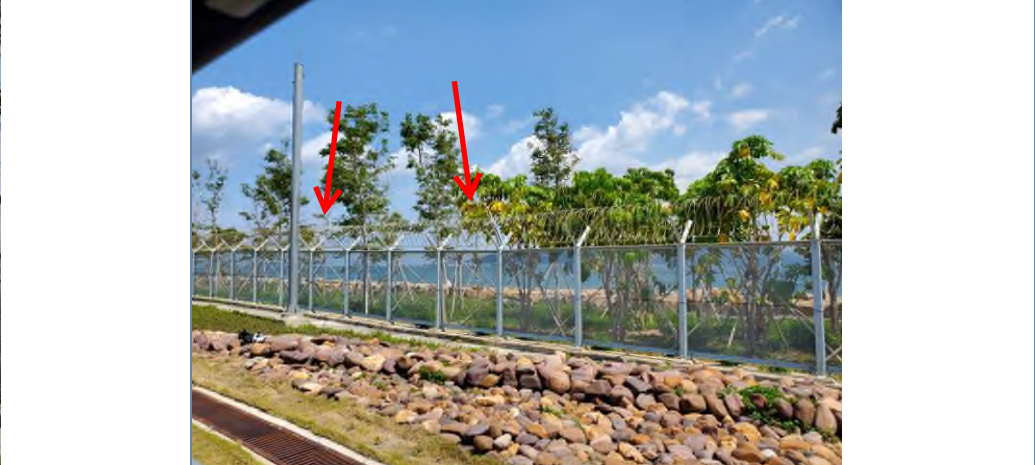
Location	Photo Record	
<p>Portion D</p>

<p>TG05: 3 <i>Bauhinia variegata</i> (BV) are found dead, replacements are necessary.</p>	<p>TG06: 1 <i>Bauhinia variegata</i> and 1 <i>Cassia siamea</i> (CS) are found dead, replacements are necessary.</p>

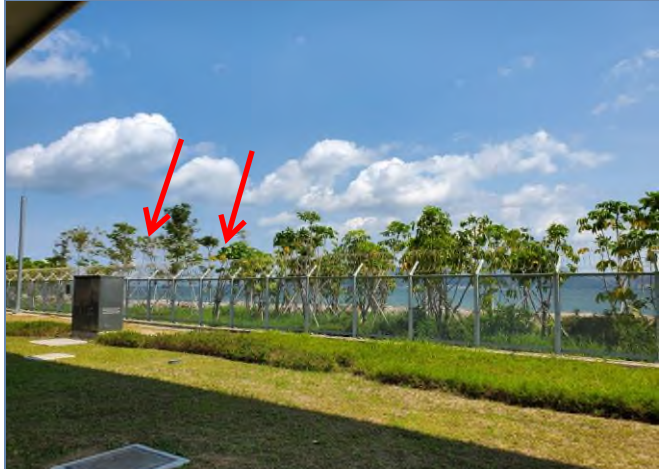
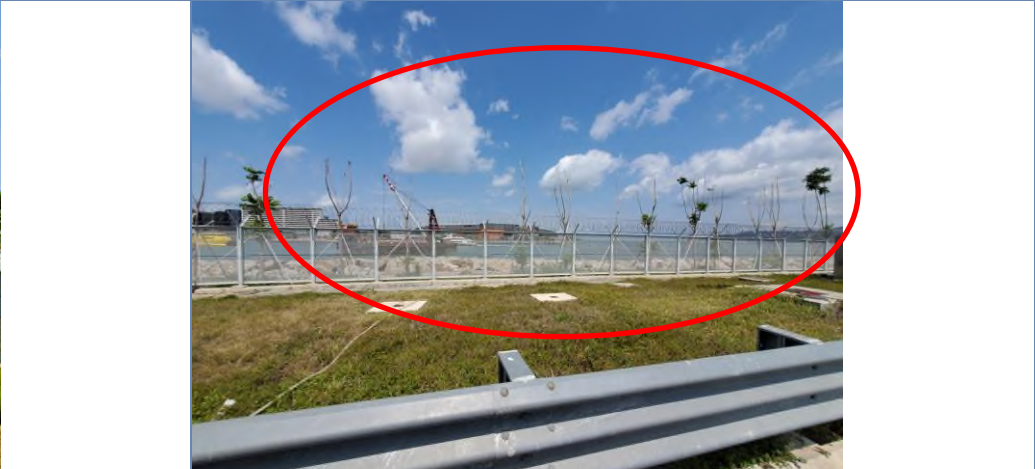
<p>TG07: 2 <i>Cassia siamea</i> (CS) are found dead, replacements are necessary.</p>	<p>TG12: 14 <i>Heteropanax fragrans</i> (HF) are found dead, replacements are necessary. 1 HF is found missing</p>

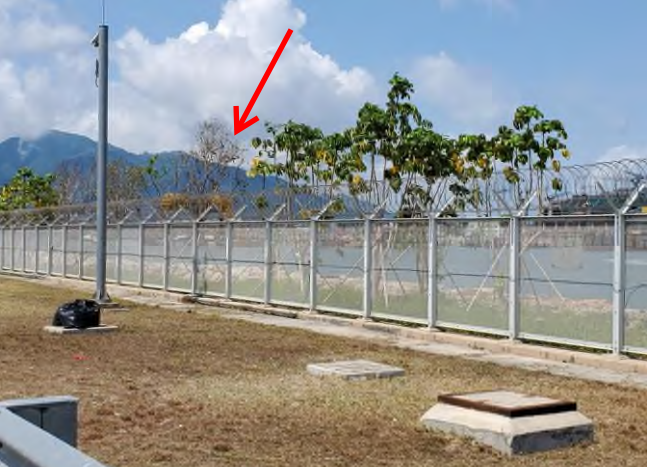
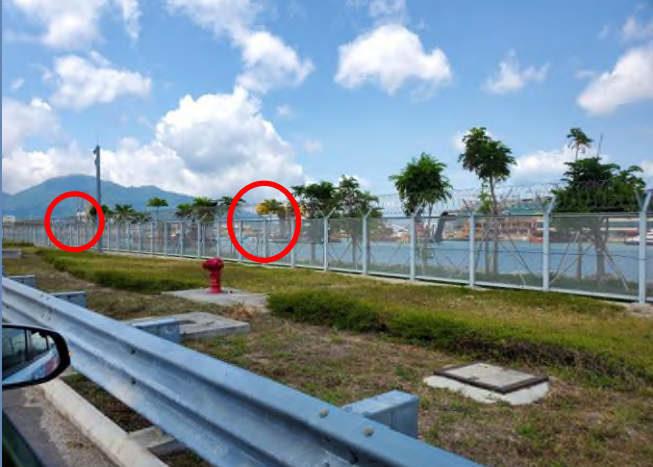
Location	Photo Record	
<b>Portion D</b>

<p>TG13: 1 <i>Bauhinia variegata</i> is found dead, replacement is necessary.</p>	<p>TG15: 10 <i>Heteropanax fragrans</i> are found dead, replacements are necessary.</p>

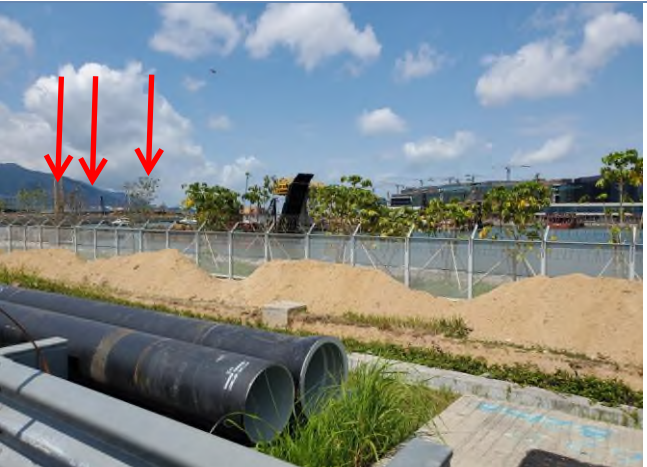
<p>TG16: 3 <i>Bauhinia variegata</i> are found dead, replacements are necessary.</p>

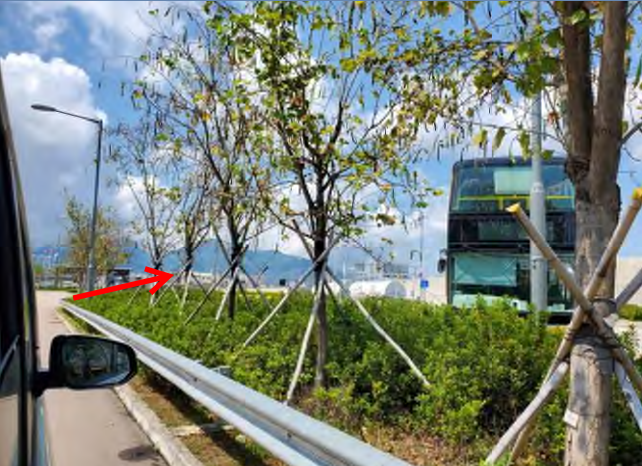
OBSERVATIONS		
Location	Photo Record	
<p>Portion E</p>

- TG11: No particular findings.
- TG42: 1 *Bauhinia variegata* (HF) is found dead, replacement is necessary.

<p>TG42: 1 <i>Bauhinia variegata</i> is found dead, replacement is necessary.</p>

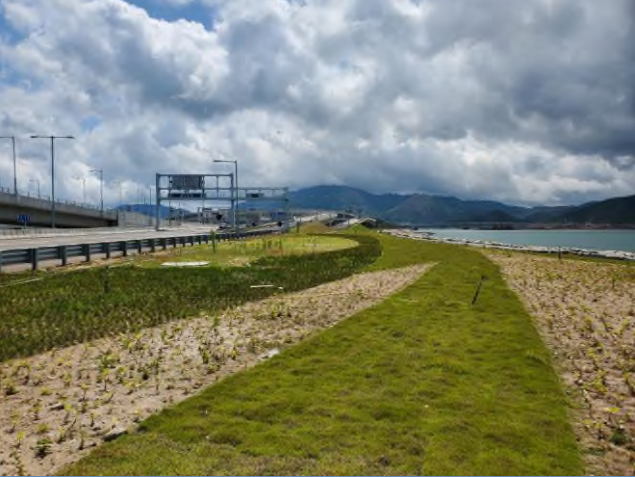
<p>Groundcover planting in Portion A-1</p>		
<b>Portion A-2</b>

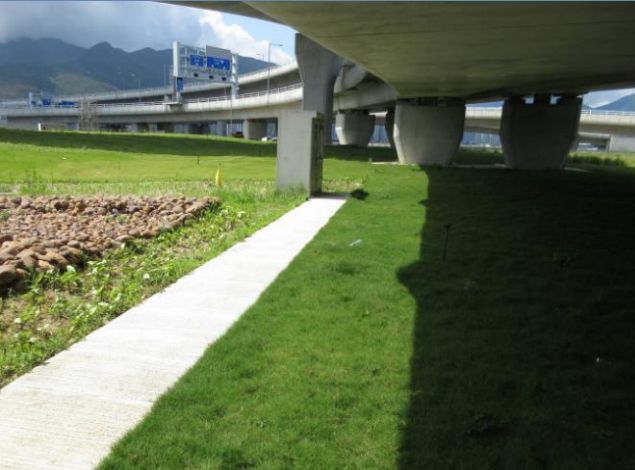
<p>Grass Planting in Portion A-2</p>

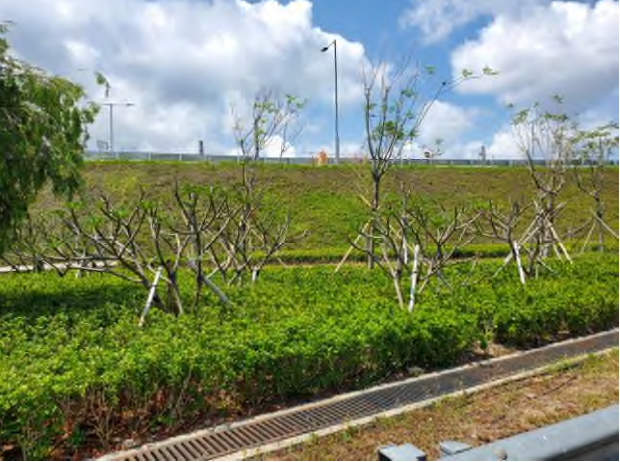
Tree planting in Portion E		
<b>Portion F</b>

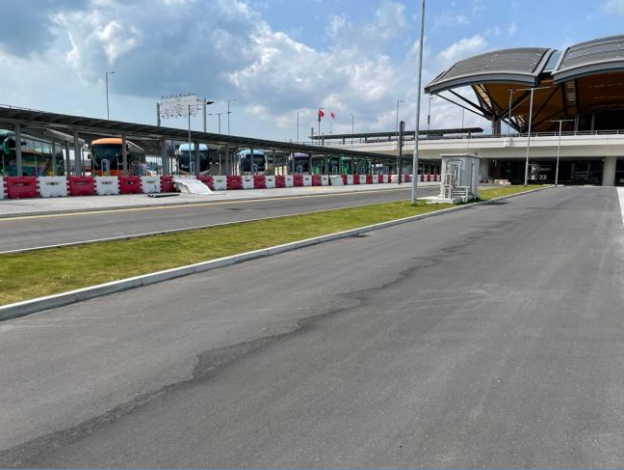
Grass planting at Portion F

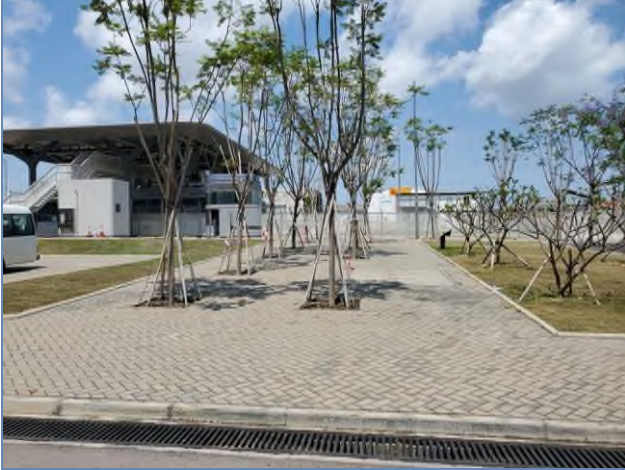
Tree planting in Portion G		
<b>Portion H</b>

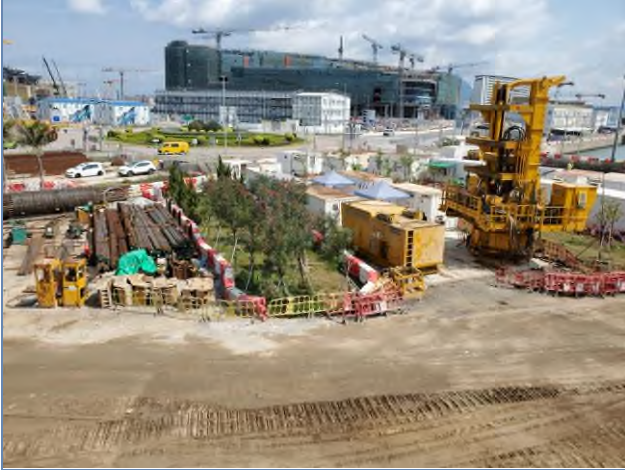
Tree planting in Portion H.
