Annex I. HKLR03 Survey Effort Database (September 2019)

Annex II. HKLR03 Chinese White Dolphin Sighting Database (September 2019)

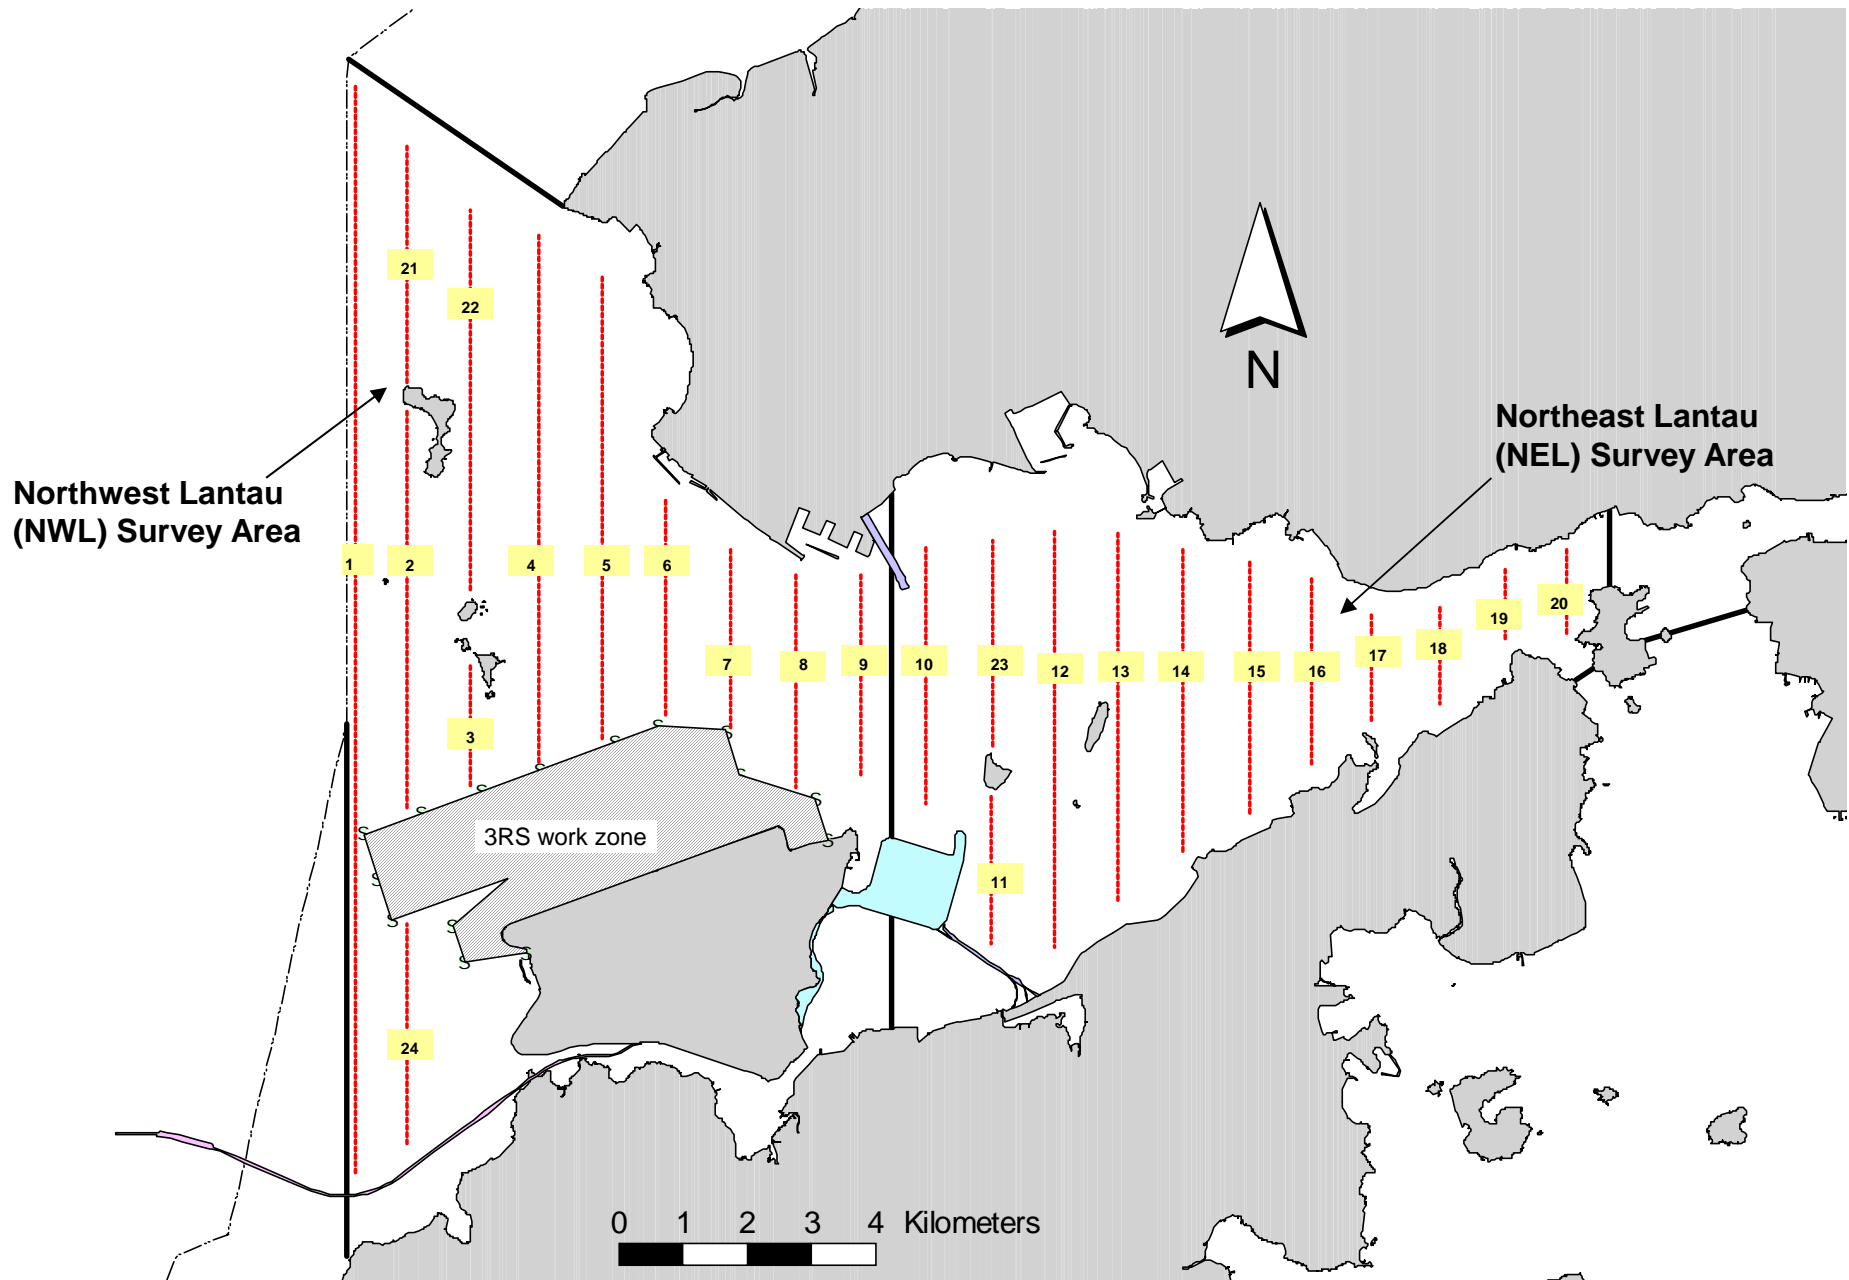
Figure 1. Transect Line Layout in Northwest and Northeast Lantau Survey Areas
