**Contract No. HY/2011/03**

**Hong Kong-Zhuhai-Macao Bridge Hong Kong Link Road  
Section between Scenic Hill and Hong Kong Boundary Crossing  
Facilities**

**First Post-Translocation Monitoring Report**

14 February 2013

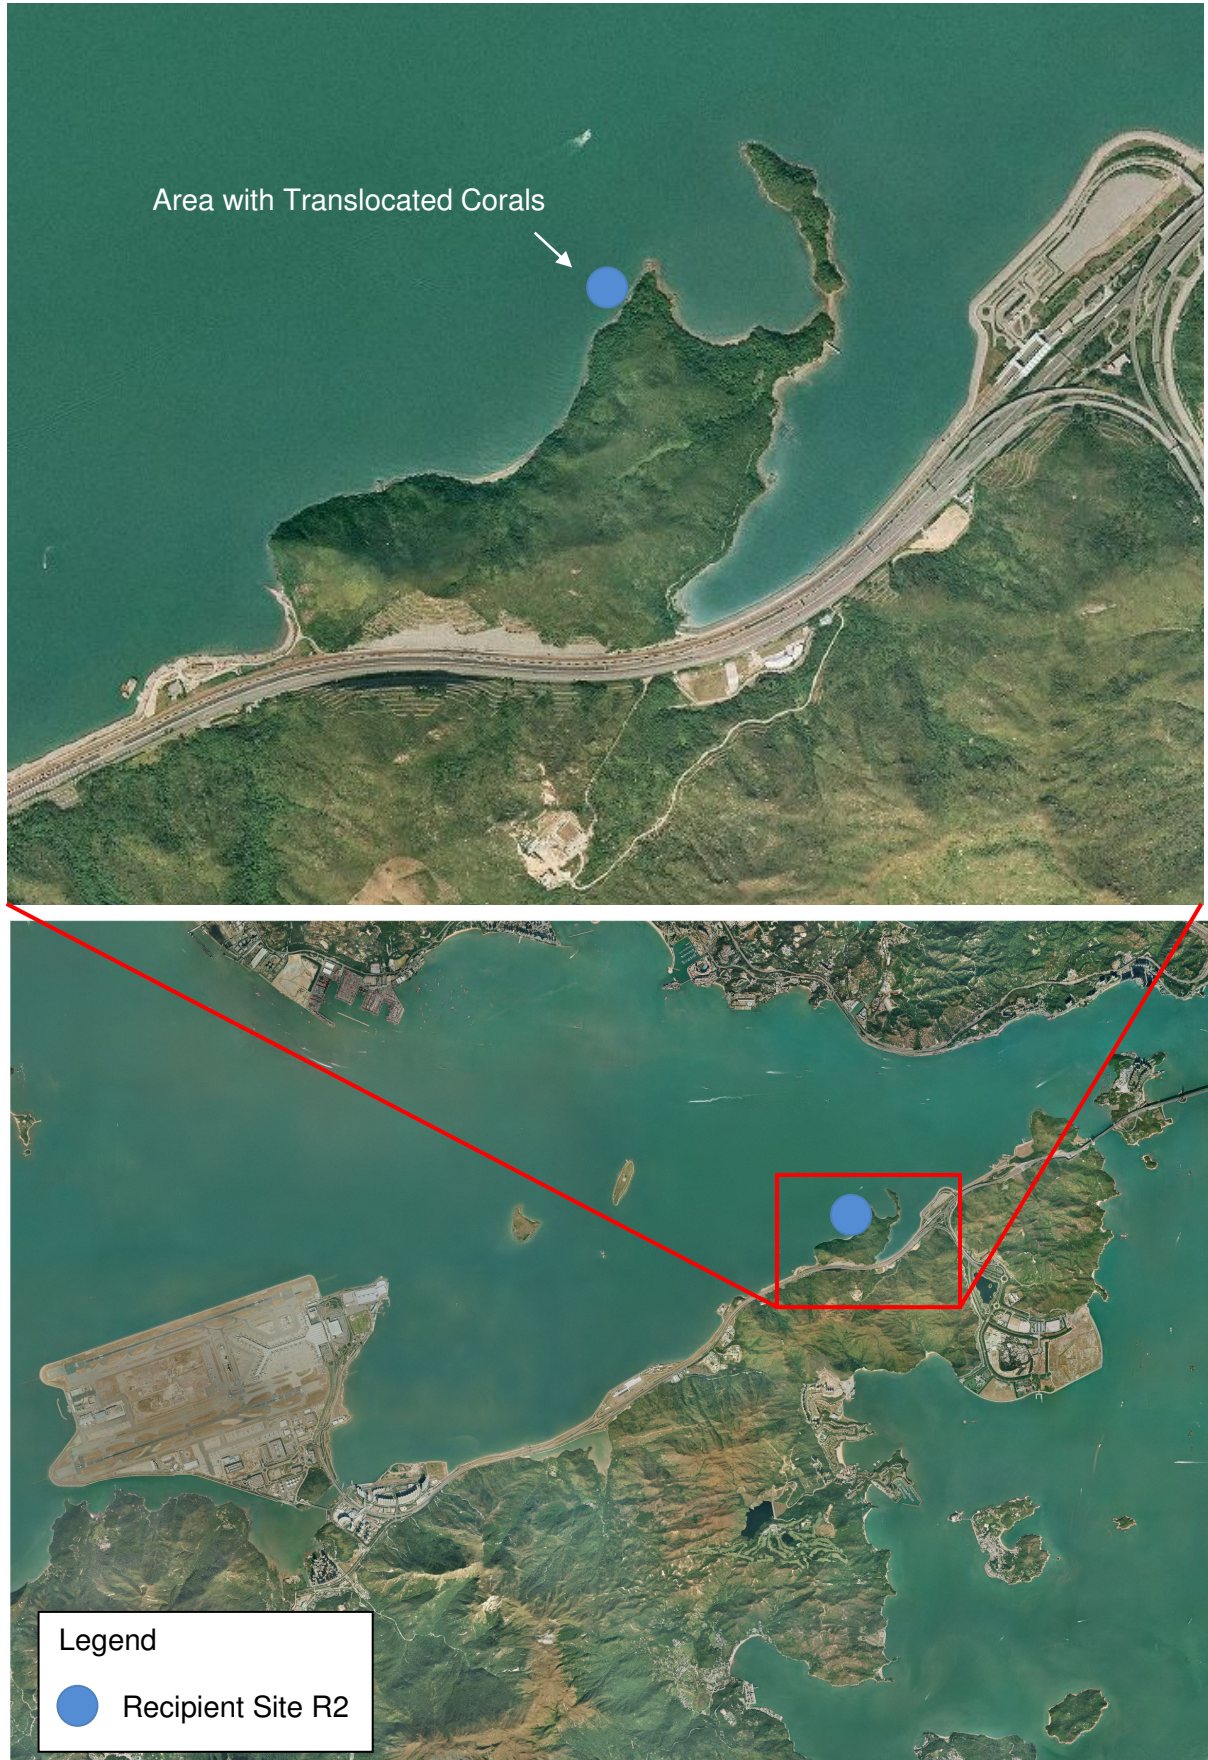
Figure 1 Area with Translocated Corals in R2

- 3.2.1 Twenty-three (23) *Echinomuricea* sp. colonies were relocated and monitored at the recipient site R2. Area with translocated coral colonies in recipient site R2 was shown in **Figure 1**. The general health conditions (size, health condition, increased mortality and increased sediment) were recorded and summarized in **Table 3-3**.
- 3.2.2 Ten (10) *Echinomuricea* sp. colonies which grow naturally at the recipient site R2 were relocated and monitored. The general health conditions (size, health condition, increased mortality and increased sediment) were recorded and summarized in **Table 3-4**.

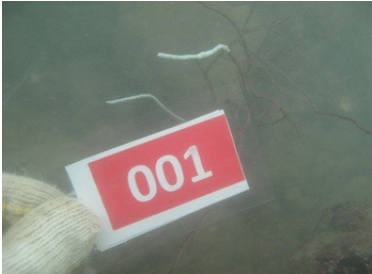
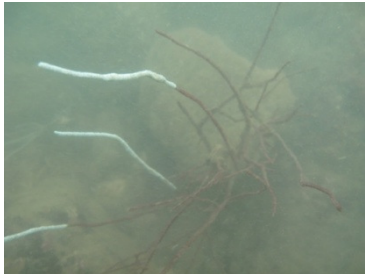
Coral No.	Translocated Corals (Baseline)	Translocated Corals During the 12 Oct 2012 Monitoring
1

Coral #	Species	Size (cm) – Max. Height	Condition	Mortality (%)		Sediment (%)	
				Baseline	Increased Mortality on 12 Oct	Baseline	Increased Sediment on 12 Oct
1	<i>Echinomuricea</i> sp.	22	Unhealthy	75	75	0	0
2	<i>Echinomuricea</i> sp.	25	Unhealthy	45	45	0	0
3	<i>Echinomuricea</i> sp.	19	Fair	30	30	0	0
4	<i>Echinomuricea</i> sp.	32	Unhealthy	50	50	0	0
5	<i>Echinomuricea</i> sp.	24	Unhealthy	40	40	0	0

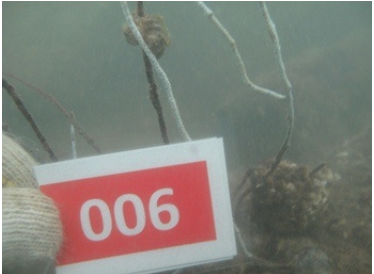
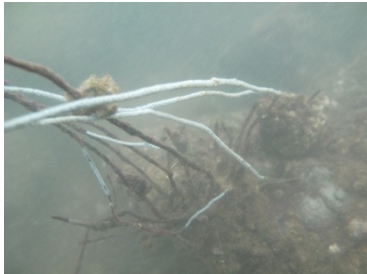
Coral No.	Translocated Corals (Baseline)	Translocated Corals During the 12 Oct 2012 Monitoring
6

Coral #	Species	Size (cm) – Max. Height	Condition	Mortality (%)		Sediment (%)	
				Baseline	Increased Mortality on 12 Oct	Baseline	Increased Sediment on 12 Oct
6	<i>Echinomuricea</i> sp.	18	Fair	30	0	0	0
7	<i>Echinomuricea</i> sp.	15	Fair	25	0	0	0
8	<i>Echinomuricea</i> sp.	17	Fair	30	0	0	0
9	<i>Echinomuricea</i> sp.	24	Fair	15	0	0	0
10	<i>Echinomuricea</i> sp.	15	Fair	10	0	0	0
11	<i>Echinomuricea</i> sp.	35	Unhealthy	60	0	0	0
12	<i>Echinomuricea</i> sp.	23	Unhealthy	40	0	0	0
13	<i>Echinomuricea</i> sp.	21	Fair	5	0	0	0
14	<i>Echinomuricea</i> sp.	17	Fair	20	0	0	0
15	<i>Echinomuricea</i> sp.	29	Fair	10	0	0	0
16	<i>Echinomuricea</i> sp.	32	Fair	5	0	0	0
17	<i>Echinomuricea</i> sp.	36	Fair	5	0	0	0
18	<i>Echinomuricea</i> sp.	27	Fair	10	0	0	0
19	<i>Echinomuricea</i> sp.	26	Fair	5	0	0	0
20	<i>Echinomuricea</i> sp.	31	Unhealthy	55	0	0	0
21	<i>Echinomuricea</i> sp.	29	Fair	5	0	0	0
22	<i>Echinomuricea</i> sp.	26	Fair	5	0	0	0

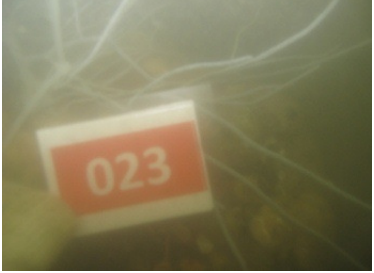
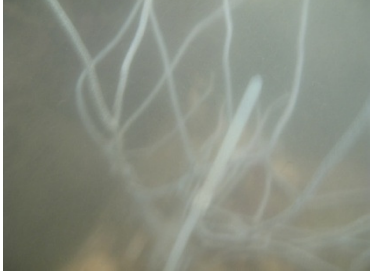
23

- 4.1.3 No sediment, bleaching or increased mortality in the general condition of coral colonies were observed during the monitoring period. No deterioration of the coral community was observed in the ecological monitoring results when compared with the baseline ecological monitoring results. There is no AL/LL exceedance during the monitoring period. Photos of each tagged translocated and natural corals were taken and shown in **Photo Plates 1 and 2**.

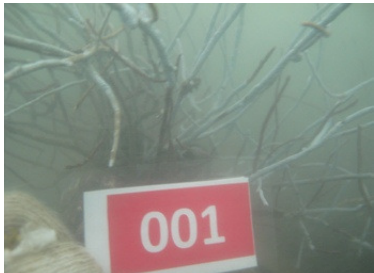
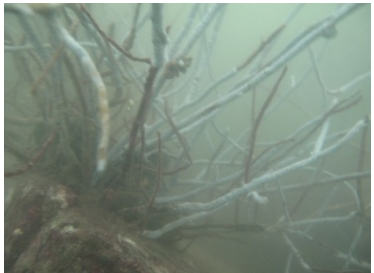
Coral No.	Natural Corals (Baseline)	Translocated Corals During the 12 Oct 2012 Monitoring
1

Coral #	Species	Size (cm) – Max. Height	Condition	Mortality (%)		Sediment (%)	
				Baseline	Increased Mortality on 12 Oct	Baseline	Increased Sediment on 12 Oct
1	<i>Echinomuricea</i> sp.	30	Unhealthy	55	0	0	0
2	<i>Echinomuricea</i> sp.	25	Unhealthy	50	0	0	0
3	<i>Echinomuricea</i> sp.	31	Fair	30	0	0	0
4	<i>Echinomuricea</i> sp.	25	Unhealthy	60	0	0	0
5	<i>Echinomuricea</i> sp.	34	Unhealthy	45	0	0	0
6	<i>Echinomuricea</i> sp.	26	Unhealthy	40	0	0	0
7	<i>Echinomuricea</i> sp.	23	Fair	35	0	0	0
8	<i>Echinomuricea</i> sp.	19	Unhealthy	45	0	0	0
9	<i>Echinomuricea</i> sp.	21	Fair	30	0	0	0
10	<i>Echinomuricea</i> sp.	28	Fair	25	0	0	0
