Contract HY/2011/09

Hong Kong-Zhuhai-Macao Bridge

Hong Kong Link Road-Section between HKSAR Boundary and Scenic Hill

Landscape Monitoring Report (Long Term Management)

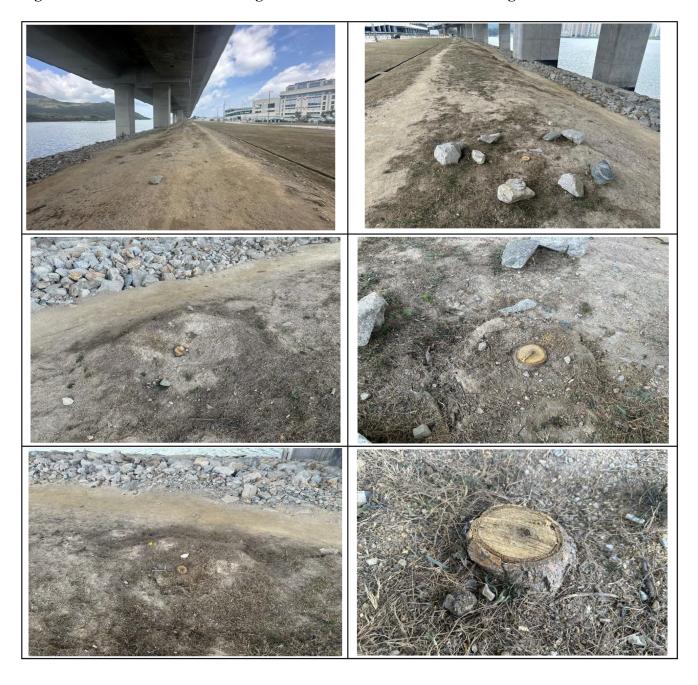
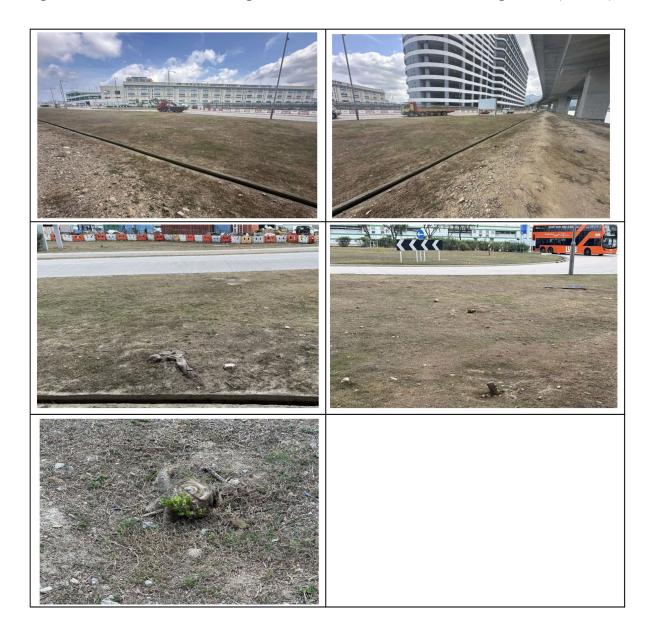
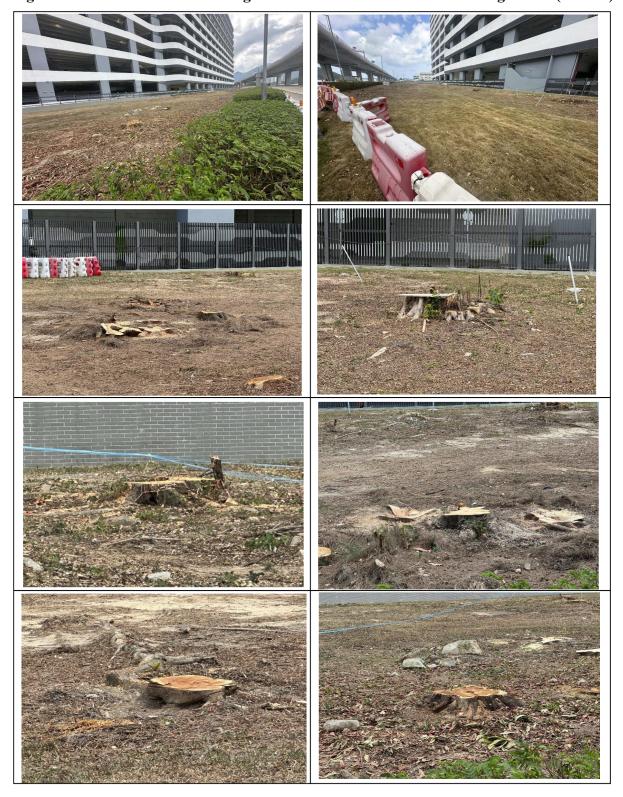
Figure 3.1 Tree Planted at Designated Areas under or Near the Bridge Deck

3.4 Trees planted at the designated planting areas under or in the vicinity of the Bridge Deck for the Contract were all observed dead/removed/cut during the site inspection. The trees planted in these areas included *Bauhinia blakeana*, *Plumeria rubra* and *Bauhinia variegate*, as listed in **Table 3.1**. The photographic records of the condition of designated planting areas under or near Bridge Deck are shown in **Figure 3.1**.

- This is the 4th Annual Monitoring Report after completion of all landscape works under 4.4 the Contract. The current stage for implementation of mitigation measures should be categorized as Operation Phase.
- It is recommended to terminate the annual landscape monitoring report, as stipulated Section 14.2.10 of the EM&A Manual, under the Contract as Highways Department is no longer the maintenance agent in operation phase.

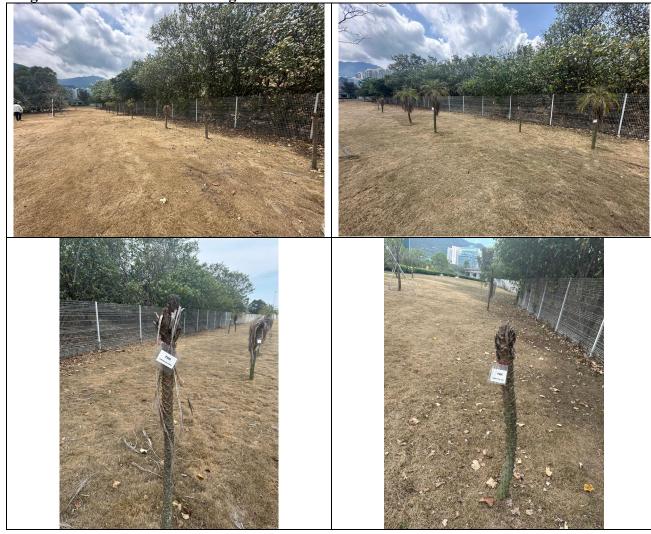
Figure 3.2 Tree Planted at Designated Areas at Kwo Lo Wan Road

- 3.5 The planted trees, *Phoenix roebelenii*, at Kwo Lo Wan Road were almost dead and only 9 were observed still alive. The trees planted, *Plumeria rubra* and *Bauhinia variegate* in this area were also observed dead/removed/cut or in poor health condition. Photographs were taken and shown in **Figure 3.2**.
- 3.6 As shown in **Figure 3.2**, the soil at the planted areas were observed packed and dried.
- 3.7 In addition, the health conditions of the remaining plants were also observed weak. Leaves are withered / yellow. Both water and nutrients were considered insufficient.

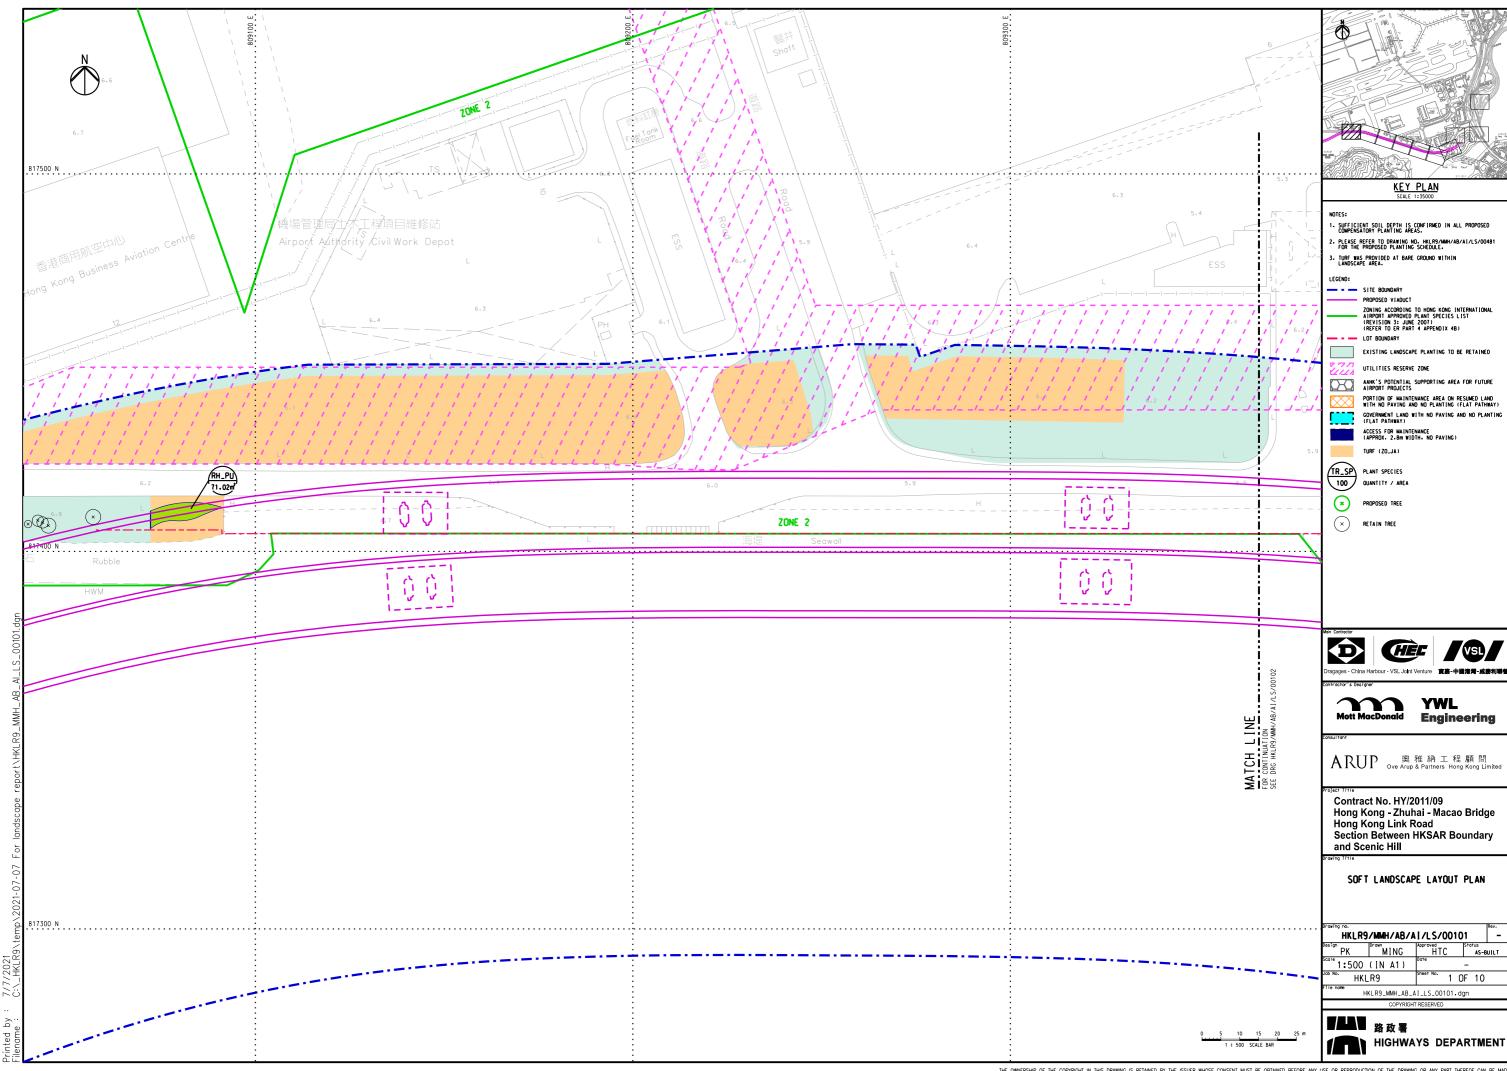
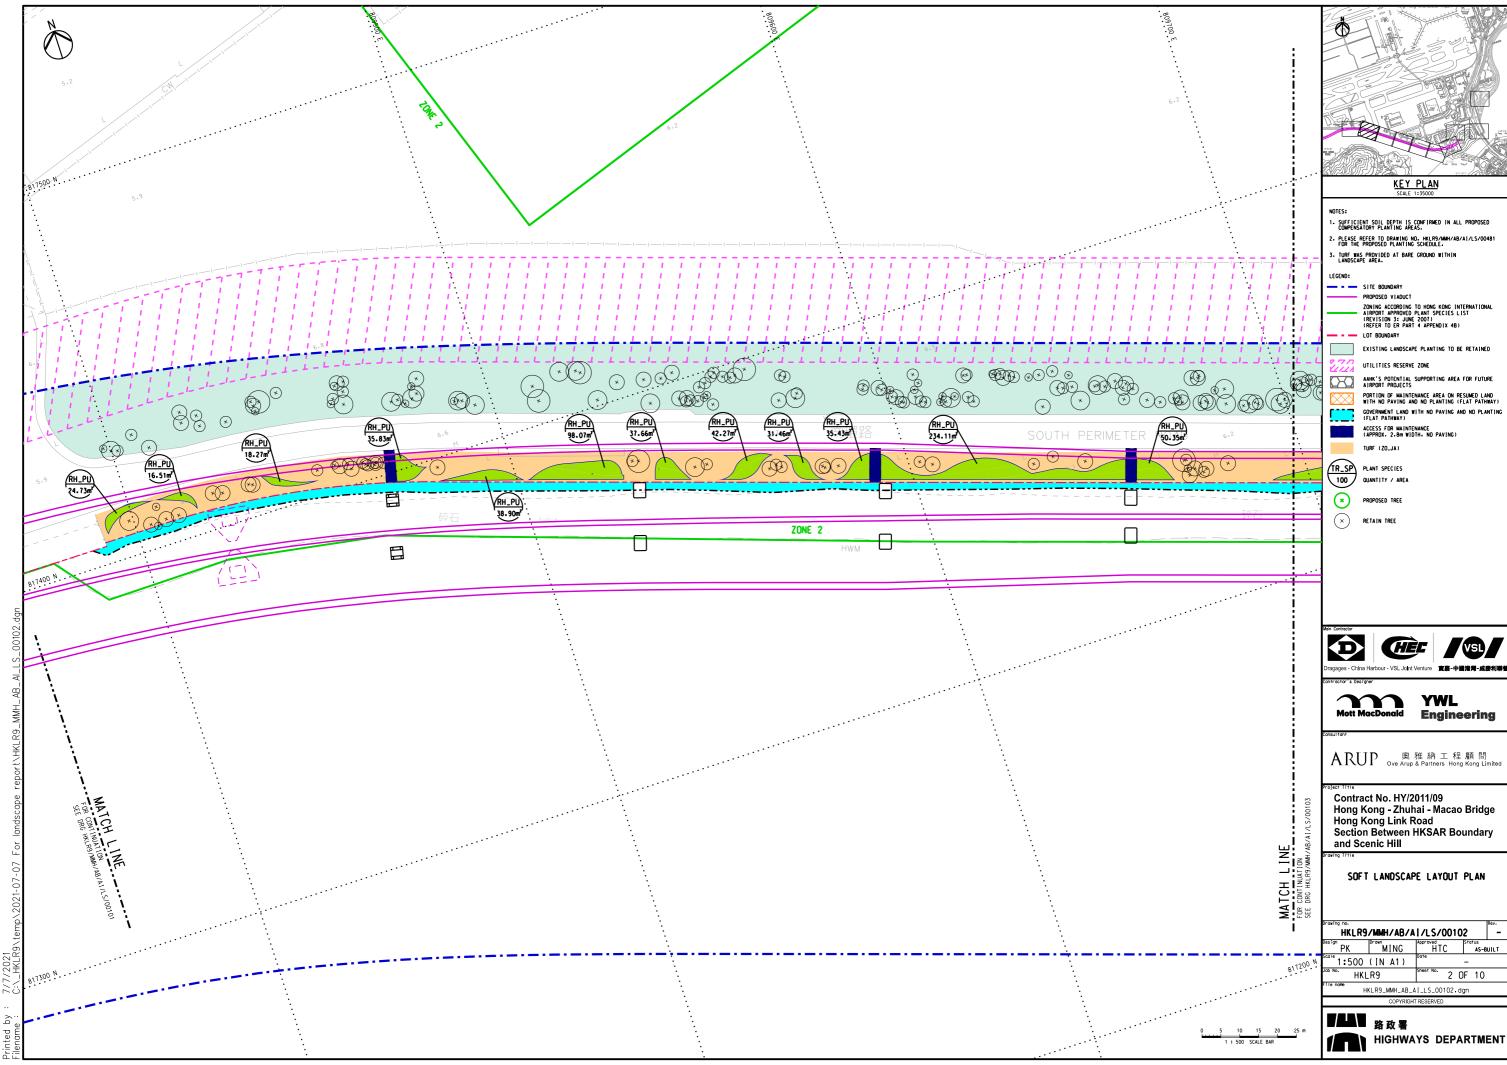
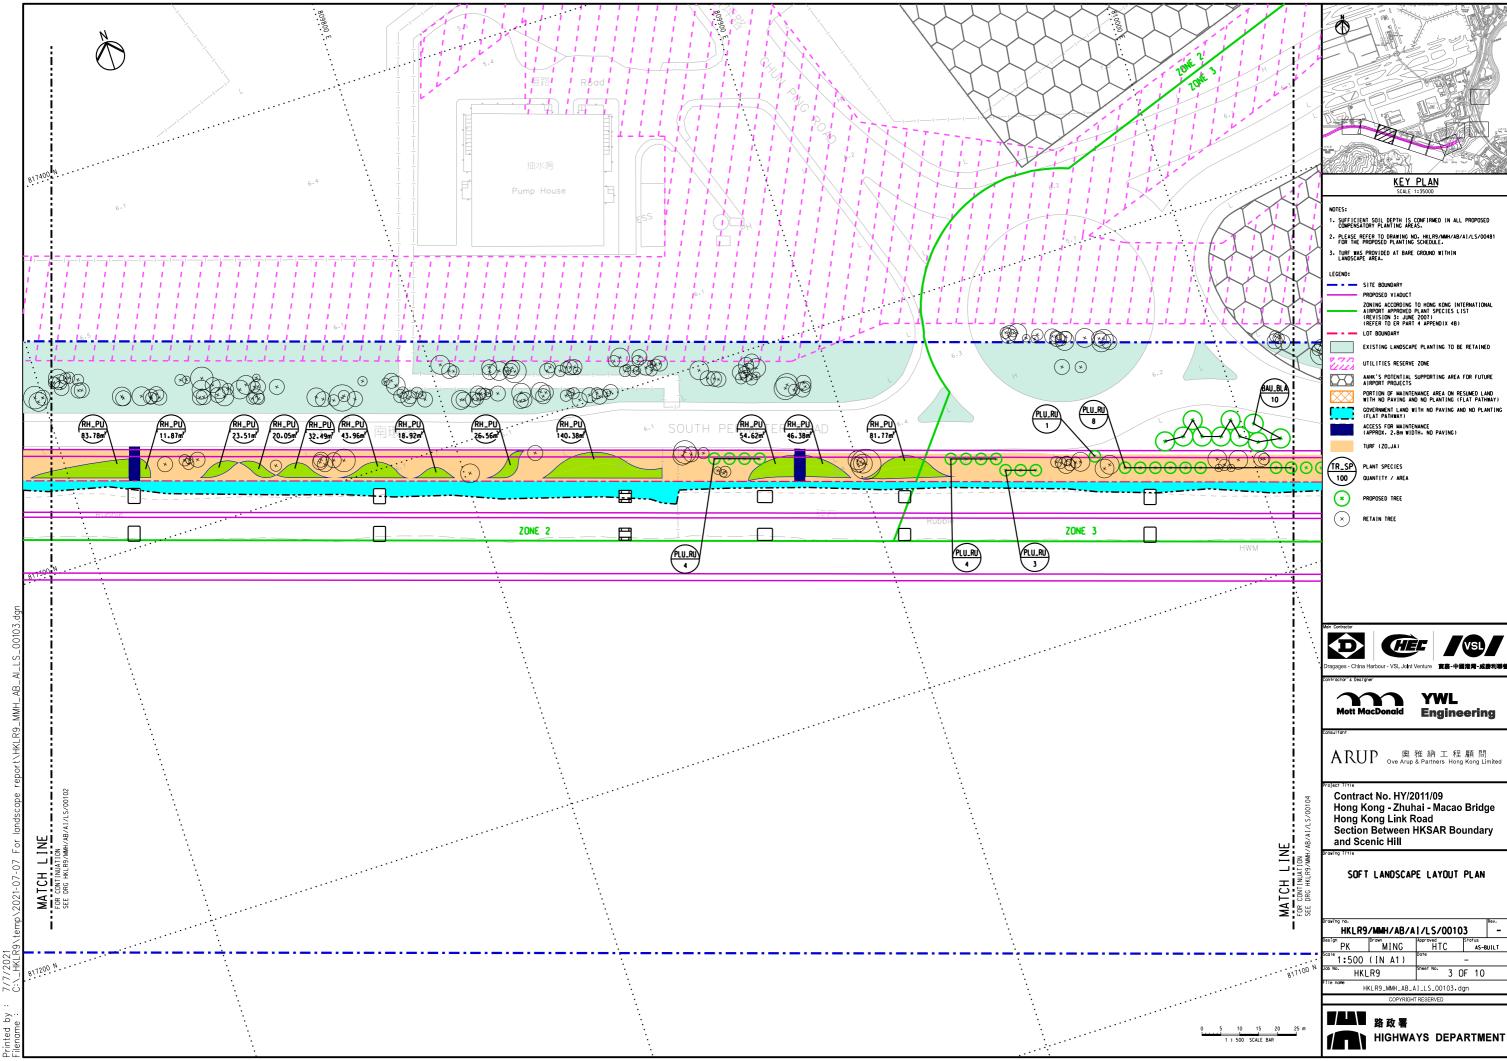
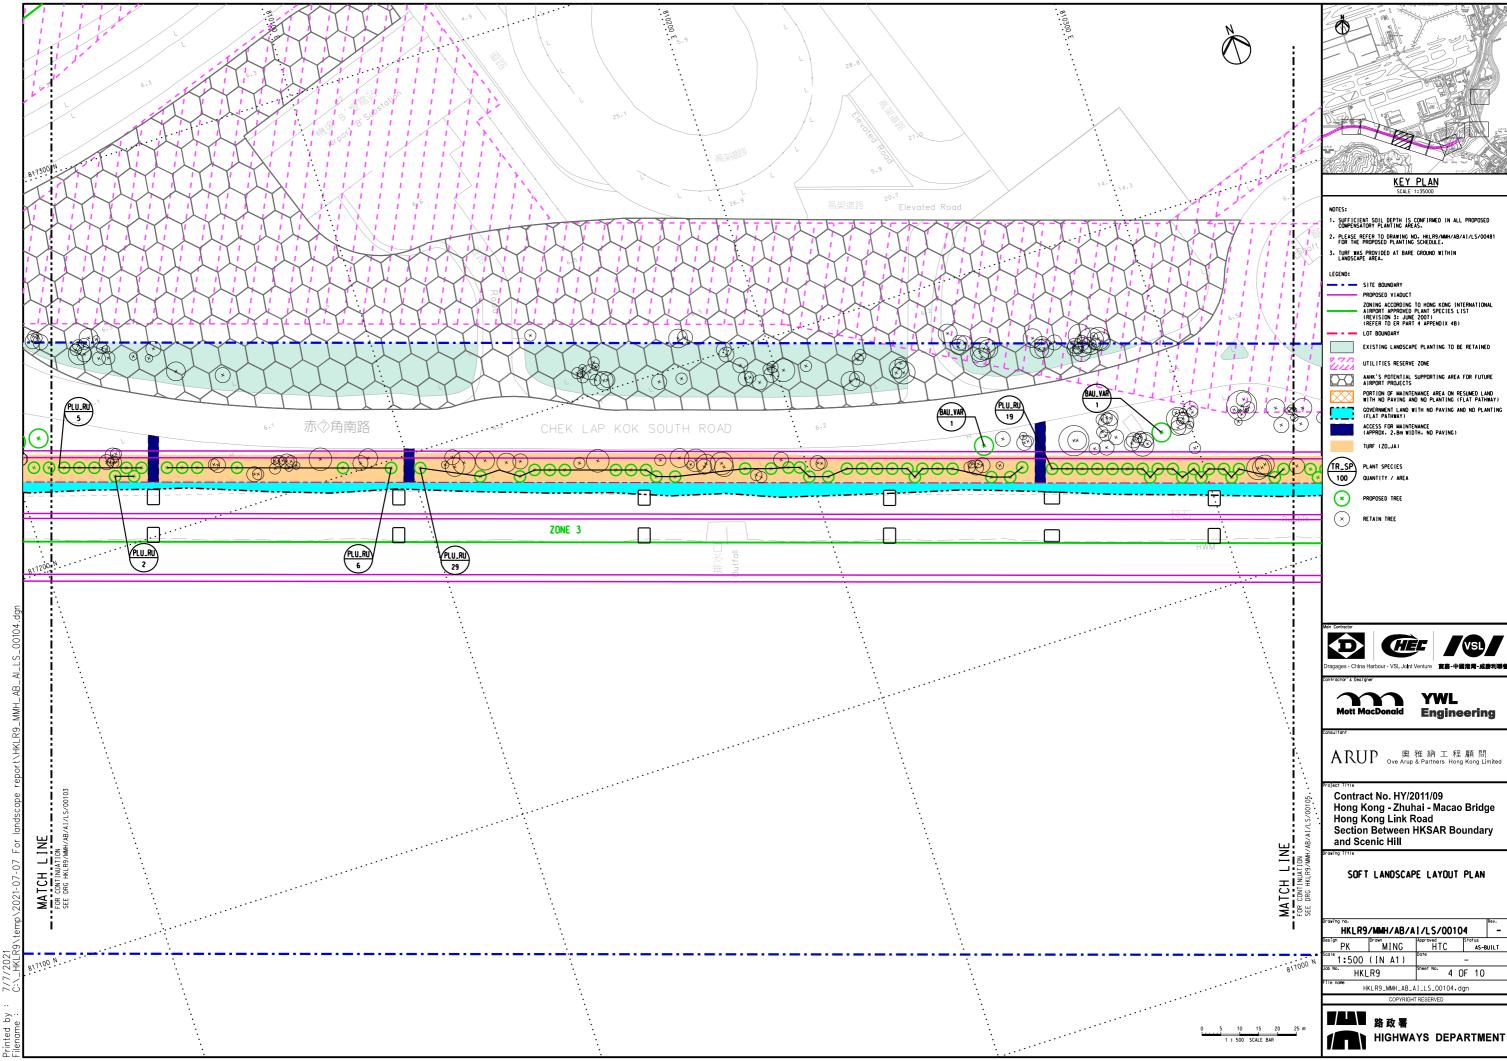
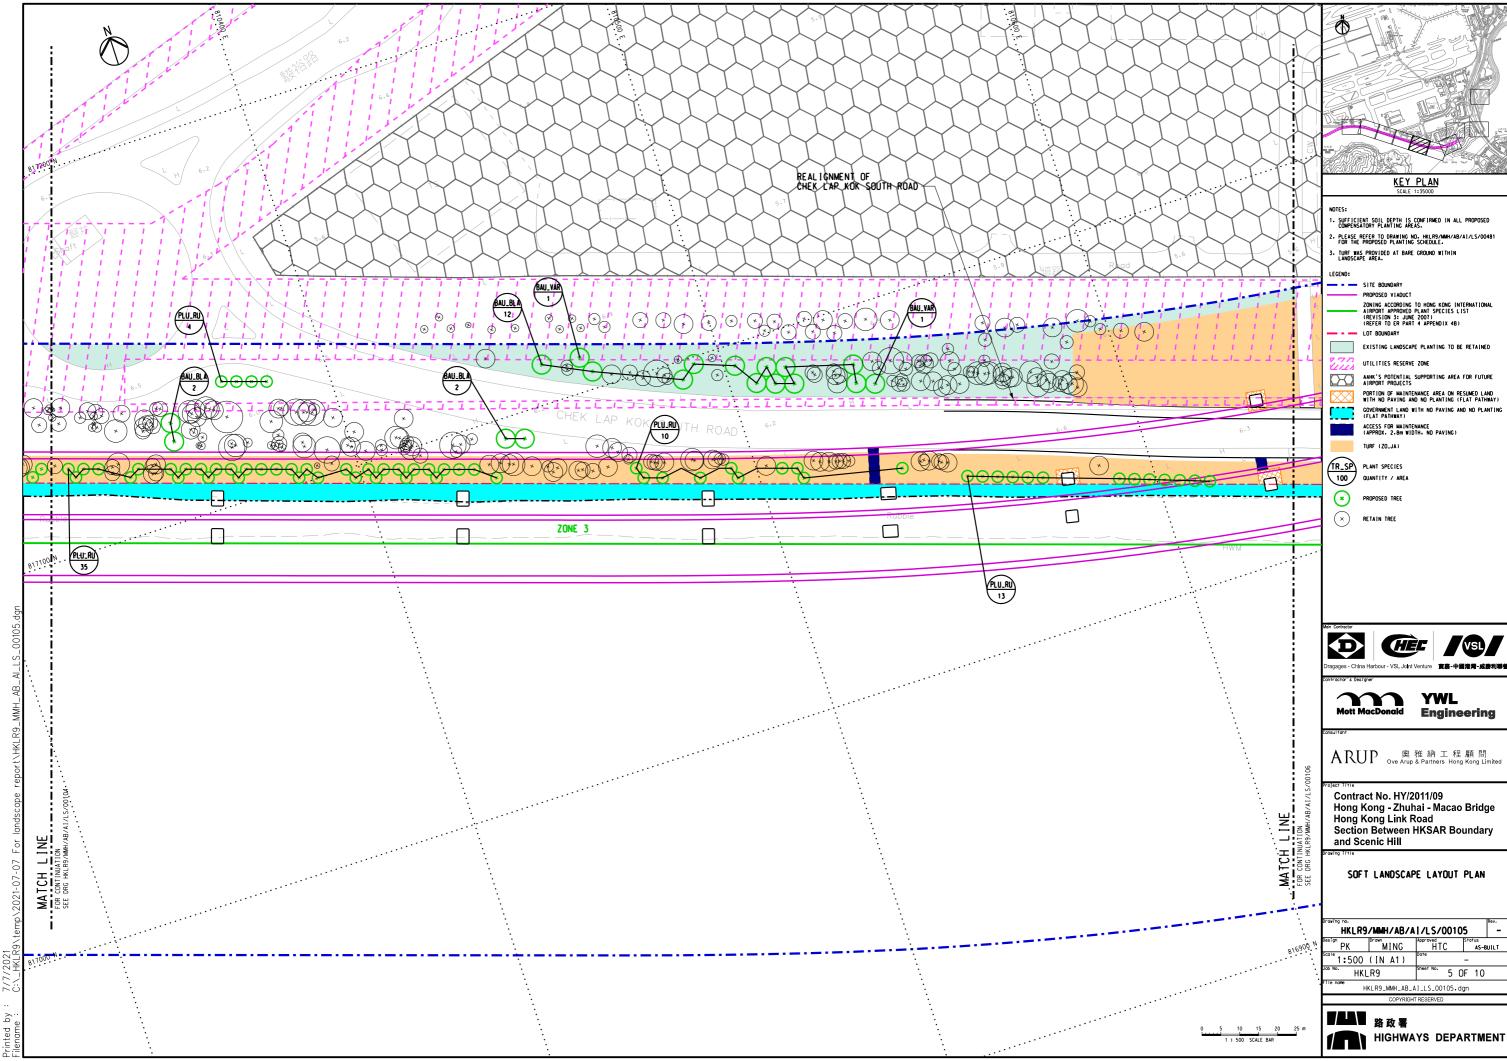
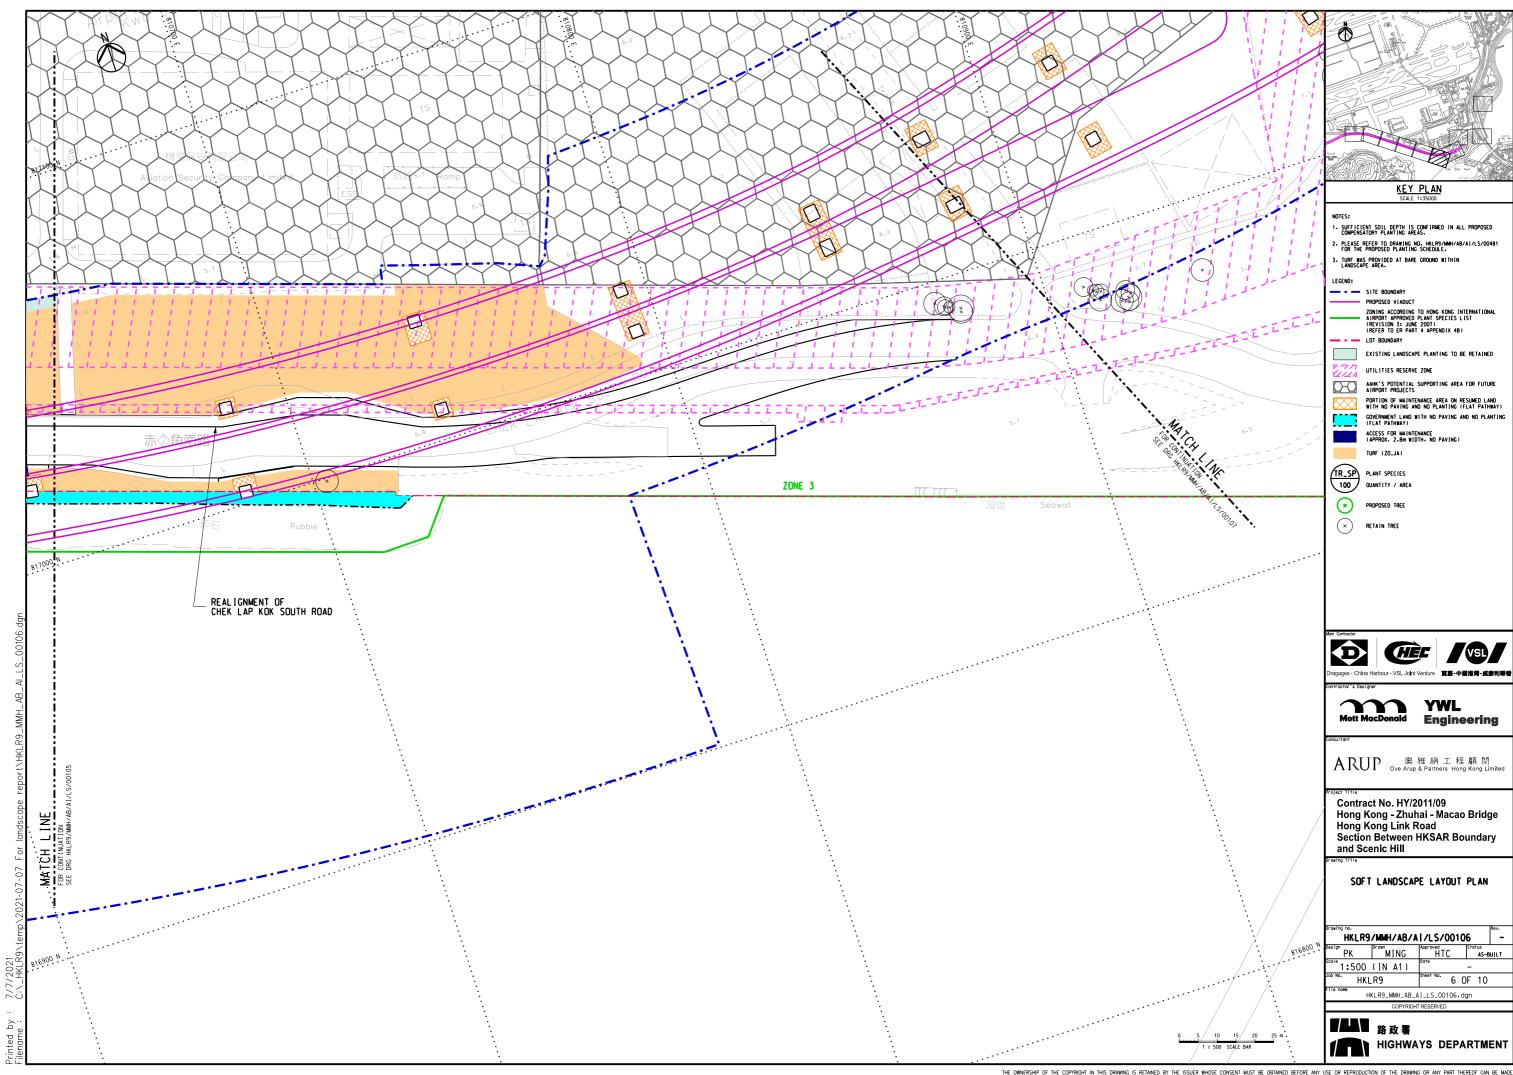
APPENDIX A SOFT LANDSCAPE LAYOUT PLAN

2.4 The soft landscape layout plan provides updated information of details such as locations of planting works and species, and these were agreed by the Airport Authority Hong Kong is shown in **Appendix A**.

- 3.2 The location and plant species have been checked during the inspection which are followed the approved Soft Landscape Layout Plan in **Appendix A**.
- 3.3 There was a total of 4 tree species were planted under the Contract at the designated planting zones at Hong Kong International Airport Island. The summary of the planted species and numbers are shown in **Table 3.1.**
