Contract HY/2011/09
Hong Kong-Zhuhai-Macao Bridge
Hong Kong Link Road-Section between
HKSAR Boundary and Scenic Hill

Quarterly EM&A Report

June to August 2018

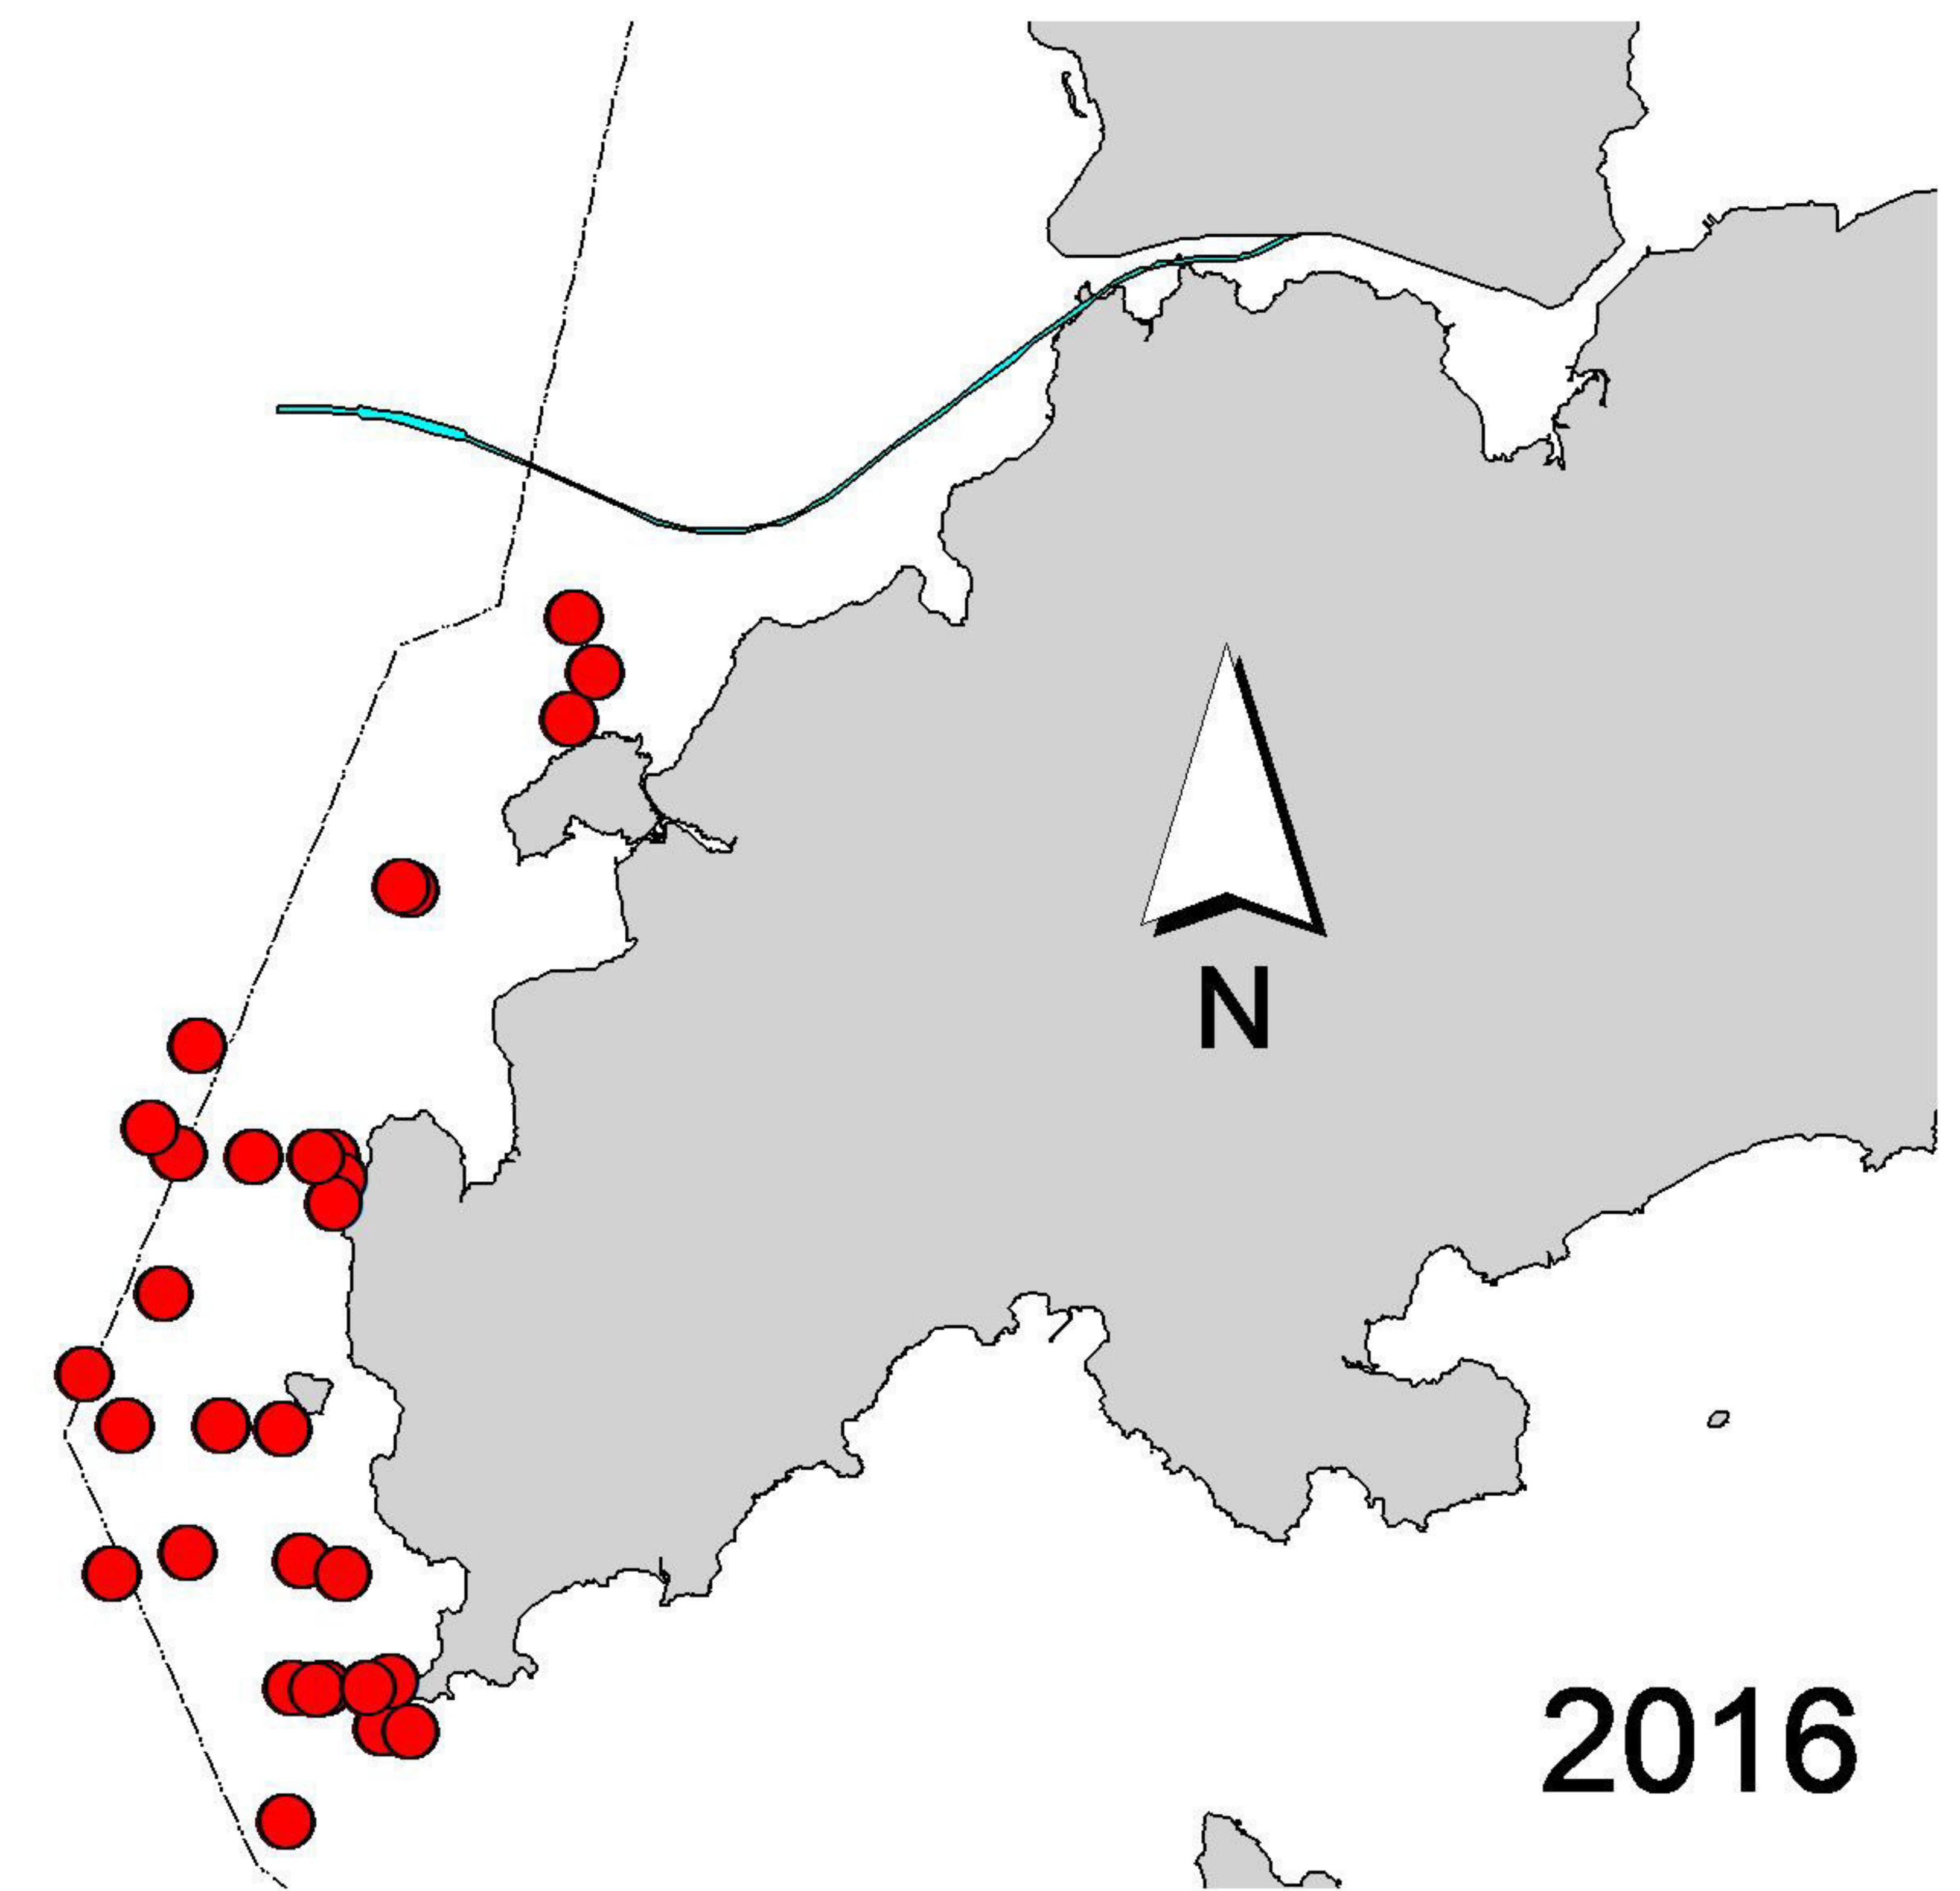
Figure 3. Comparisons on distribution of Chinese white dolphin sightings in West Lantau in the summer months (June-August) of 2015, 2016, 2017 and 2018 during HKLR09 impact phase

- 3.2.3. Notably, three of the 35 dolphin groups were sighted near the HKLR09 alignment in WL survey area during the present quarter (Figure 2). When pooling the data from HKLR03 monitoring surveys from the same summer quarter of 2018, several dolphin groups were also observed near the bridge alignment in NWL waters, which was comparable to the dolphin distribution in this same area during the baseline phase (Figure 2).

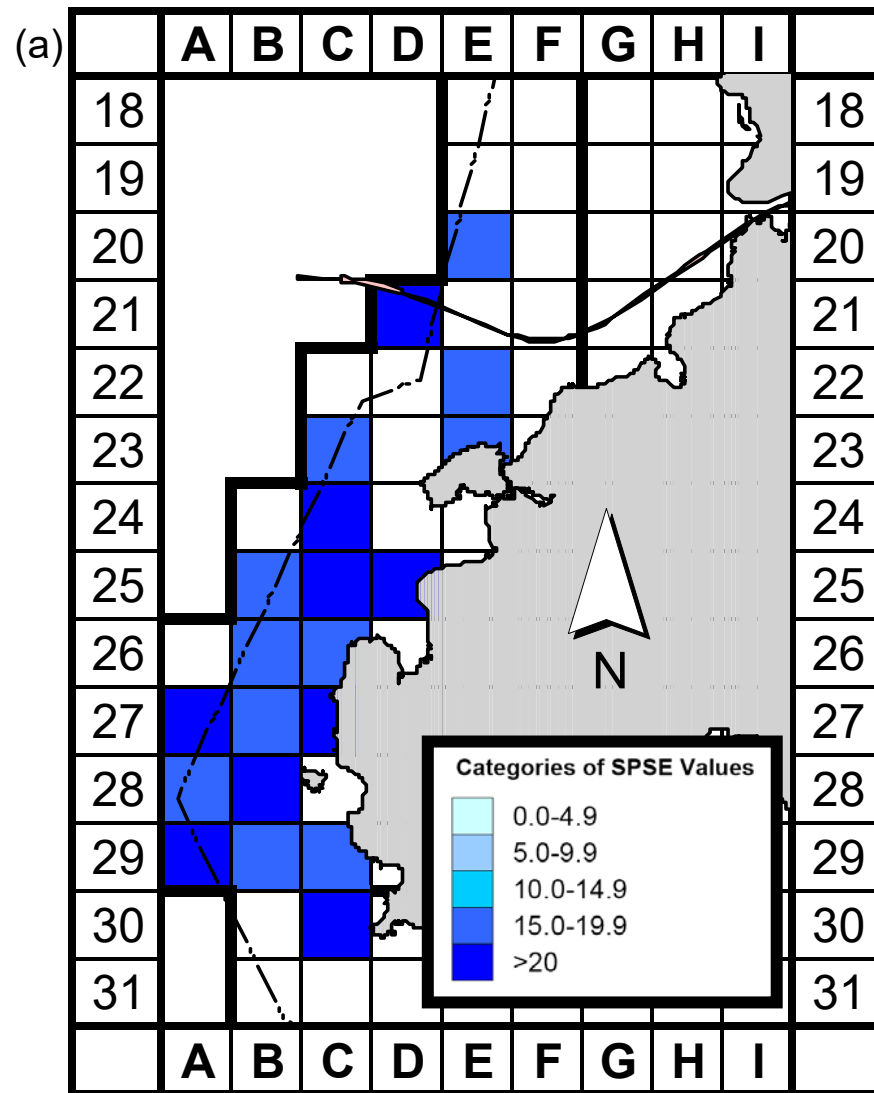
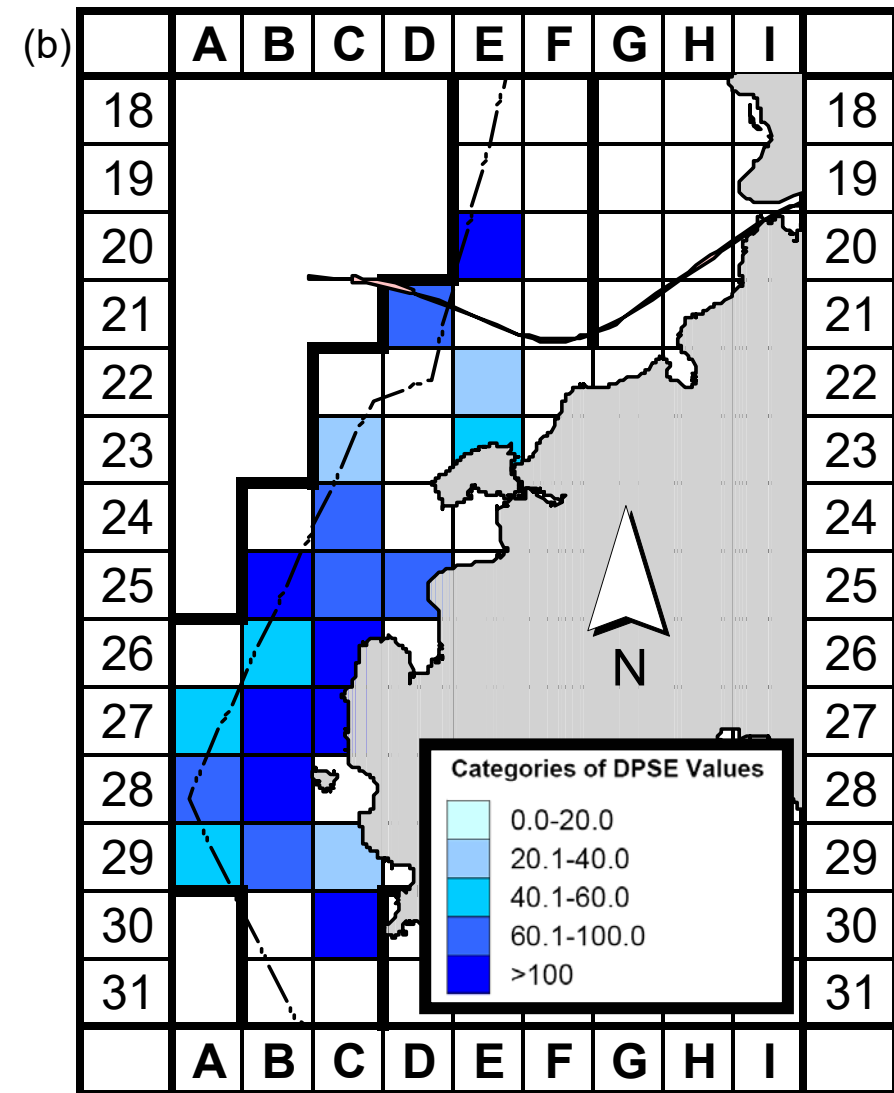
Figure 5a. Sighting density of Chinese white dolphins with corrected survey effort per km² in West Lantau survey area, using data collected during HKLR09 impact monitoring period (June-August 18) (SPSE = no. of on-effort sightings per 100 units of survey effort)

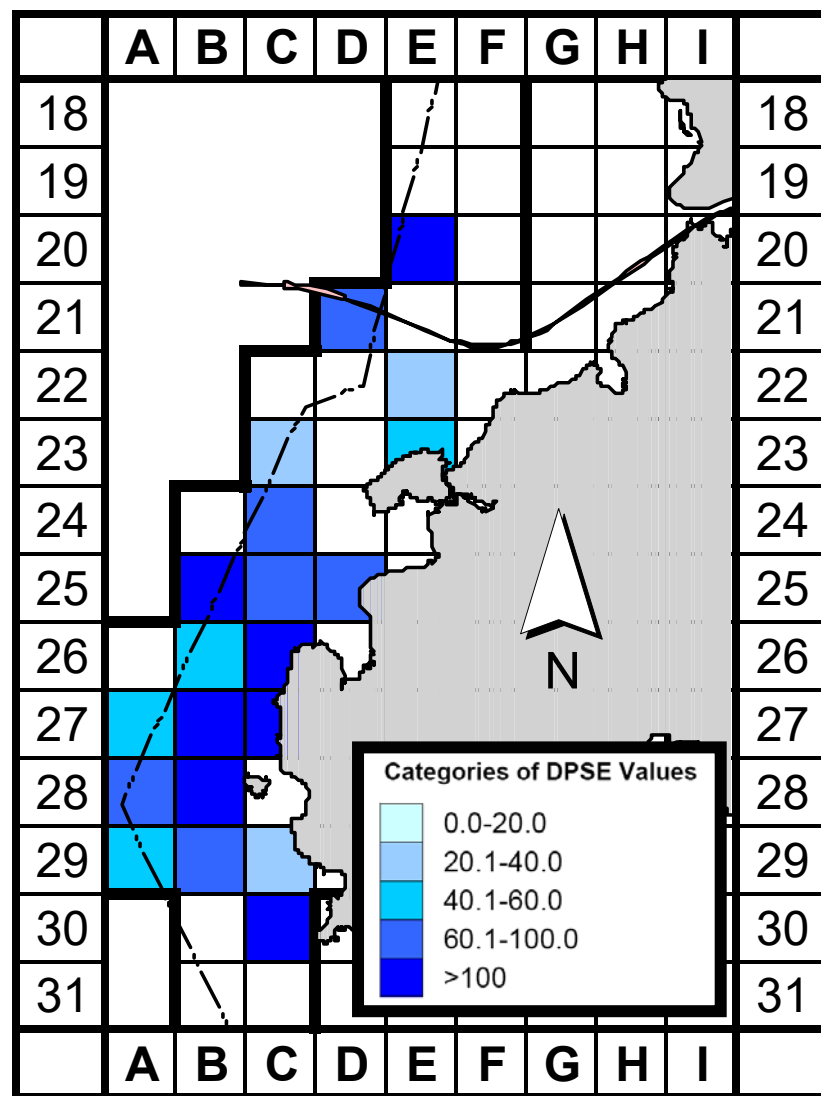
Figure 6. Comparison of density of Chinese white dolphins with corrected survey effort per km² in West Lantau survey area between the impact monitoring period (June-August 2018; left) and baseline monitoring period (September-November 2011; right)
(DPSE = no. of dolphins per 100 units of survey effort)
