**Agreement No. HMWSD 1/2019 (EP)
Post-Construction Monitoring of
Chinese White Dolphin (Line-transect
Vessel Surveys) for the Hong Kong-
Zhuhai-Macao Bridge Hong Kong Link
Road at West Lantau Waters –
Investigation**

Monthly EM&A Report – December 2019

Monthly EM&A Report for December 2019

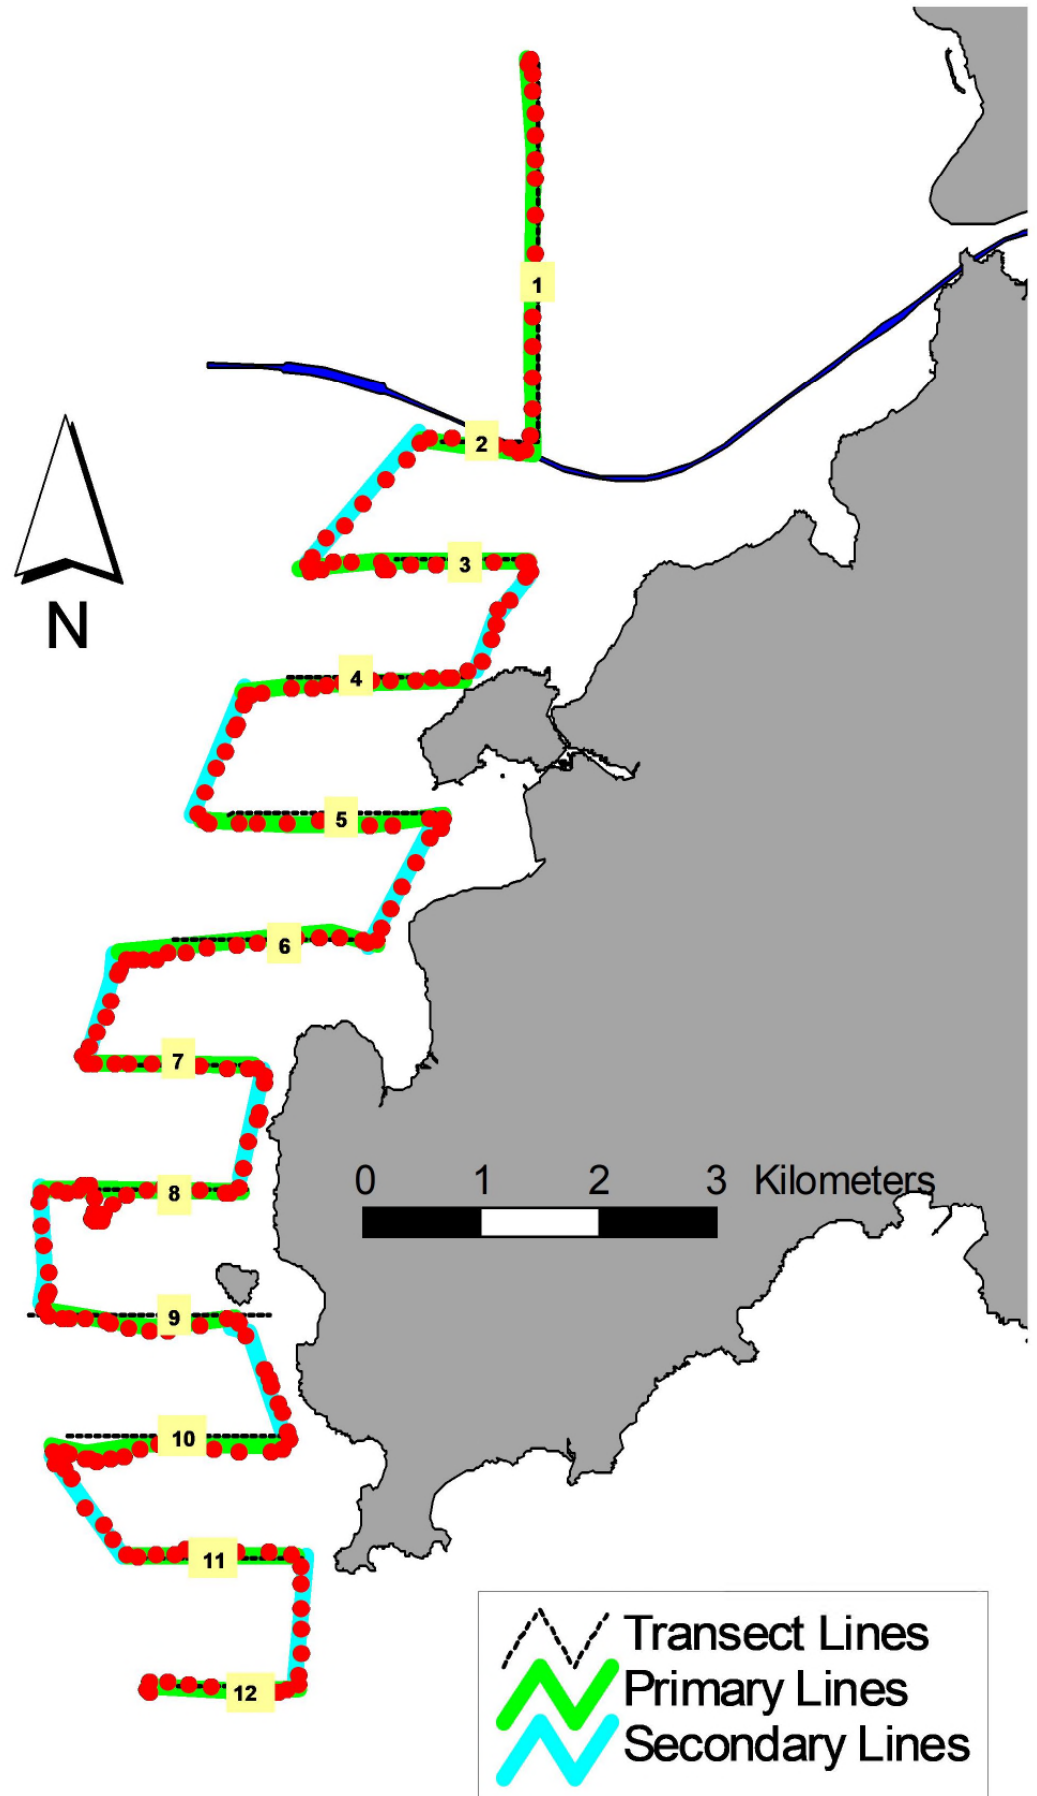
Figure 2. Survey Route on December 2nd, 2019 (note: red dots represent the tracked positions of survey boat logged continuously by GPS throughout the course of the survey)

Two sets of systematic line-transect vessel surveys were conducted on 2 and 4 December 2019, to cover all transect lines in WL survey area twice. The survey routes of each survey day are presented in Figures 2 to 3 of **Appendix B**.

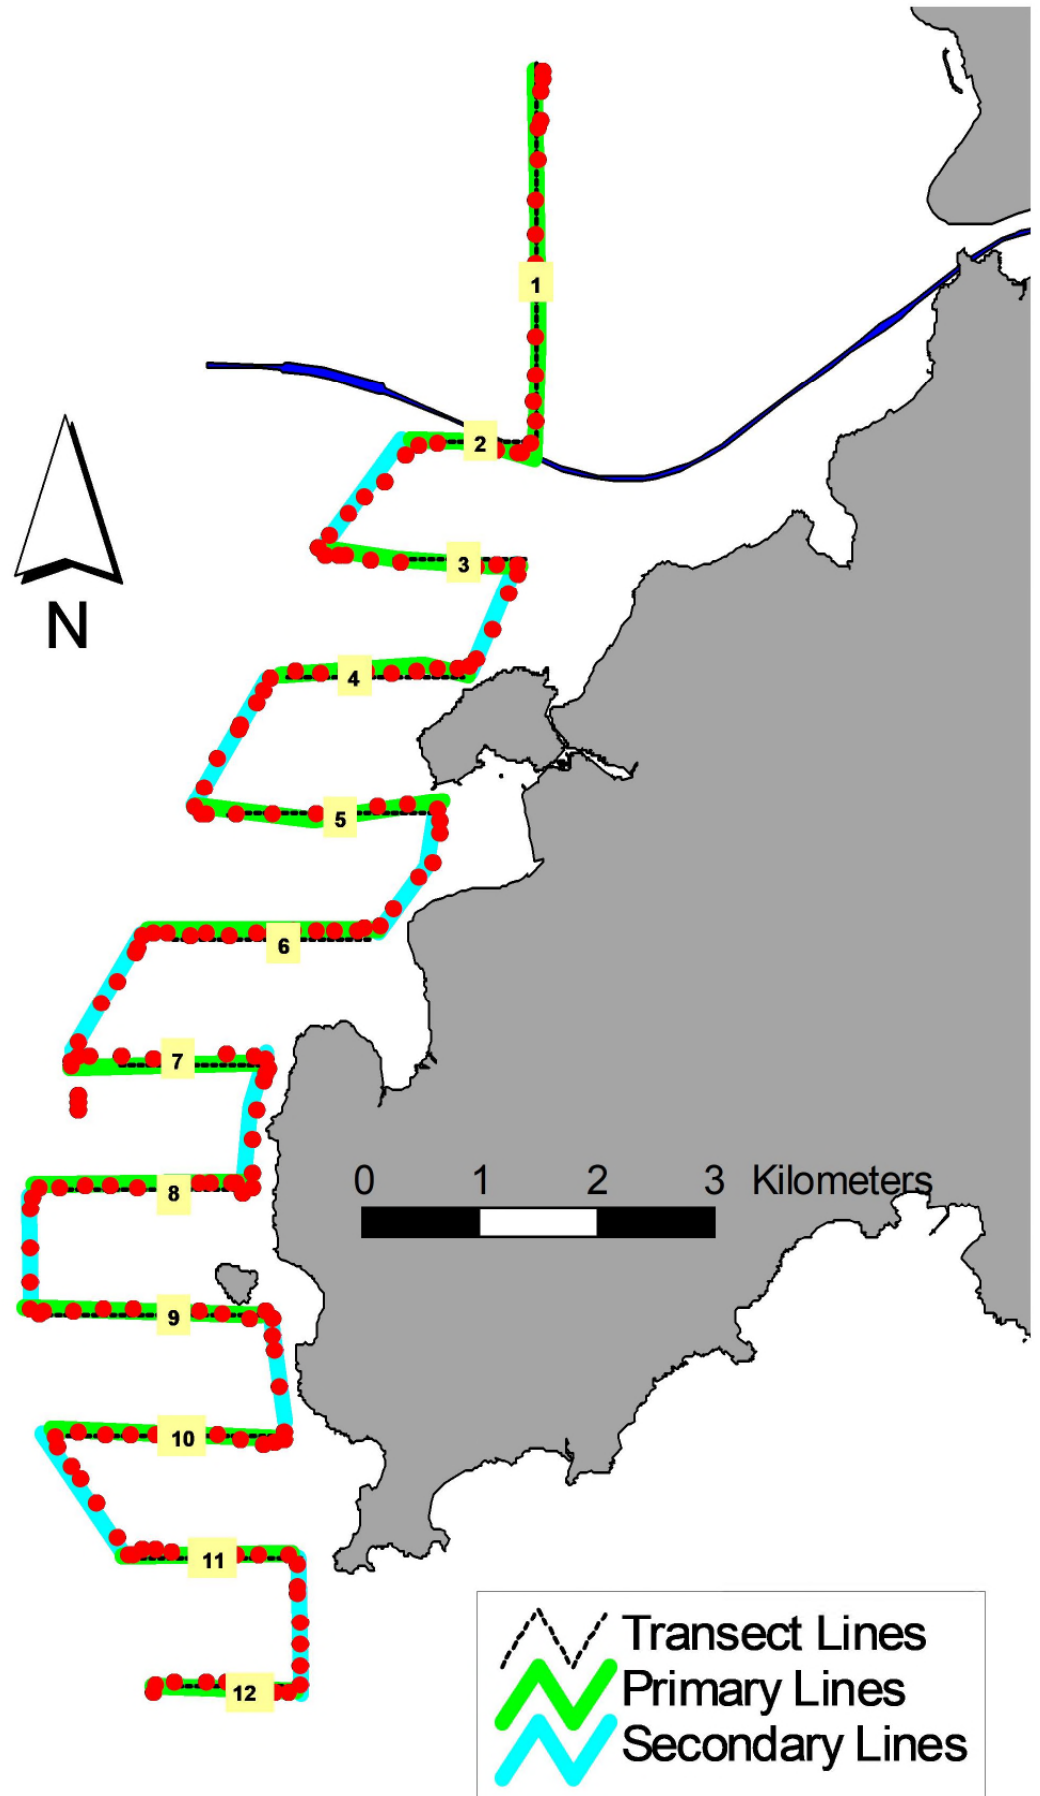
Figure 3. Survey Route on December 4th, 2019 (note: red dots represent the tracked positions of survey boat logged continuously by GPS throughout the course of the survey)

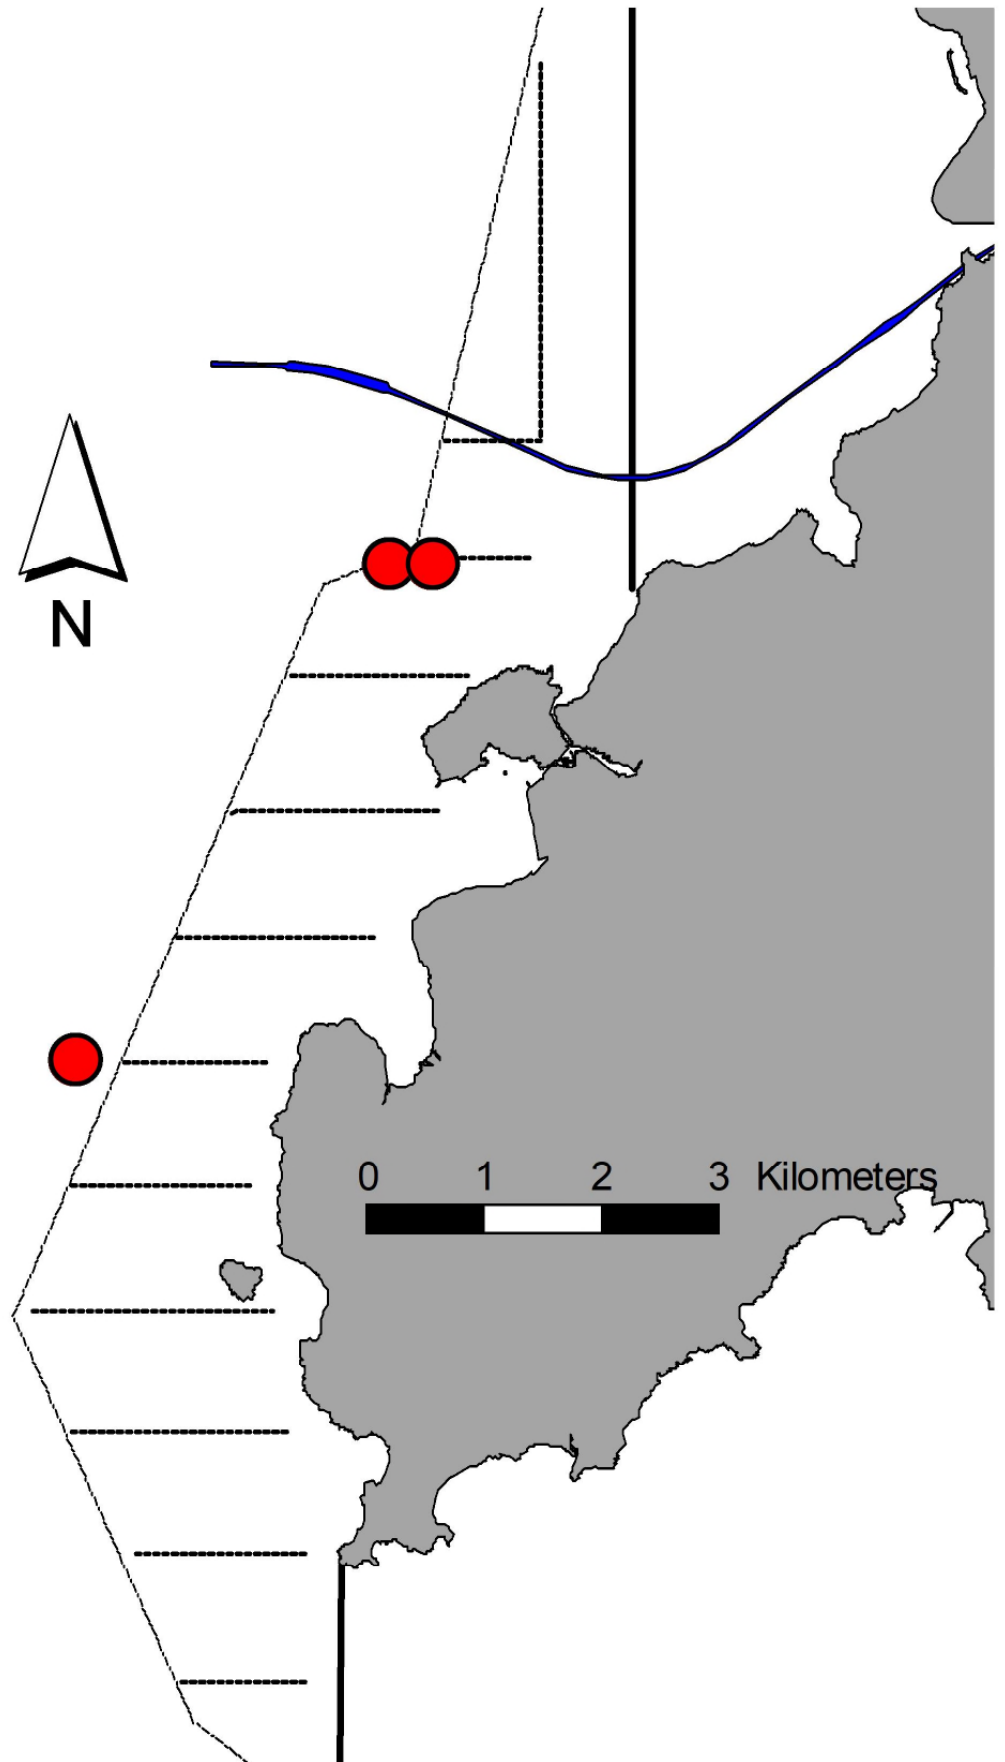
Figure 4. Distribution of Chinese White Dolphin sightings during the monitoring surveys conducted in December 2019

Distribution of the dolphin sightings made in the reporting period is shown in Figure 4 of **Appendix B**. Two of the three sightings were made to the northwest of Tai O Peninsula, while another sighting was made at the offshore waters to the west of Kai Kung Shan.
