**Agreement No. HMWSD 1/2019 (EP)
Post-Construction Monitoring of
Chinese White Dolphin (Line-transect
Vessel Surveys) for the Hong Kong-
Zhuhai-Macao Bridge Hong Kong Link
Road at West Lantau Waters –
Investigation**

Monthly EM&A Report – February 2020

Monthly EM&A Report for February 2020

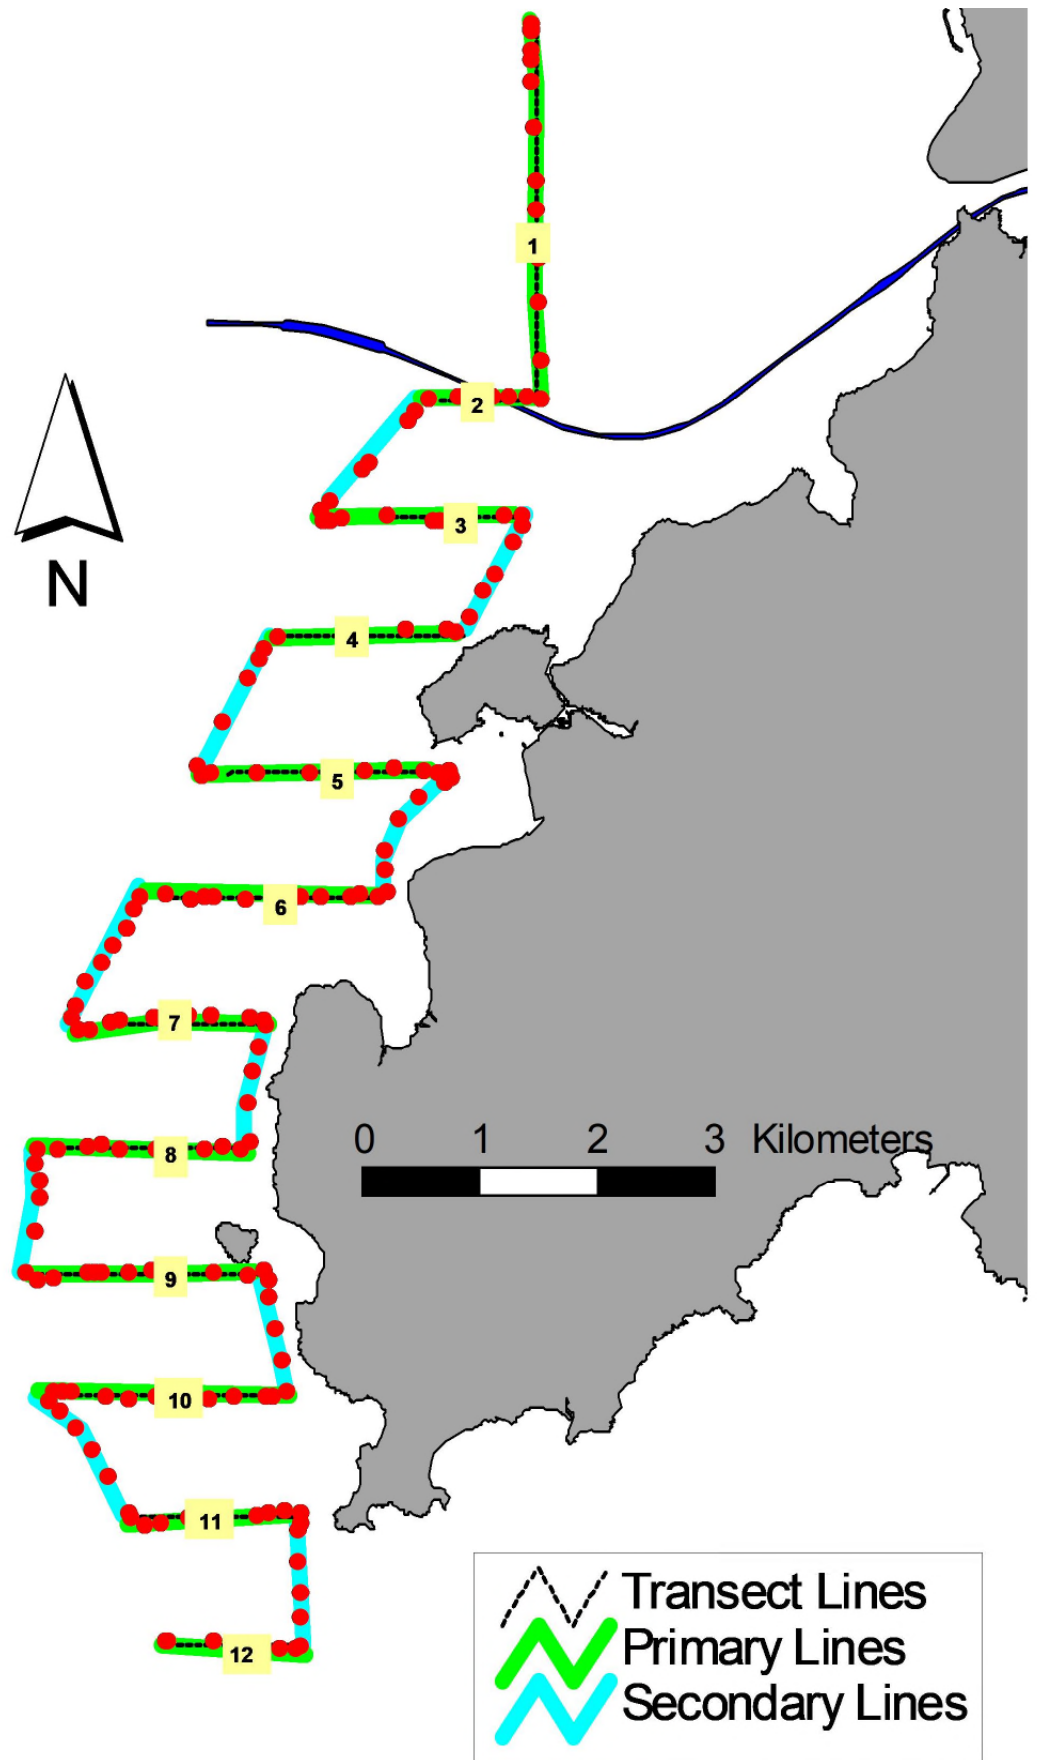
Figure 2. Survey Route on February 5th, 2020 (note: red dots represent the tracked positions of survey boat logged continuously by GPS throughout the course of the survey)

Two sets of systematic line-transect vessel surveys were conducted on 5 and 12 February 2020, to cover all transect lines in WL survey area twice. The survey routes of each survey day are presented in Figures 2 to 3 of **Appendix B**.

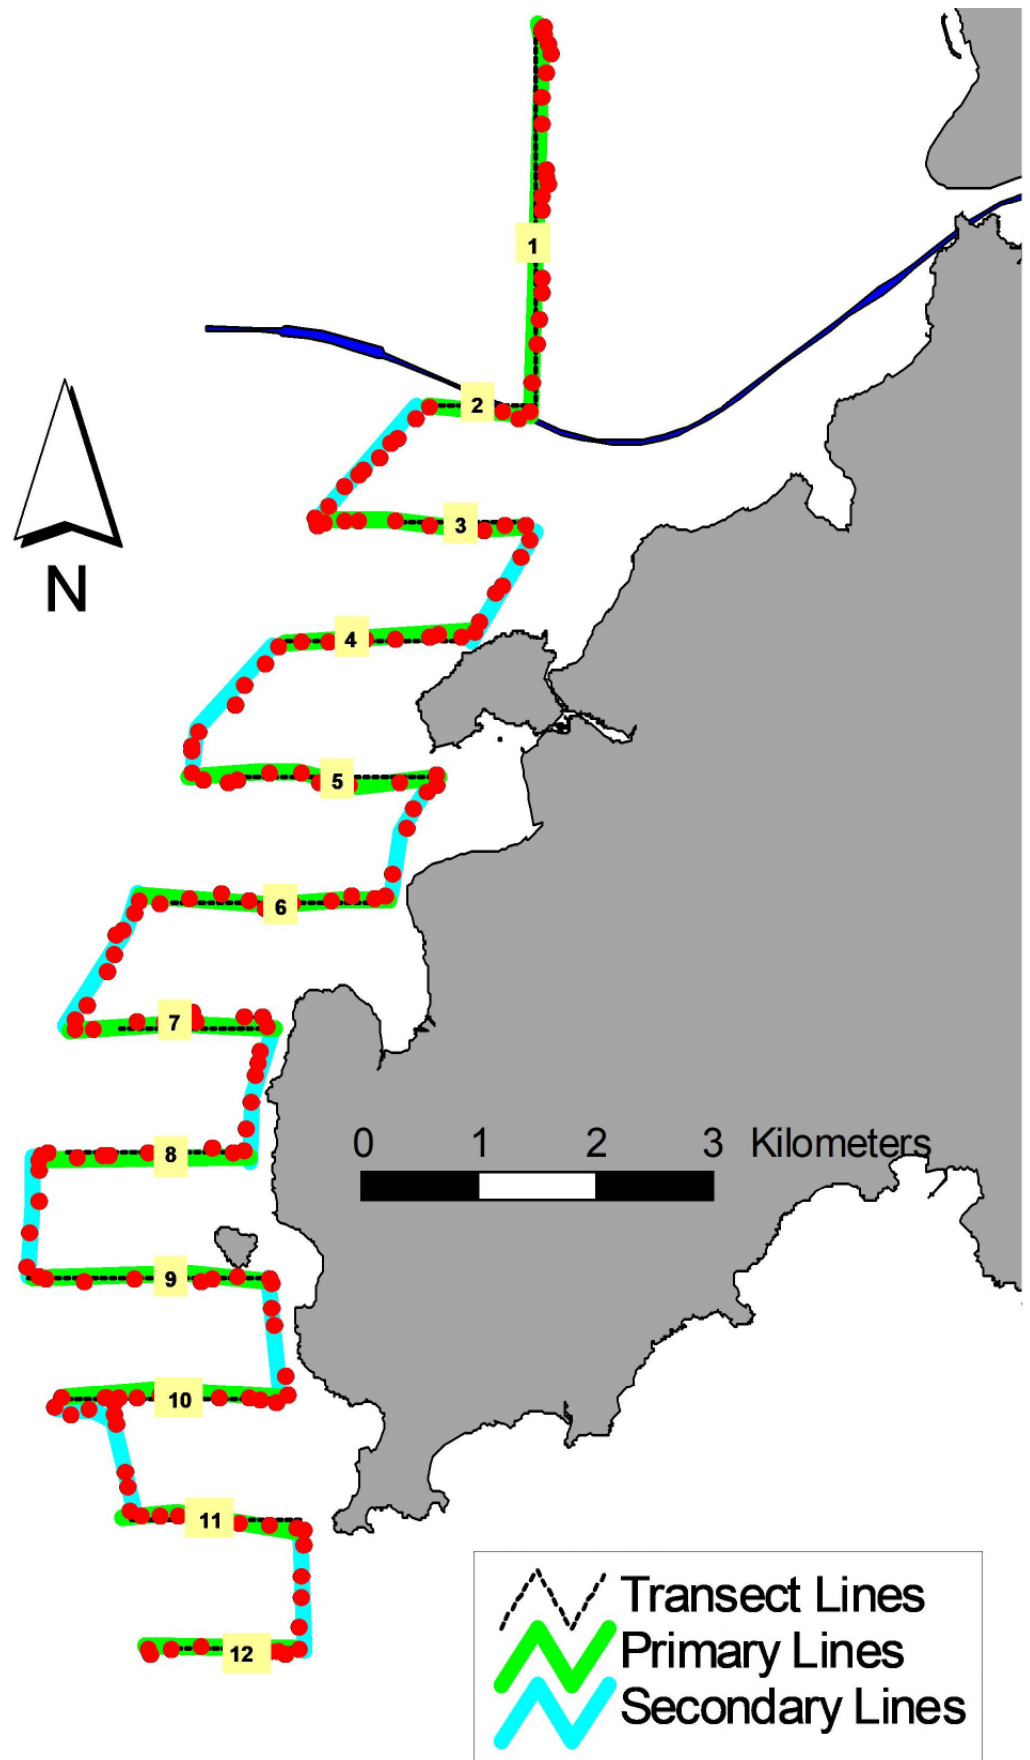
Figure 3. Survey Route on February 12th, 2020 (note: red dots represent the tracked positions of survey boat logged continuously by GPS throughout the course of the survey)
