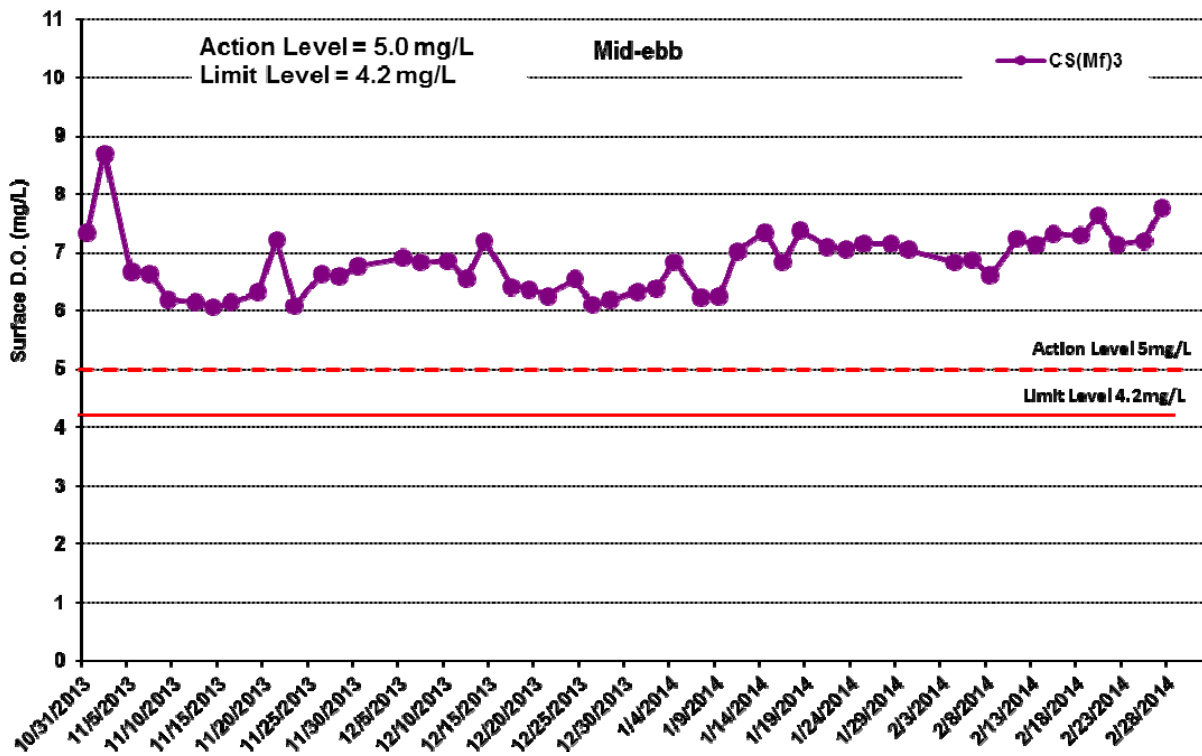
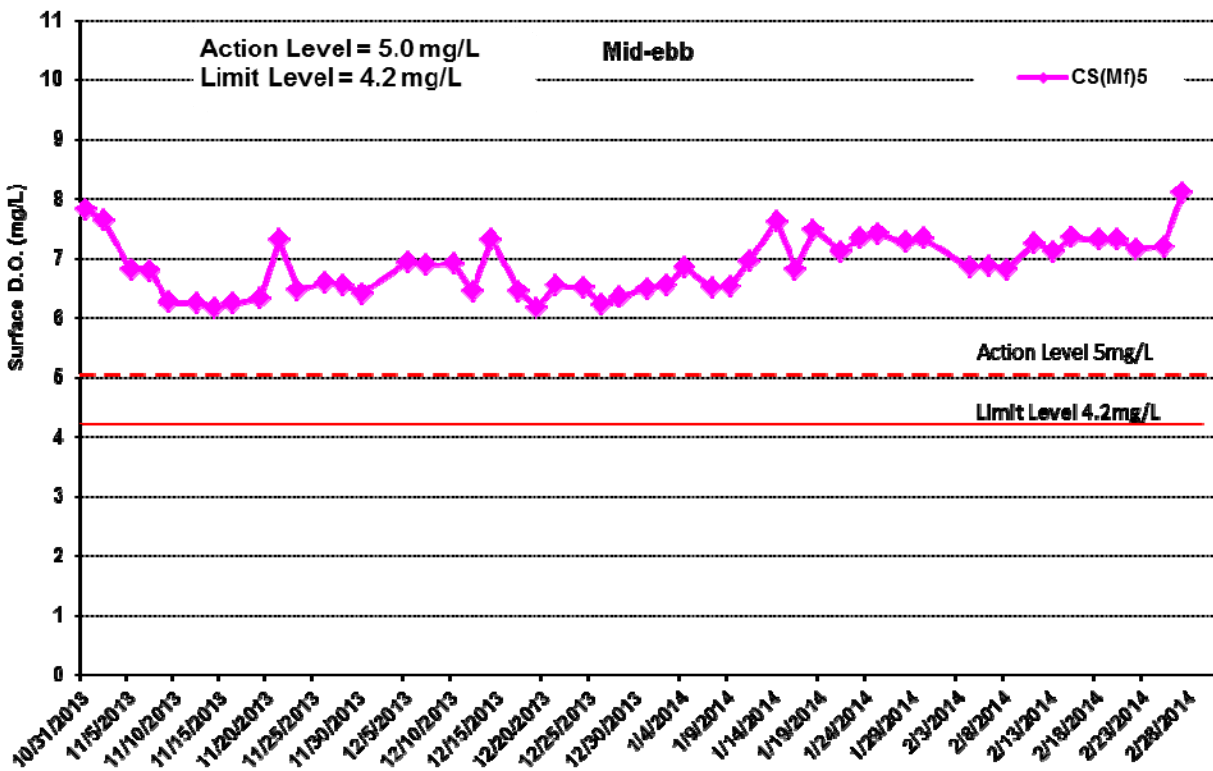
Figure I1 Impact Monitoring – Mean Level of Dissolved Oxygen (mg/L) in surface waters during mid-ebb tide between 31 October 2013 to 28 February 2014 at CS(Mf)3 and CS(Mf)5.

(Weather condition varied between sunny to rainy within the reporting period. Marine works within the reporting period include rockfill platform construction, marine piling platform installation and survey tower erection.)

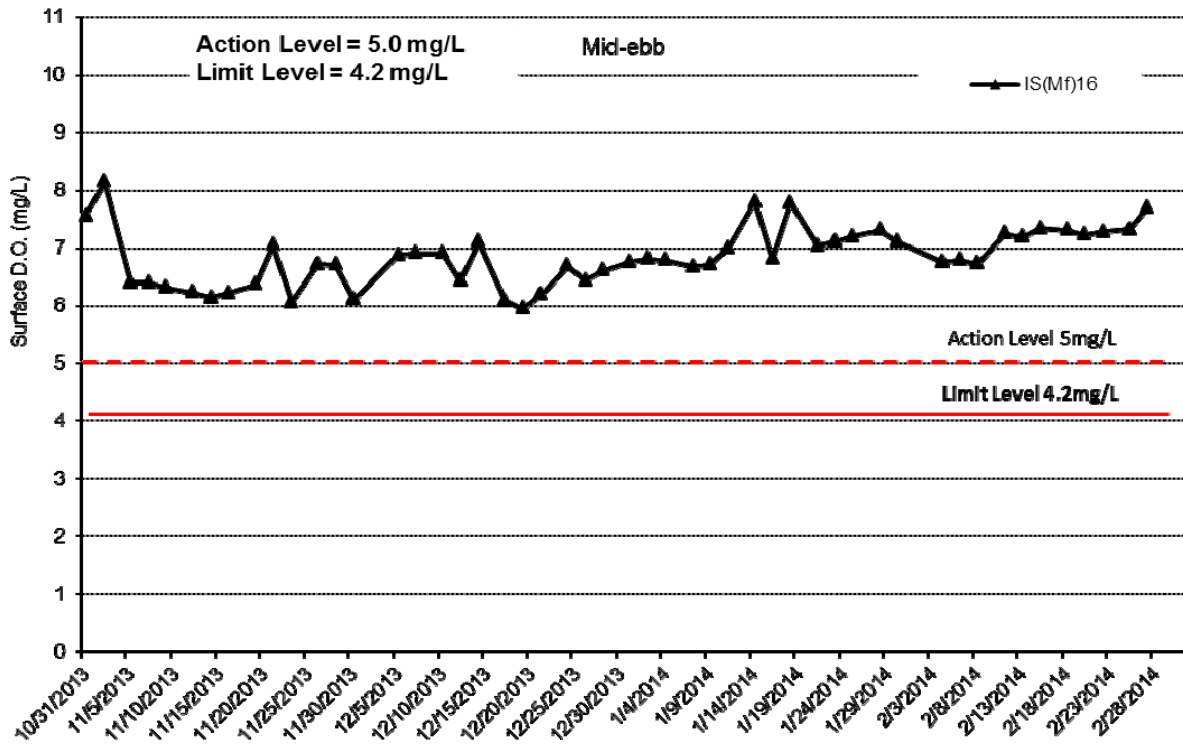
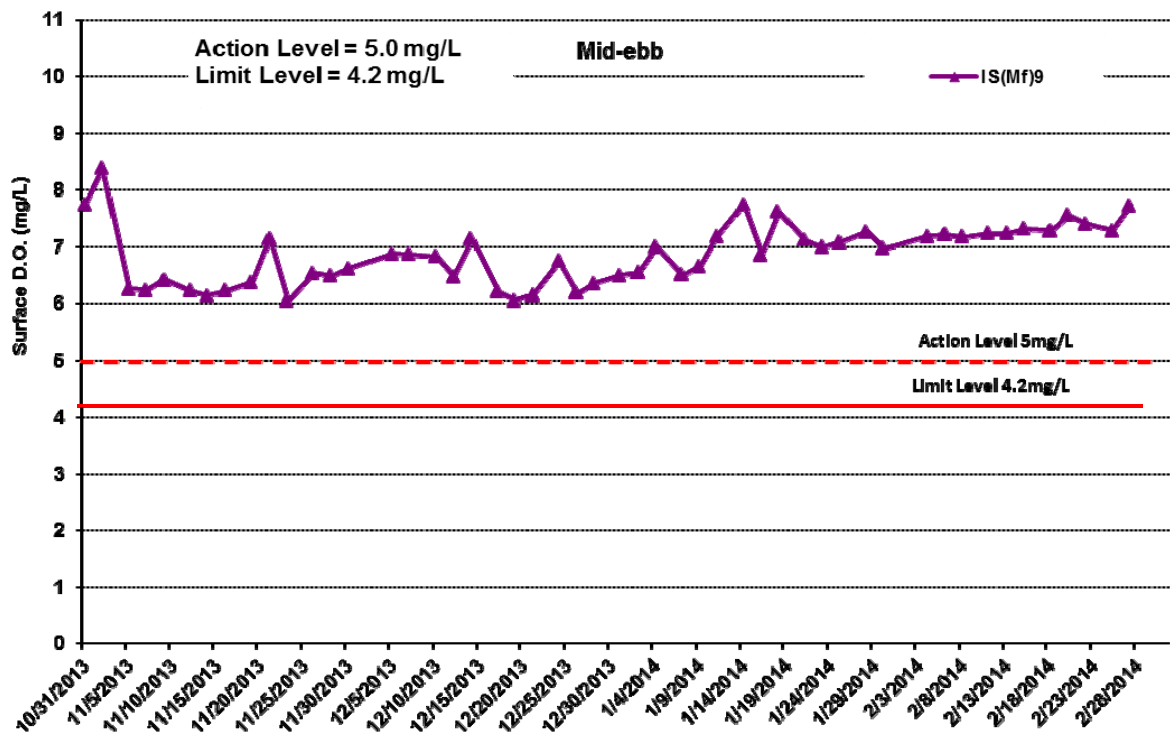
Figure I2 Impact Monitoring – Mean Level of Dissolved Oxygen (mg/L) in surface waters during mid-ebb tide between 31 October 2013 to 28 February 2014 at IS(Mf)16 and IS(Mf)9.

(Weather condition varied between sunny to rainy within the reporting period. Marine works within the reporting period include rockfill platform construction, marine piling platform installation and survey tower erection.)

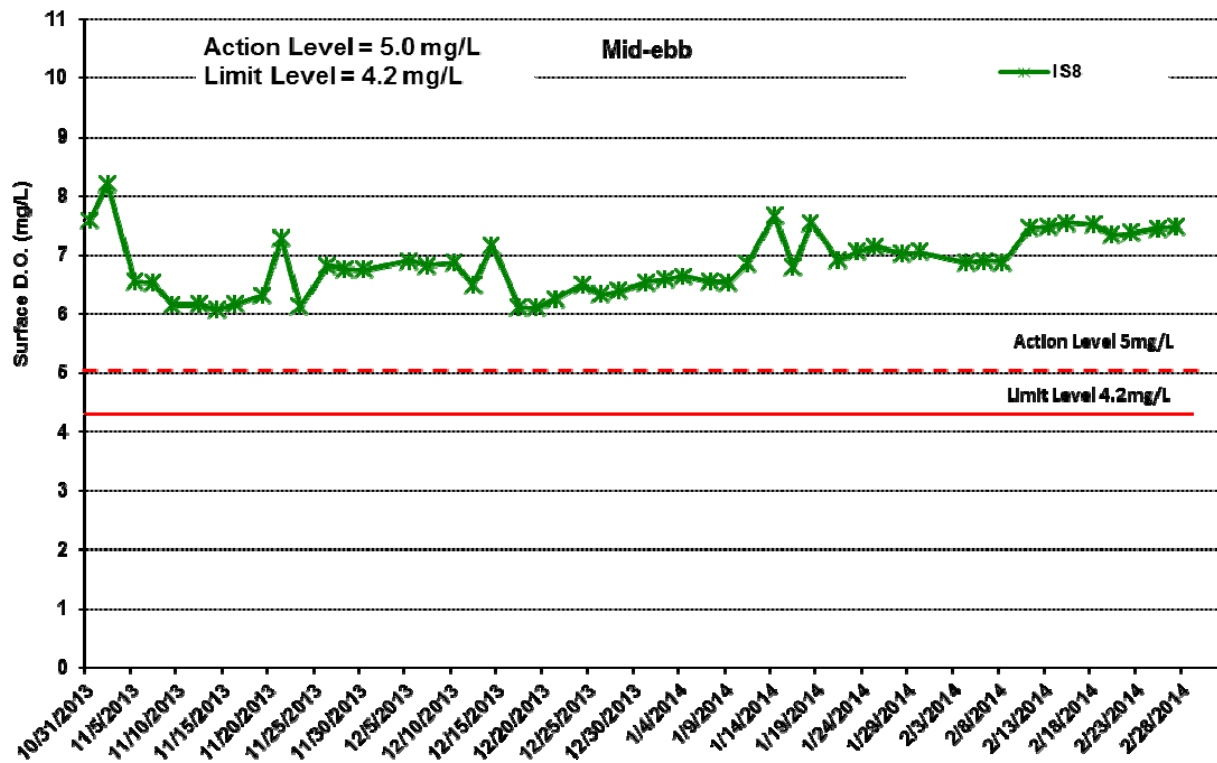
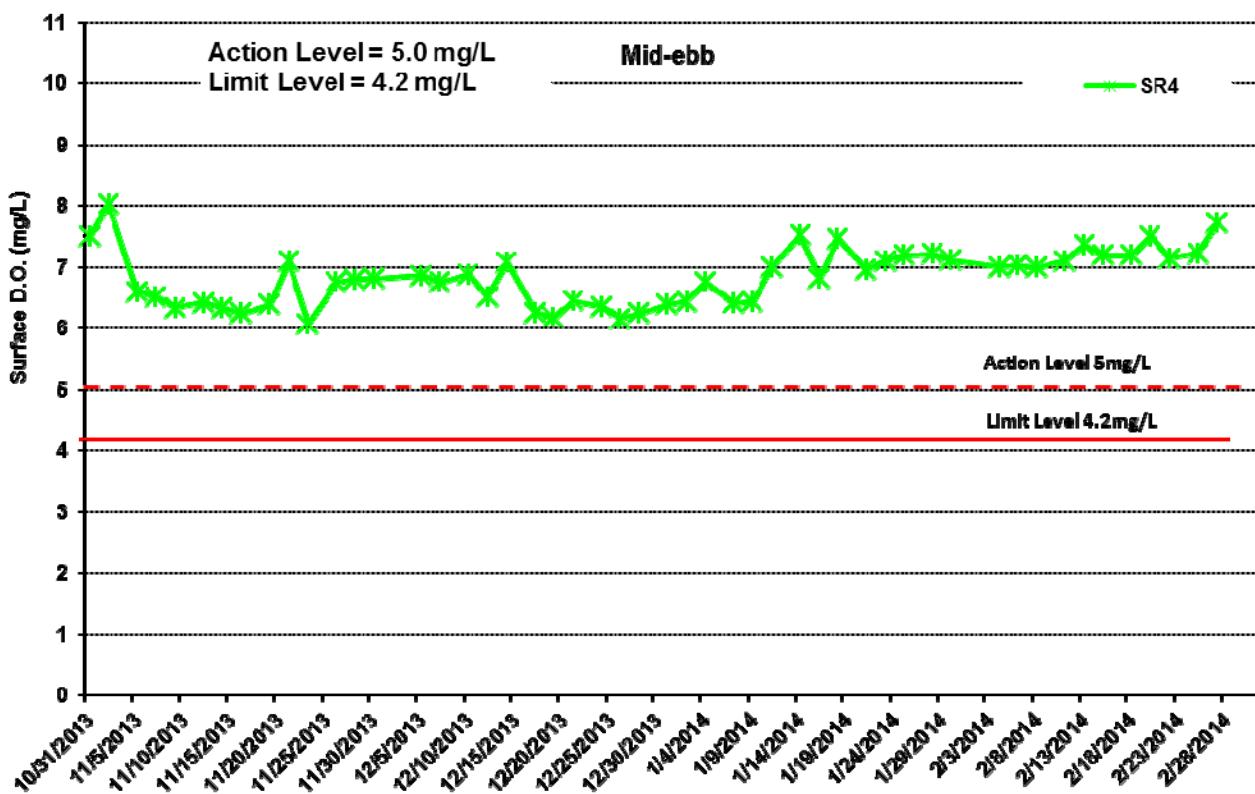
Figure I3 Impact Monitoring - Mean Level of Dissolved Oxygen (mg/L) in surface waters during mid-ebb tide between 31 October 2013 to 28 February 2014 at IS8 and SR4.

(Weather condition varied between sunny to rainy within the reporting period. Marine works within the reporting period include rockfill platform construction, marine piling platform installation and survey tower erection.)

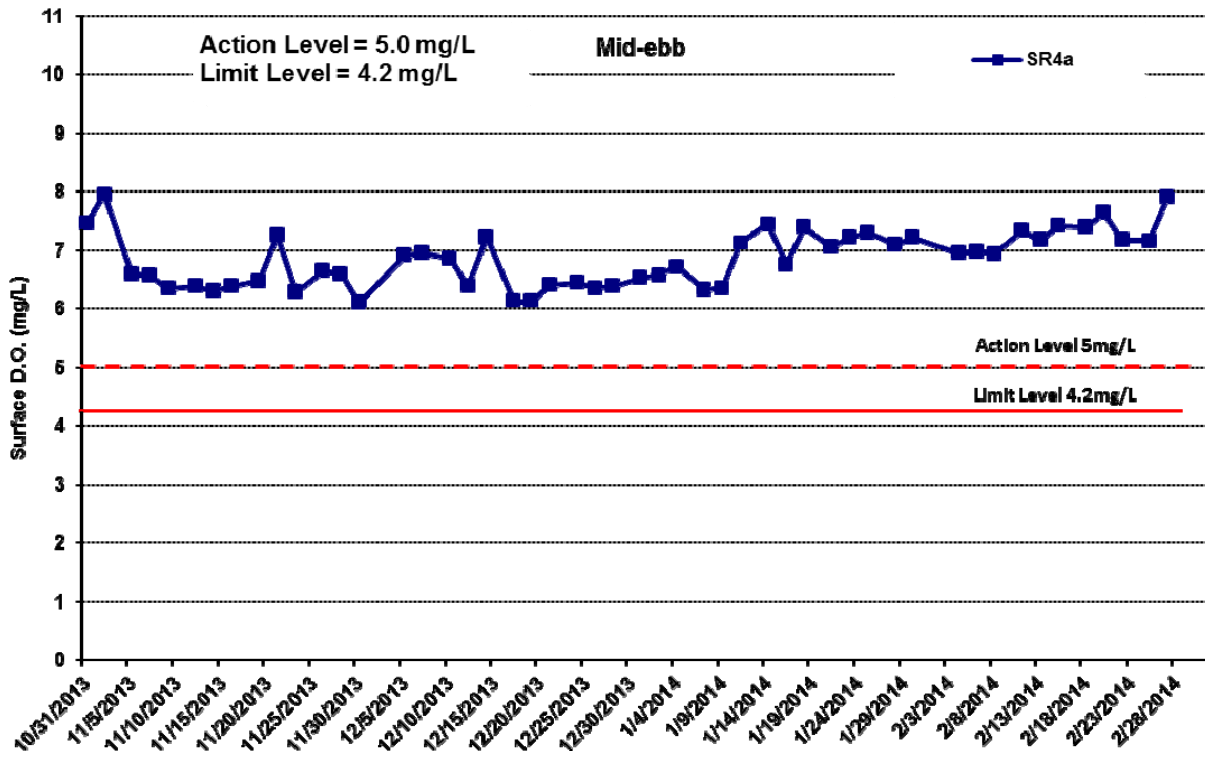
Figure I4 Impact Monitoring - Mean Level of Dissolved Oxygen (mg/L) in surface waters during mid-ebb tide between 31 October 2013 to 28 February 2014 at SR4a.

(Weather condition varied between sunny to rainy within the reporting period. Marine works within the reporting period include rockfill platform construction, marine piling platform installation and survey tower erection.)

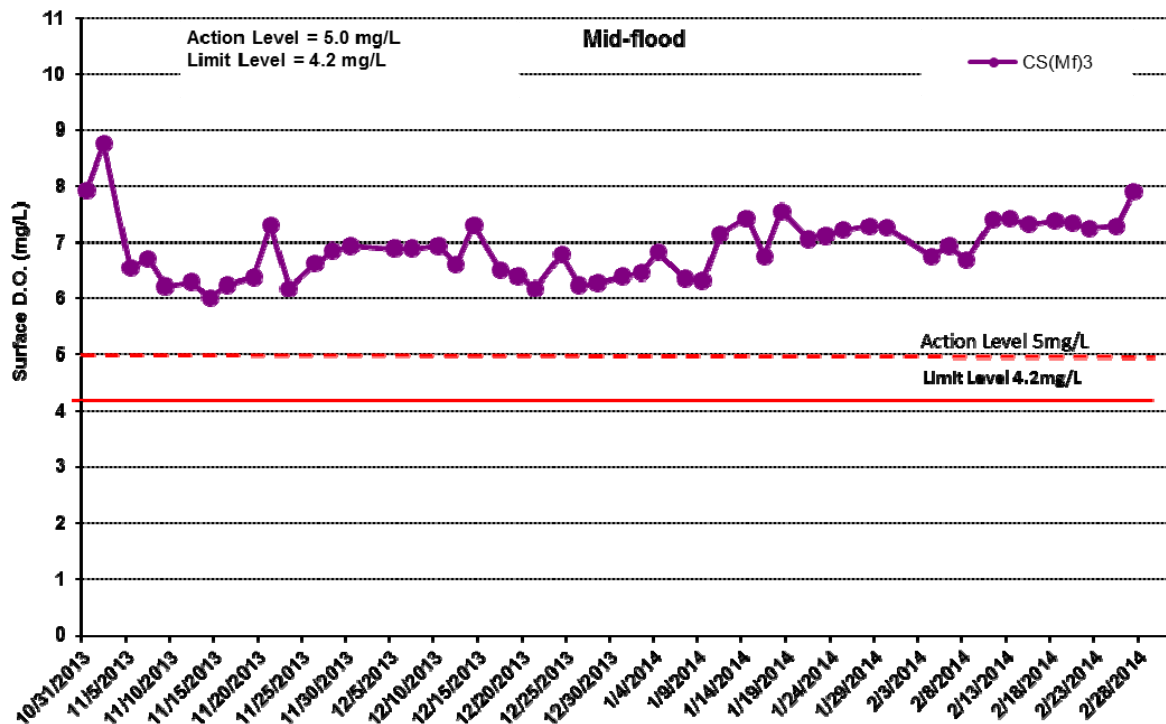
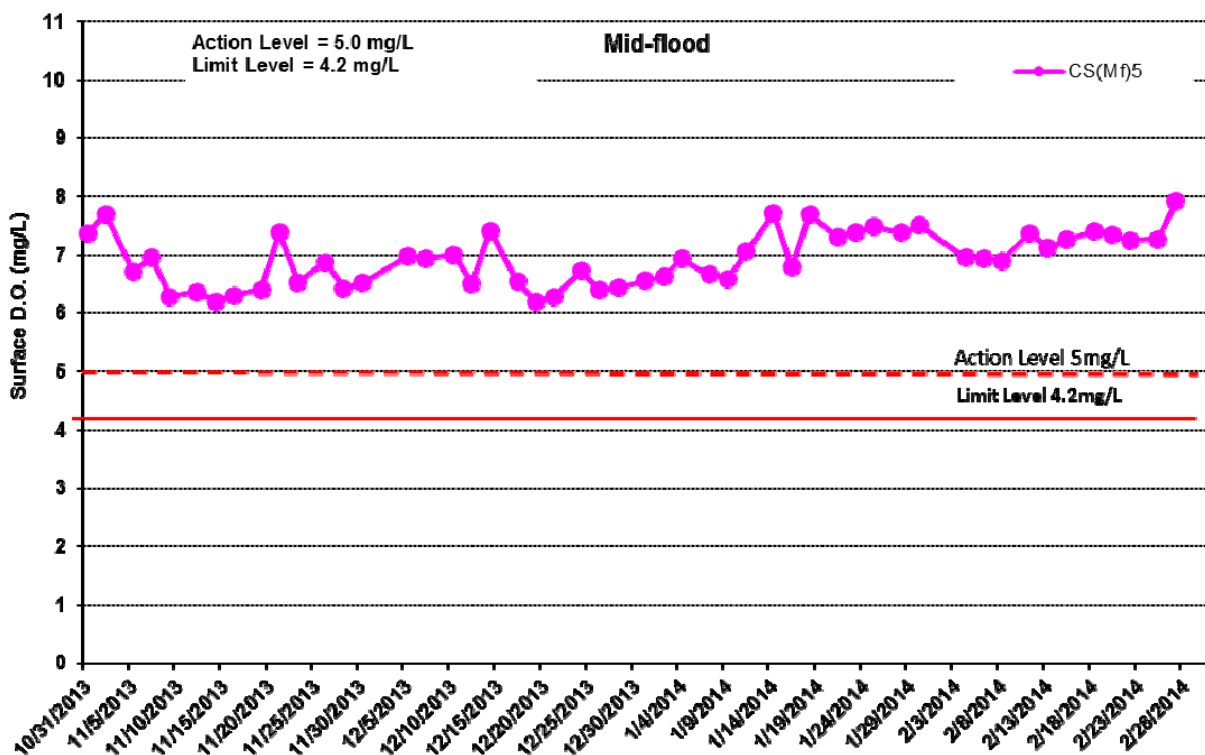
Figure I5 Impact Monitoring - Mean Level of Dissolved Oxygen (mg/L) in surface waters during mid-flood tide between 31 October 2013 to 28 February 2014 at CS(Mf)3 and CS(Mf)5.

(Weather condition varied between sunny to rainy within the reporting period. Marine works within the reporting period include rockfill platform construction, marine piling platform installation and survey tower erection.)

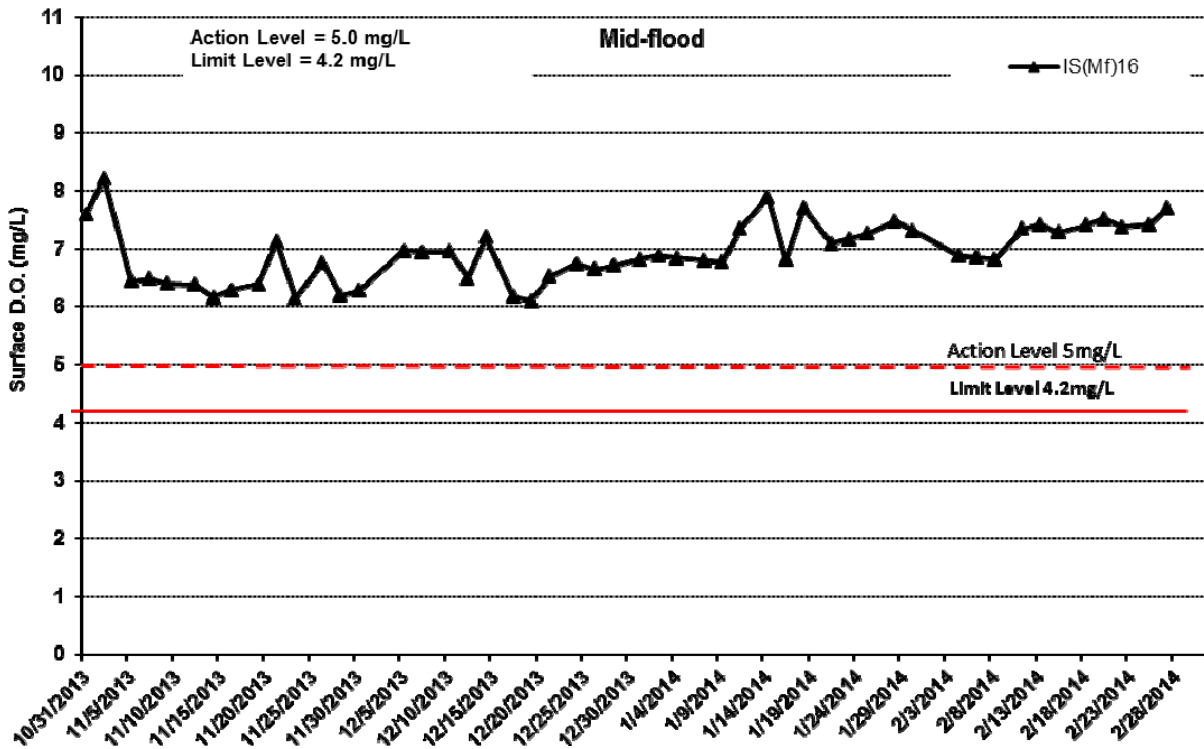
Figure I6 Impact Monitoring - Mean Level of Dissolved Oxygen (mg/L) in surface waters during mid-flood tide between 31 October 2013 to 28 February 2014 at IS(Mf)16 and IS(Mf)9.

(Weather condition varied between sunny to rainy within the reporting period. Marine works within the reporting period include rockfill platform construction, marine piling platform installation and survey tower erection.)

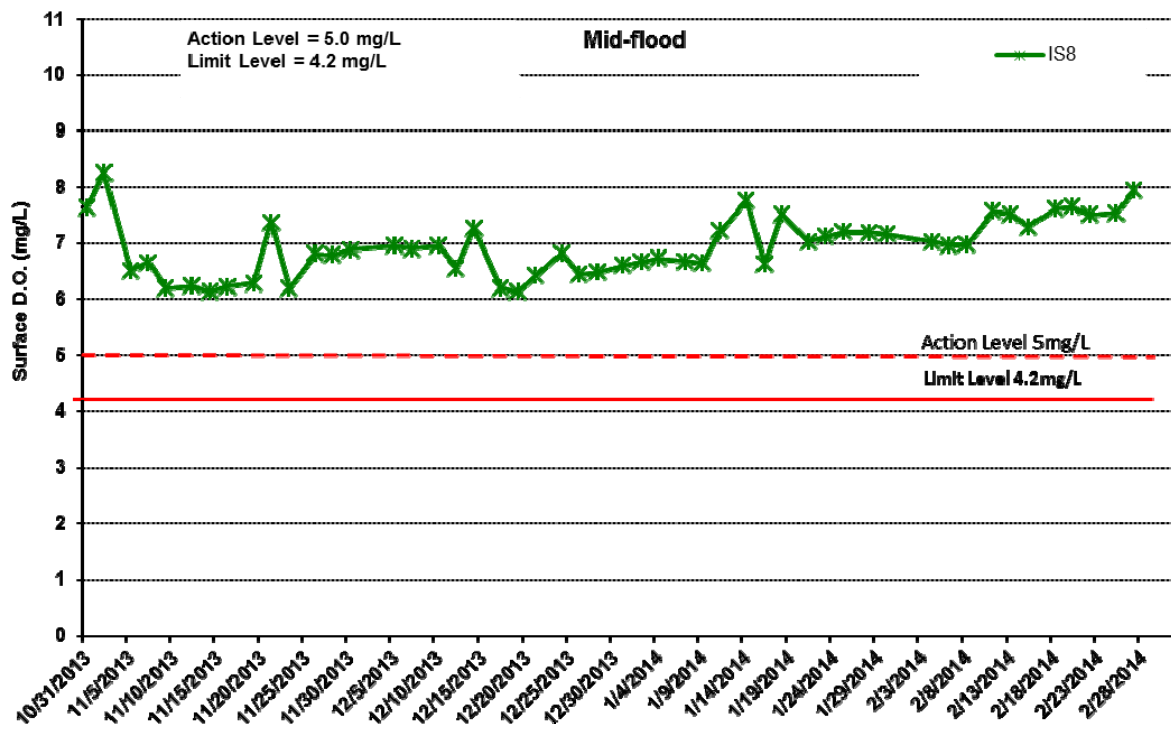
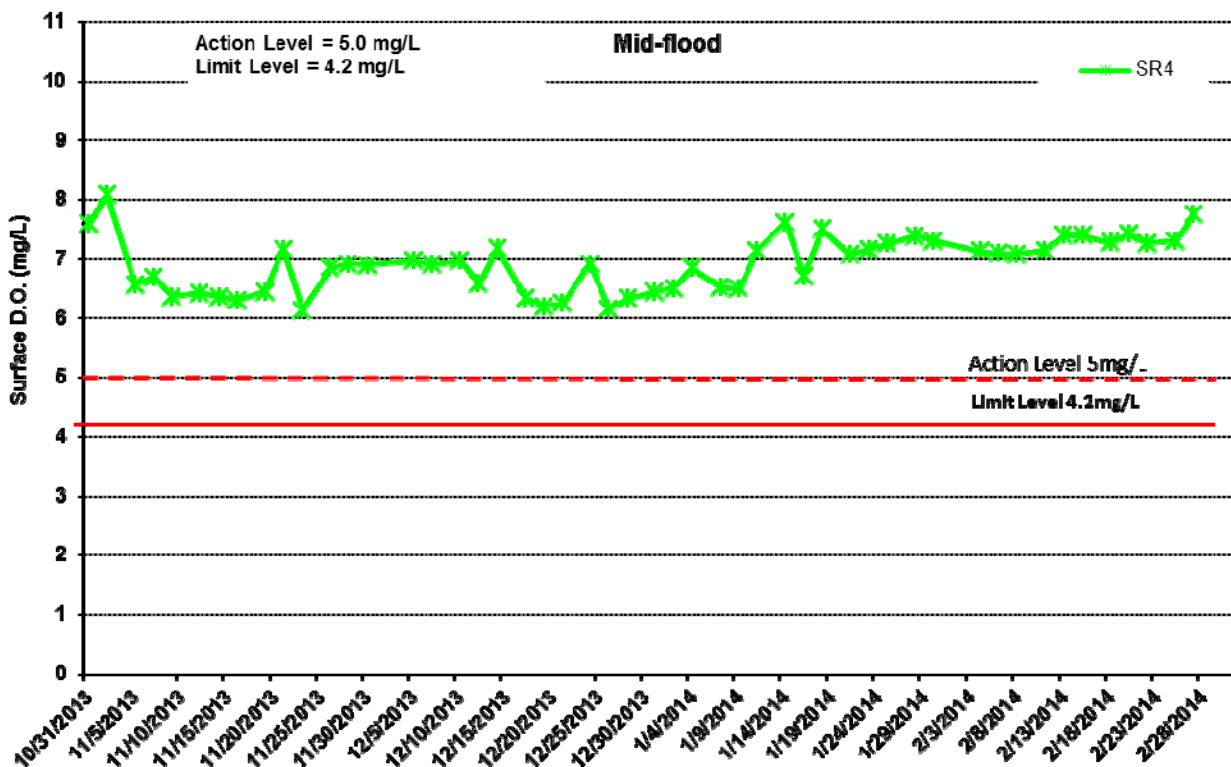
Figure I7 Impact Monitoring - Mean Level of Dissolved Oxygen (mg/L) in surface waters during mid-flood tide between 31 October 2013 to 28 February 2014 at IS8 and SR4.

(Weather condition varied between sunny to rainy within the reporting period. Marine works within the reporting period include rockfill platform construction, marine piling platform installation and survey tower erection.)

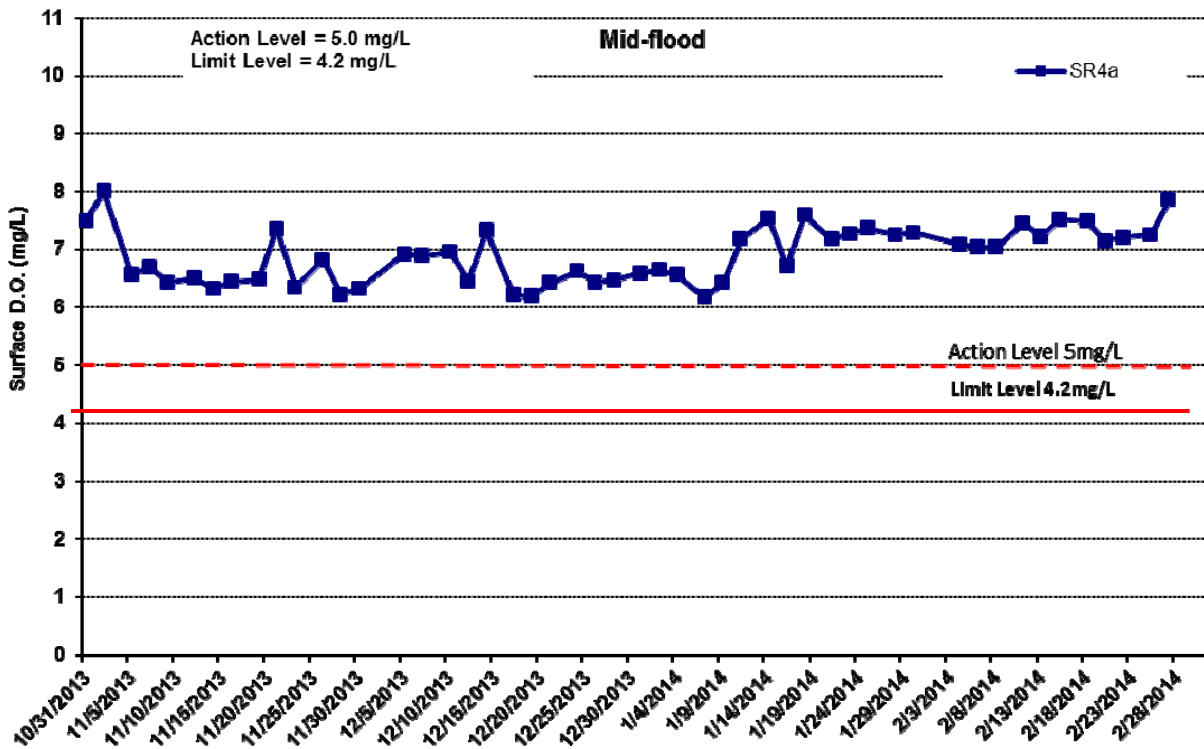
Figure I8 Impact Monitoring - Mean Level of Dissolved Oxygen (mg/L) in surface waters during mid-flood tide between 31 October 2013 to 28 February 2014 at SR4a.

(Weather condition varied between sunny to rainy within the reporting period. Marine works within the reporting period include rockfill platform construction, marine piling platform installation and survey tower erection.)

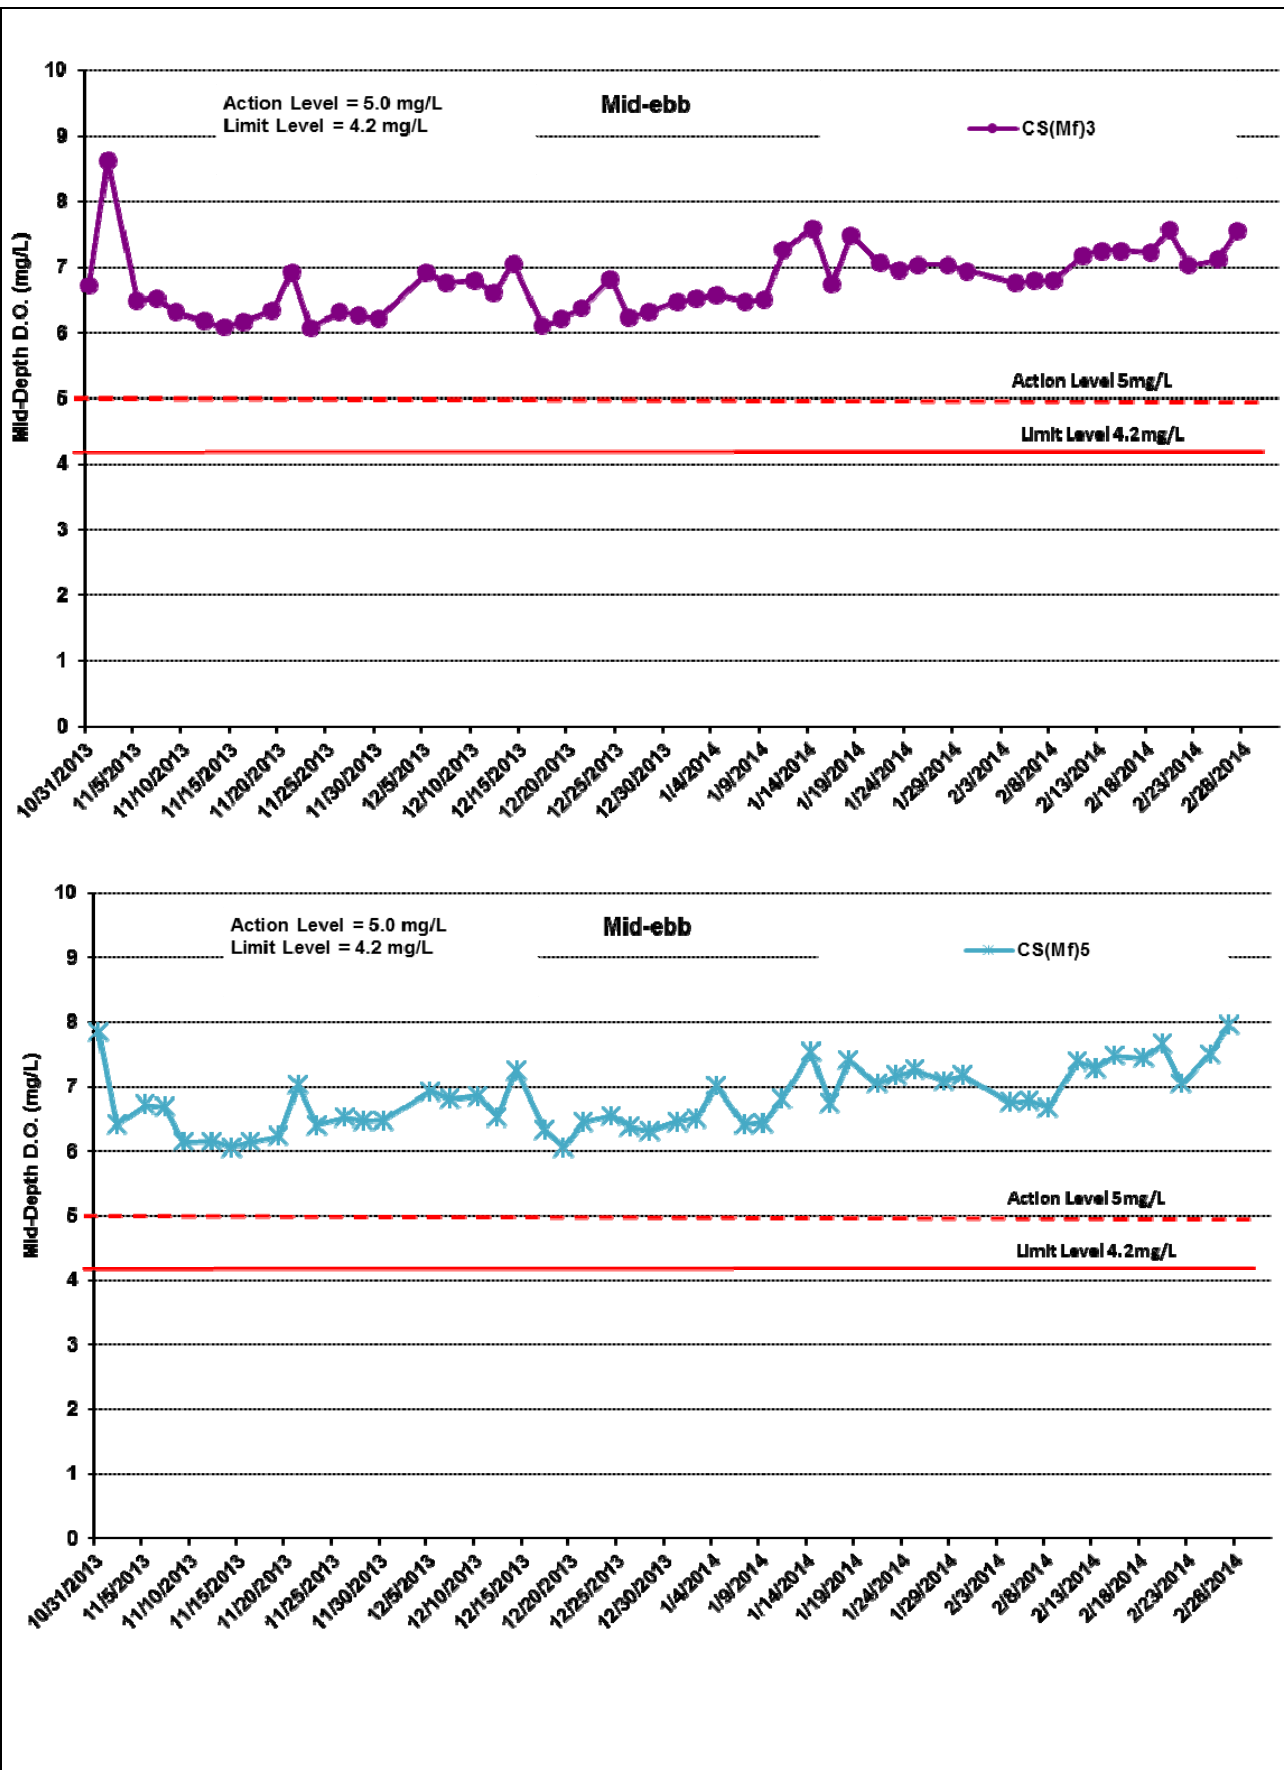
Figure I9 Impact Monitoring – Mean Level of Dissolved Oxygen (mg/L) in mid-depth waters during mid-ebb tide between 31 October 2013 to 28 February 2014 at CS(Mf)3 and IS(Mf)5.

(Weather condition varied between sunny to rainy within the reporting period. Marine works within the reporting period include rockfill platform construction, marine piling platform installation and survey tower erection.)

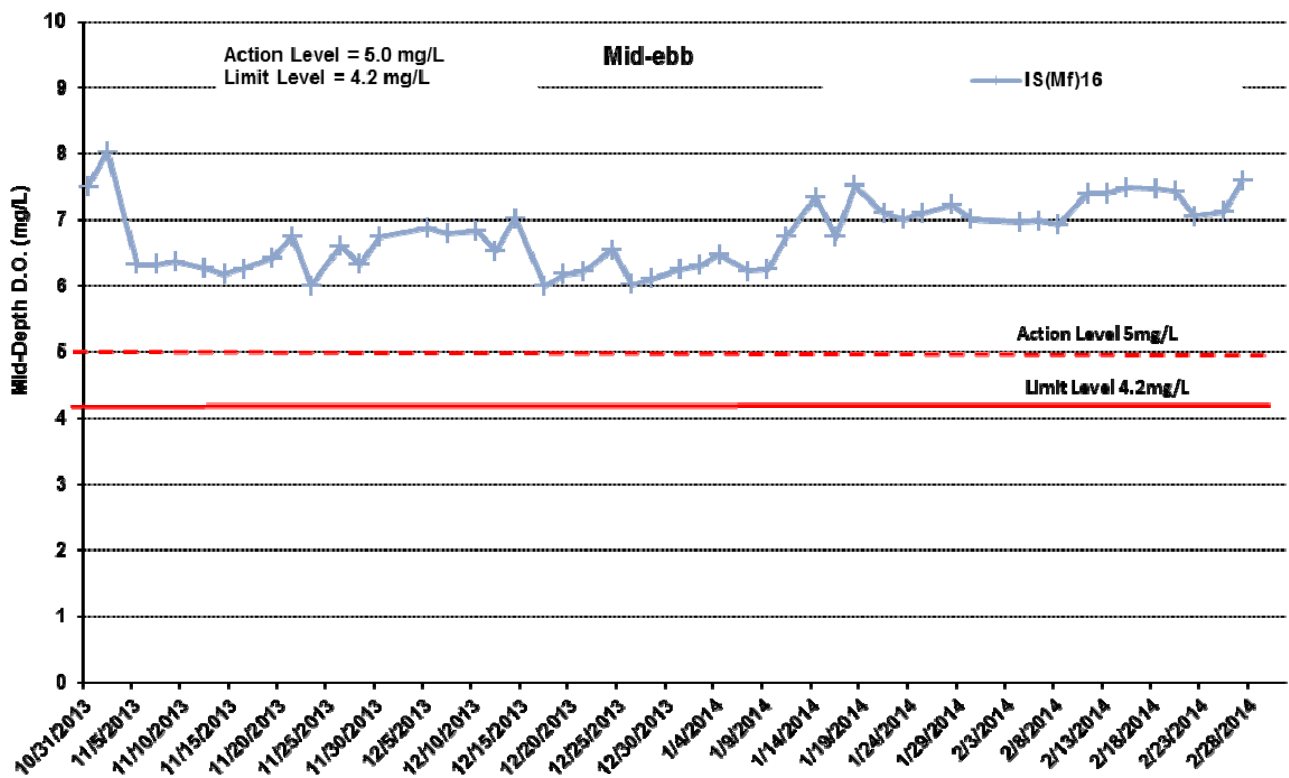
Figure I10 Impact Monitoring - Mean Level of Dissolved Oxygen (mg/L) in mid-depth waters during mid-ebb tide between 31 October 2013 to 28 February 2014 at IS(Mf)16.

(Weather condition varied between sunny to rainy within the reporting period. Marine works within the reporting period include rockfill platform construction, marine piling platform installation and survey tower erection.)

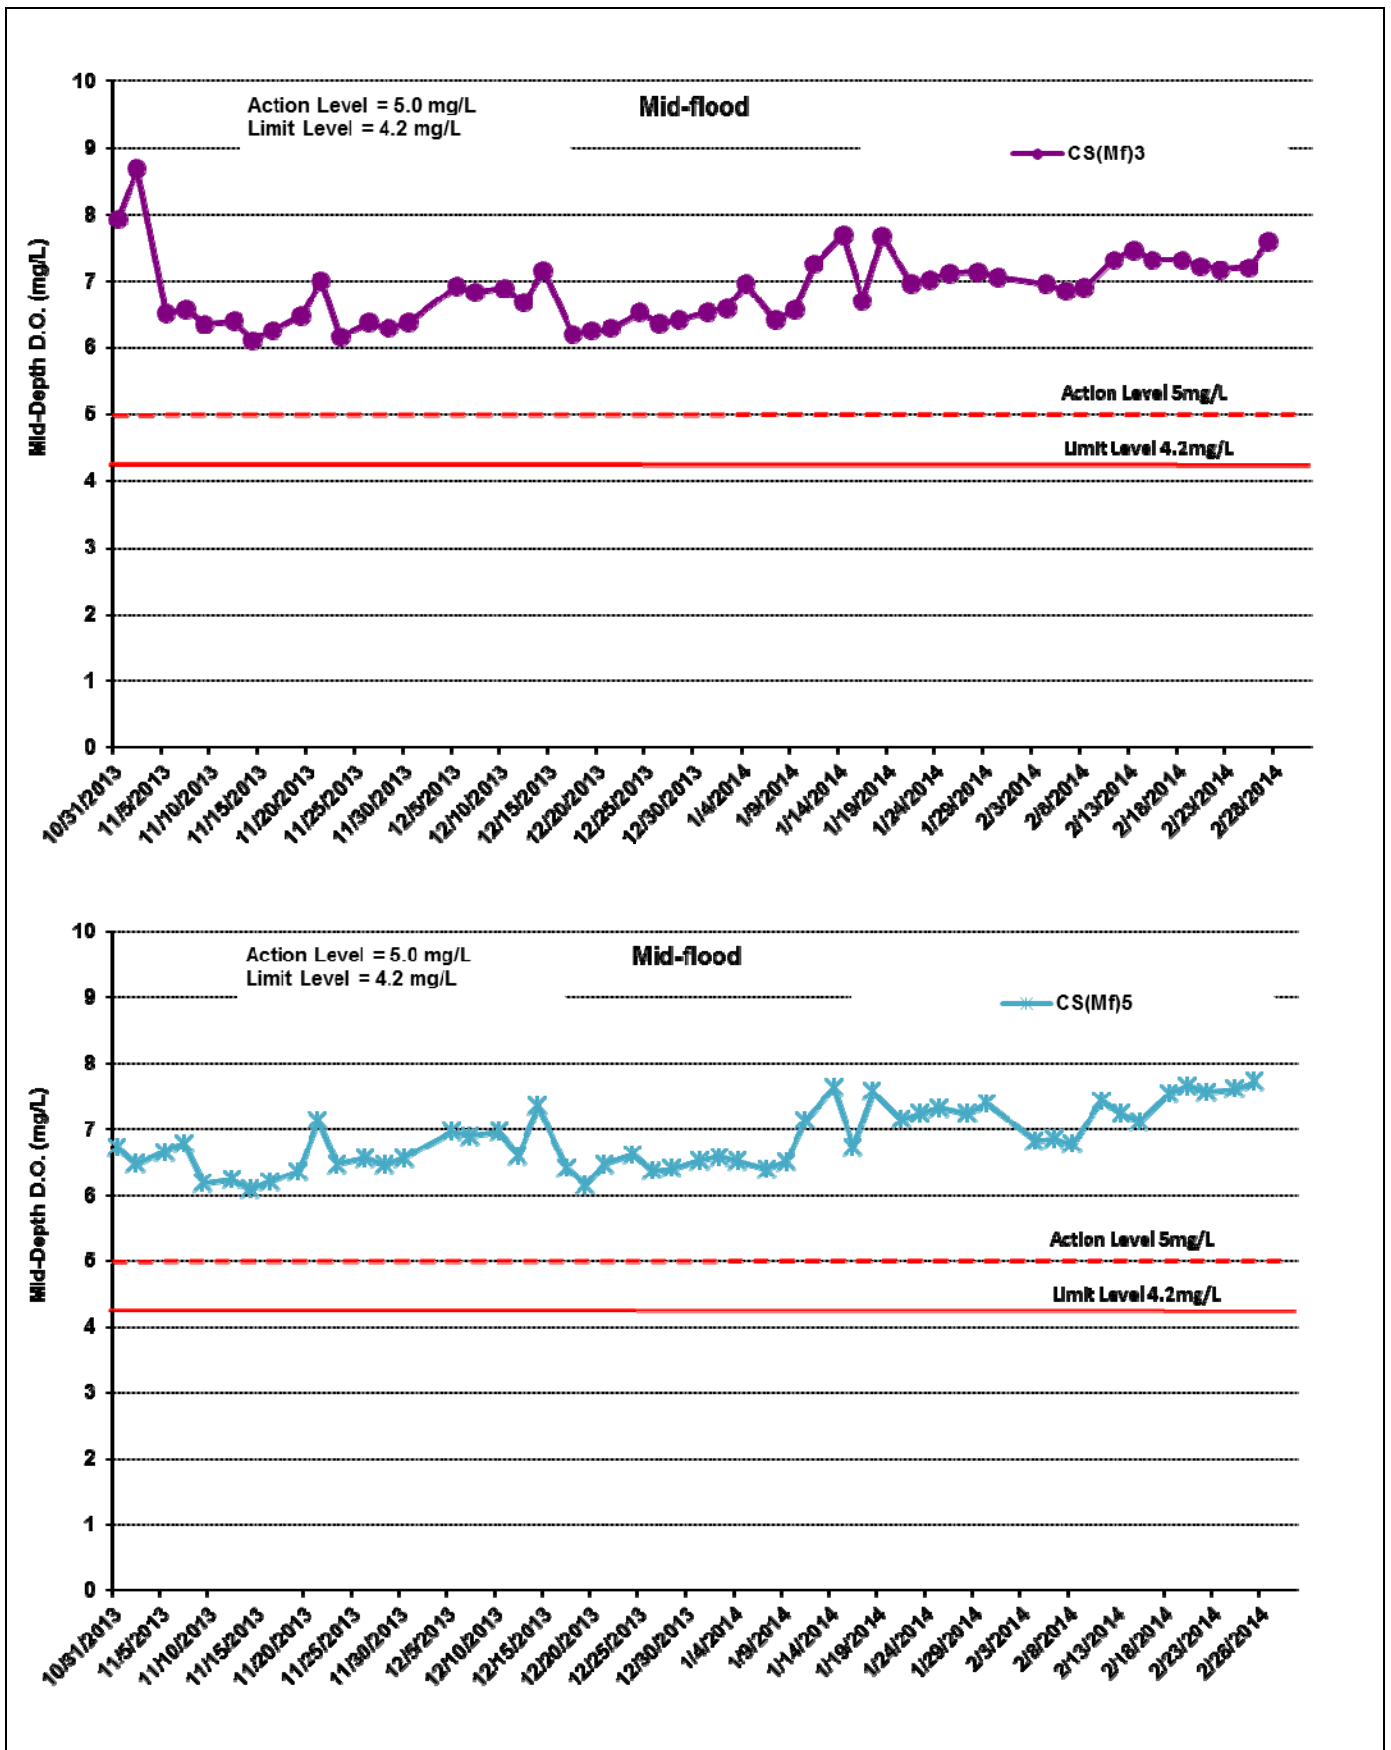
Figure I11 Impact Monitoring – Mean Level of Dissolved Oxygen (mg/L) in mid-depth waters during mid-flood tide between 31 October 2013 to 28 February 2014 at CS(Mf)3 and IS(Mf)5. (Weather condition varied between sunny to rainy within the reporting period. Marine works within the reporting period include rockfill platform construction, marine piling platform installation and survey tower erection.)

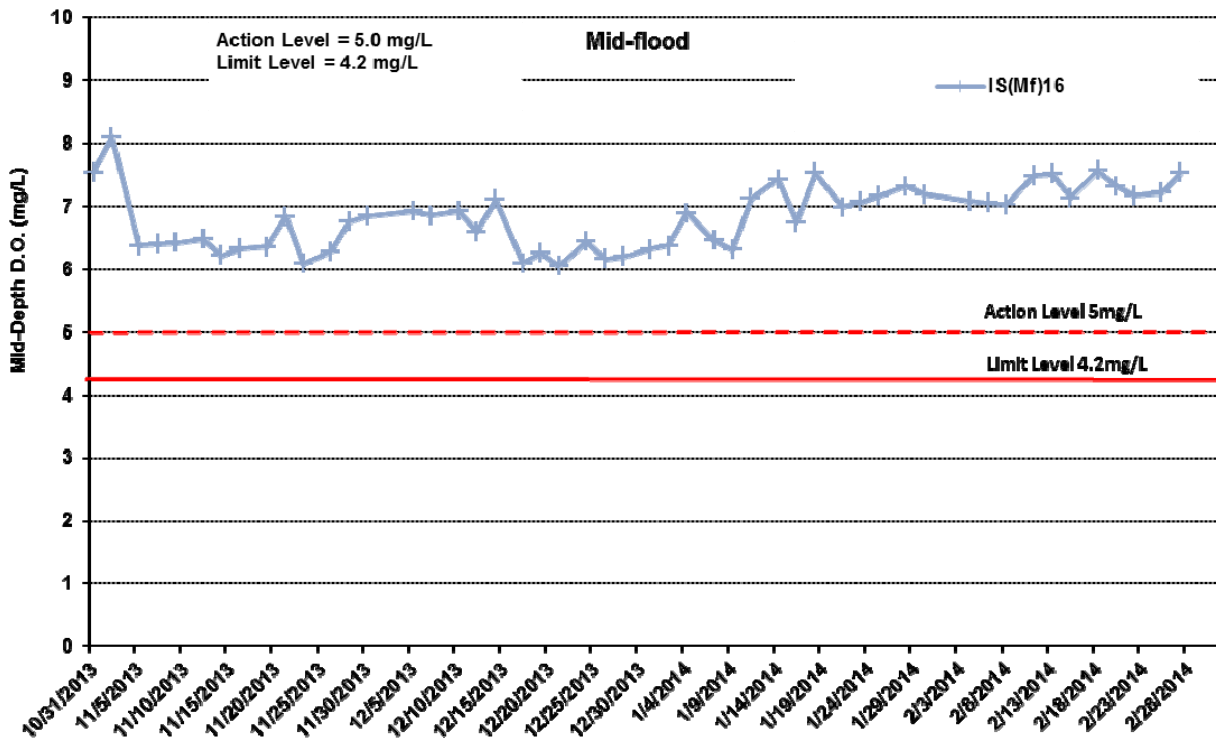
Figure I12 Impact Monitoring – Mean Level of Dissolved Oxygen (mg/L) in mid-depth waters during mid-flood tide between 31 October 2013 to 28 February 2014 at IS(Mf)16.

(Weather condition varied between sunny to rainy within the reporting period. Marine works within the reporting period include rockfill platform construction, marine piling platform installation and survey tower erection.)

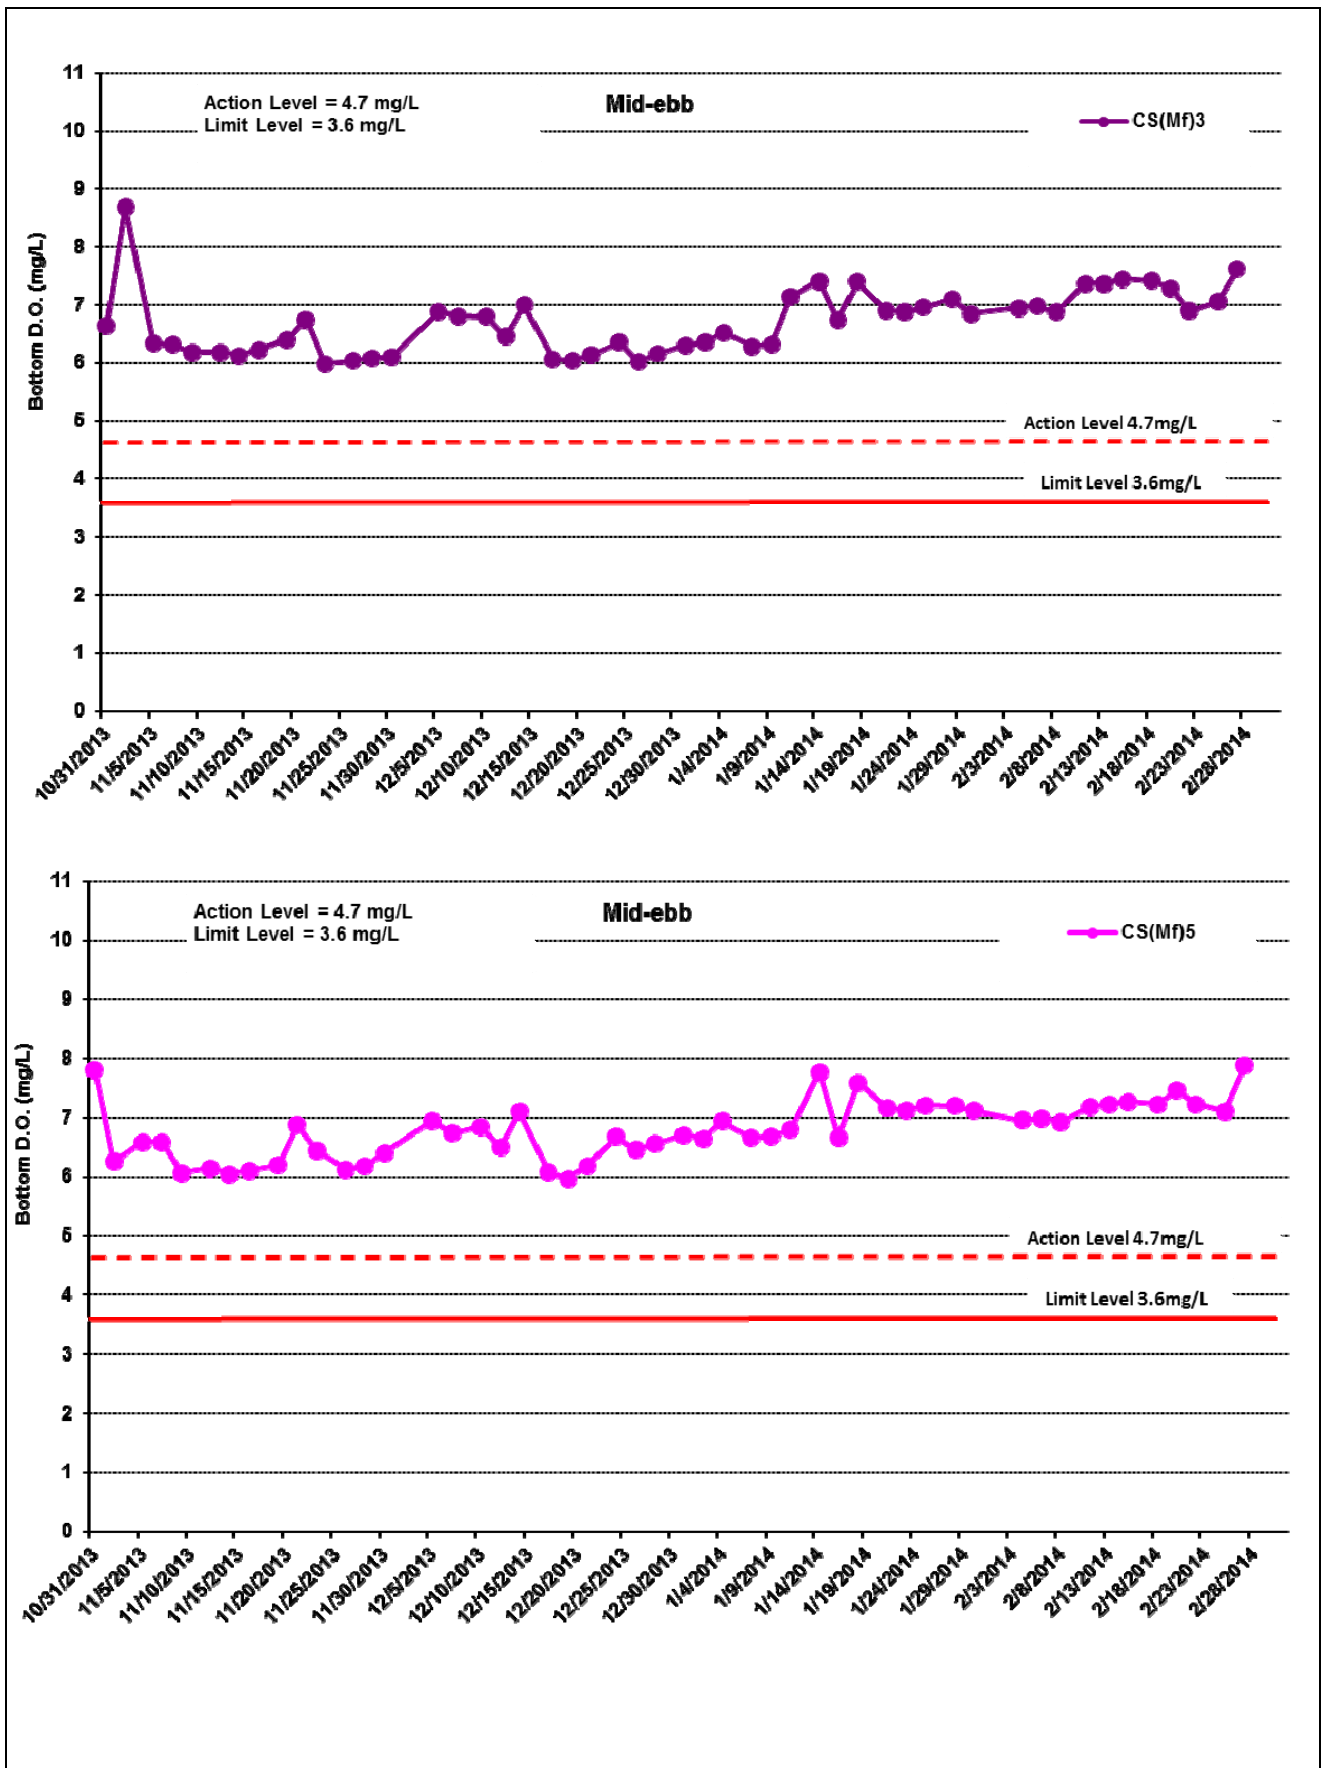
Figure I13 Impact Monitoring - Mean Level of Dissolved Oxygen (mg/L) in bottom waters during mid-ebb tide between 31 October 2013 to 28 February 2014 at CS(Mf)3 and CS(Mf)5.

(Weather condition varied between sunny to rainy within the reporting period. Marine works within the reporting period include rockfill platform construction, marine piling platform installation and survey tower erection.)
