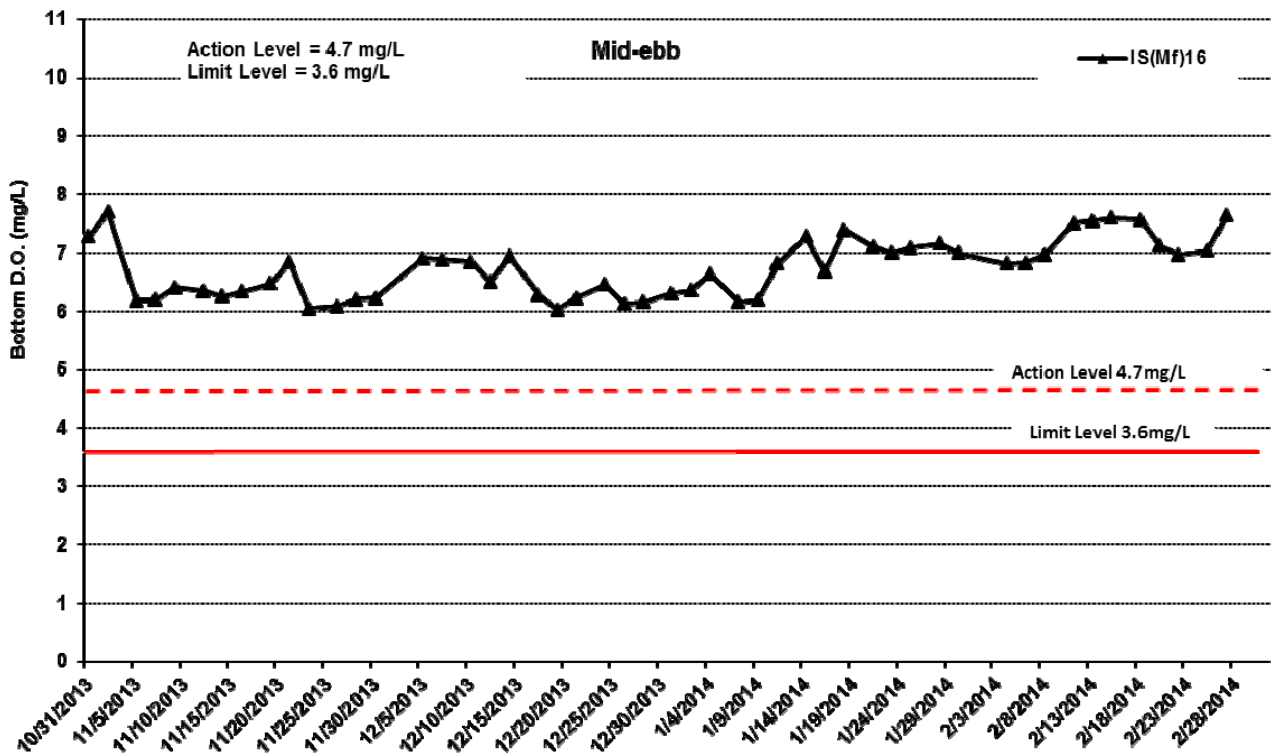
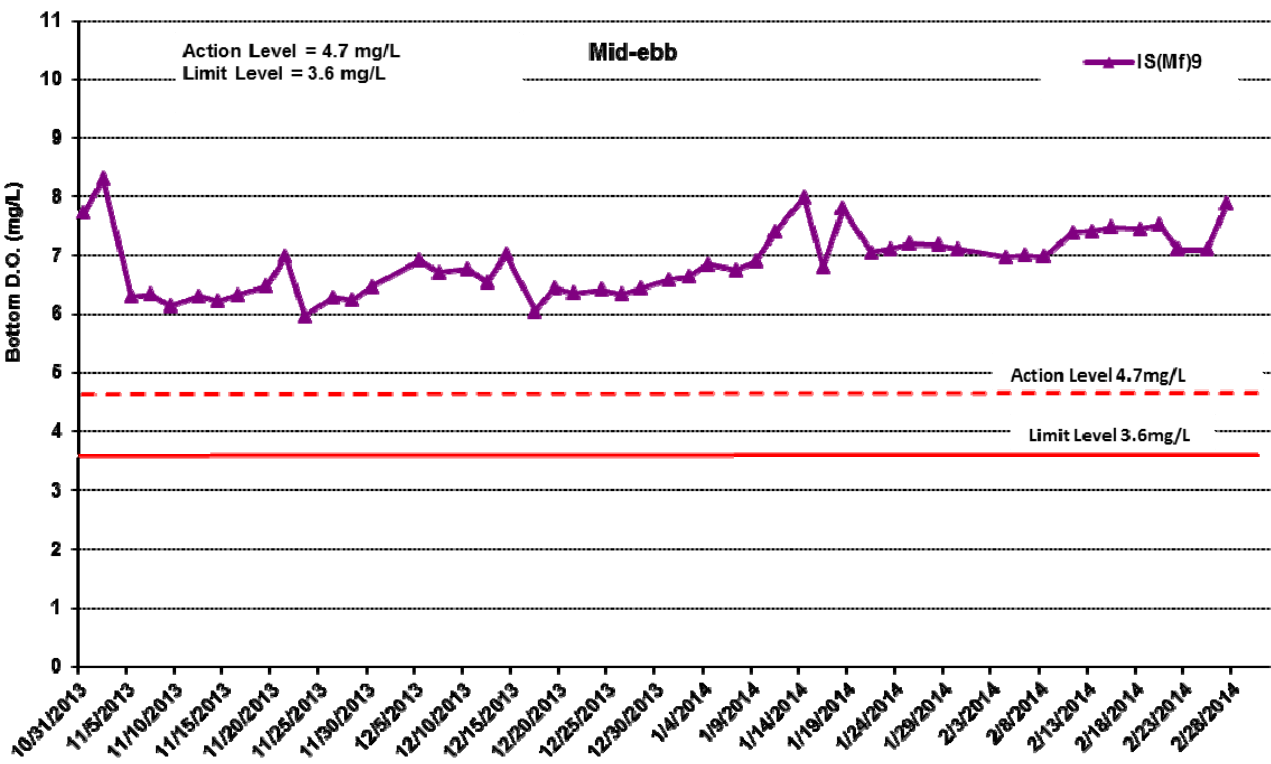
Figure I14 Impact Monitoring - Mean Level of Dissolved Oxygen (mg/L) in bottom waters during mid-ebb tide between 1 to 28 February 2014 at IS(Mf)16 and IS(Mf)9.

(Weather condition varied between sunny to rainy within the reporting period. Marine works within the reporting period include rockfill platform construction, marine piling platform installation and survey tower erection.)

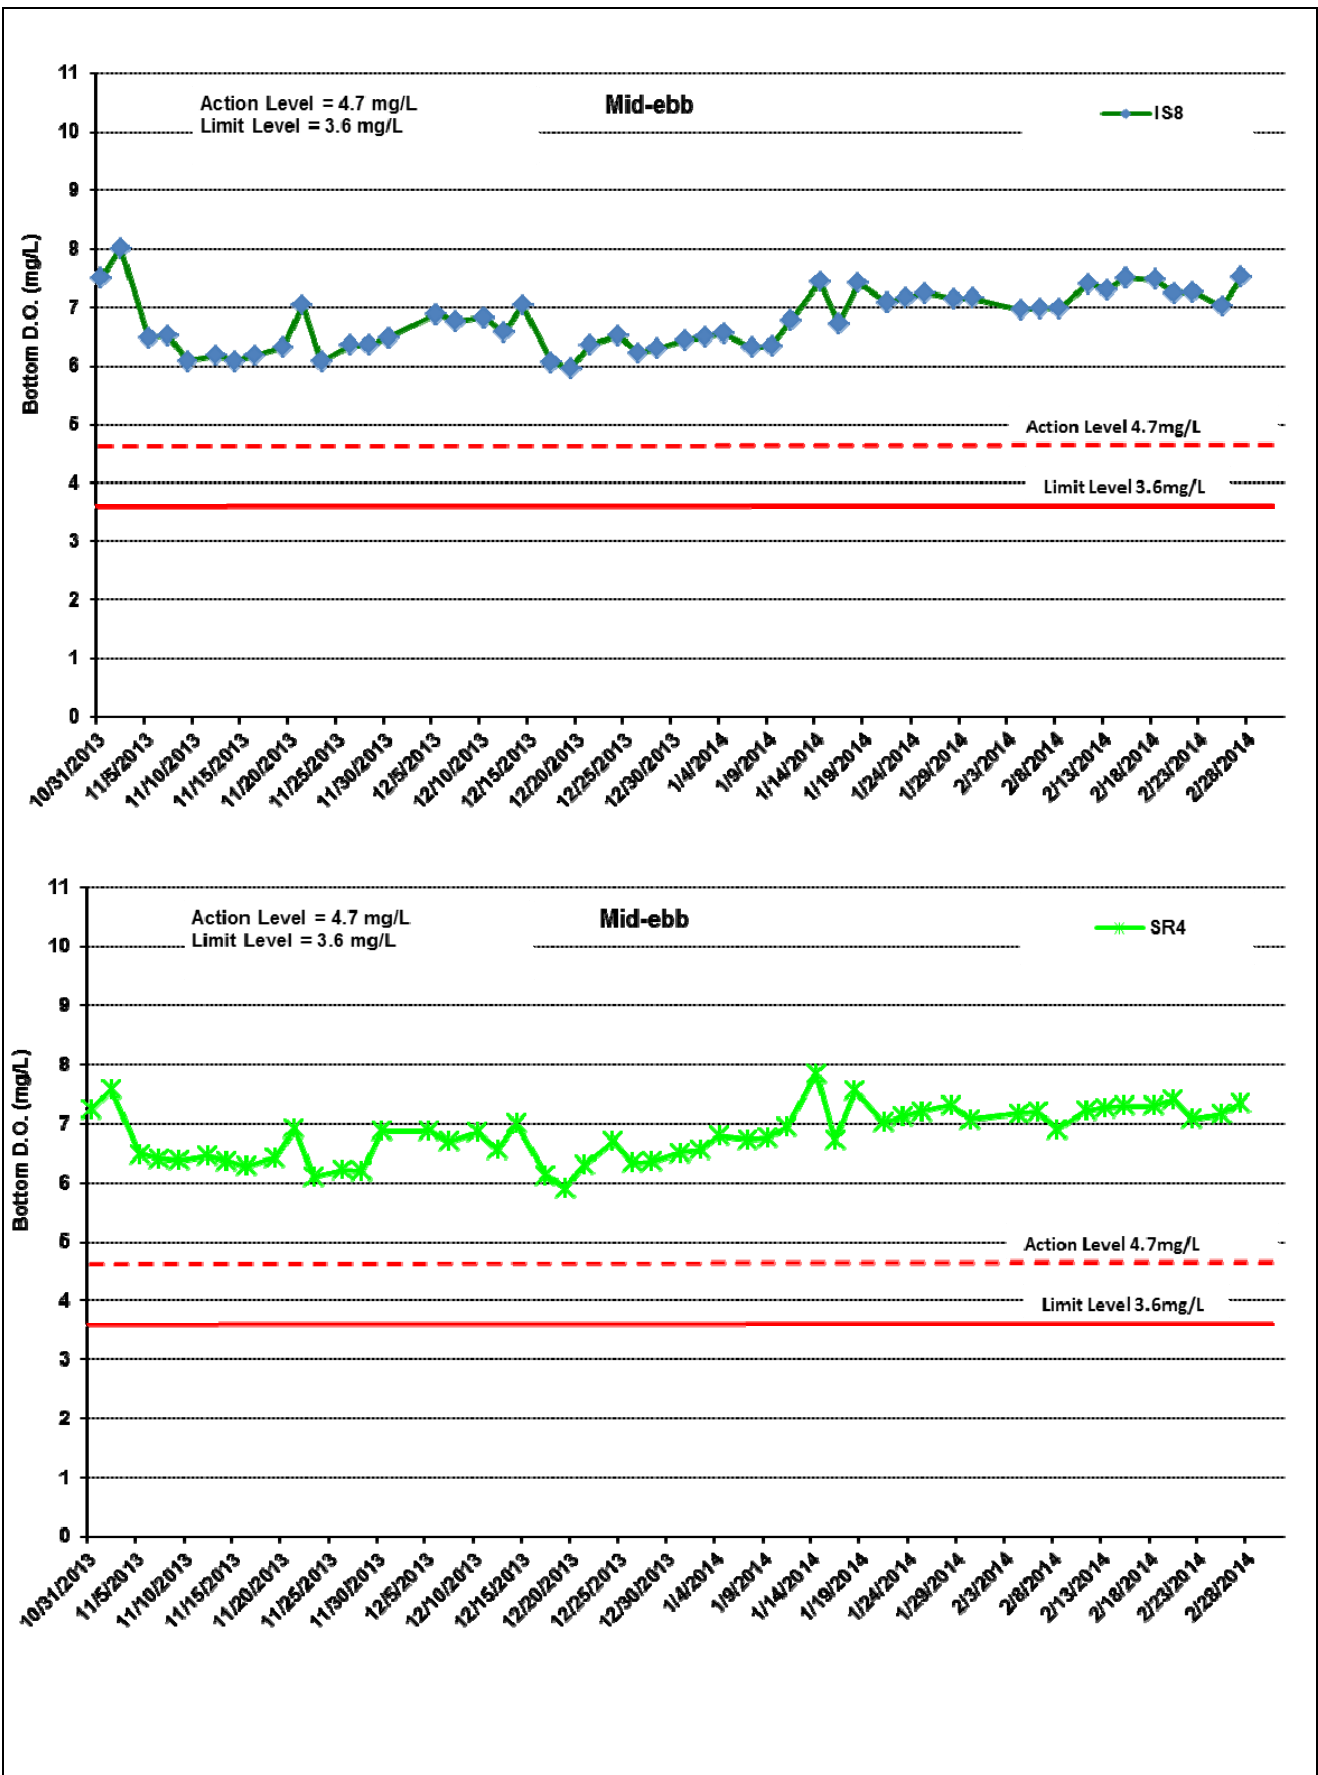
Figure I15 Impact Monitoring - Mean Level of Dissolved Oxygen (mg/L) in bottom waters during mid-ebb tide between 31 October 2013 to 28 February 2014 at IS8 and SR4.
(Weather condition varied between sunny to rainy within the reporting period. Marine works within the reporting period include rockfill platform construction, marine piling platform installation and survey tower erection.)

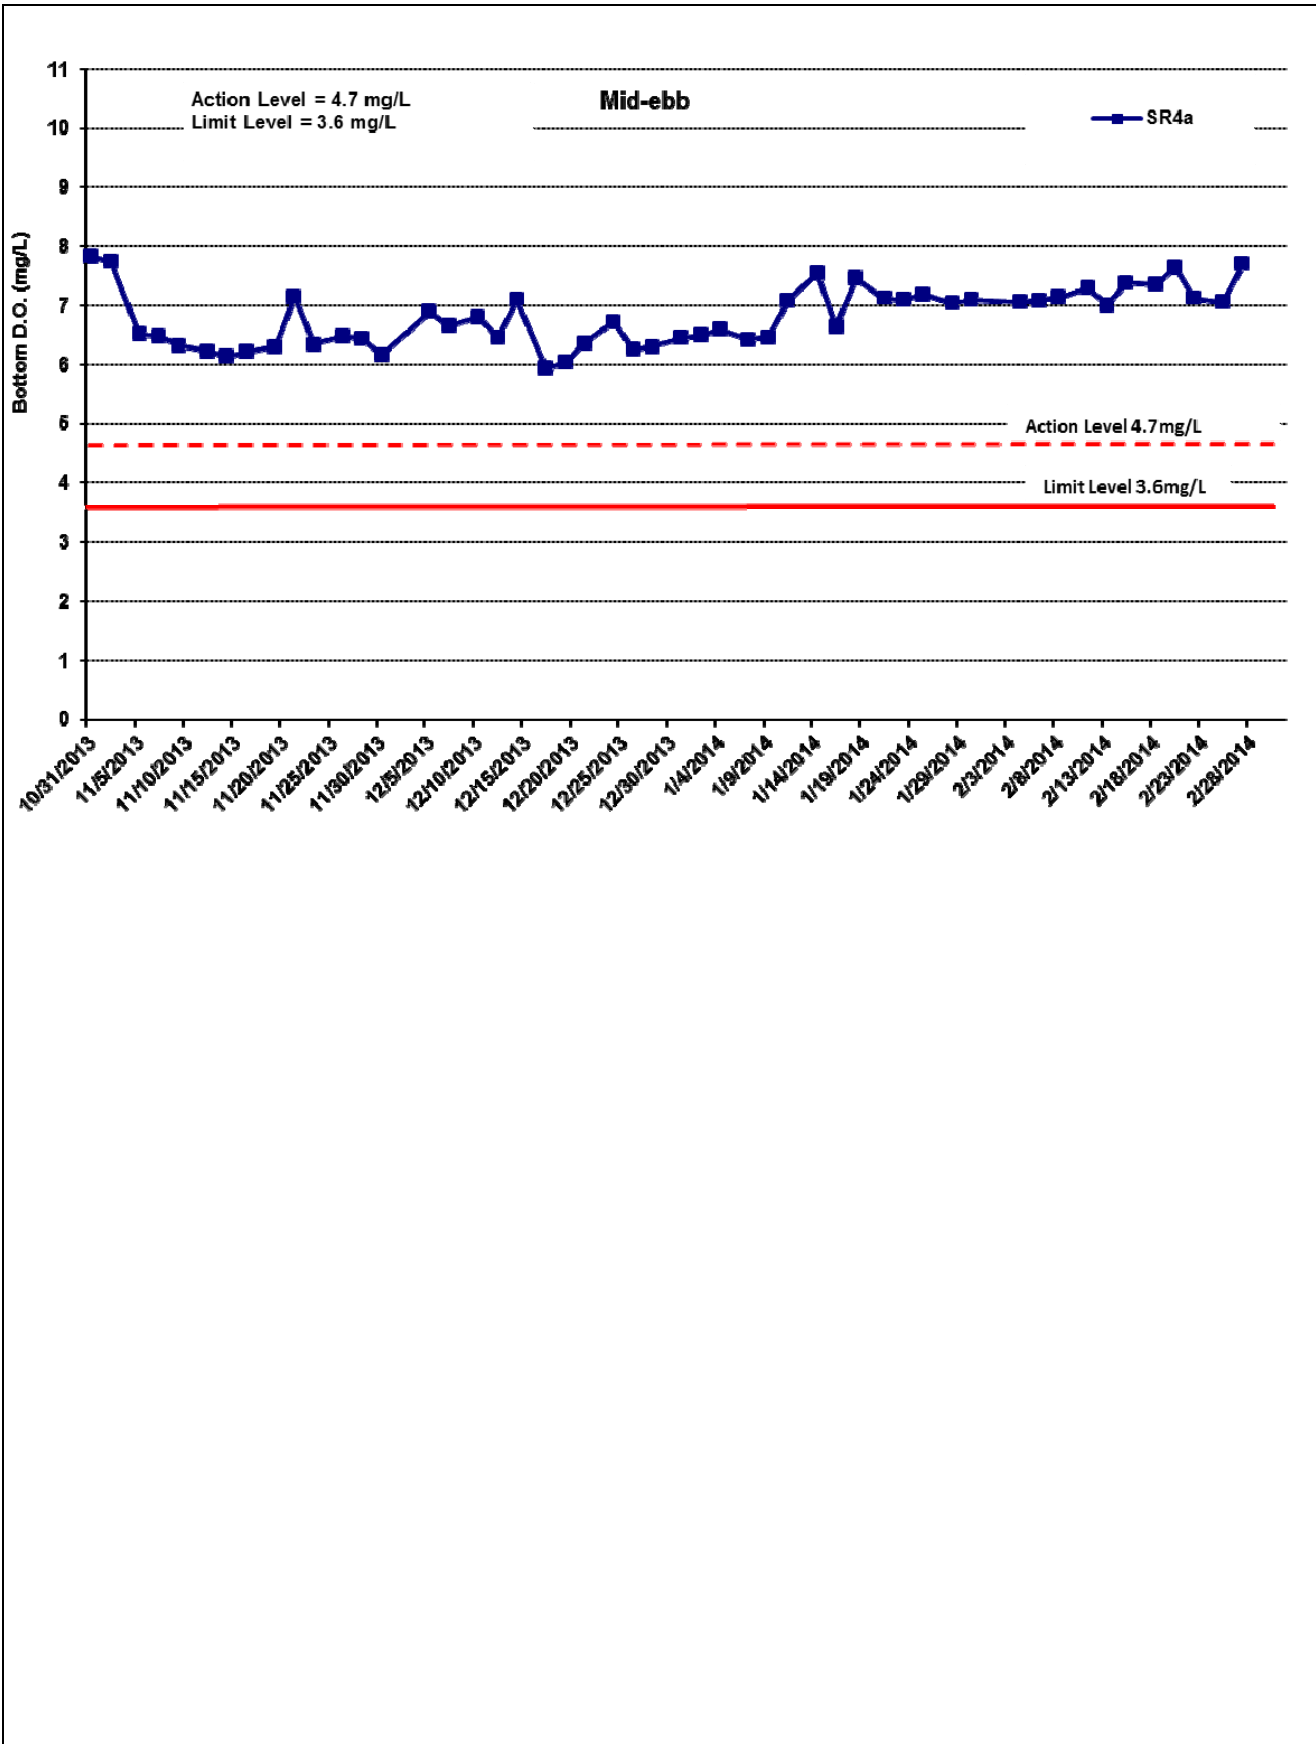
Figure I16 Impact Monitoring – Mean Level of Dissolved Oxygen (mg/L) in bottom waters during mid-ebb tide between 31 October 2013 to 28 February 2014 at SR4a.

(Weather condition varied between sunny to rainy within the reporting period. Marine works within the reporting period include rockfill platform construction, marine piling platform installation and survey tower erection.)

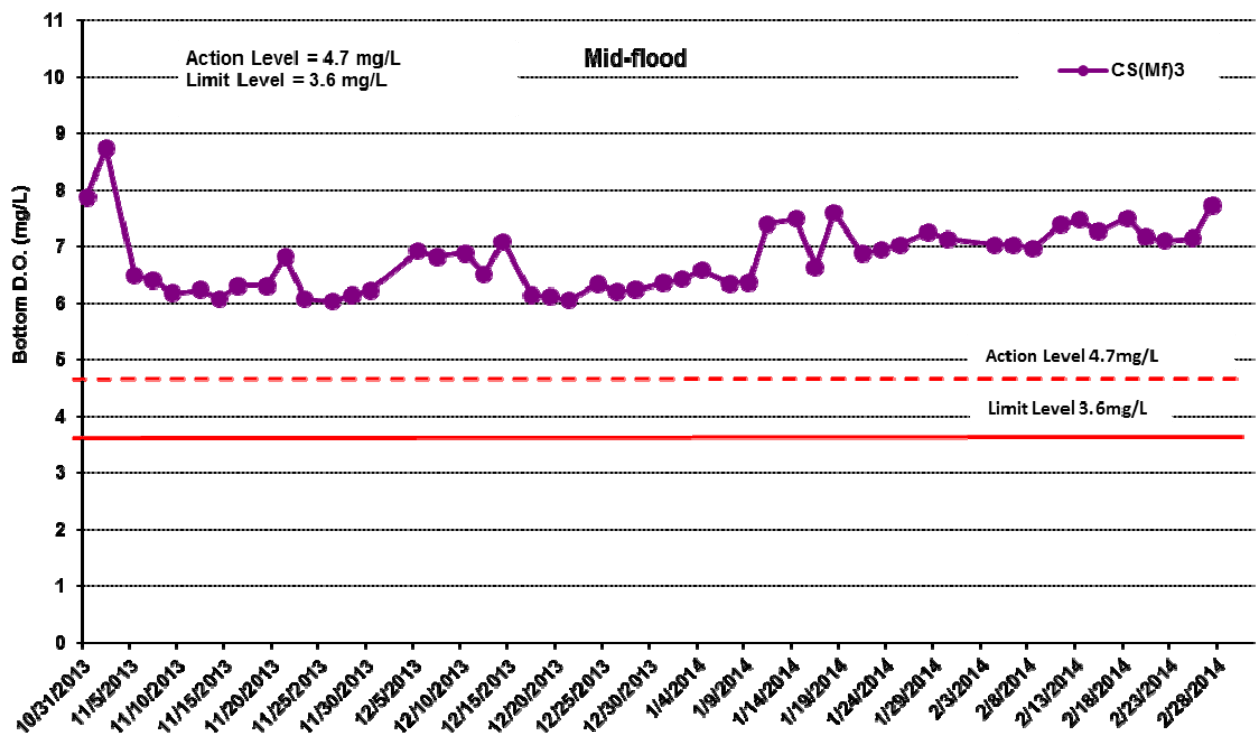
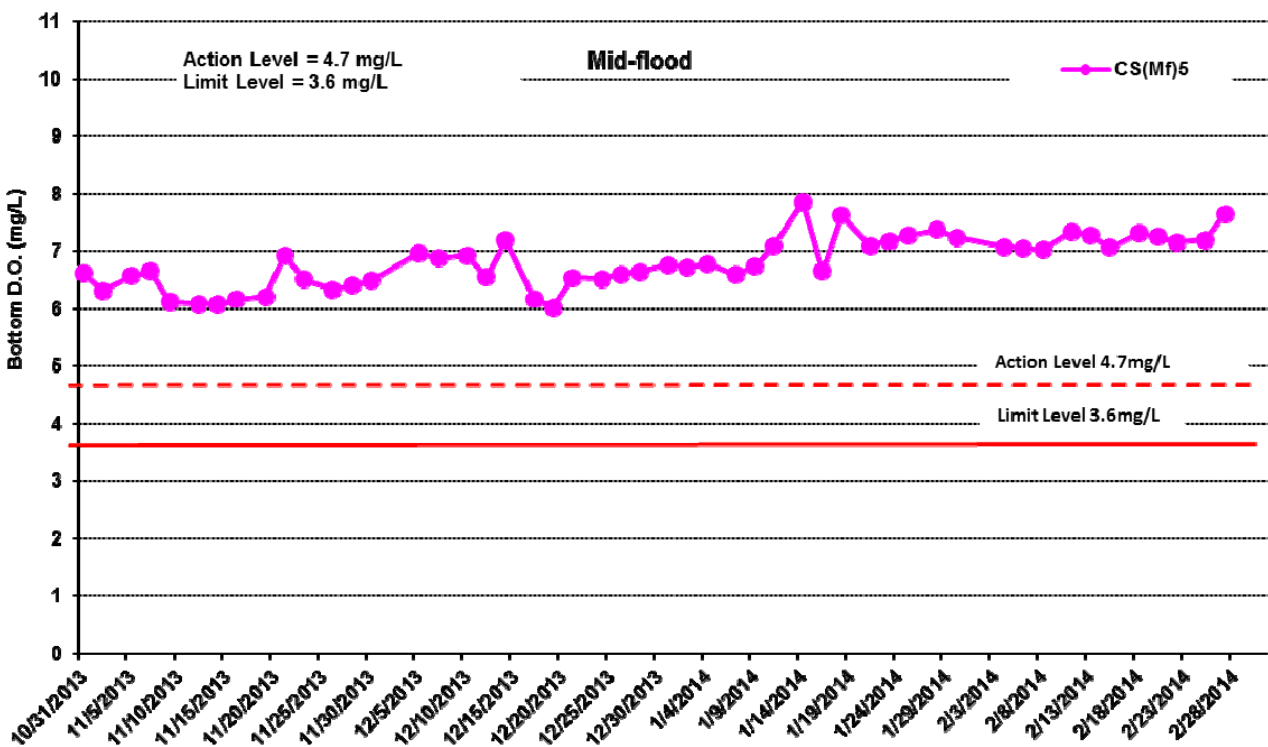
Figure I17 Impact Monitoring - Mean Level of Dissolved Oxygen (mg/L) in bottom waters during mid-flood tide between 31 October 2013 to 28 February 2014 at CS(Mf)3 and CS(Mf)5.

(Weather condition varied between sunny to rainy within the reporting period. Marine works within the reporting period include rockfill platform construction, marine piling platform installation and survey tower erection.)

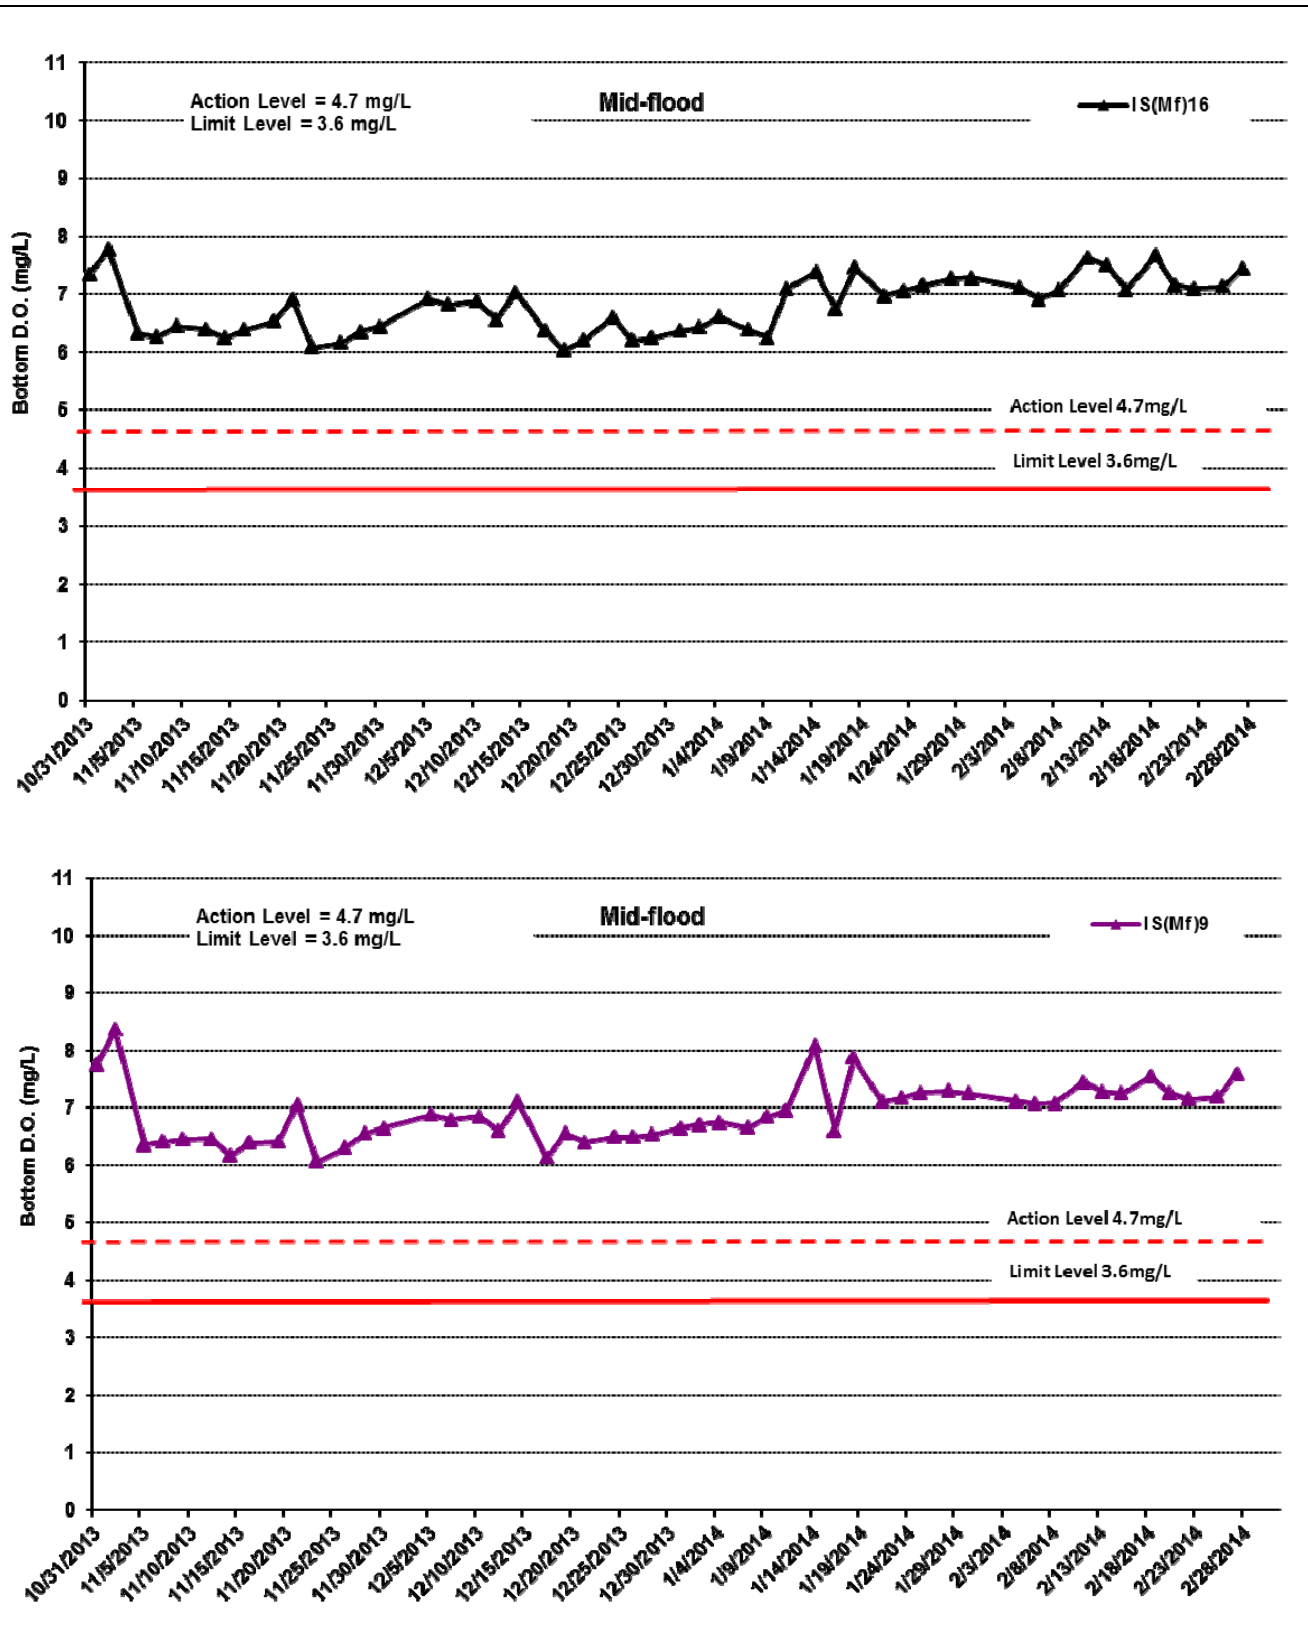
Figure I18 Impact Monitoring - Mean Level of Dissolved Oxygen (mg/L) in bottom waters during mid-flood tide between 31 October 2013 to 28 February 2014 at IS(Mf)16 and IS(Mf)9.

(Weather condition varied between sunny to rainy within the reporting period. Marine works within the reporting period include rockfill platform construction, marine piling platform installation and survey tower erection.)

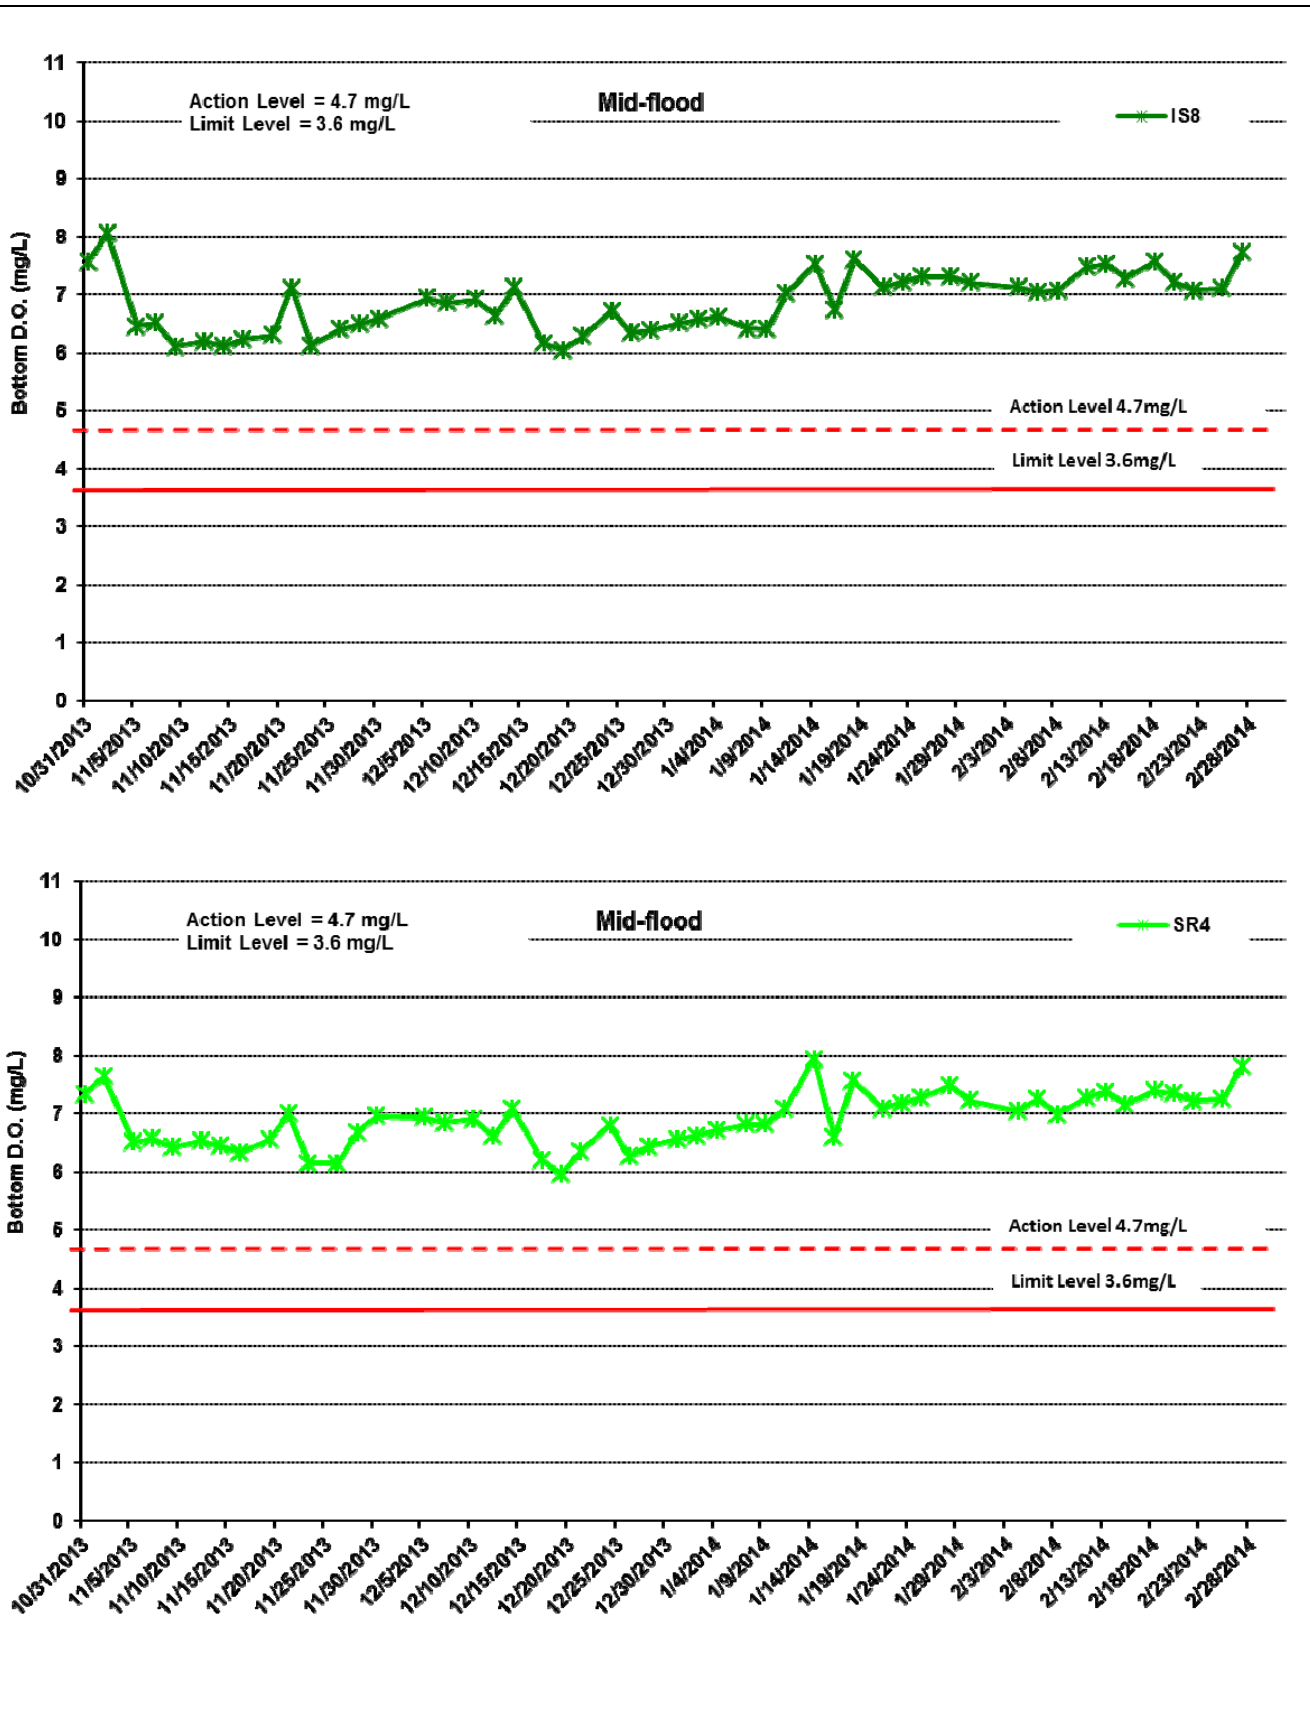
Figure I19 Impact Monitoring - Mean Level of Dissolved Oxygen (mg/L) in bottom waters during mid-flood tide between 31 October 2013 to 28 February 2014 at IS8 and SR4.

(Weather condition varied between sunny to rainy within the reporting period. Marine works within the reporting period include rockfill platform construction, marine piling platform installation and survey tower erection.)

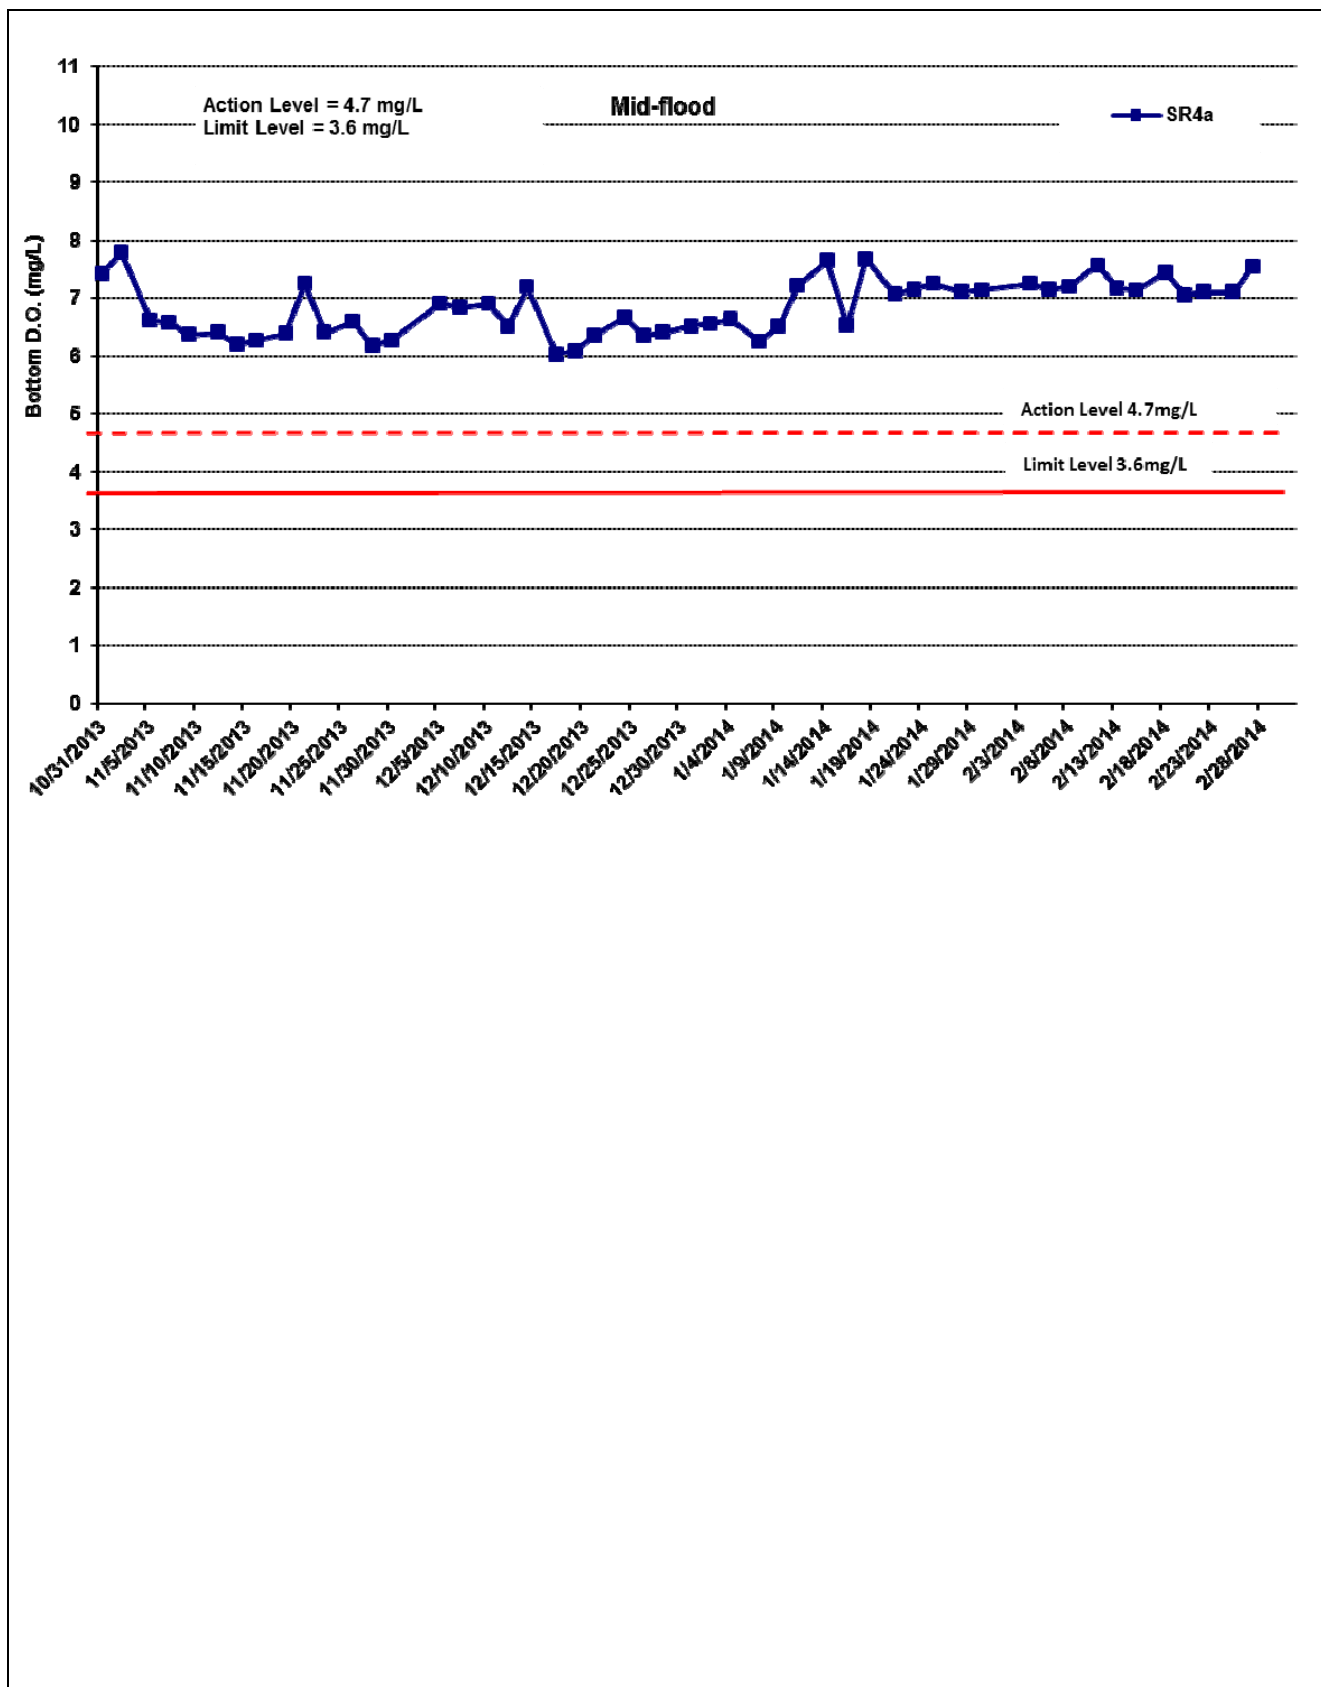
Figure I20 Impact Monitoring - Mean Level of Dissolved Oxygen (mg/L) in bottom waters during mid-flood tide between 31 October 2013 to 28 February 2014 at SR4a.

(Weather condition varied between sunny to rainy within the reporting period. Marine works within the reporting period include rockfill platform construction, marine piling platform installation and survey tower erection.)

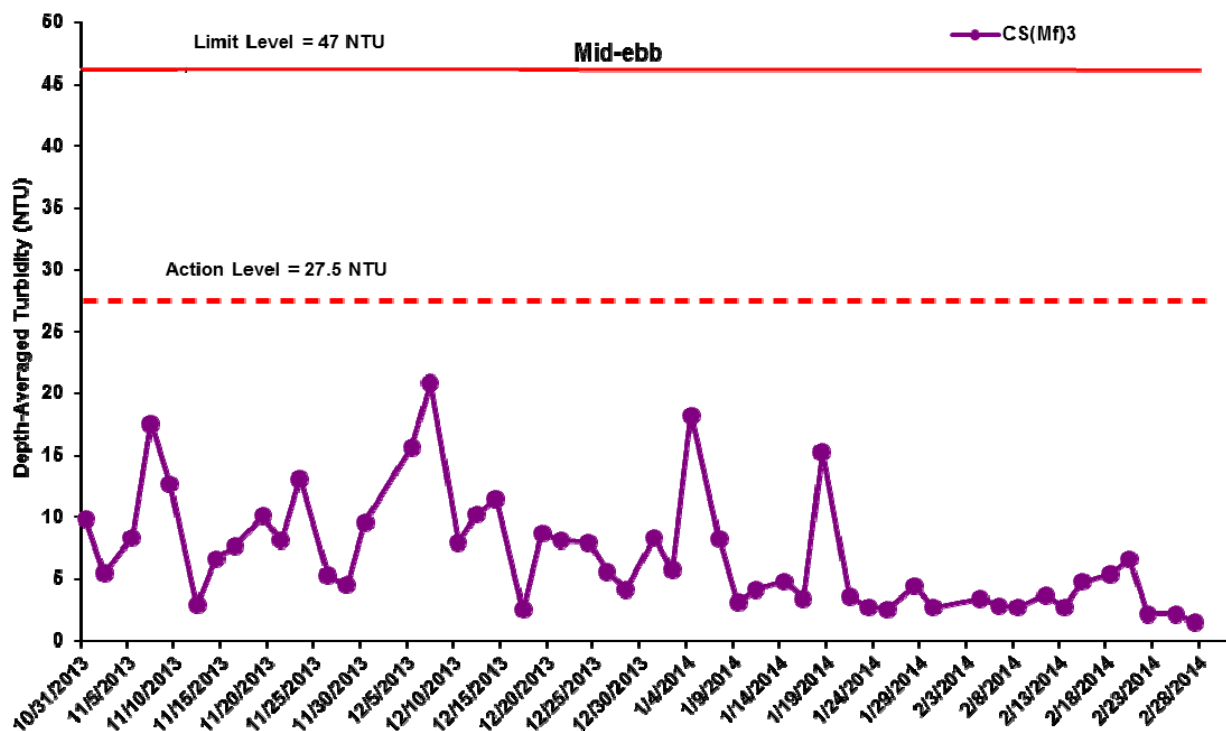
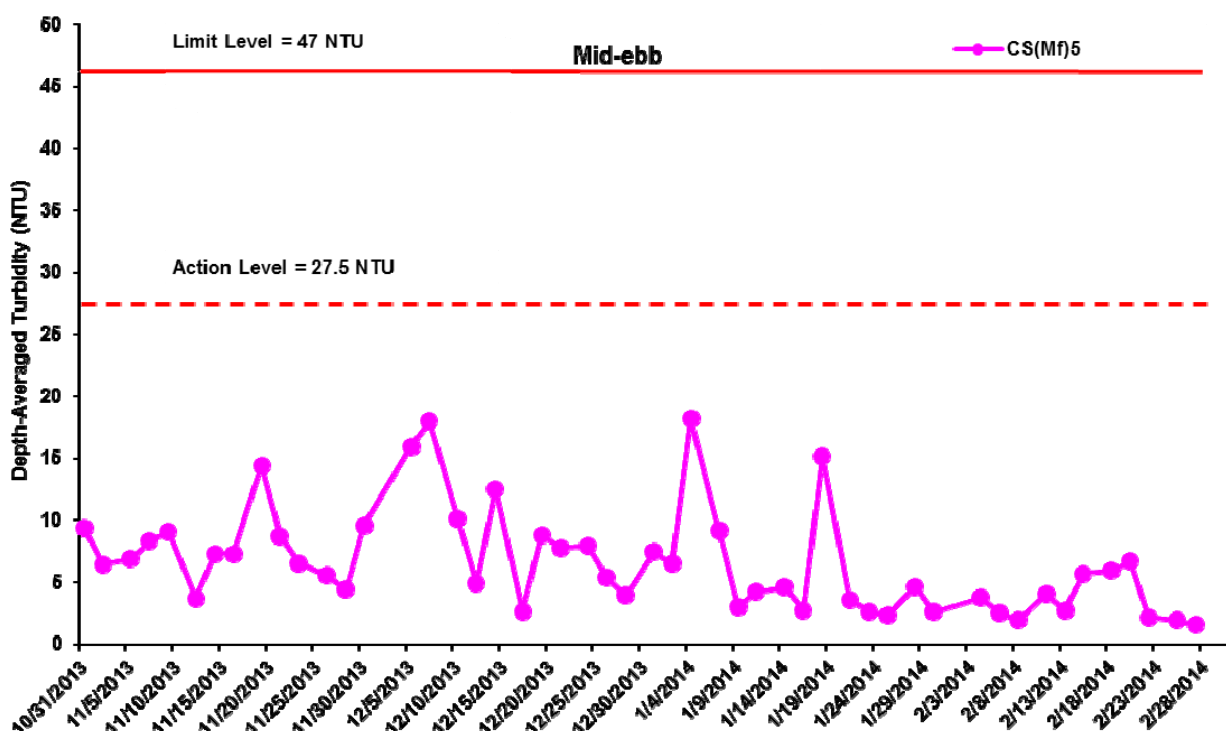
Figure I21 Impact Monitoring – Mean Level of depth-averaged Turbidity (NTU) during mid-ebb tide between 31 October 2013 to 28 February 2014 at CS(Mf)3 and CS(Mf)5.

(Weather condition varied between sunny to rainy within the reporting period. Marine works within the reporting period include rockfill platform construction, marine piling platform installation and survey tower erection.)

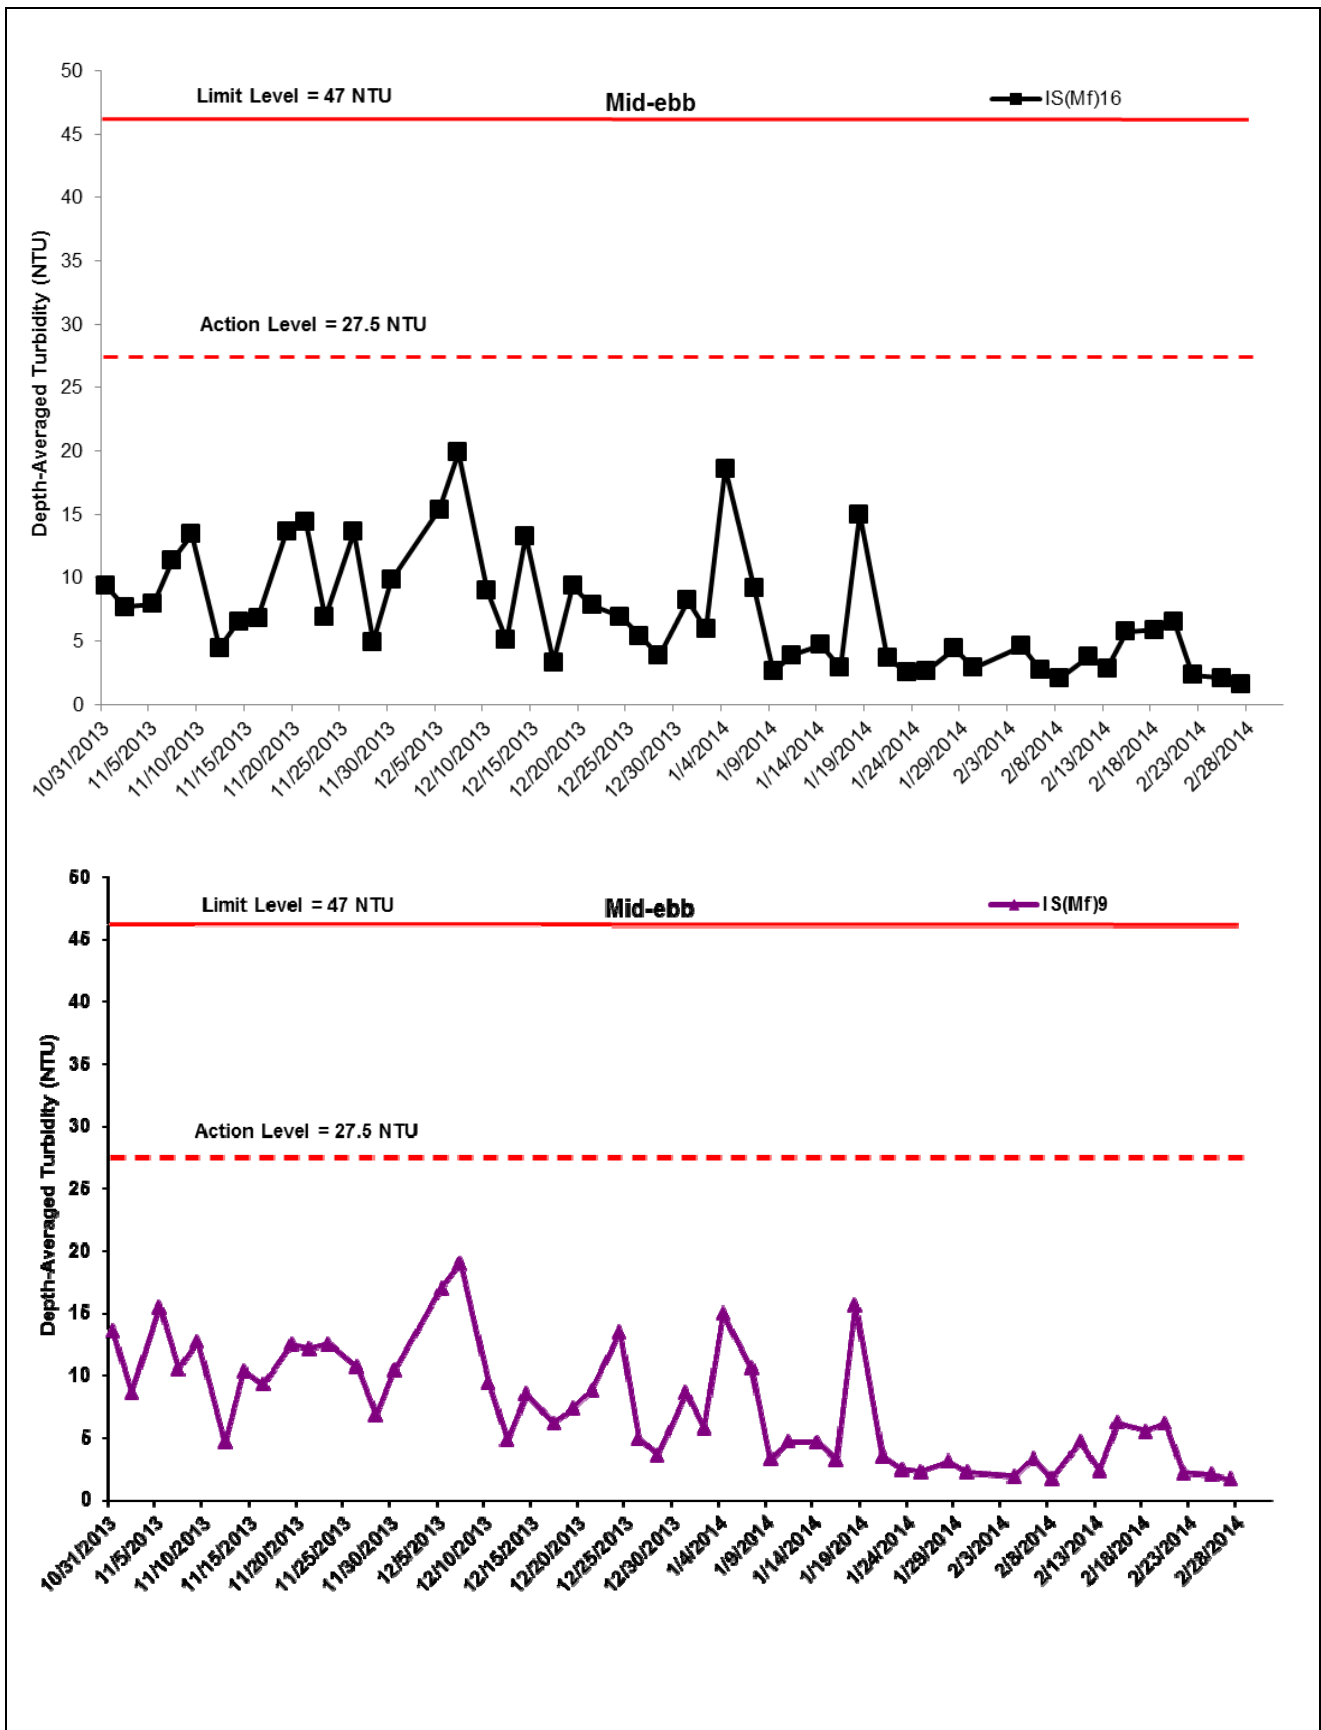
Figure I22 Impact Monitoring - Mean Level of depth-averaged Turbidity (NTU) during mid-ebb tide between 31 October 2013 to 28 February 2014 at IS(Mf)16 and IS(Mf)9.

(Weather condition varied between sunny to rainy within the reporting period. Marine works within the reporting period include rockfill platform construction, marine piling platform installation and survey tower erection.)

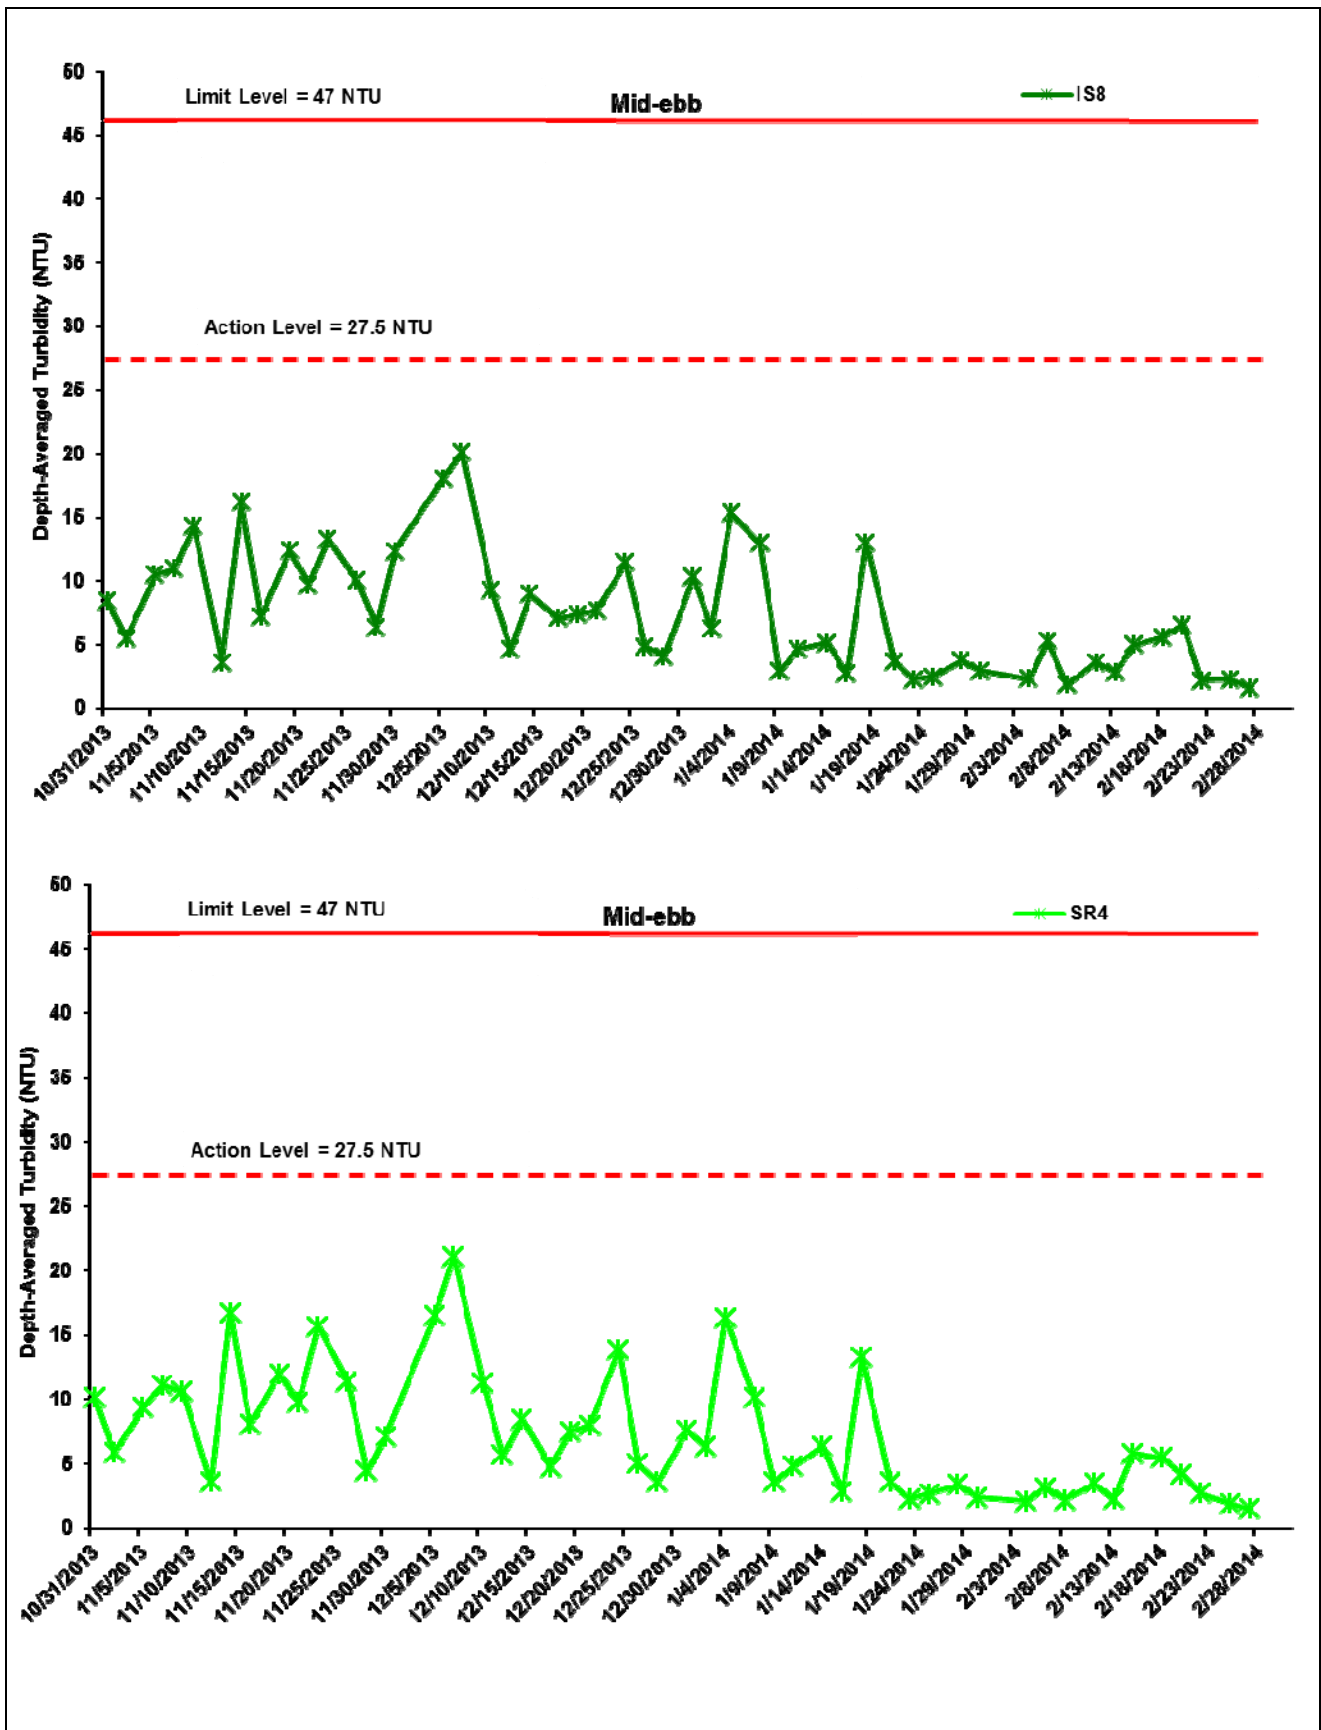
Figure I23 Impact Monitoring - Mean Level of depth-averaged Turbidity (NTU) during mid-ebb tide between 31 October 2013 to 28 February 2014 at IS8 and SR4.

(Weather condition varied between sunny to rainy within the reporting period. Marine works within the reporting period include rockfill platform construction, marine piling platform installation and survey tower erection.)
