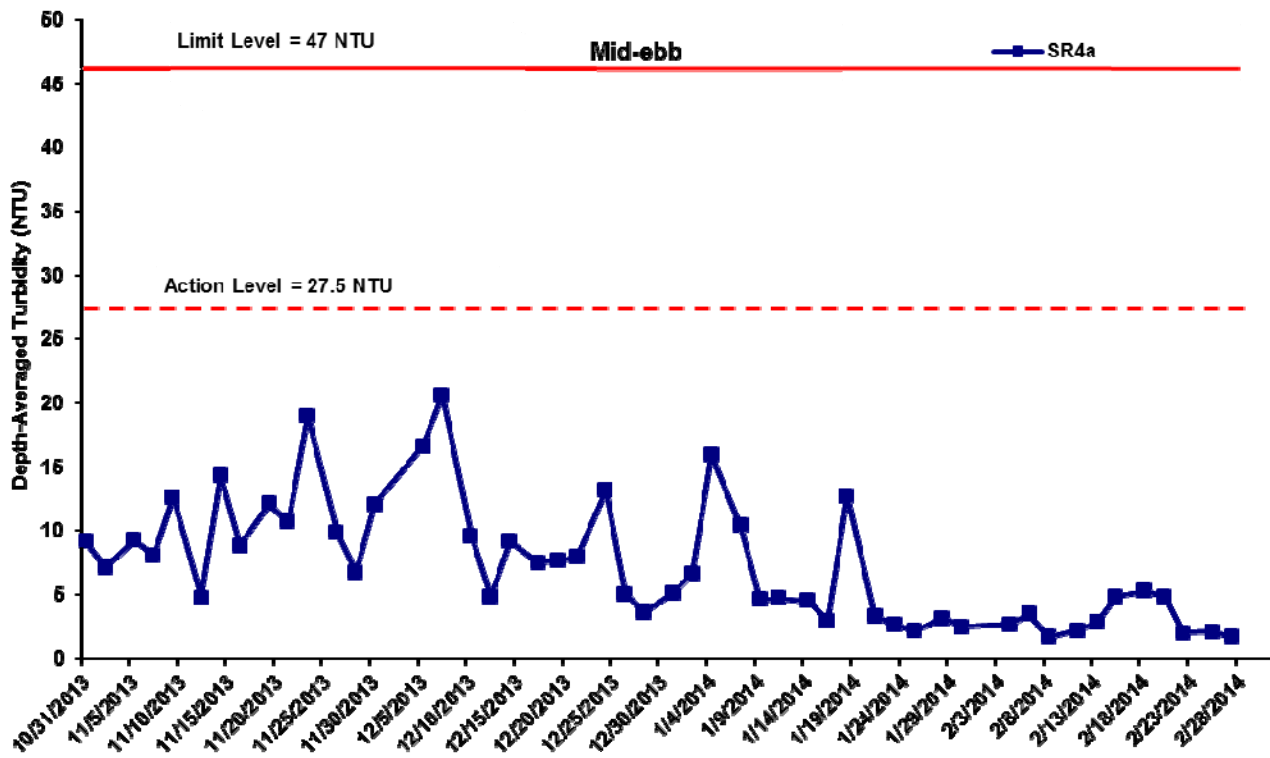
Figure I24 Impact Monitoring - Mean Level of depth-averaged Turbidity (NTU) during mid-ebb tide between 31 October 2013 to 28 February 2014 at SR4a.

(Weather condition varied between sunny to rainy within the reporting period. Marine works within the reporting period include rockfill platform construction, marine piling platform installation and survey tower erection.)

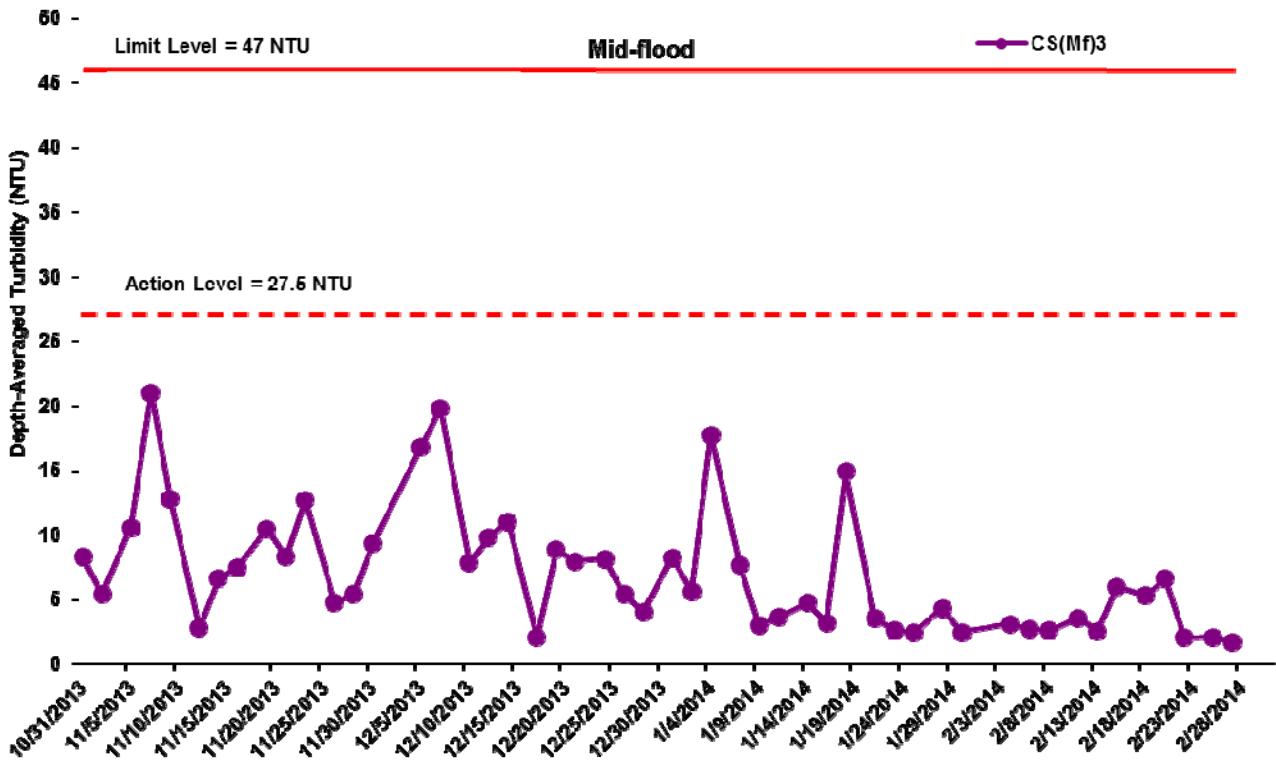
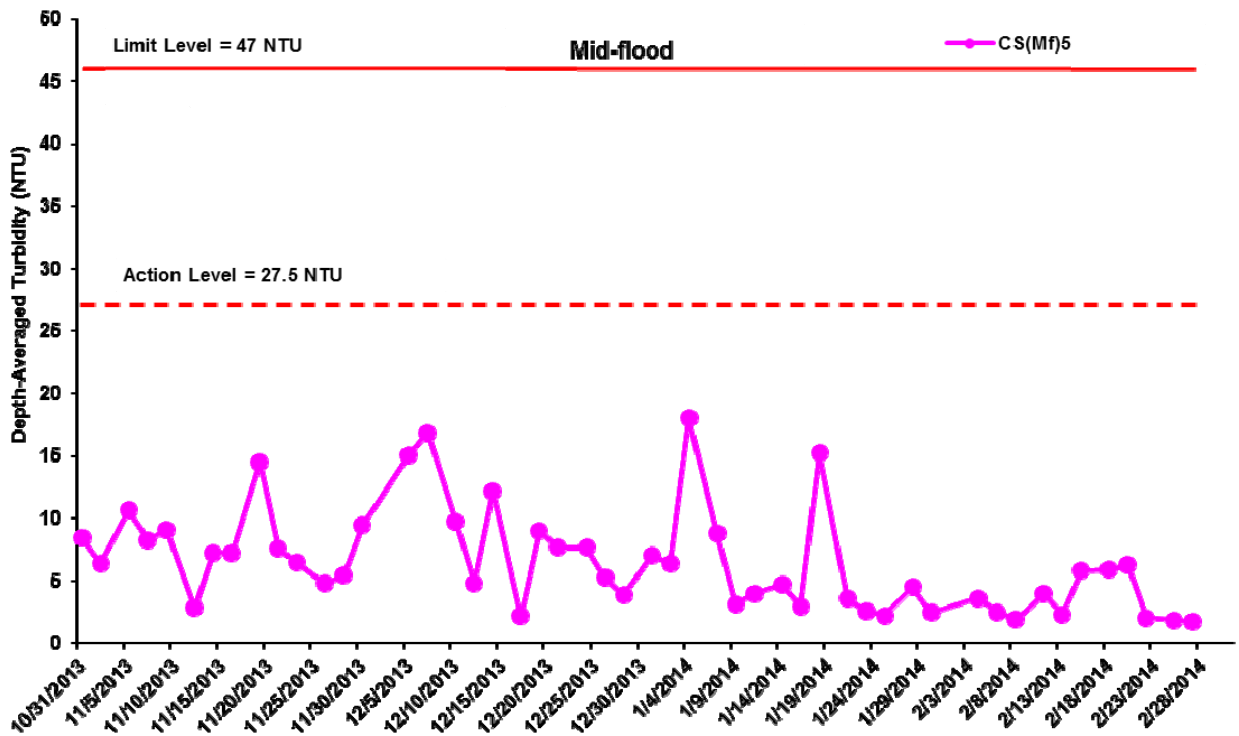
Figure I25 Impact Monitoring – Mean Level of depth-averaged Turbidity (NTU) during mid-flood tide between 31 October 2013 to 28 February 2014 at CS(Mf)3 and CS(Mf)5.

(Weather condition varied between sunny to rainy within the reporting period. Marine works within the reporting period include rockfill platform construction, marine piling platform installation and survey tower erection.)

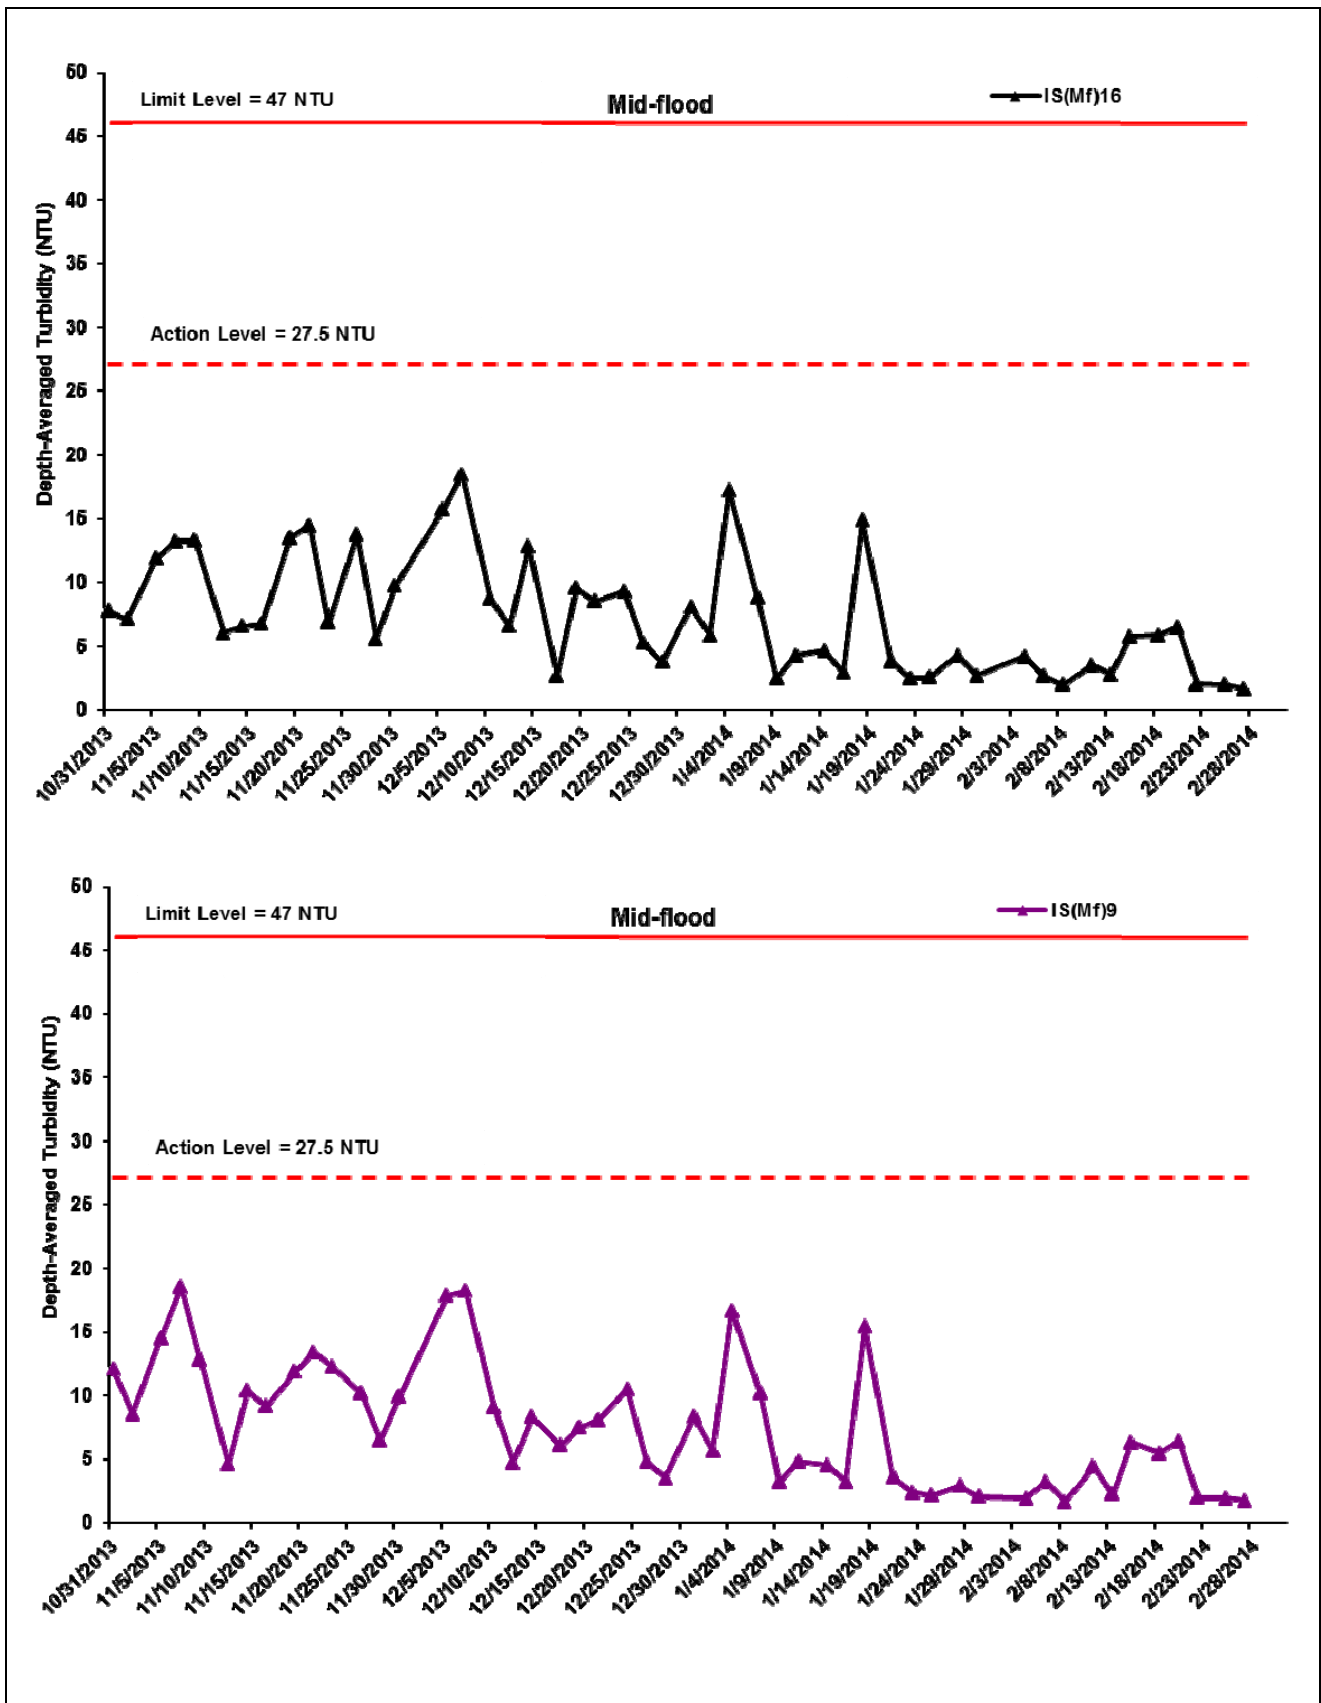
Figure I26 Impact Monitoring - Mean Level of depth-averaged Turbidity (NTU) during mid-flood tide between 31 October 2013 to 28 February 2014 at IS(Mf)16 and IS(Mf)9.

(Weather condition varied between sunny to rainy within the reporting period. Marine works within the reporting period include rockfill platform construction, marine piling platform installation and survey tower erection.)

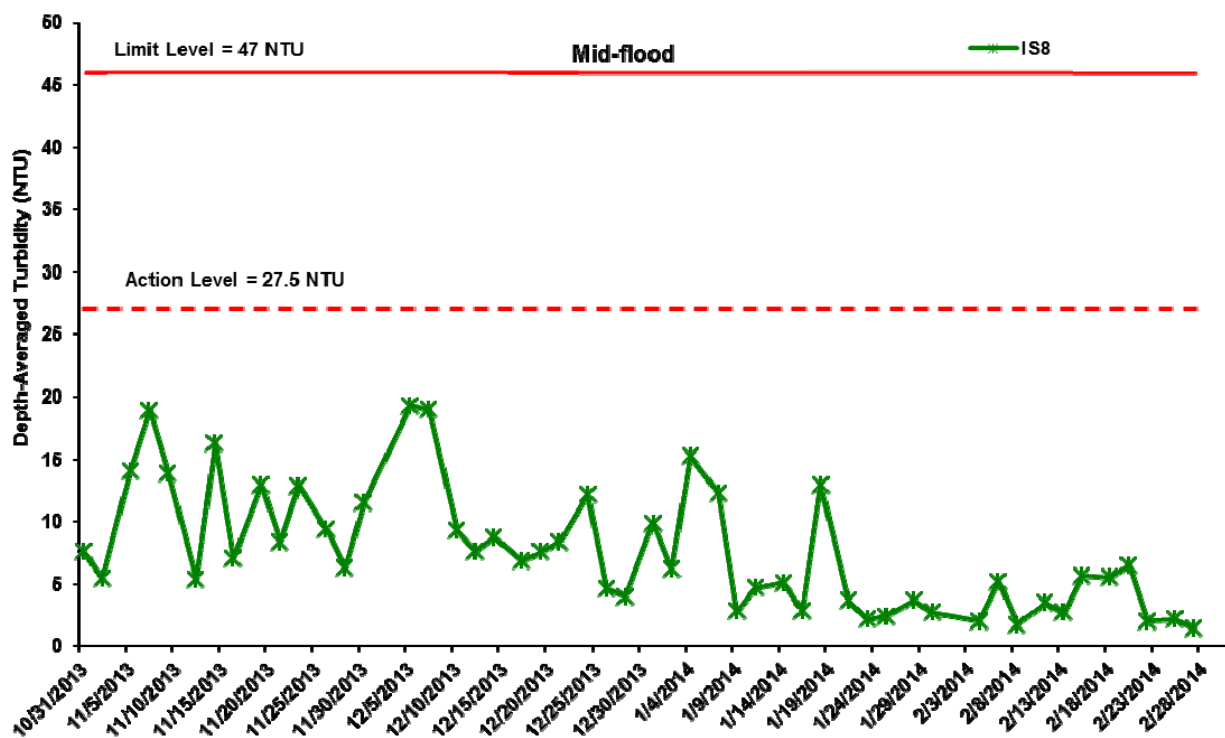
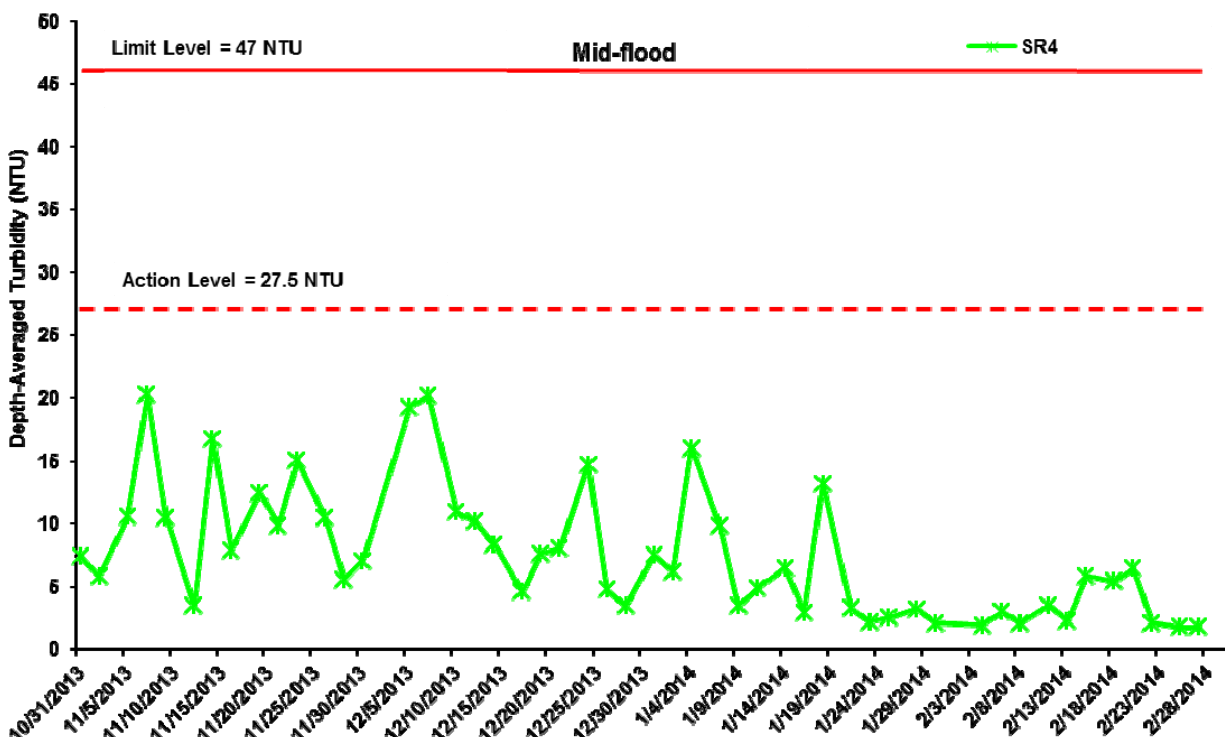
Figure I27 Impact Monitoring – Mean Level of depth-averaged Turbidity (NTU) during mid-flood tide between 31 October 2013 to 28 February 2014 at IS8 and SR4.

(Weather condition varied between sunny to rainy within the reporting period. Marine works within the reporting period include rockfill platform construction, marine piling platform installation and survey tower erection.)

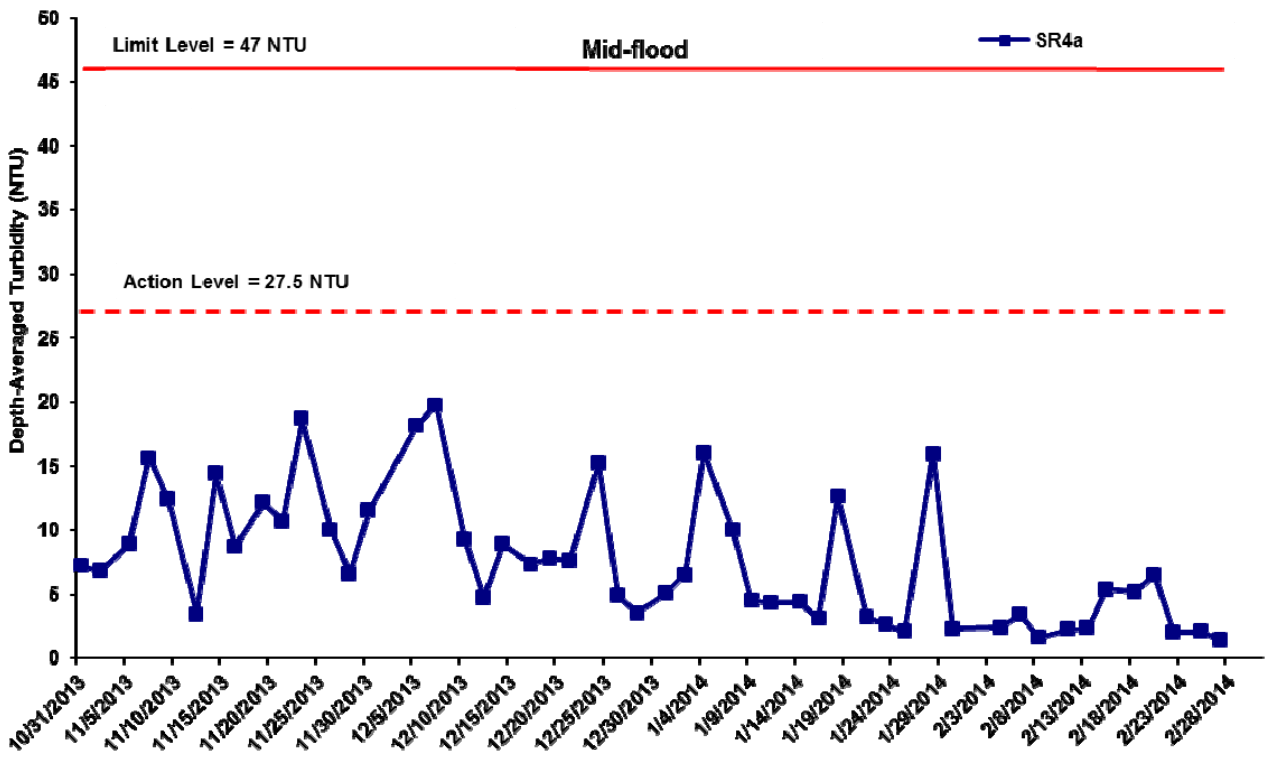
Figure I28 Impact Monitoring - Mean Level of depth-averaged Turbidity (NTU) during mid-flood tide between 31 October 2013 to 28 February 2014 at SR4a.

(Weather condition varied between sunny to rainy within the reporting period. Marine works within the reporting period include rockfill platform construction, marine piling platform installation and survey tower erection.)

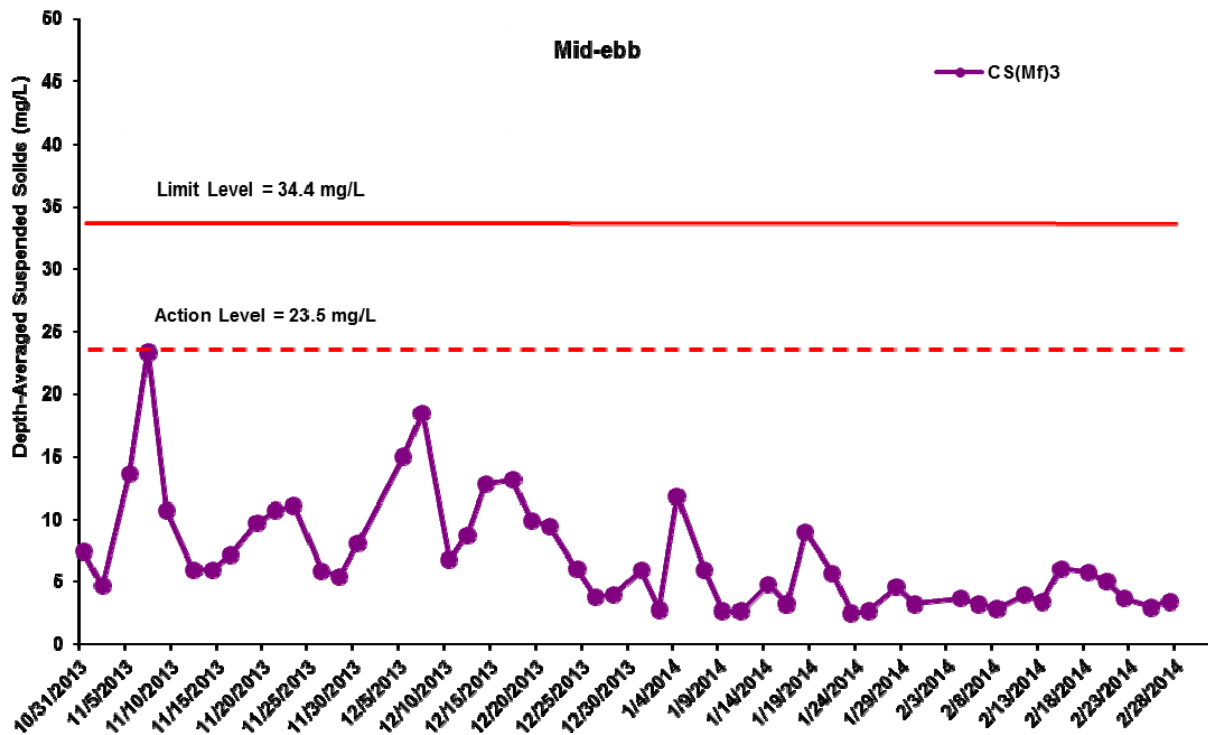
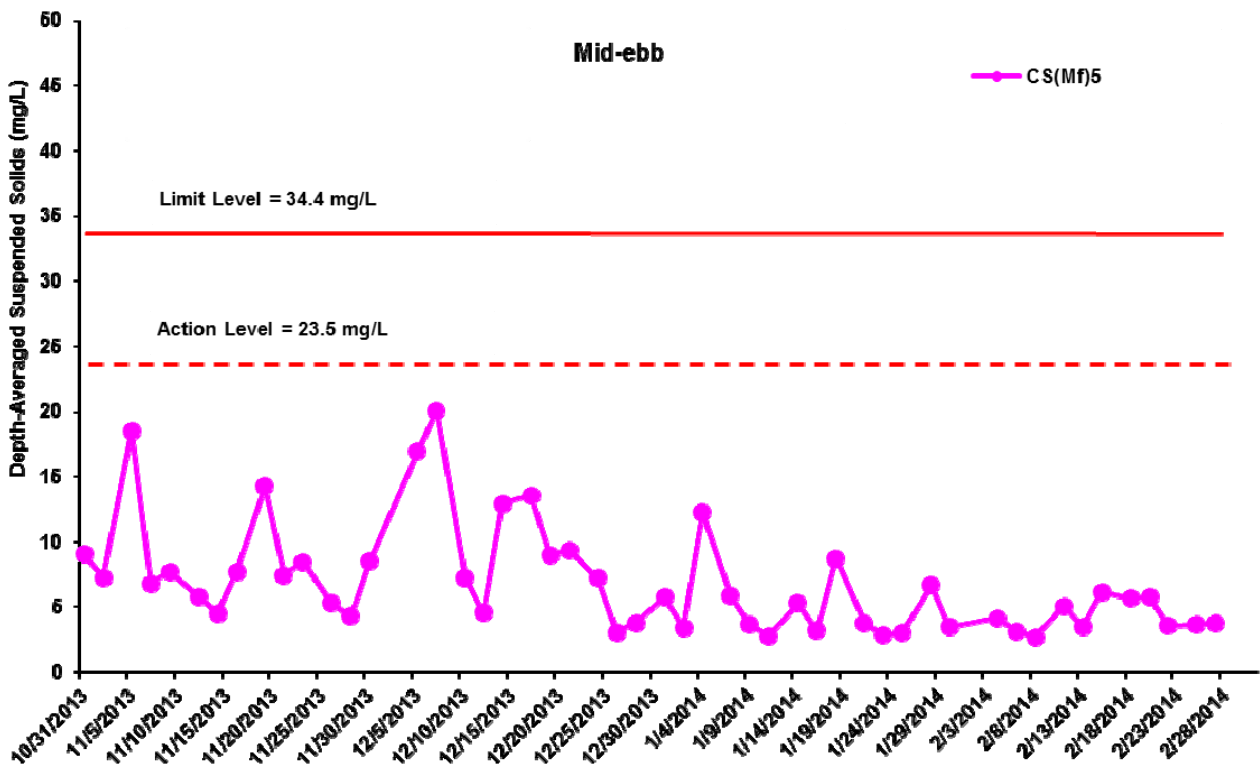
Figure I29 Impact Monitoring - Mean Level of depth-averaged Suspended Solids (mg/L) during mid-ebb tide between 31 October 2013 to 28 February 2014 at CS(Mf)3 and CS(Mf)5.

(Weather condition varied between sunny to rainy within the reporting period. Marine works within the reporting period include rockfill platform construction, marine piling platform installation and survey tower erection.)

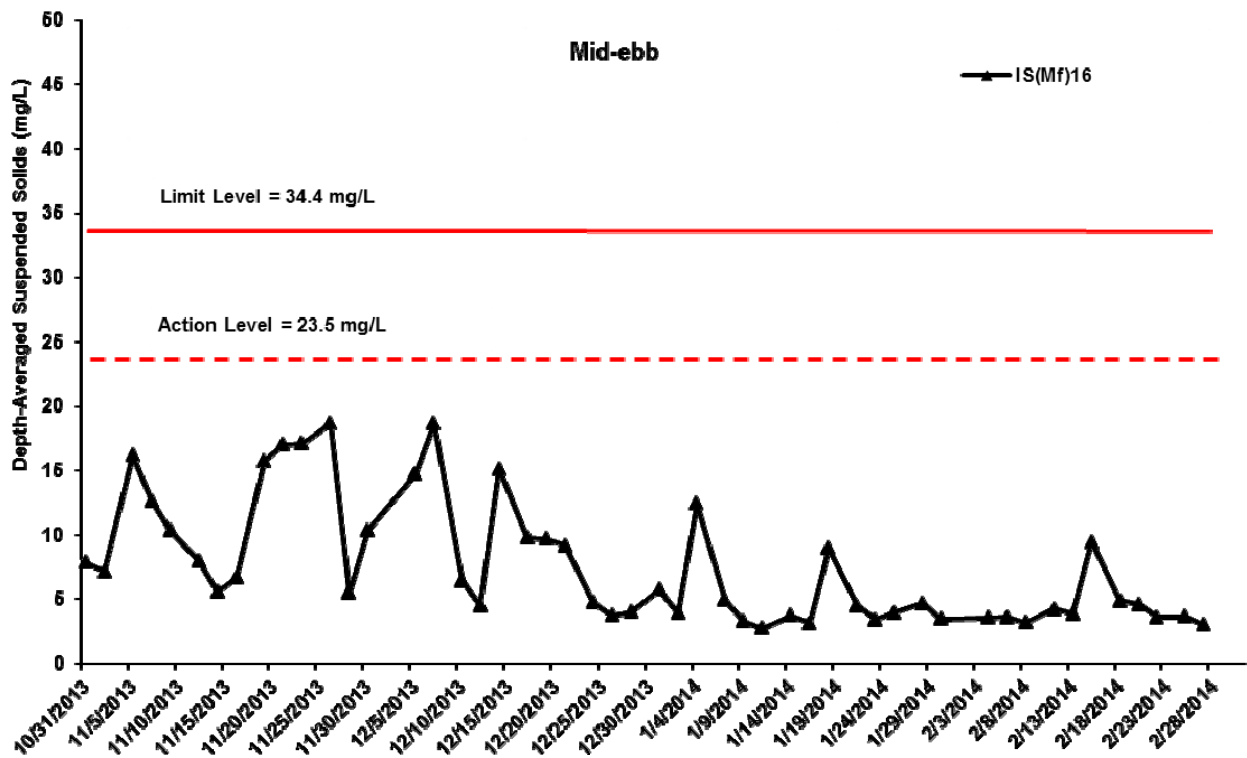
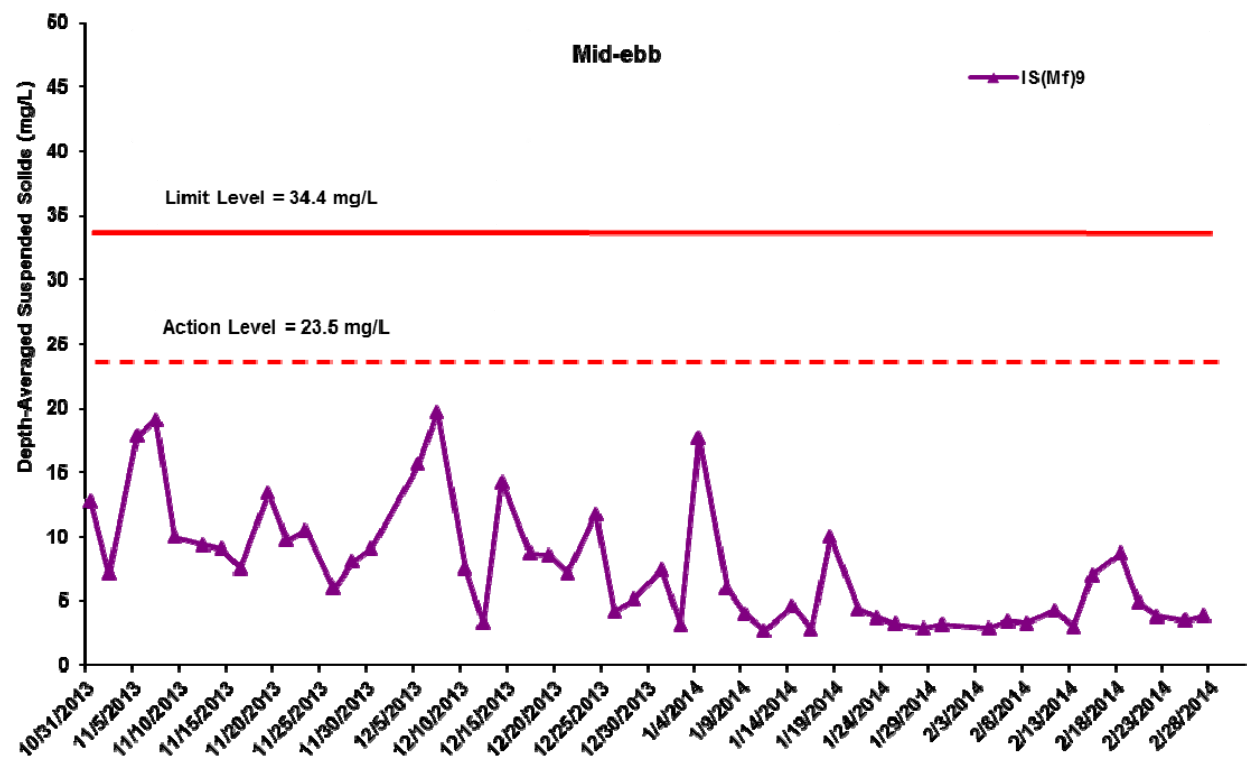
Figure I30 Impact Monitoring - Mean Level of depth-averaged Suspended Solids (mg/L) during mid-ebb tide between 31 October 2013 to 28 February 2014 at IS(Mf)16 and IS(Mf)9.

(Weather condition varied between sunny to rainy within the reporting period. Marine works within the reporting period include rockfill platform construction, marine piling platform installation and survey tower erection.)

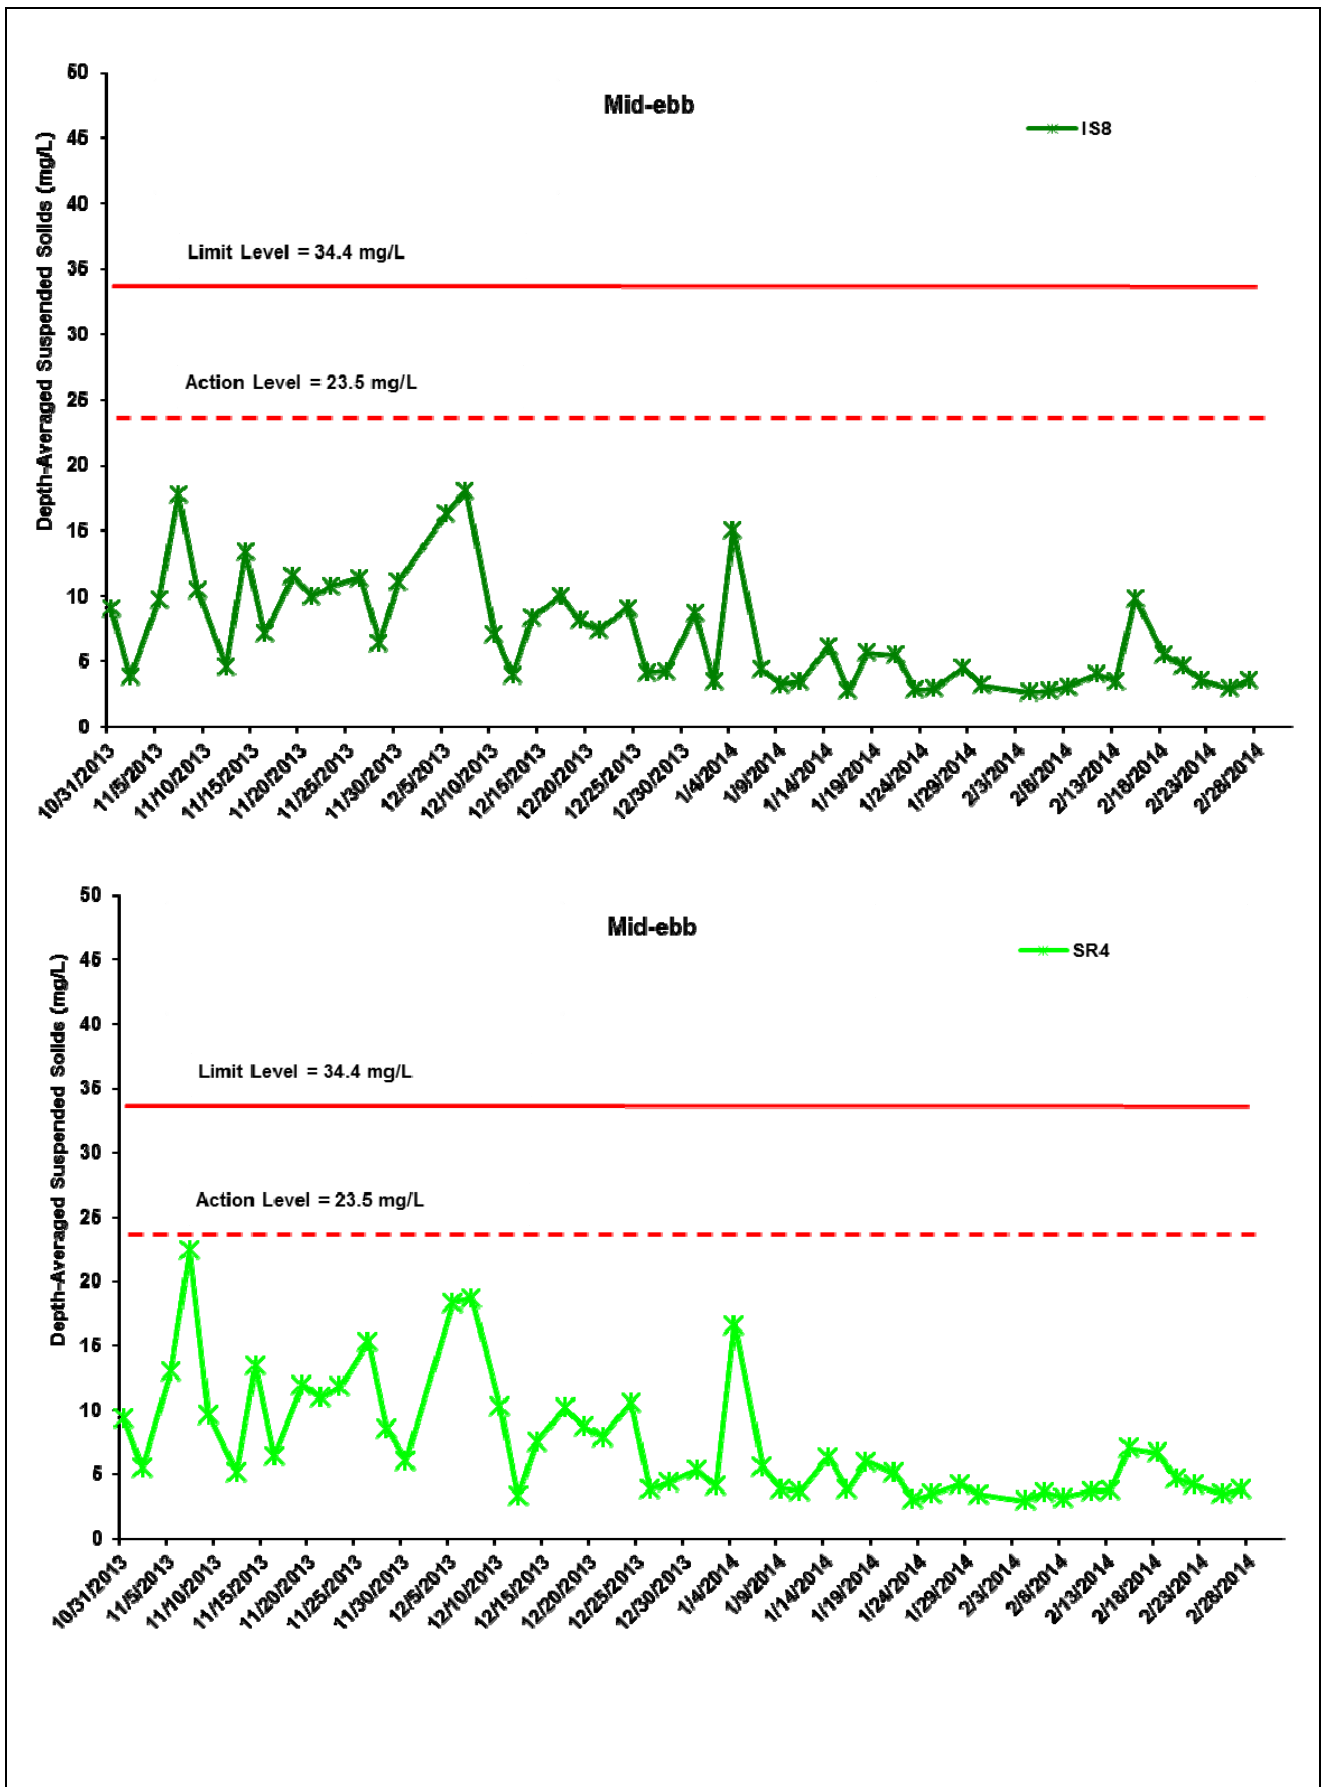
Figure I31 Impact Monitoring – Mean Level of depth-averaged Suspended Solids (mg/L) during mid-ebb tide between 31 October 2013 to 28 February 2014 at IS8 and SR4.

(Weather condition varied between sunny to rainy within the reporting period. Marine works within the reporting period include rockfill platform construction, marine piling platform installation and survey tower erection.)

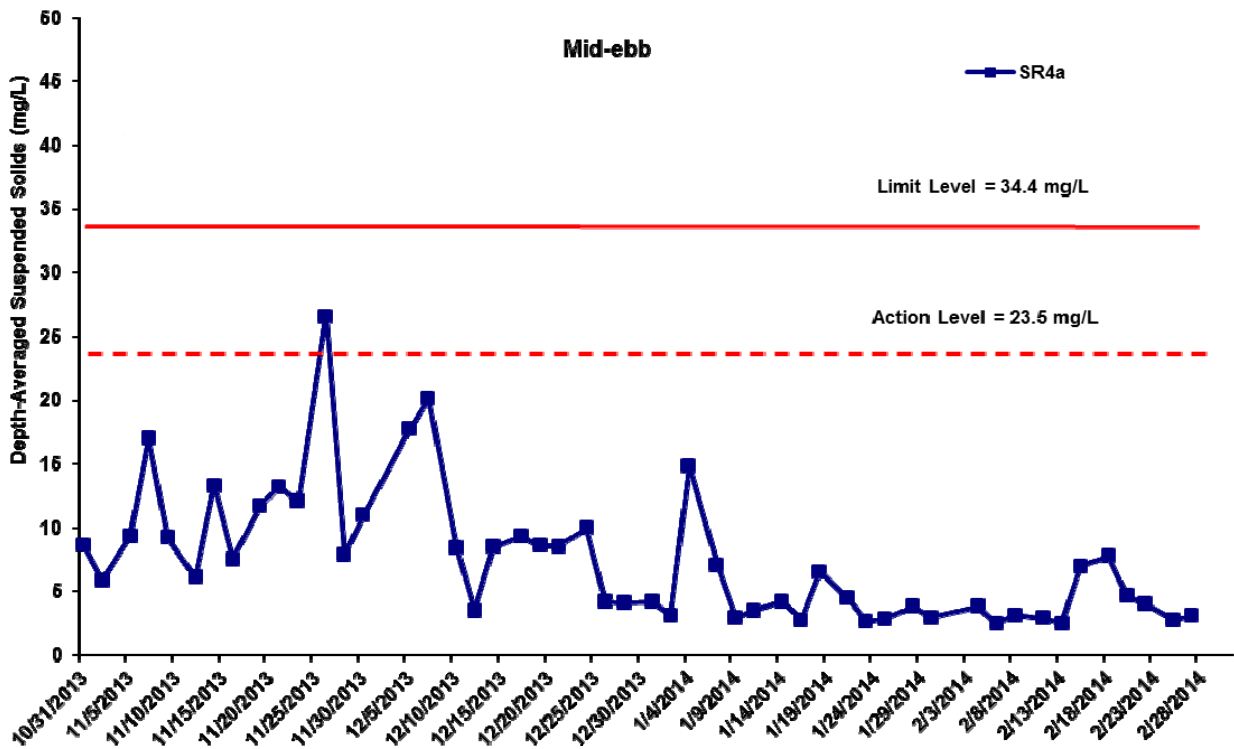
Figure I32 Impact Monitoring - Mean Level of depth-averaged Suspended Solids (mg/L) during mid-ebb tide between 31 October 2013 to 28 February 2014 at SR4a.

(Weather condition varied between sunny to rainy within the reporting period. Marine works within the reporting period include rockfill platform construction, marine piling platform installation and survey tower erection.)

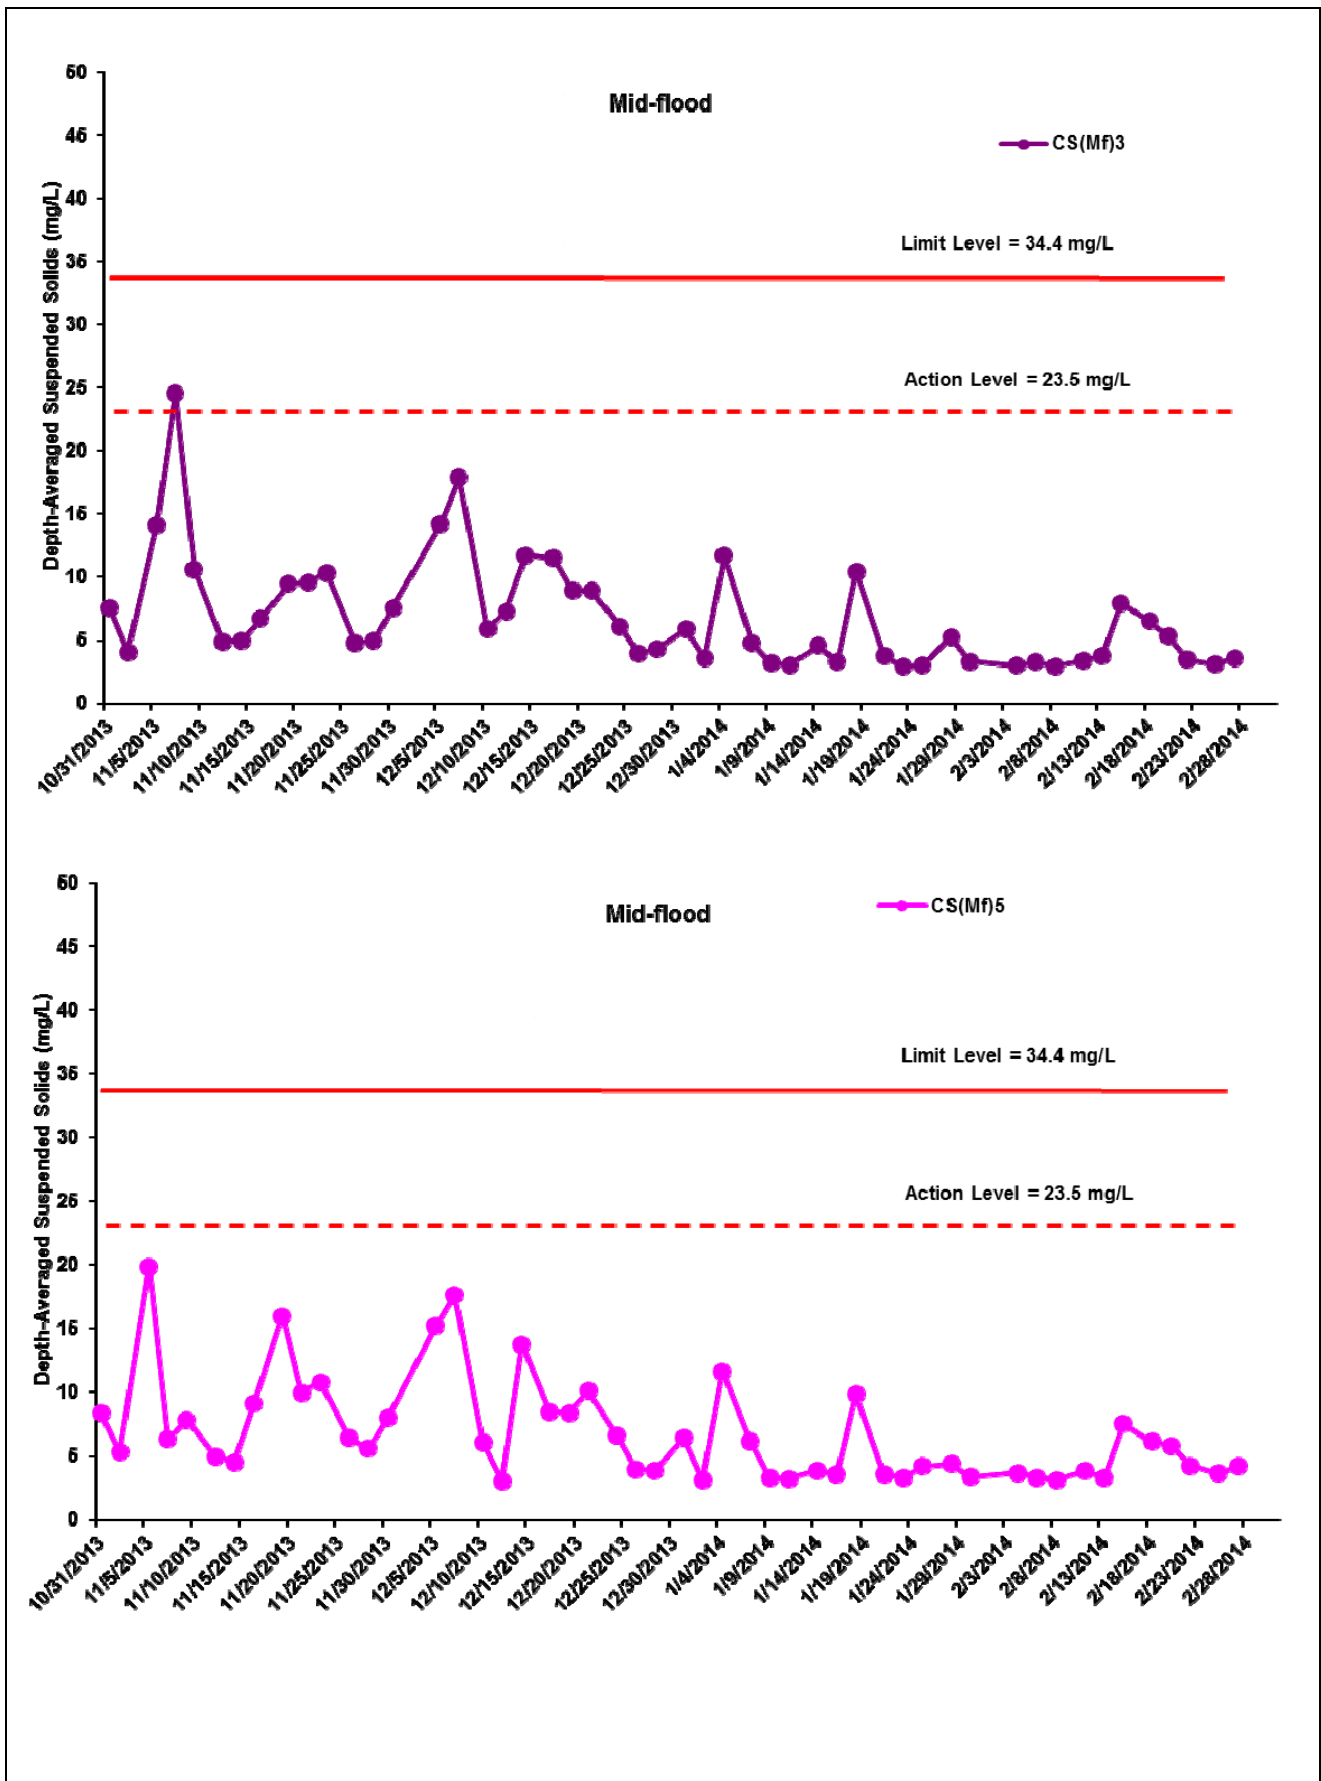
Figure I33 Impact Monitoring – Mean Level of depth-averaged Suspended Solids (mg/L) during mid-flood tide between 31 October 2013 to 28 February 2014 at CS(Mf)3 and CS(Mf)5.

(Weather condition varied between sunny to rainy within the reporting period. Marine works within the reporting period include rockfill platform construction, marine piling platform installation and survey tower erection.)

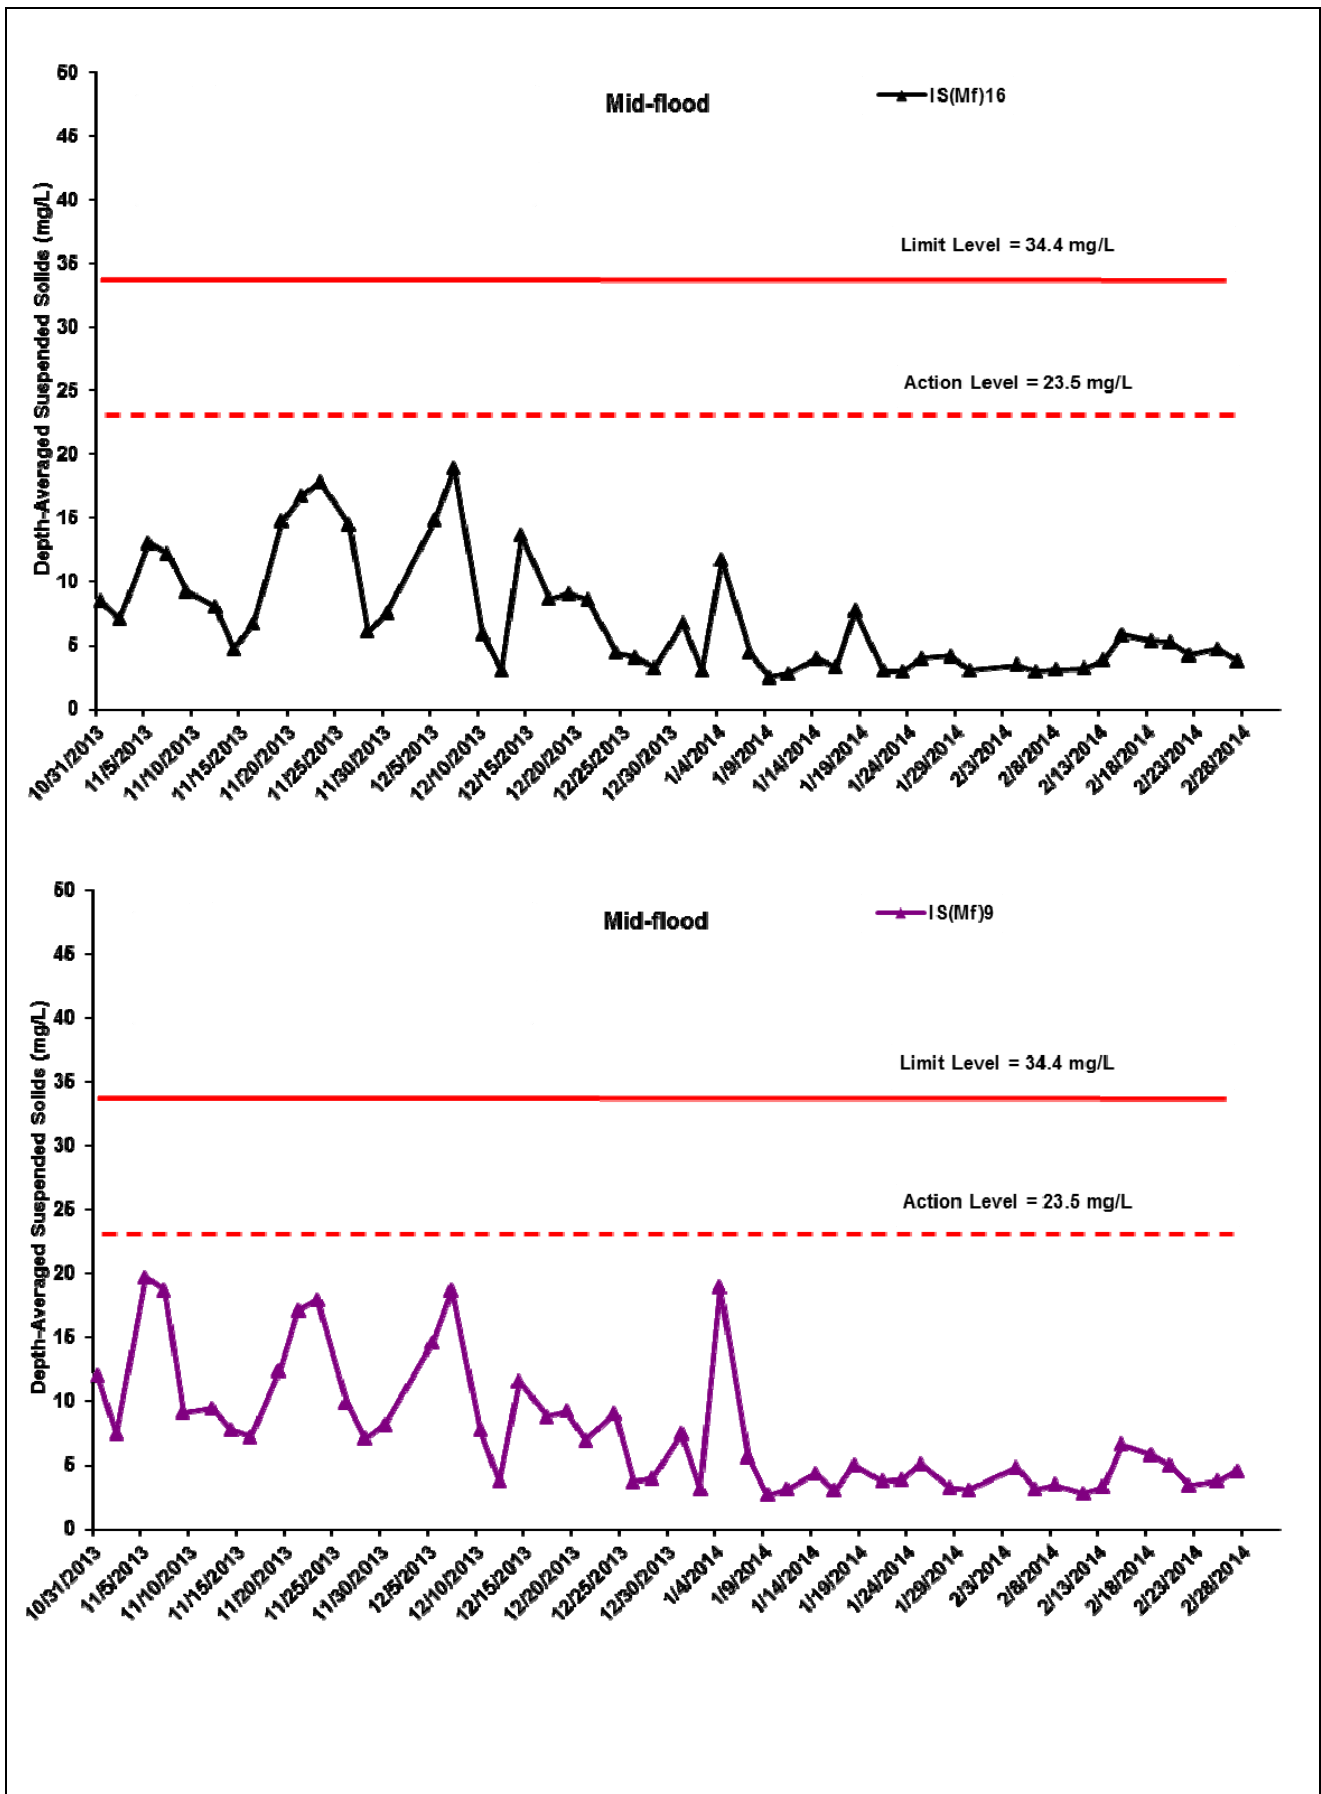
Figure I34 Impact Monitoring - Mean Level of depth-averaged Suspended Solids (mg/L) during mid-flood tide between 31 October 2013 to 28 February 2014 at IS(Mf)16 and IS(Mf)9 .
(Weather condition varied between sunny to rainy within the reporting period. Marine works within the reporting period include rockfill platform construction, marine piling platform installation and survey tower erection.)

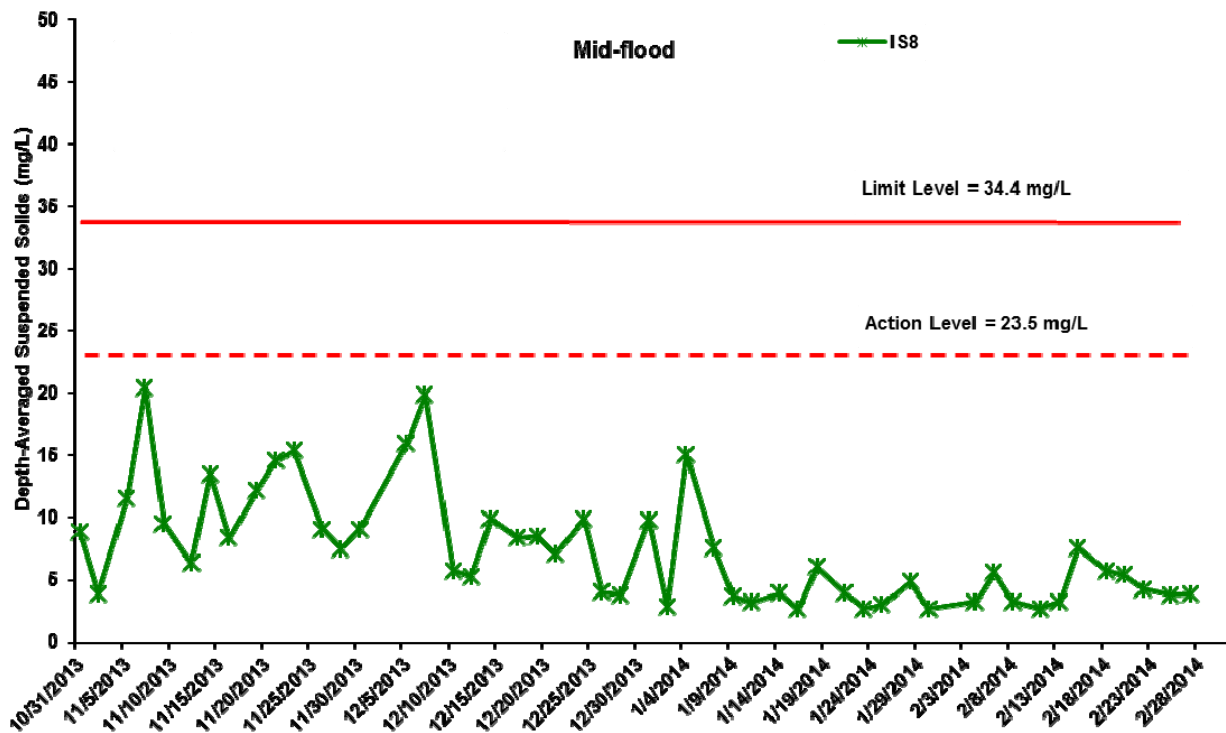
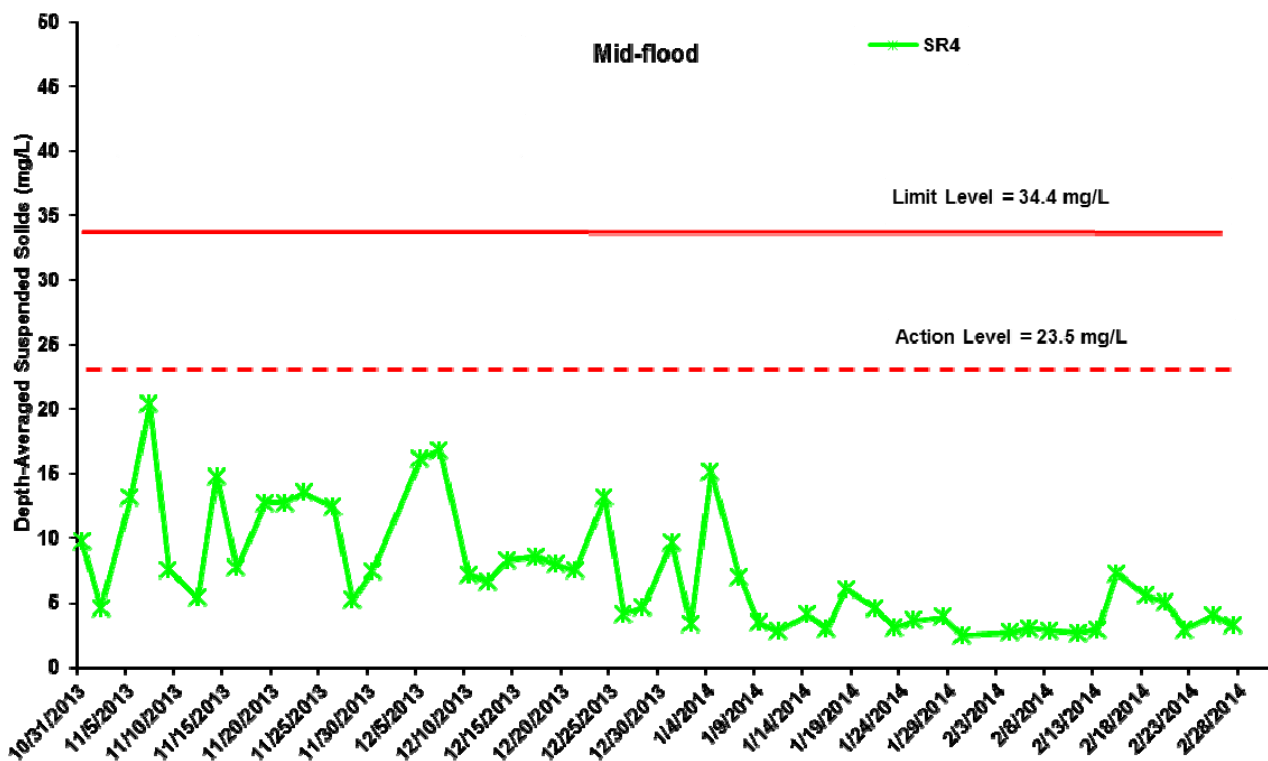
Figure I35 Impact Monitoring - Mean Level of depth-averaged Suspended Solids (mg/L) during mid-flood tide between 31 October 2013 to 28 February 2014 at IS8 and SR4.

(Weather condition varied between sunny to rainy within the reporting period. Marine works within the reporting period include rockfill platform construction, marine piling platform installation and survey tower erection.)
