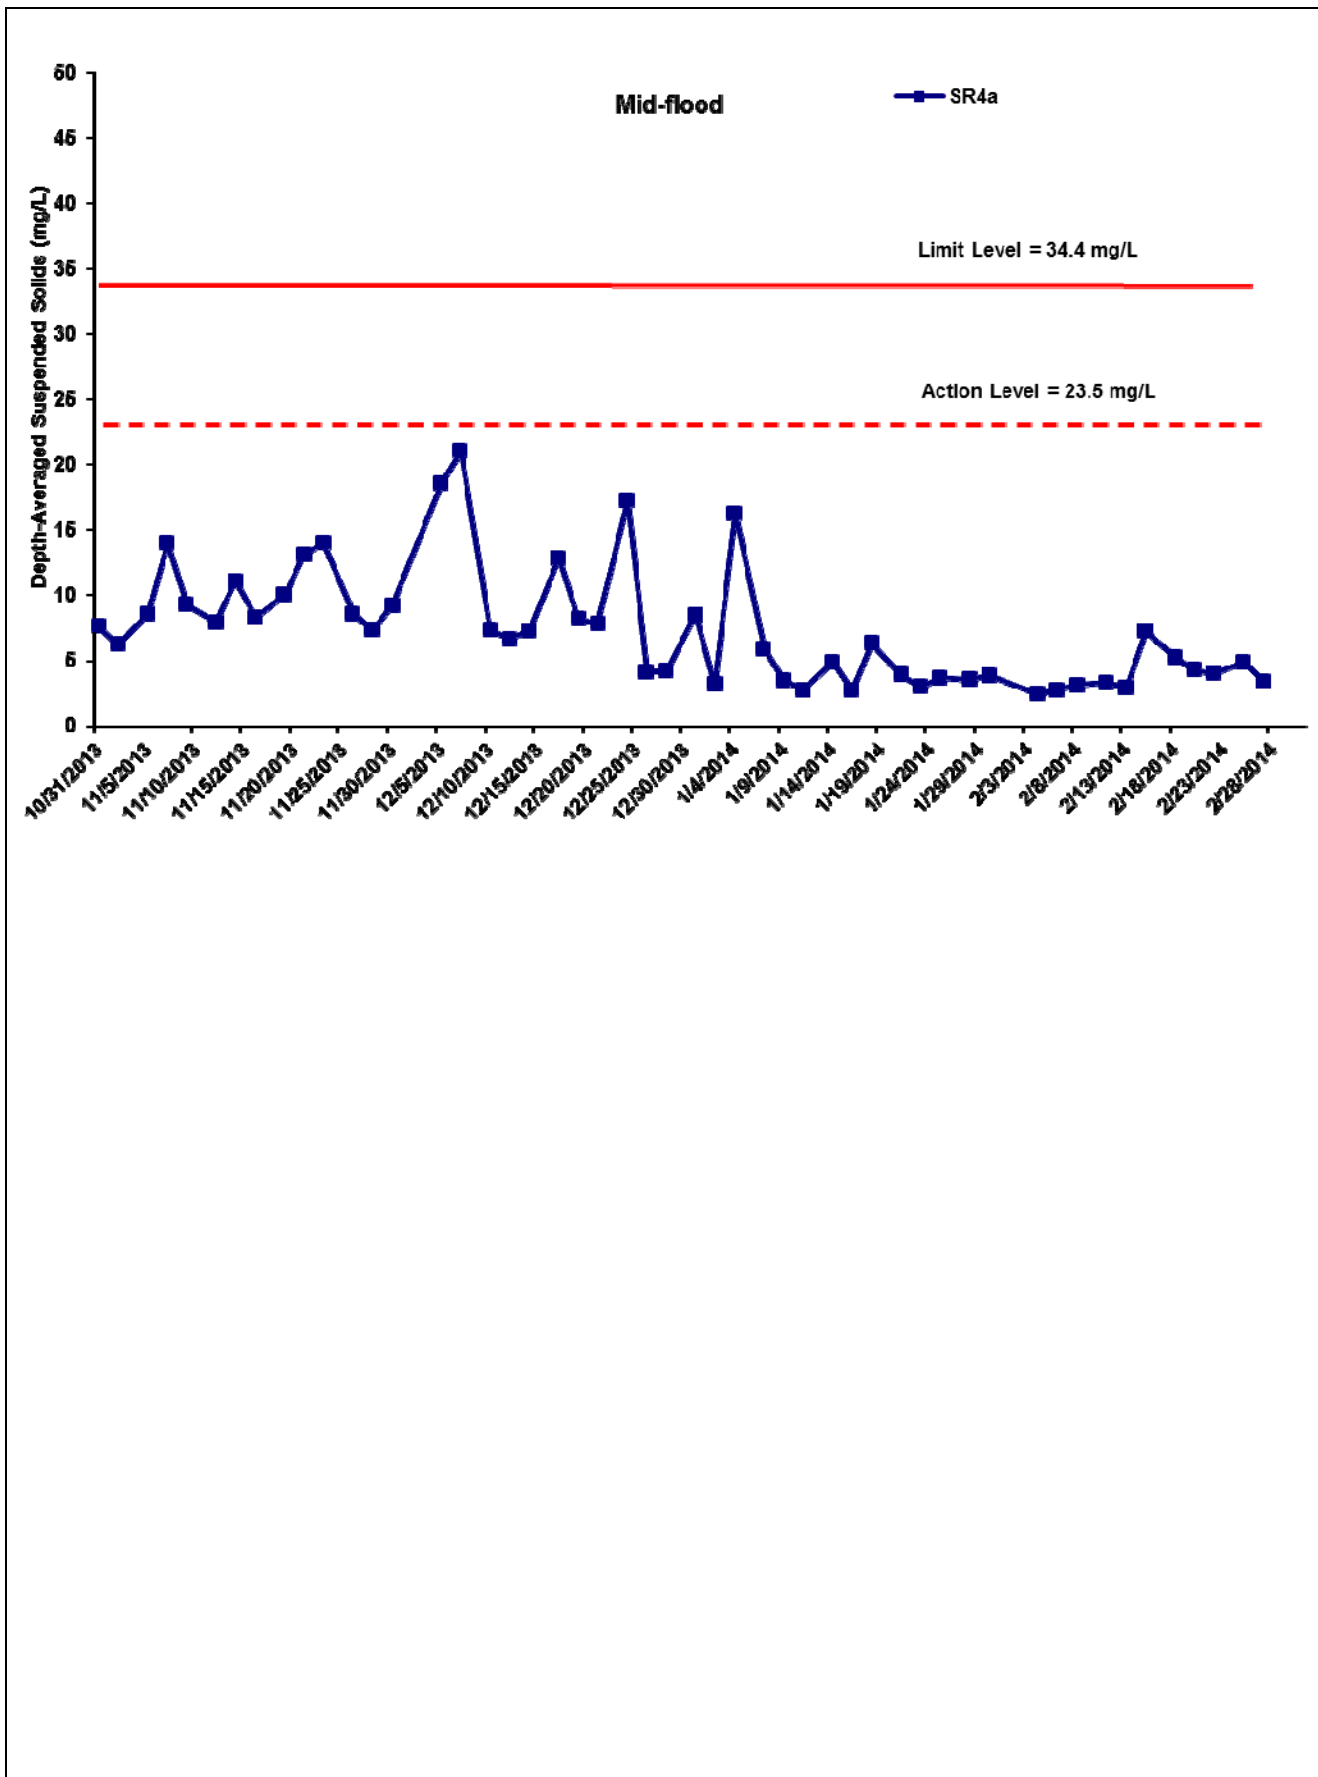
Figure I36 Impact Monitoring - Mean Level of depth-averaged Suspended Solids (mg/L) during mid-flood tide between 31 October 2013 to 28 February 2014 at SR4a.

(Weather condition varied between sunny to rainy within the reporting period. Marine works within the reporting period include rockfill platform construction, marine piling platform installation and survey tower erection.)
