**Contract No. HY/2012/07
Tuen Mun – Chek Lap Kok Link –
Southern Connection Viaduct Section**

***Twenty-second Quarterly Environmental
Monitoring & Audit (EM&A) Report***

30 September 2019

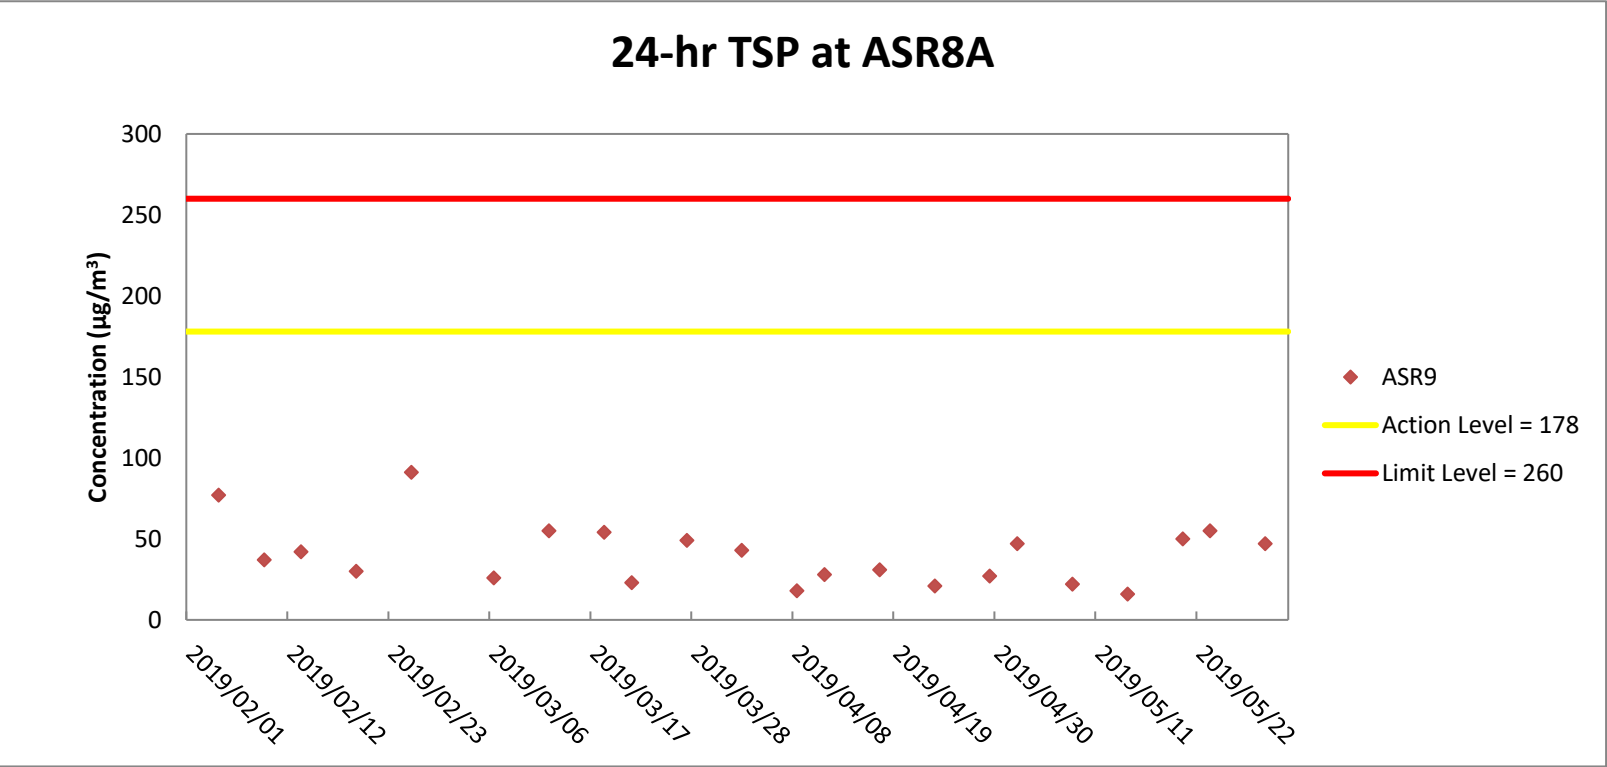
24-hr TSP at ASR8A

Weather condition within the reporting period varied between sunny to cloudy.
Major construction works undertaken within the reporting period include slope work at Viaduct D and landscaping works at HKBCF.
Marine works within the reporting period include reinstatement of seawall at seafront

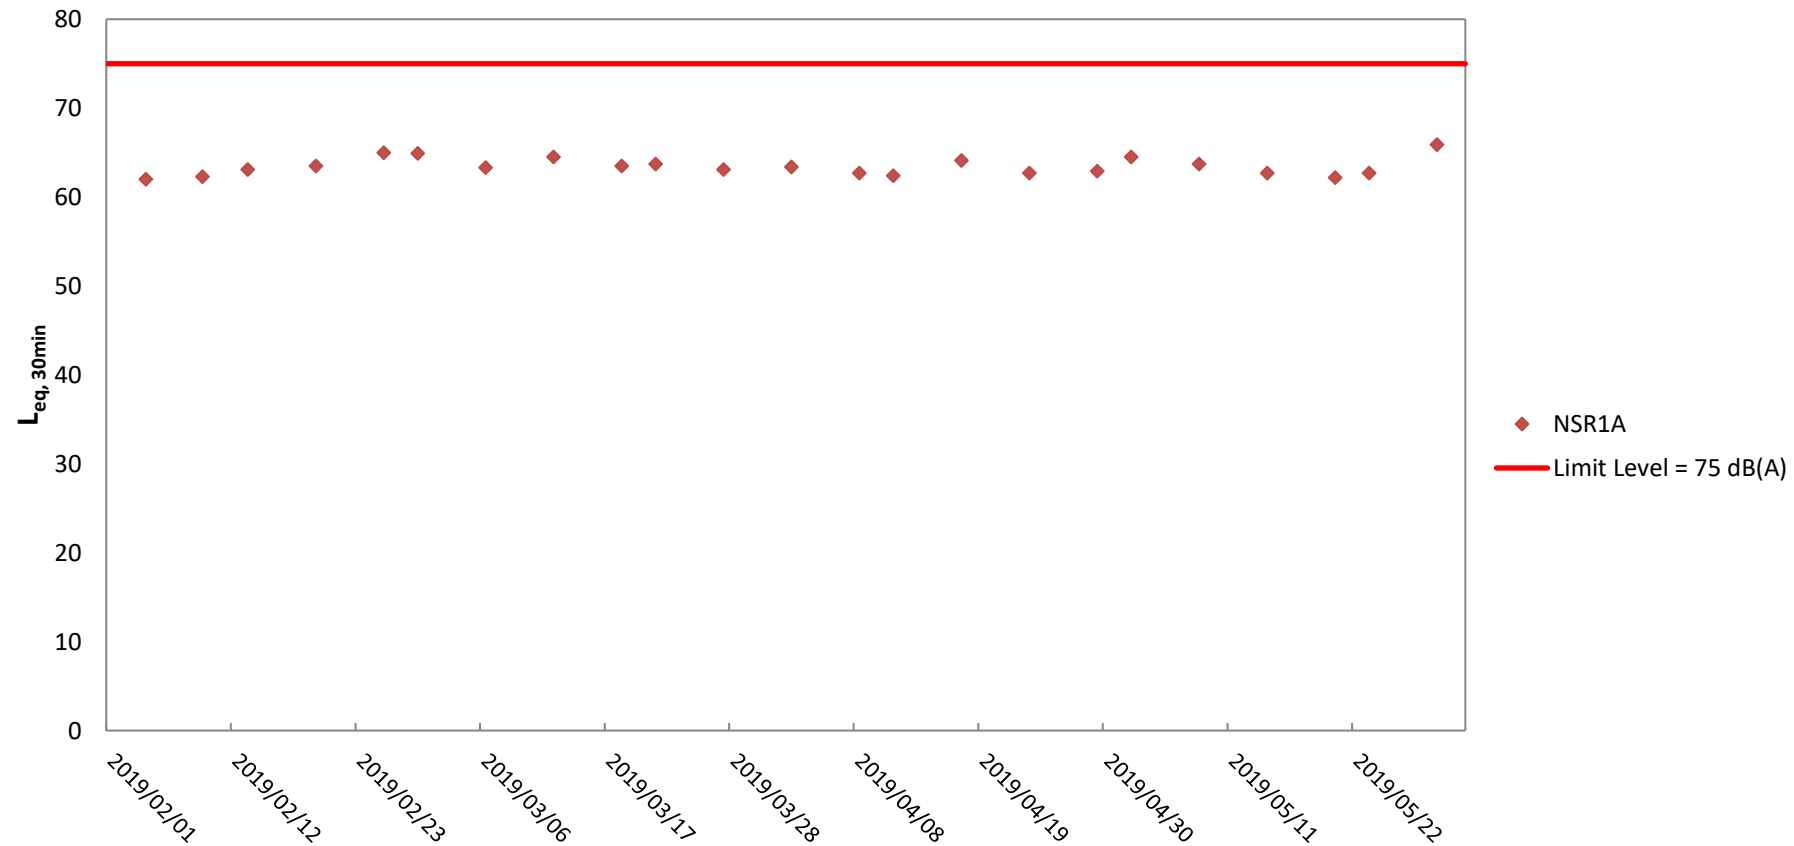
Noise Monitoring Results at NSR 1A ($L_{eq, 30min}$)

Weather condition within the reporting period varied between sunny to cloudy.

Major construction works undertaken within the reporting period include slope work of viaduct D, landscaping works at HKBCF.

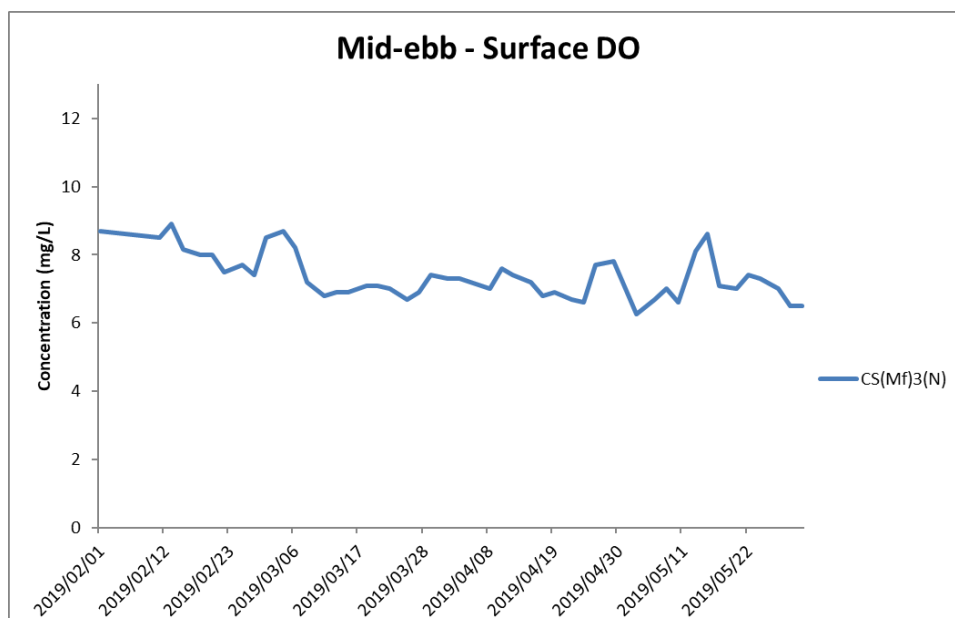
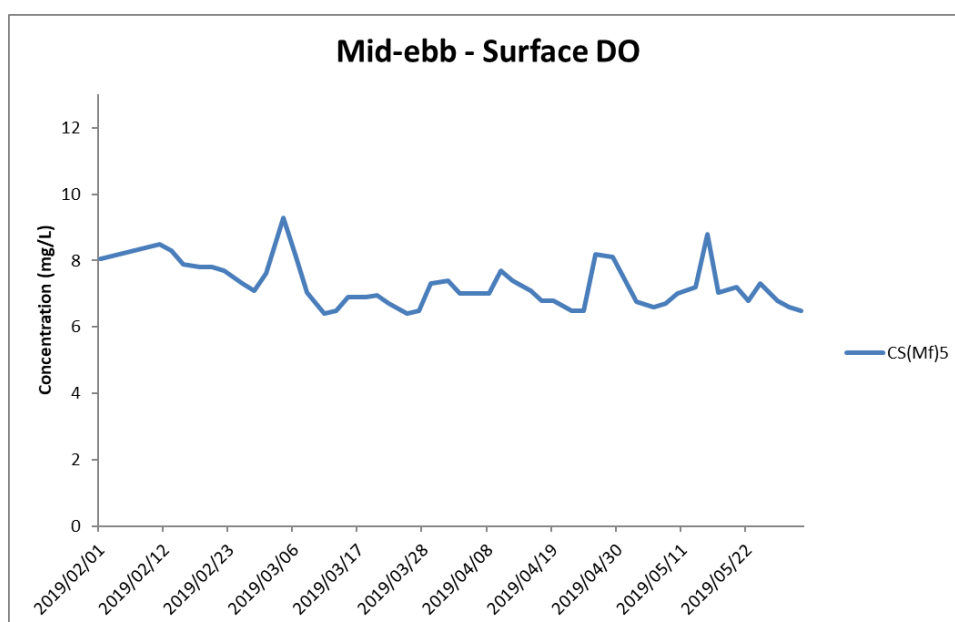
Figure H1 Impact Monitoring – Mean Level of Dissolved Oxygen (mg/L) in surface waters during mid-ebb tide between 1 February and 31 May 2019 at CS(Mf)3(N) and CS(Mf)5.

(Weather condition varied between sunny to rainy within the reporting period.)
WQM on 5 April and 5 April and 1 May 2019 was cancelled due to site closure on holiday.

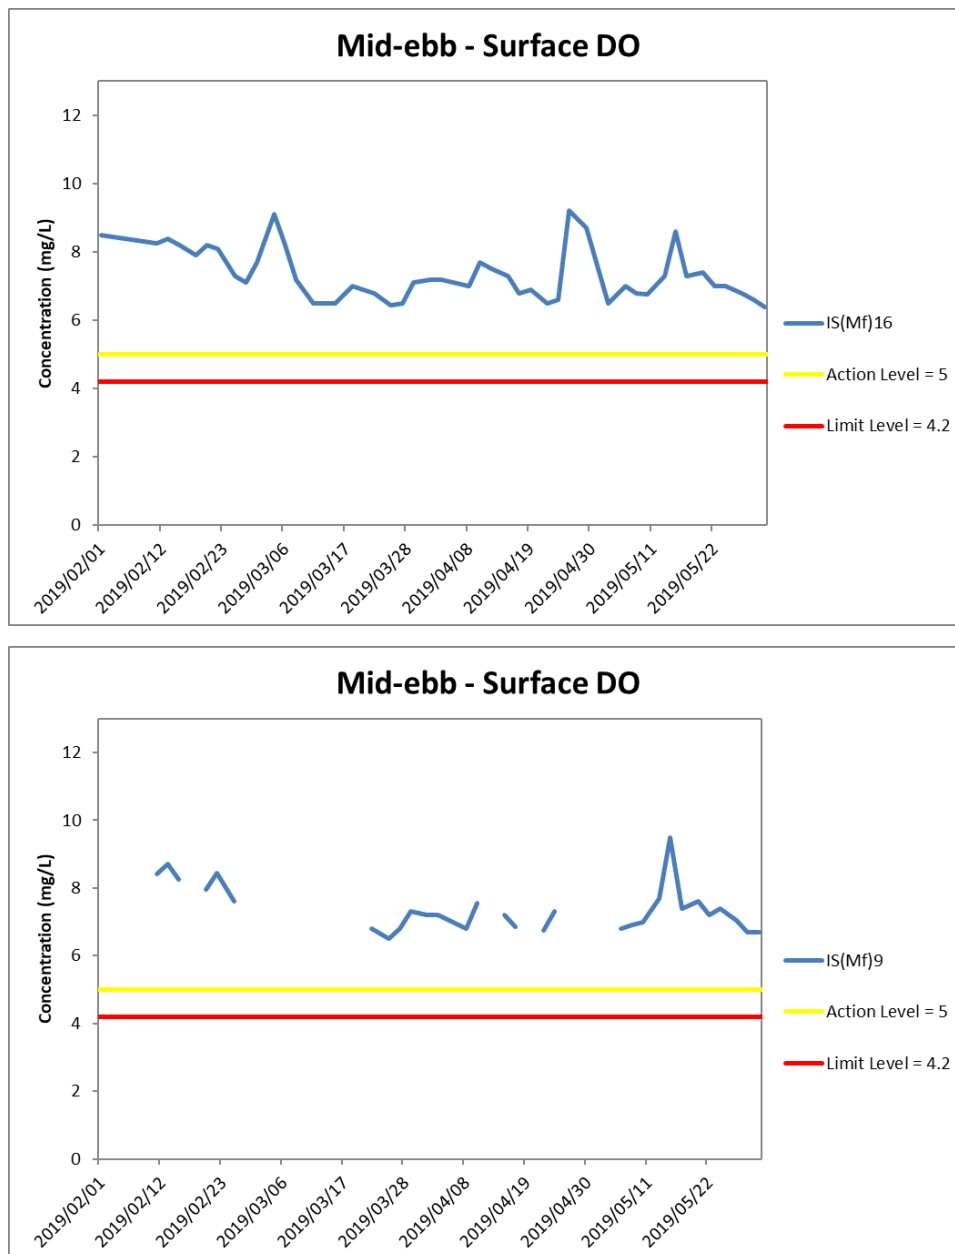
Figure H2 Impact Monitoring – Mean Level of Dissolved Oxygen (mg/L) in surface waters during mid-ebb tide between 1 February and 31 May 2019 at IS(Mf)16 and IS(Mf)9.

(Weather condition varied between sunny to rainy within the reporting period.)
WQM on 5 April and 1 May 2019 was cancelled due to site closure on holiday.
In-situ monitoring is taken according to the requirement specified in the EM&A Manual, i.e. 3 water depth namely 1m below sea surface, mid-depth and 1m above sea bed. If the water depth is less than 3m, mid-depth sampling only. If water depth less than 6m, mid-depth may be omitted.

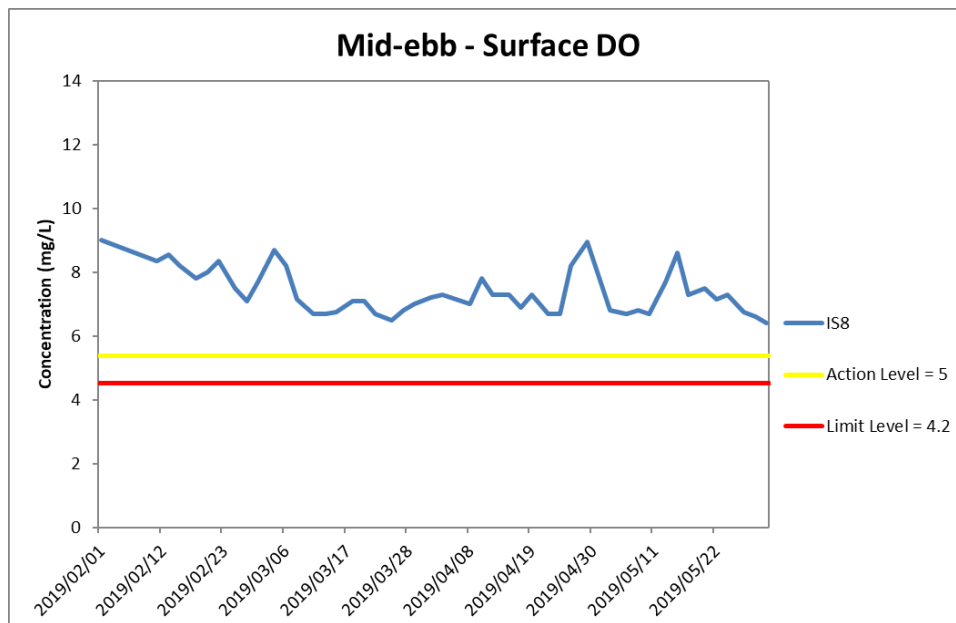
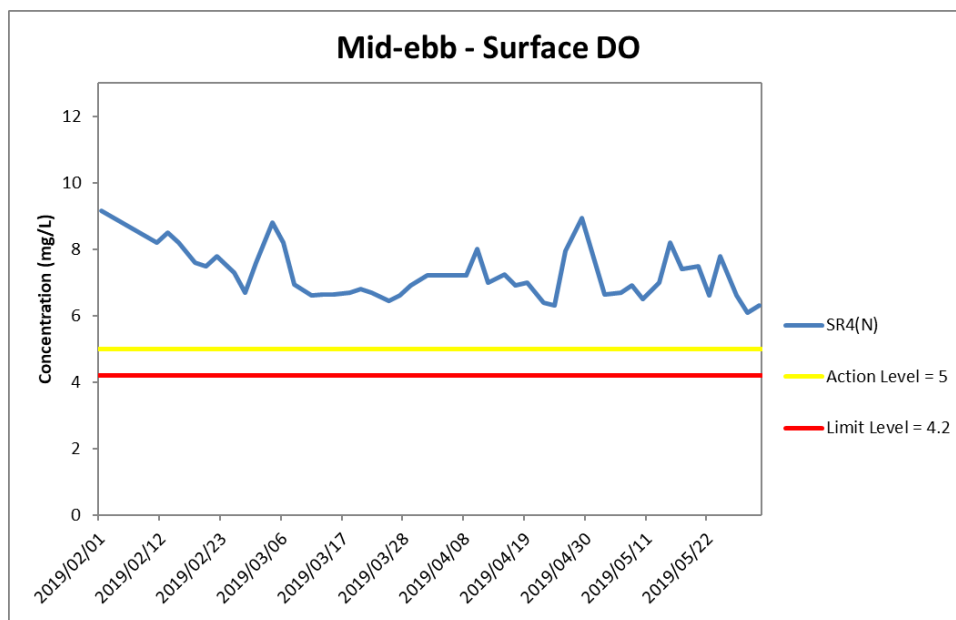
Figure H3 Impact Monitoring – Mean Level of Dissolved Oxygen (mg/L) in surface waters during mid-ebb tide between 1 February and 31 May 2019 at IS8 and SR4(N).

(Weather condition varied between sunny to rainy within the reporting period.)
WQM on 5 April and 1 May 2019 was cancelled due to site closure on holiday.
In-situ monitoring is taken according to the requirement specified in the EM&A Manual, i.e. 3 water depth namely 1m below sea surface, mid-depth and 1m above sea bed. If the water depth is less than 3m, mid-depth sampling only. If water depth less than 6m, mid-depth may be omitted.

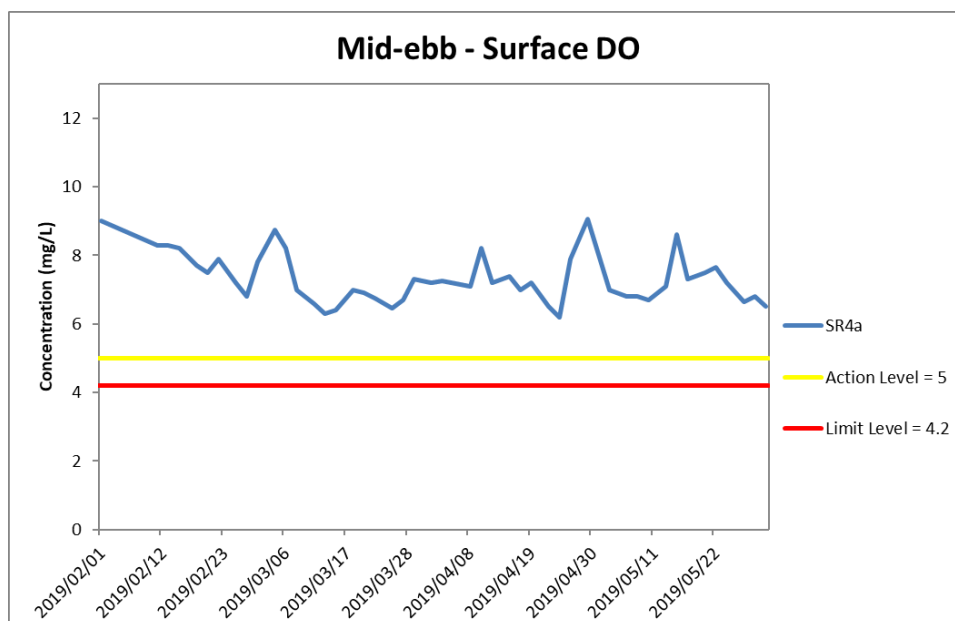
Figure H4 Impact Monitoring – Mean Level of Dissolved Oxygen (mg/L) in surface waters during mid-ebb tide between 1 February and 31 May 2019 at SR4a.

(Weather condition varied between sunny to rainy within the reporting period.)
 WQM on 5 April and 1 May 2019 was cancelled due to site closure on holiday.
 In-situ monitoring is taken according to the requirement specified in the EM&A Manual, i.e. 3 water depth namely 1m below sea surface, mid-depth and 1m above sea bed. If the water depth is less than 3m, mid-depth sampling only. If water depth less than 6m, mid-depth may be omitted.

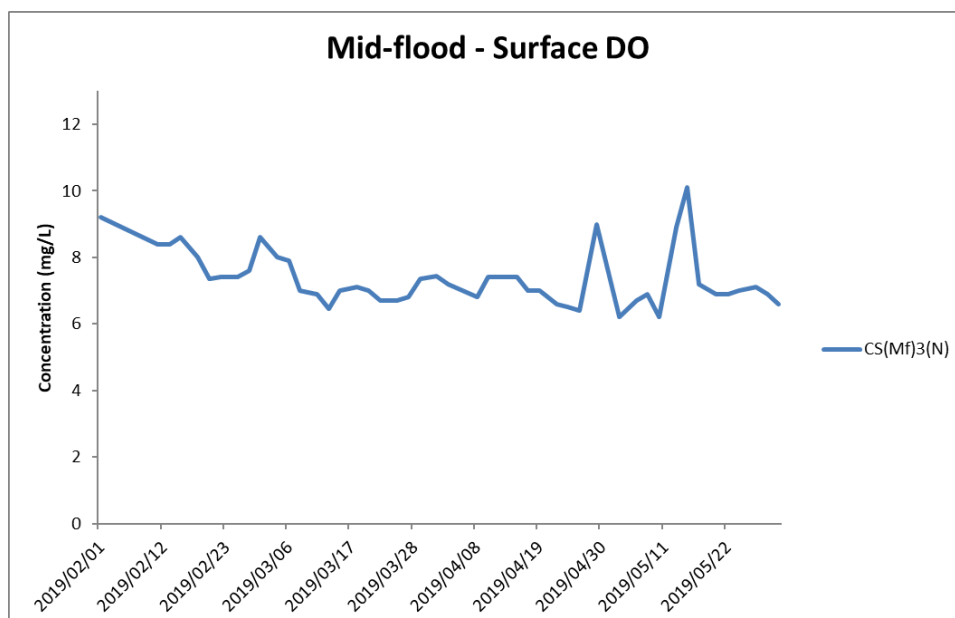
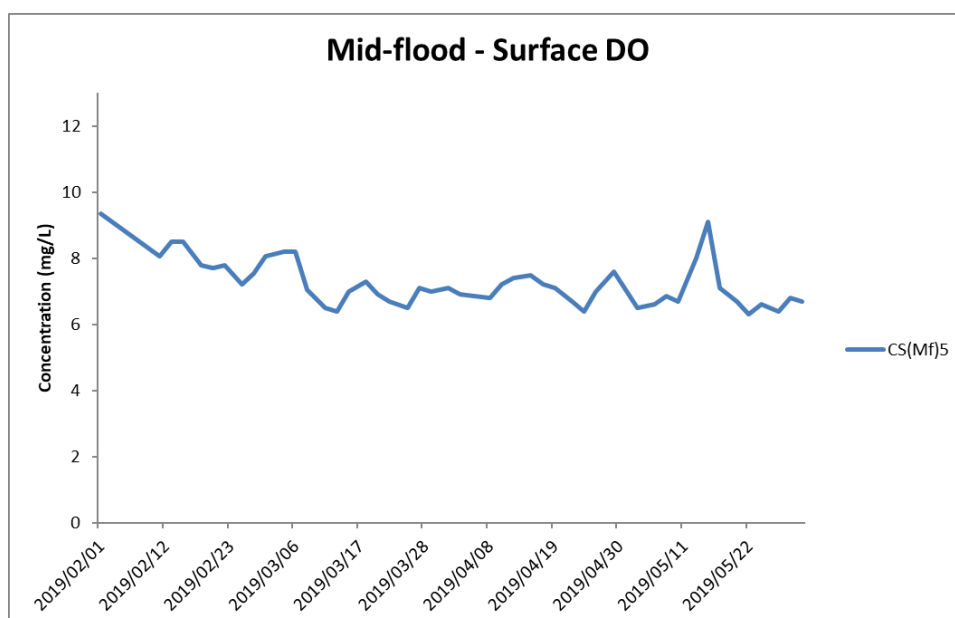
Figure H5 Impact Monitoring – Mean Level of Dissolved Oxygen (mg/L) in surface waters during mid-flood tide between 1 February and 31 May 2019 at CS(Mf)3(N) and CS(Mf)5.

(Weather condition varied between sunny to rainy within the reporting period.)
WQM on 5 April and 1 May 2019 was cancelled due to site closure on holiday.
In-situ monitoring is taken according to the requirement specified in the EM&A Manual, i.e. 3 water depth namely 1m below sea surface, mid-depth and 1m above sea bed. If the water depth is less than 3m, mid-depth sampling only. If water depth less than 6m, mid-depth may be omitted.

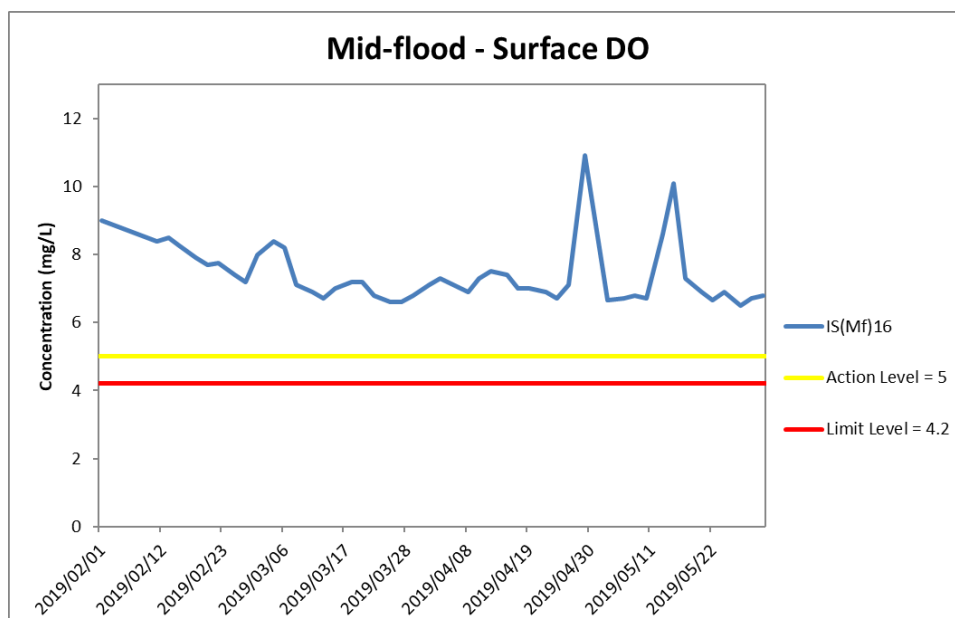
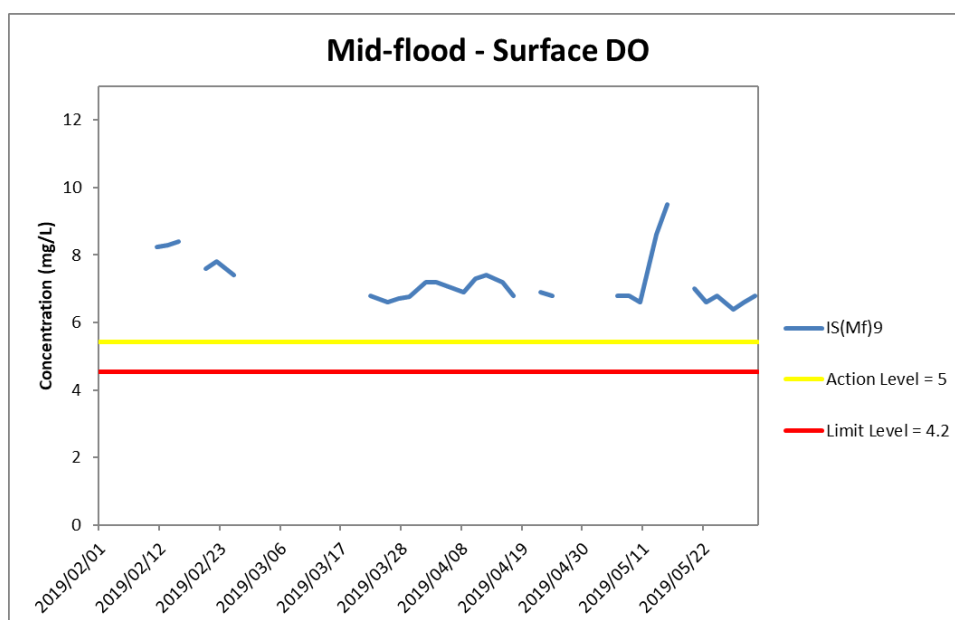
Figure H6 Impact Monitoring – Mean Level of Dissolved Oxygen (mg/L) in surface waters during mid-flood tide between 1 February and 31 May 2019 at IS(Mf)16 and IS(Mf)9.

(Weather condition varied between sunny to rainy within the reporting period.)
 WQM on 5 April and 1 May 2019 was cancelled due to site closure on holiday.
 In-situ monitoring is taken according to the requirement specified in the EM&A Manual, i.e. 3 water depth namely 1m below sea surface, mid-depth and 1m above sea bed. If the water depth is less than 3m, mid-depth sampling only. If water depth less than 6m, mid-depth may be omitted.

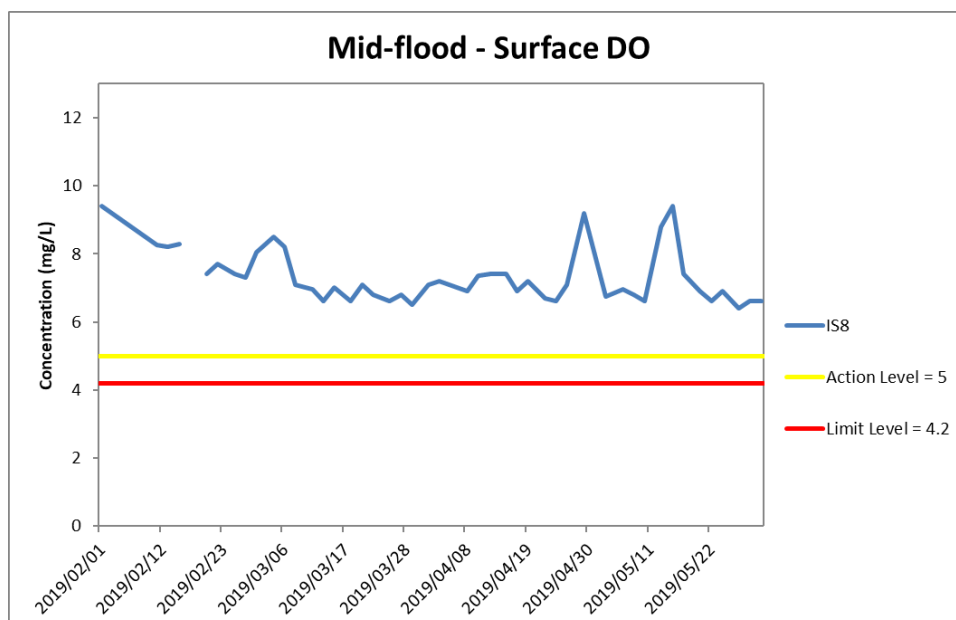
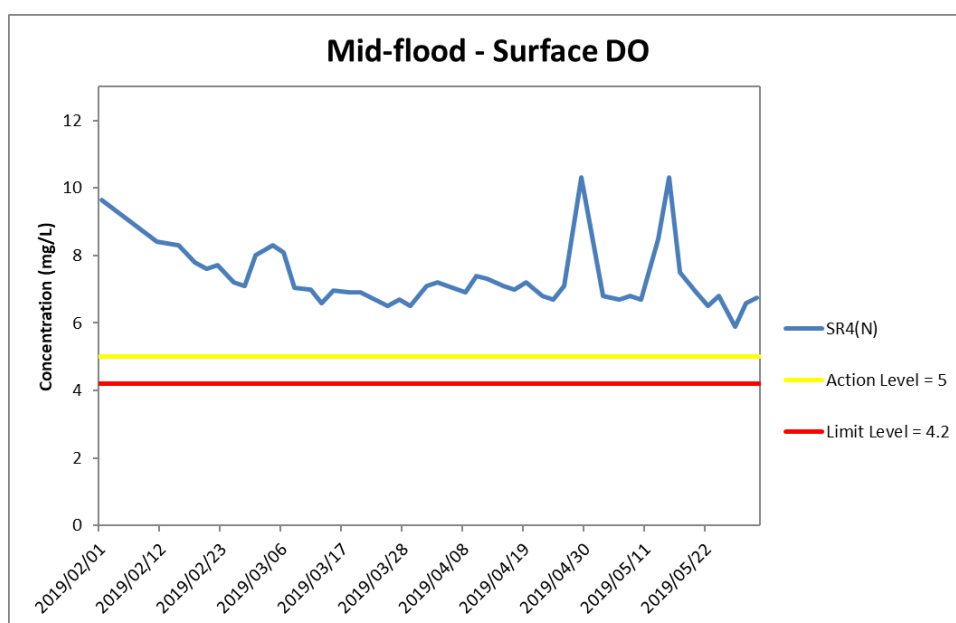
Figure H7 Impact Monitoring – Mean Level of Dissolved Oxygen (mg/L) in surface waters during mid-flood tide between 1 February and 31 May 2019 at IS8 and SR4(N).

(Weather condition varied between sunny to rainy within the reporting period.)
 WQM on 5 April and 1 May 2019 was cancelled due to site closure on holiday.
 In-situ monitoring is taken according to the requirement specified in the EM&A Manual, i.e. 3 water depth namely 1m below sea surface, mid-depth and 1m above sea bed. If the water depth is less than 3m, mid-depth sampling only. If water depth less than 6m, mid-depth may be omitted.

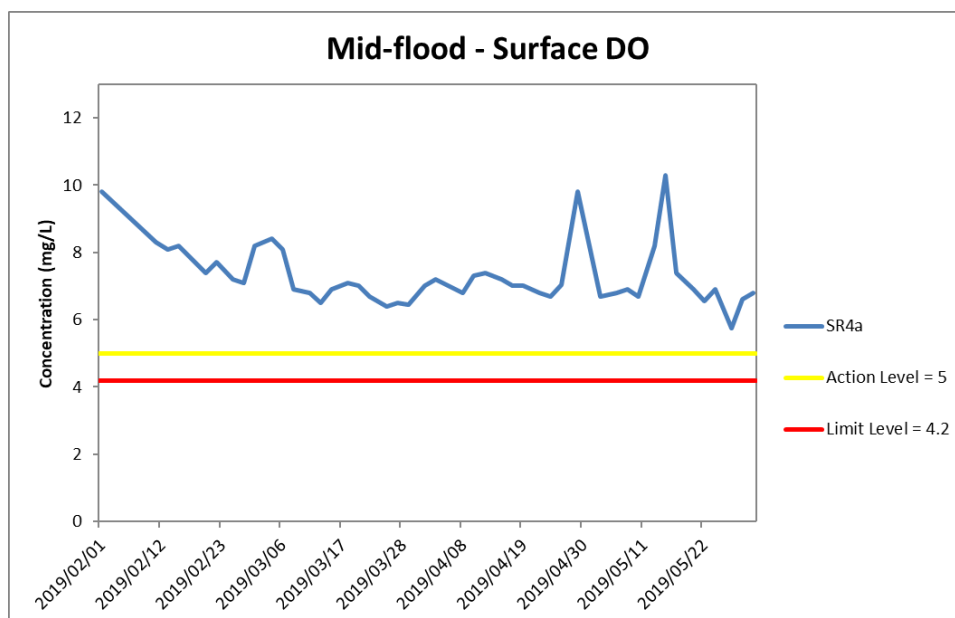
Figure H8 Impact Monitoring - Mean Level of Dissolved Oxygen (mg/L) in surface waters during mid-flood tide between 1 February and 31 May 2019 at SR4a.

(Weather condition varied between sunny to rainy within the reporting period.)
WQM on 5 April and 1 May 2019 was cancelled due to site closure on holiday.
In-situ monitoring is taken according to the requirement specified in the EM&A Manual, i.e. 3 water depth namely 1m below sea surface, mid-depth and 1m above sea bed. If the water depth is less than 3m, mid-depth sampling only. If water depth less than 6m, mid-depth may be omitted.

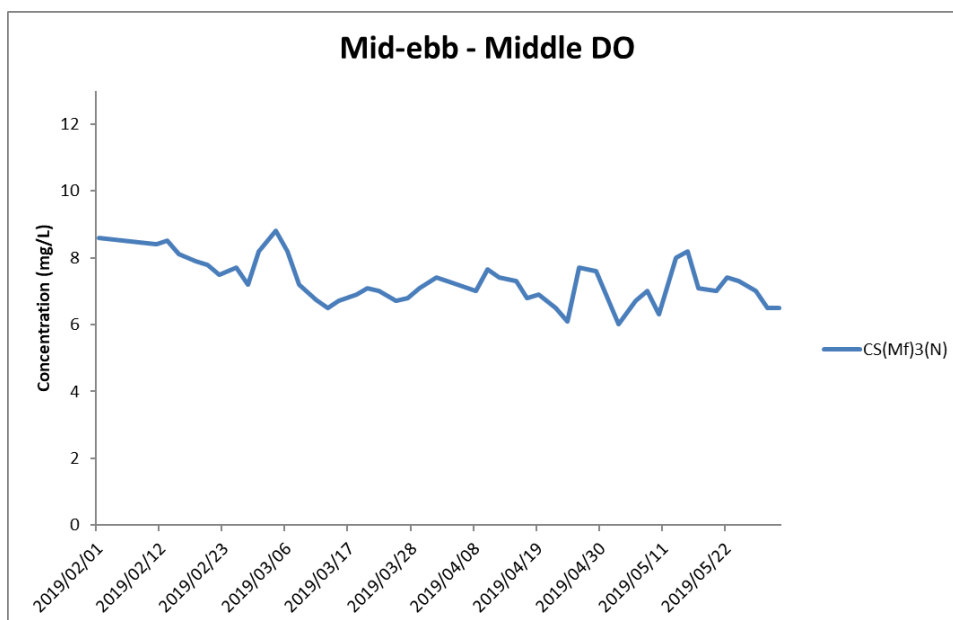
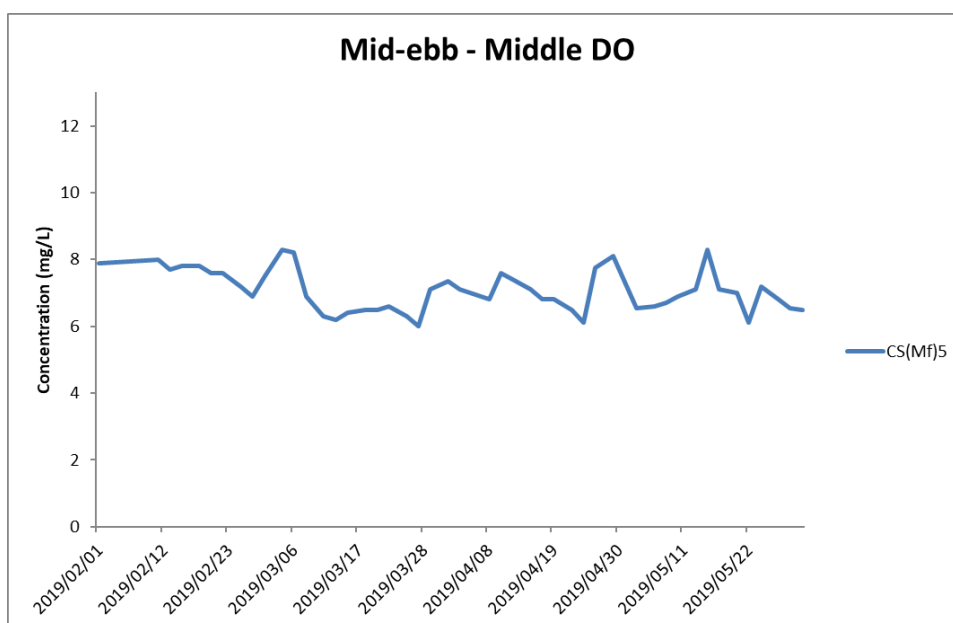
Figure H9 Impact Monitoring – Mean Level of Dissolved Oxygen (mg/L) in mid-depth waters during mid-ebb tide between 1 February and 31 May 2019 at CS(Mf)3(N) and CS(Mf)5.

(Weather condition varied between sunny to rainy within the reporting period.)
 WQM on 5 April and 1 May 2019 was cancelled due to site closure on holiday.
 In-situ monitoring is taken according to the requirement specified in the EM&A Manual, i.e. 3 water depth namely 1m below sea surface, mid-depth and 1m above sea bed. If the water depth is less than 3m, mid-depth sampling only. If water depth less than 6m, mid-depth may be omitted.

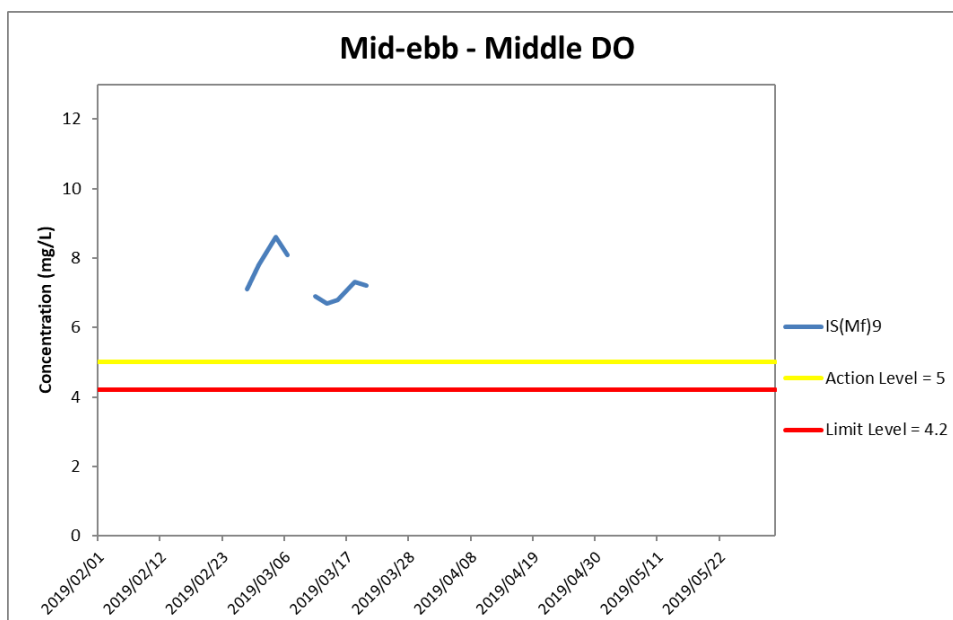
Figure H10 Impact Monitoring – Mean Level of Dissolved Oxygen (mg/L) in mid-depth waters during mid-ebb tide between 1 February and 31 May 2019 at IS(Mf)9.

(Weather condition varied between sunny to rainy within the reporting period.)
 WQM on 5 April and 1 May 2019 was cancelled due to site closure on holiday.
 In-situ monitoring is taken according to the requirement specified in the EM&A Manual, i.e. 3 water depth namely 1m below sea surface, mid-depth and 1m above sea bed. If the water depth is less than 3m, mid-depth sampling only. If water depth less than 6m, mid-depth may be omitted.

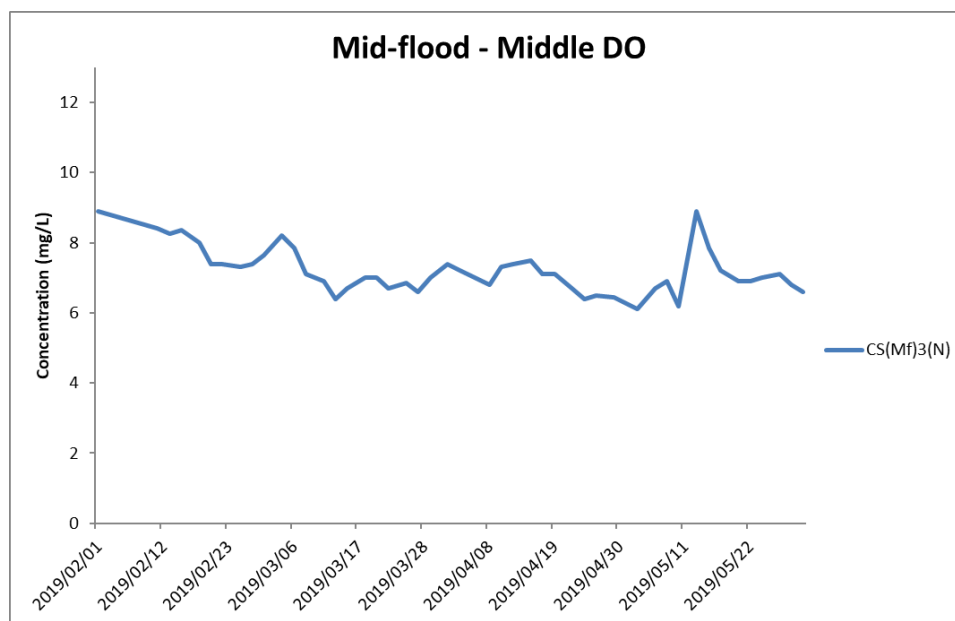
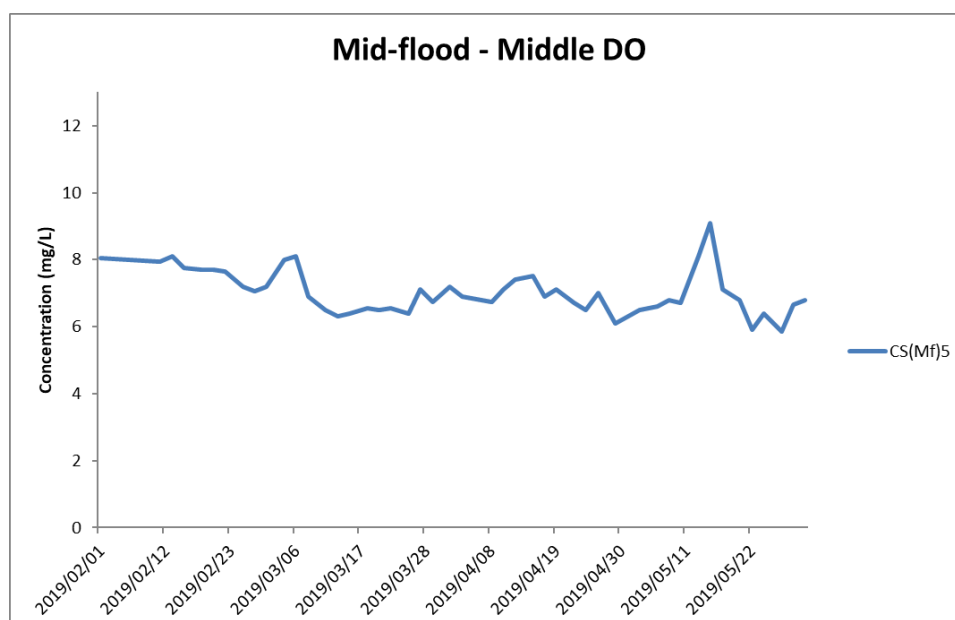
Figure H11 Impact Monitoring – Mean Level of Dissolved Oxygen (mg/L) in mid-depth waters during mid-flood tide between 1 February and 31 May 2019 at CS(Mf)3(N) and CS(Mf)5.

(Weather condition varied between sunny to rainy within the reporting period.)
 WQM on 5 April and 1 May 2019 was cancelled due to site closure on holiday.
 In-situ monitoring is taken according to the requirement specified in the EM&A Manual, i.e. 3 water depth namely 1m below sea surface, mid-depth and 1m above sea bed. If the water depth is less than 3m, mid-depth sampling only. If water depth less than 6m, mid-depth may be omitted.

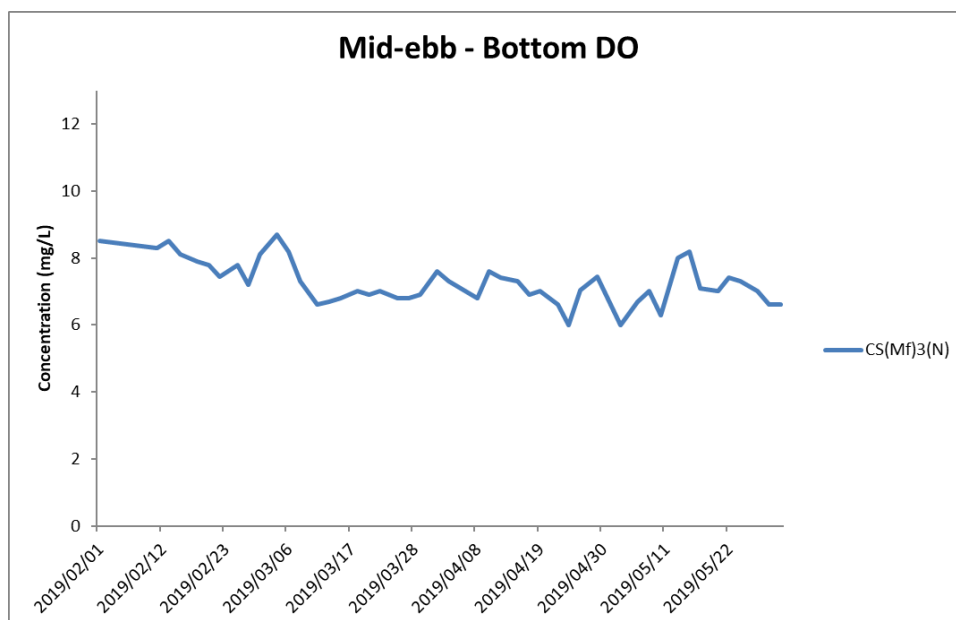
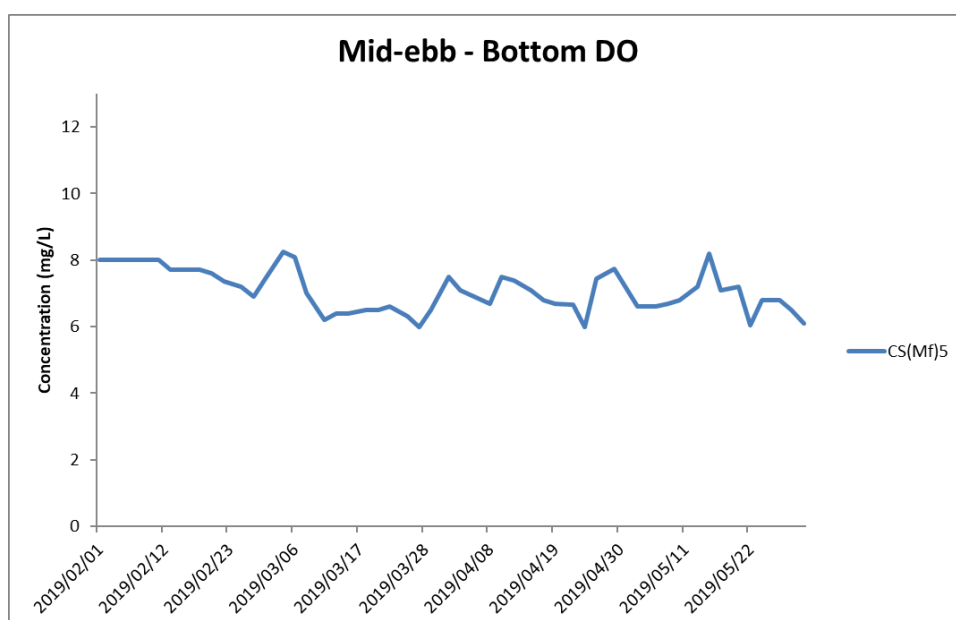
Figure H13 Impact Monitoring – Mean Level of Dissolved Oxygen (mg/L) in bottom waters during mid-ebb tide between 1 February and 31 May 2019 at CS(Mf)3(N) and CS(Mf)5.

(Weather condition varied between sunny to rainy within the reporting period.)
 WQM on 5 April and 1 May 2019 was cancelled due to site closure on holiday.
 In-situ monitoring is taken according to the requirement specified in the EM&A Manual, i.e. 3 water depth namely 1m below sea surface, mid-depth and 1m above sea bed. If the water depth is less than 3m, mid-depth sampling only. If water depth less than 6m, mid-depth may be omitted.

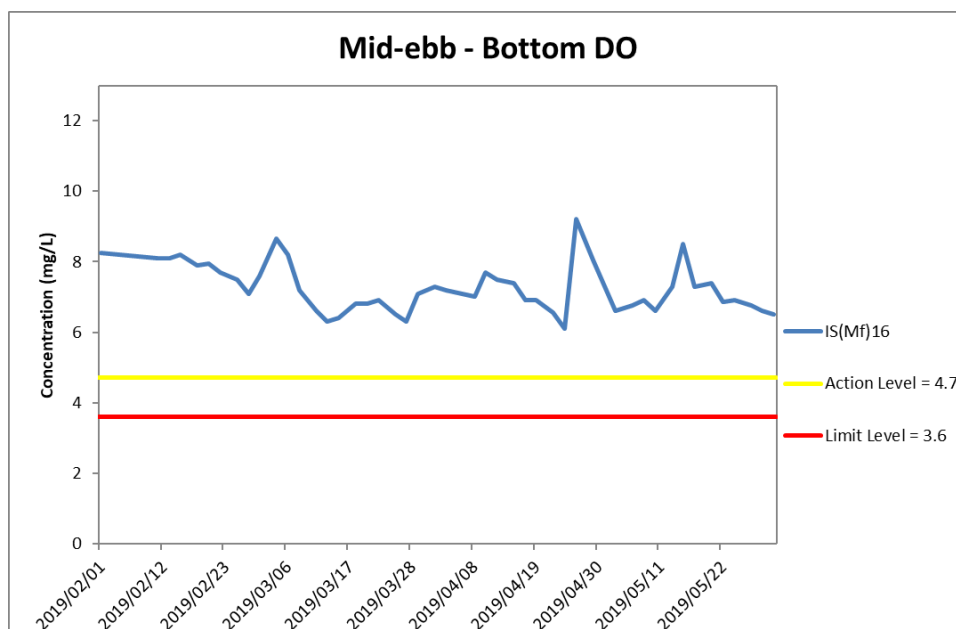
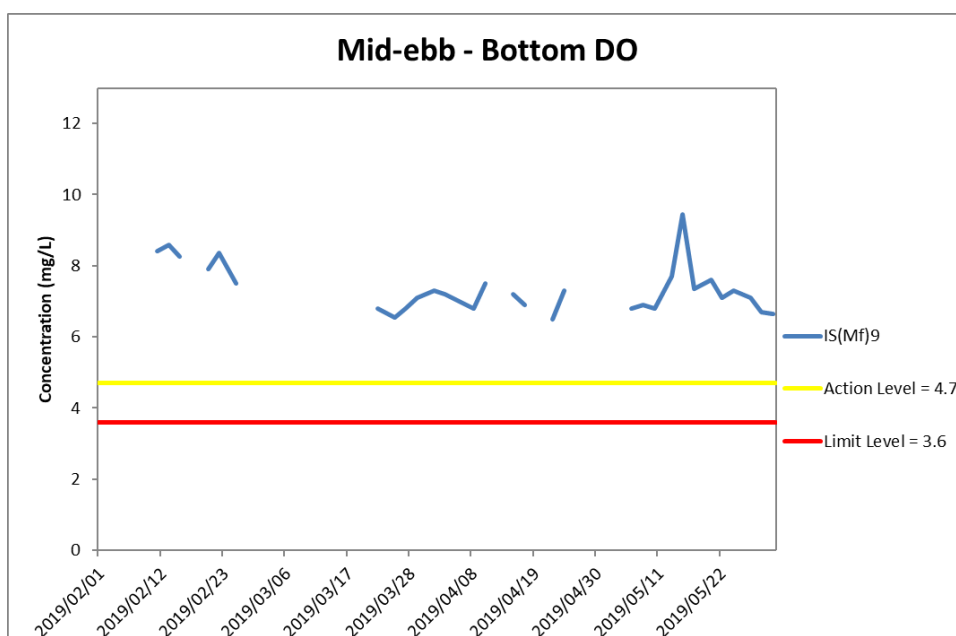
Figure H14 Impact Monitoring – Mean Level of Dissolved Oxygen (mg/L) in bottom waters during mid-ebb tide between 1 February and 31 May 2019 at IS(Mf)16 and IS(Mf)9.

(Weather condition varied between sunny to rainy within the reporting period.)
WQM on 5 April and 1 May 2019 was cancelled due to site closure on holiday.
In-situ monitoring is taken according to the requirement specified in the EM&A Manual, i.e. 3 water depth namely 1m below sea surface, mid-depth and 1m above sea bed. If the water depth is less than 3m, mid-depth sampling only. If water depth less than 6m, mid-depth may be omitted.

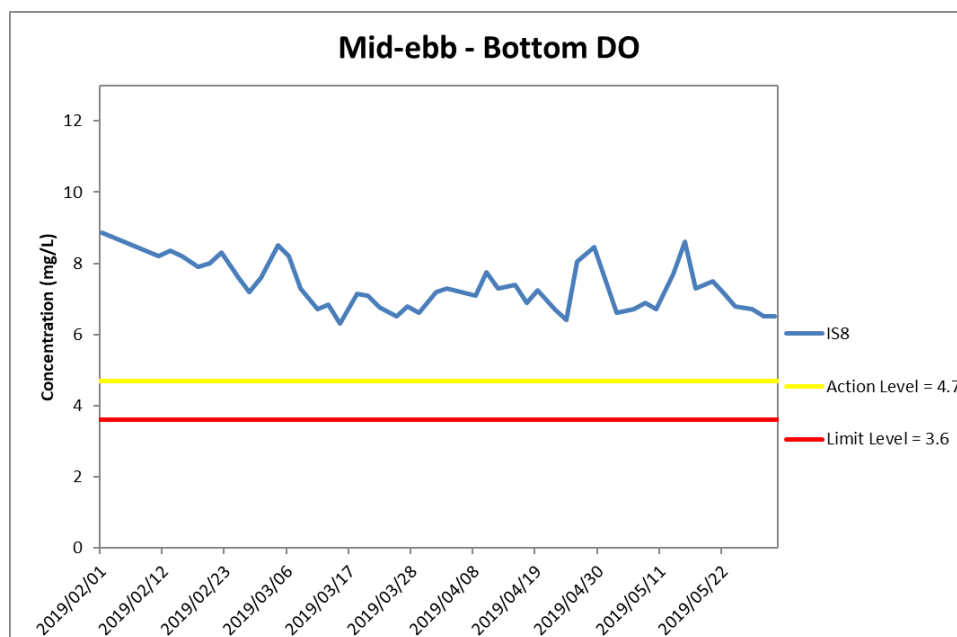
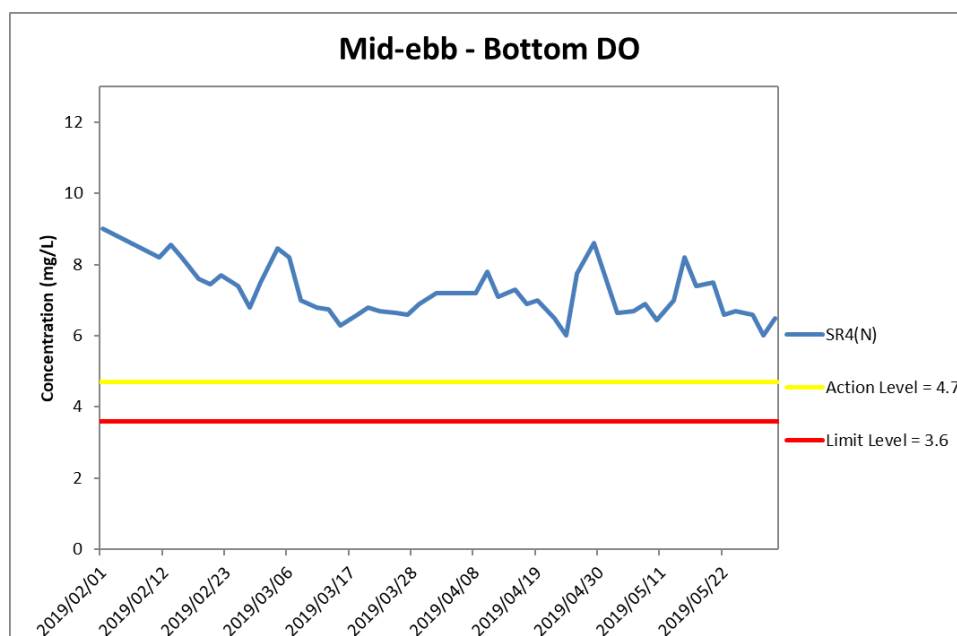
Figure H15 Impact Monitoring – Mean Level of Dissolved Oxygen (mg/L) in bottom waters during mid-ebb tide between 1 February and 31 May 2019 at IS8 and SR4(N).

(Weather condition varied between sunny to rainy within the reporting period.)
 WQM on 5 April and 1 May 2019 was cancelled due to site closure on holiday.
 In-situ monitoring is taken according to the requirement specified in the EM&A Manual, i.e. 3 water depth namely 1m below sea surface, mid-depth and 1m above sea bed. If the water depth is less than 3m, mid-depth sampling only. If water depth less than 6m, mid-depth may be omitted.

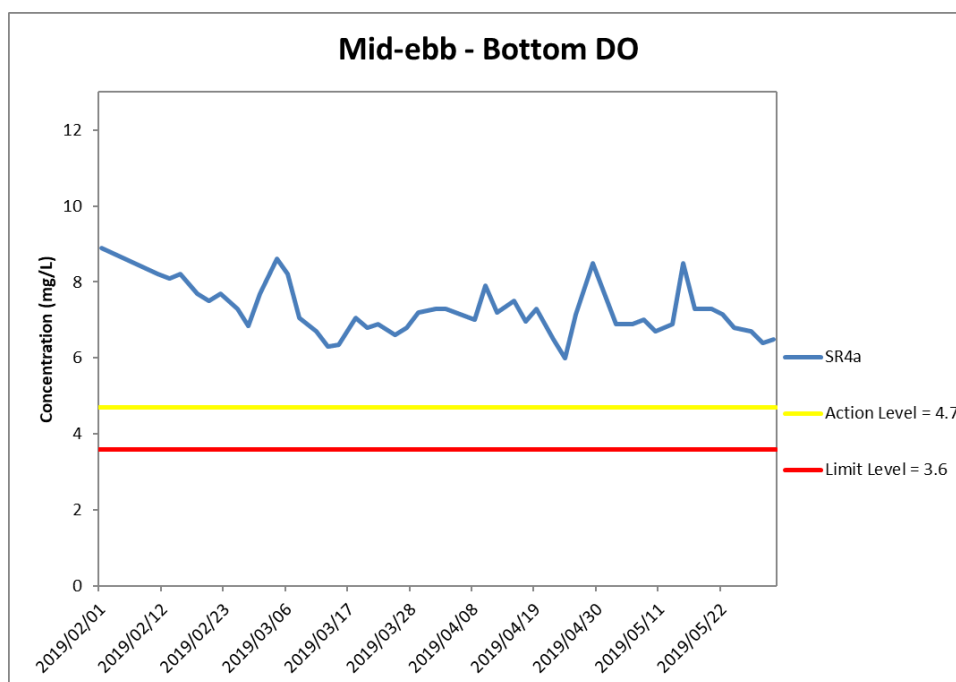
Figure H16 Impact Monitoring – Mean Level of Dissolved Oxygen (mg/L) in bottom waters during mid-ebb tide between 1 February and 31 May 2019 at SR4a.

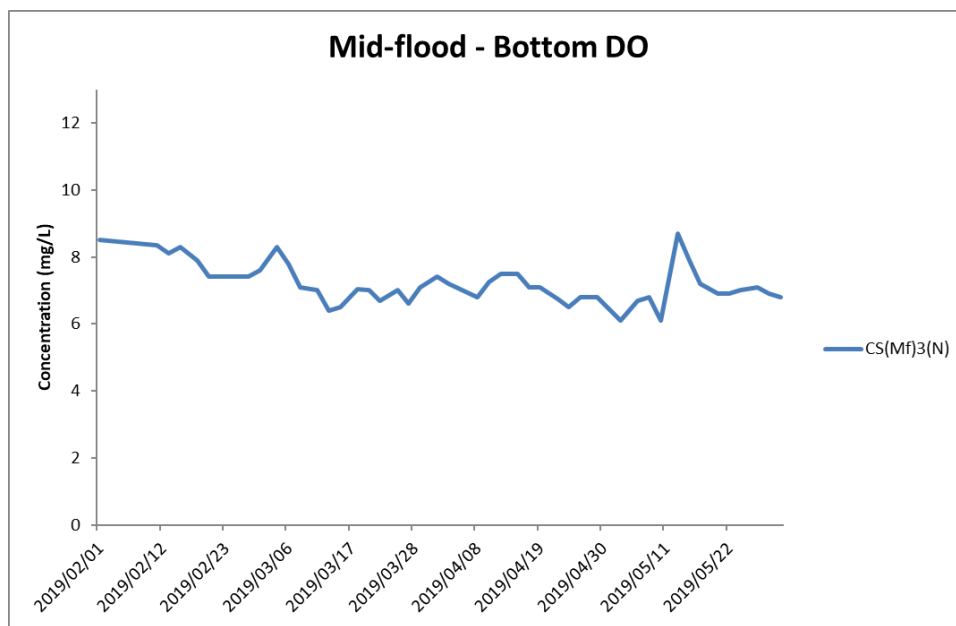
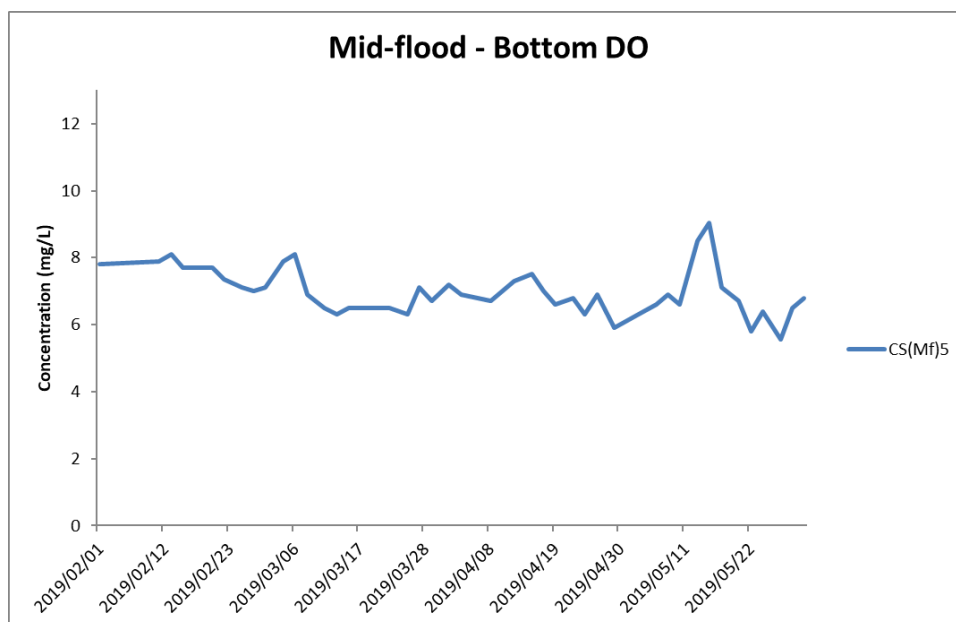
Figure H17 Impact Monitoring – Mean Level of Dissolved Oxygen (mg/L) in bottom waters during mid-flood tide between 1 February and 31 May 2019 at CS(Mf)3(N) and CS(Mf)5.
