**Contract No. HY/2012/07
Tuen Mun – Chek Lap Kok Link –
Southern Connection Viaduct Section**

***Twenty-second Quarterly Environmental
Monitoring & Audit (EM&A) Report***

30 September 2019

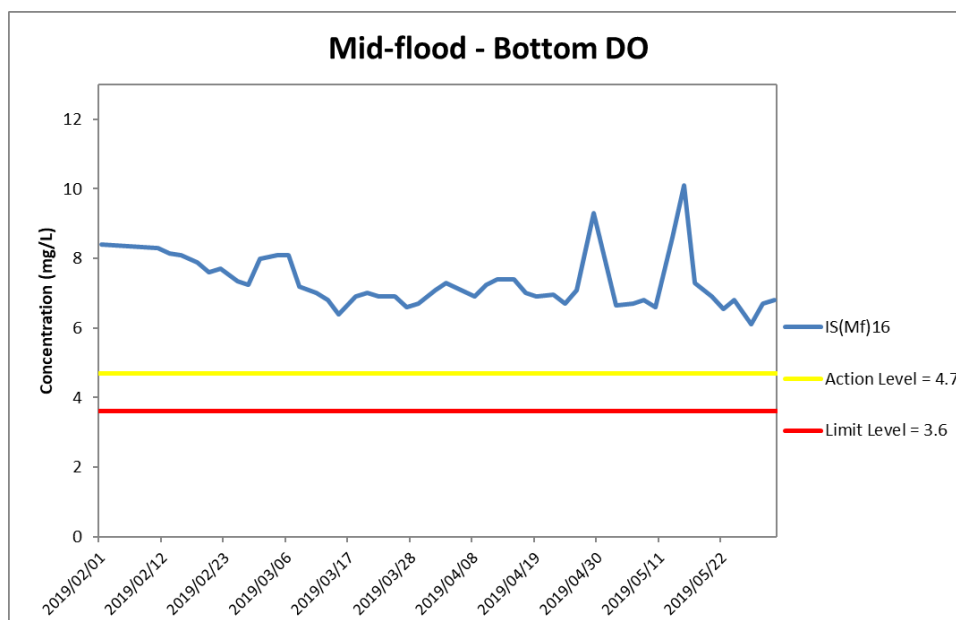
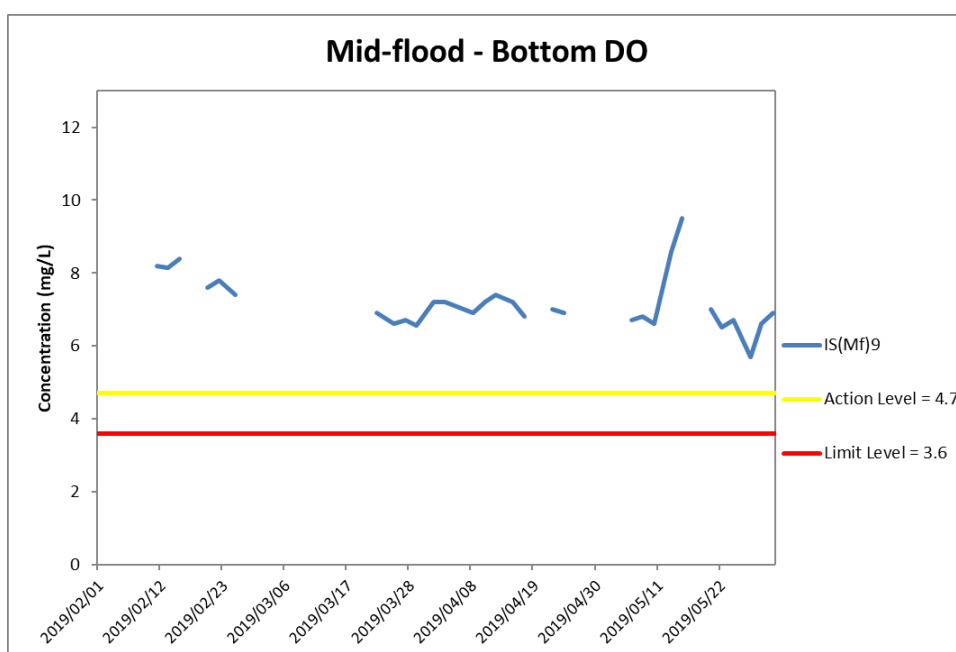
Figure H18 Impact Monitoring – Mean Level of Dissolved Oxygen (mg/L) in bottom waters during mid-flood tide between 1 February and 31 May 2019 at IS(Mf)16 and IS(Mf)9.

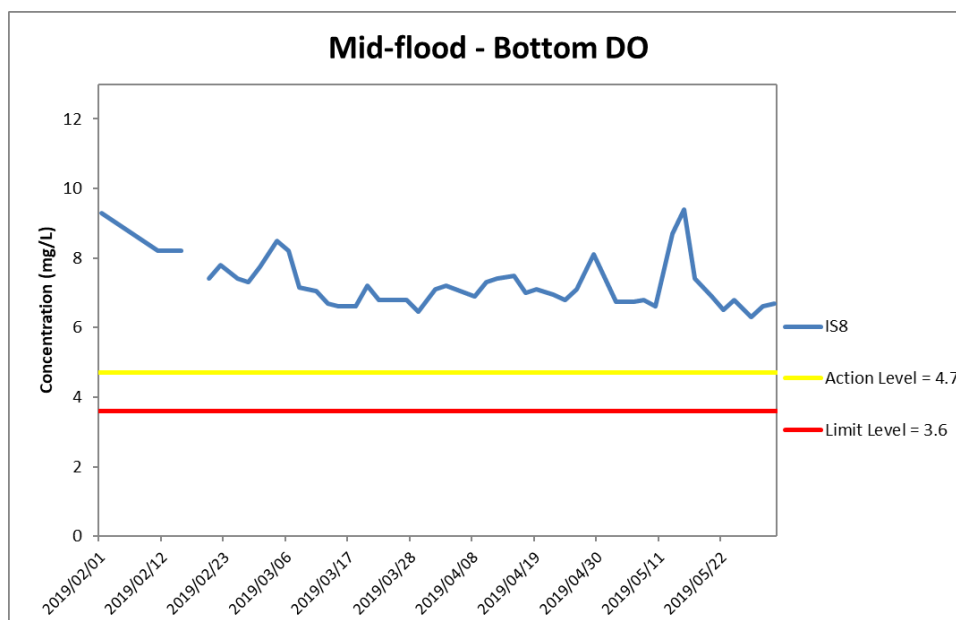
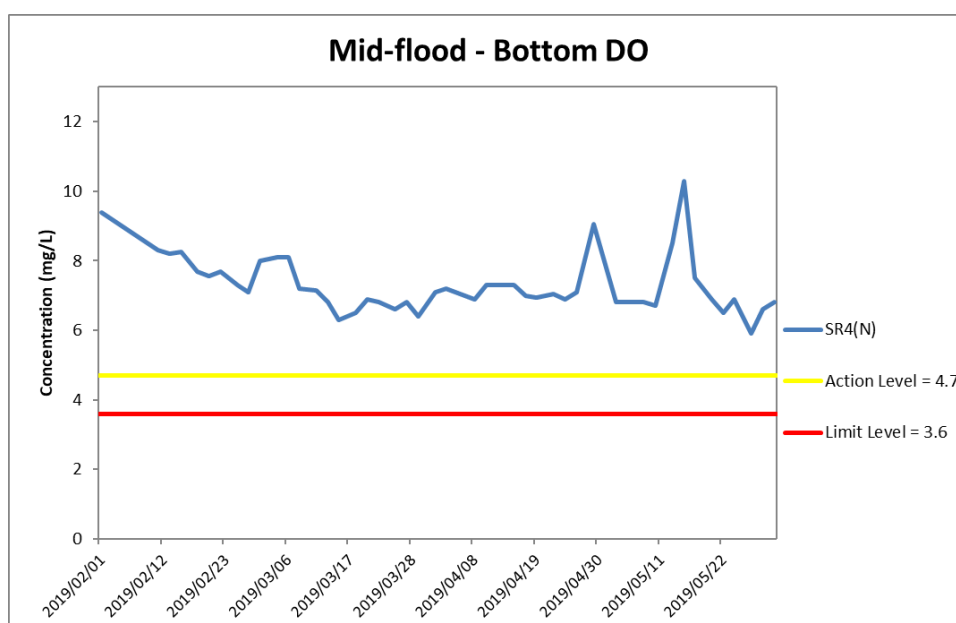
Figure H19 Impact Monitoring – Mean Level of Dissolved Oxygen (mg/L) in bottom waters during mid-flood tide between 1 February and 31 May 2019 at IS8 and SR4(N).

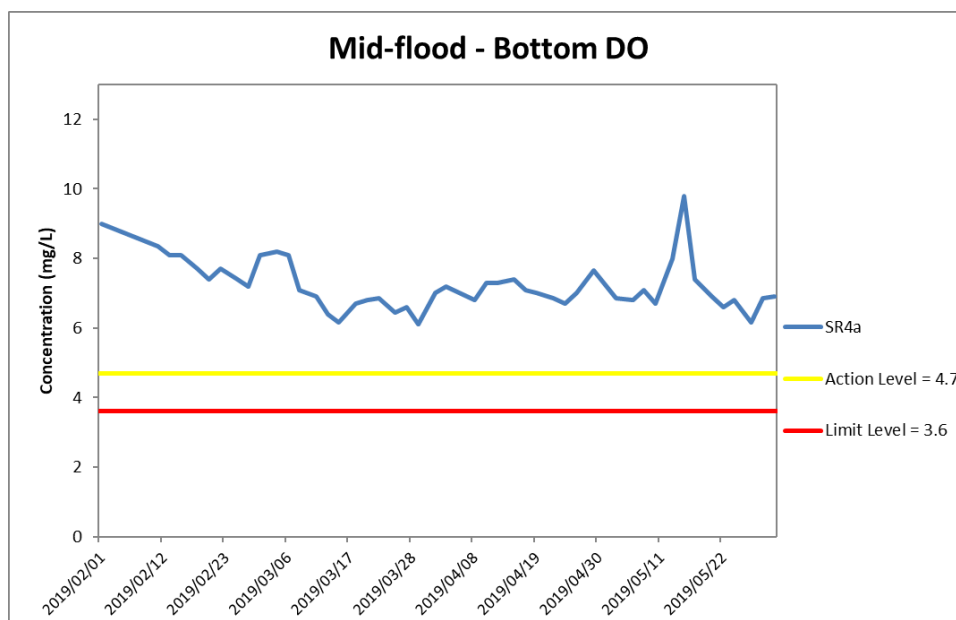
Figure H20 Impact Monitoring – Mean Level of Dissolved Oxygen (mg/L) in bottom waters during mid-flood tide between 1 February and 31 May 2019 at SR4a.

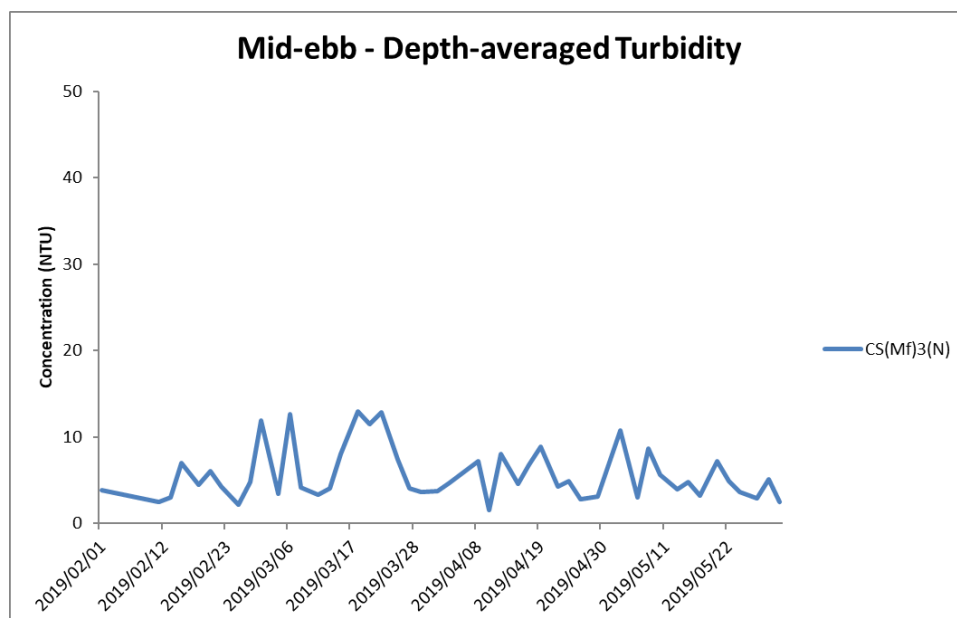
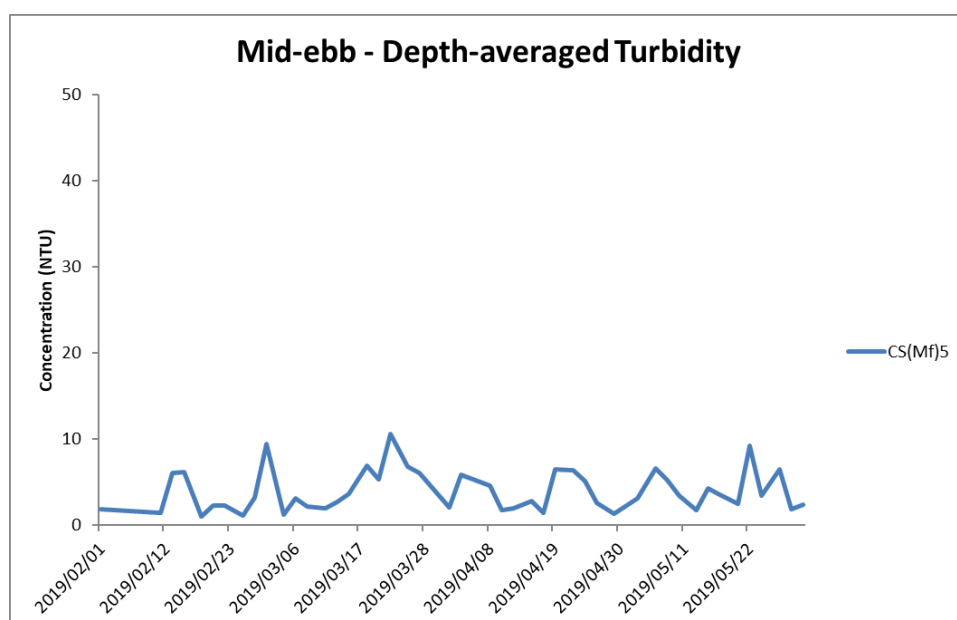
Figure H21 Impact Monitoring – Mean Level of depth-averaged Turbidity (NTU) during mid-ebb tide between 1 February and 31 May 2019 at CS(Mf)3(N) and CS(Mf)5.

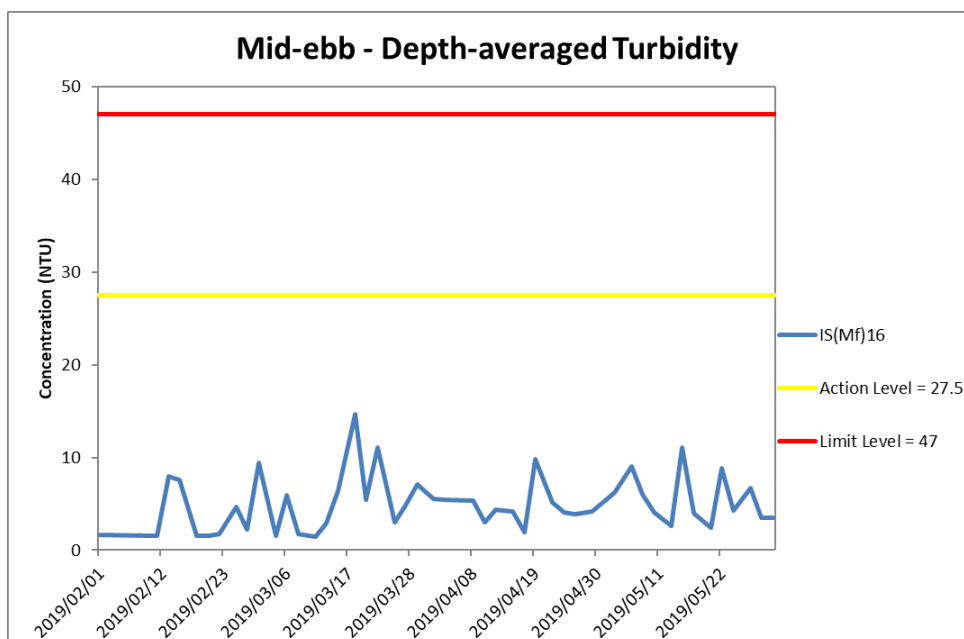
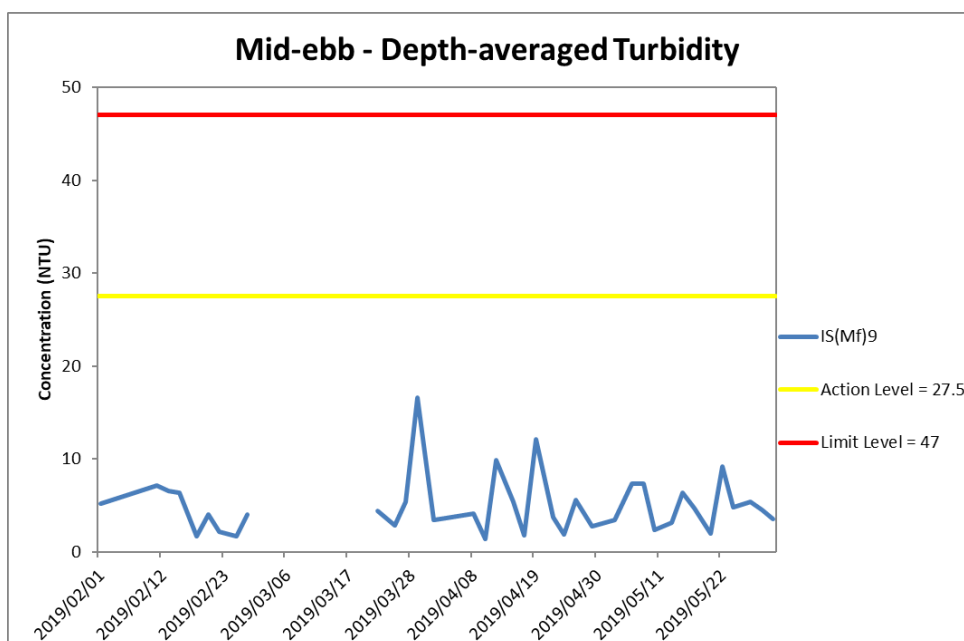
Figure H22 Impact Monitoring – Mean Level of depth-averaged Turbidity (NTU) during mid-ebb tide between 1 February and 31 May 2019 at IS(Mf)16 and IS(Mf)9.

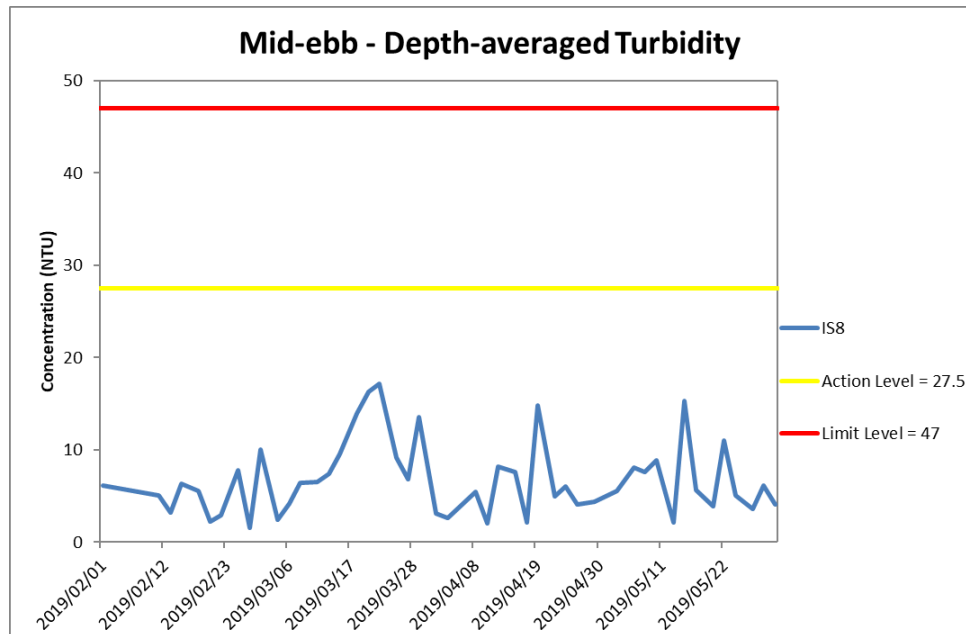
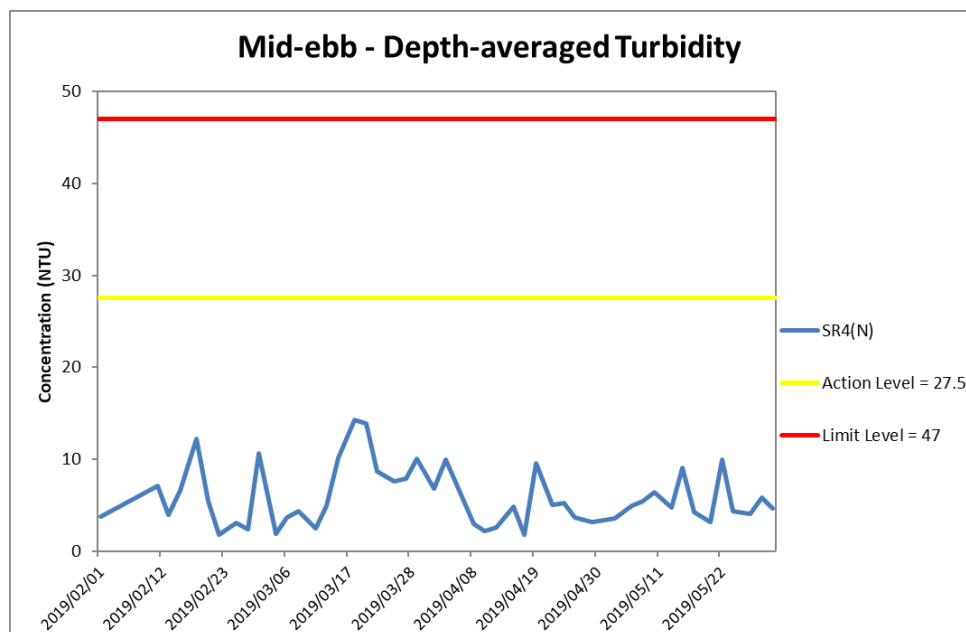
Figure H23 Impact Monitoring – Mean Level of depth-averaged Turbidity (NTU) during mid-ebb tide between 1 February and 31 May 2019 at IS8 and SR4(N).

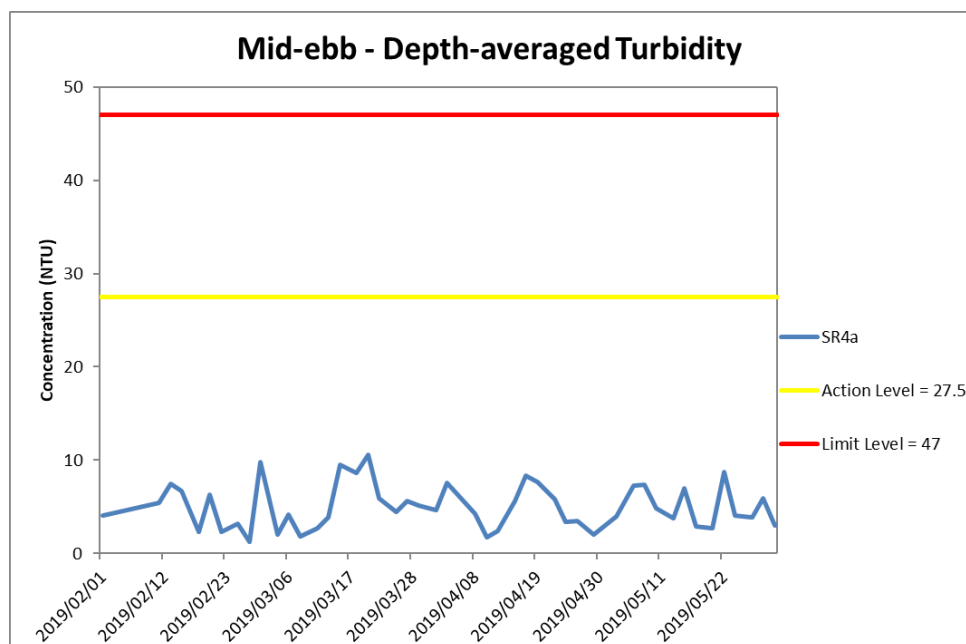
Figure H24 Impact Monitoring – Mean Level of depth-averaged Turbidity (NTU) during mid-ebb tide between 1 February and 31 May 2019 at SR4a.

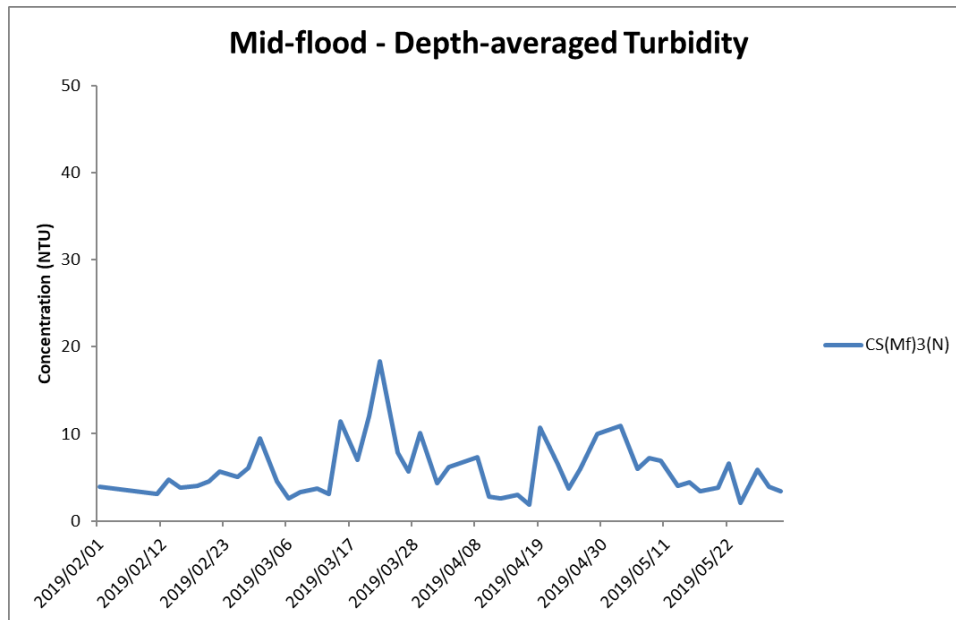
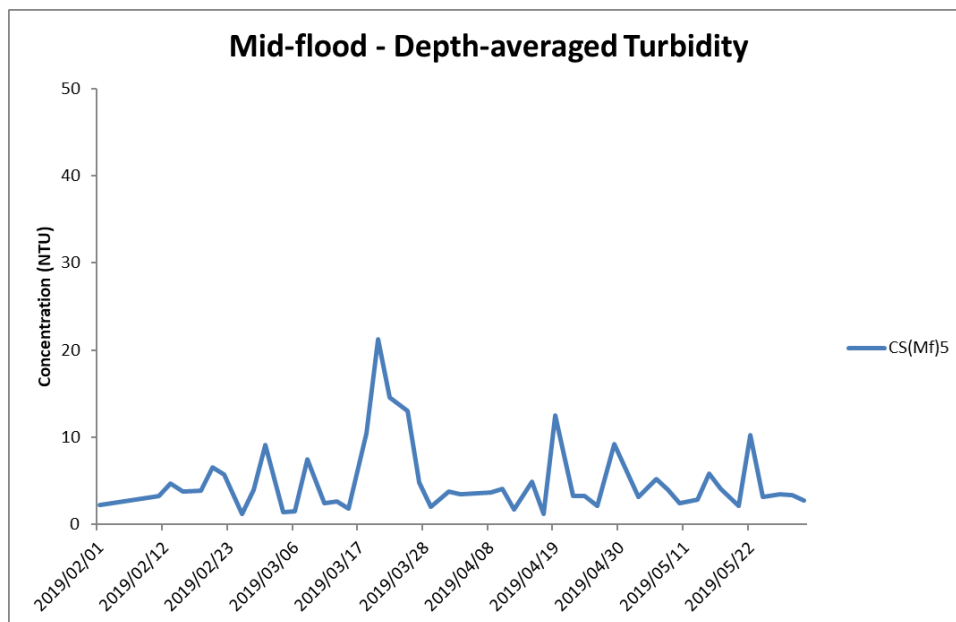
Figure H25 Impact Monitoring – Mean Level of depth-averaged Turbidity (NTU) during mid-flood tide between 1 February and 31 May 2019 at CS(Mf)3(N) and CS(MF)5.

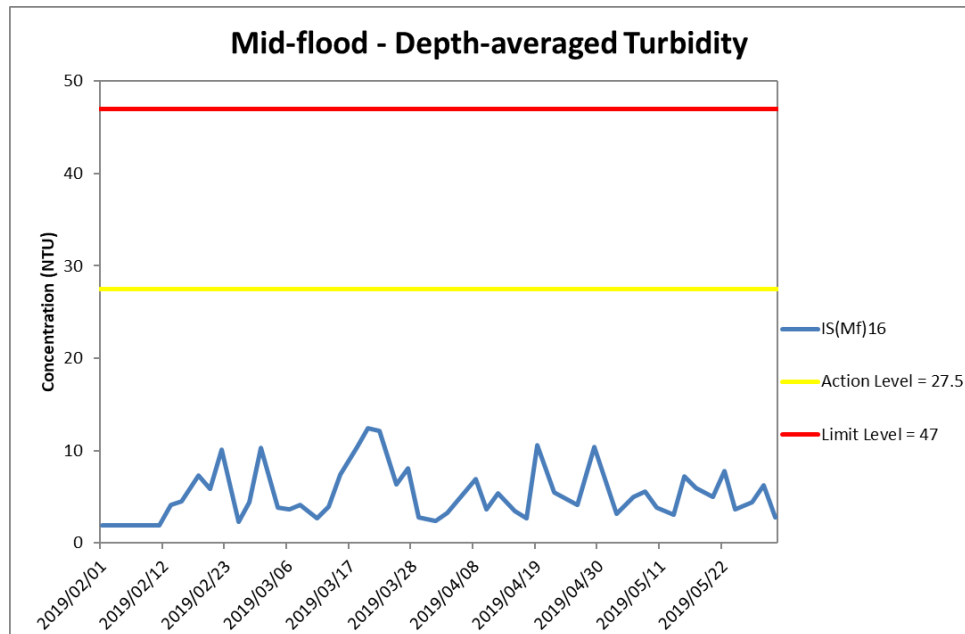
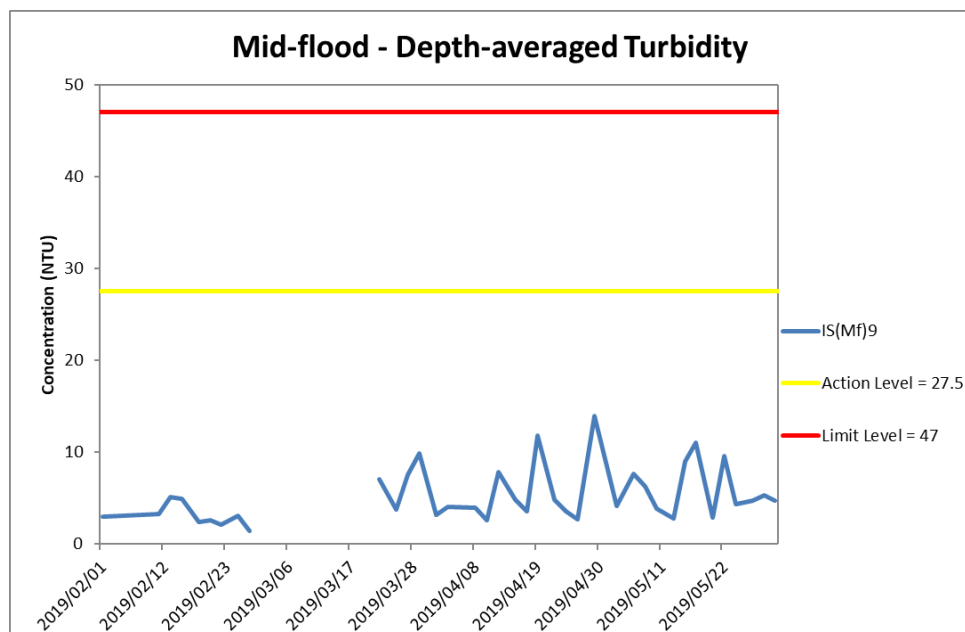
Figure H26 Impact Monitoring – Mean Level of depth-averaged Turbidity (NTU) during mid-flood tide between 1 February and 31 May 2019 at IS(Mf)16 and IS(Mf)9.

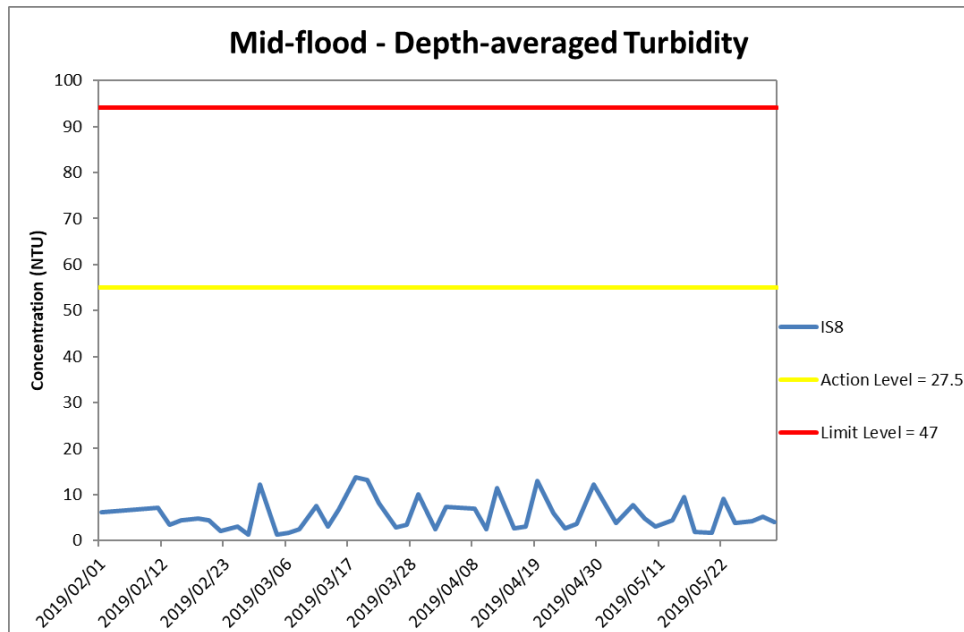
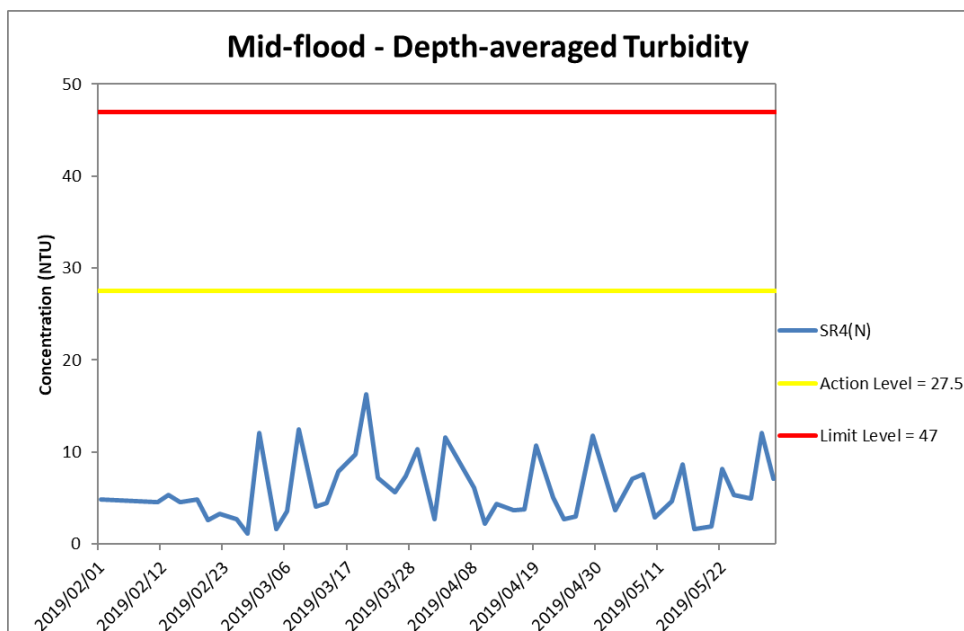
Figure H27 Impact Monitoring – Mean Level of depth-averaged Turbidity (NTU) during mid-flood tide between 1 February and 31 May 2019 at IS8 and SR4(N).

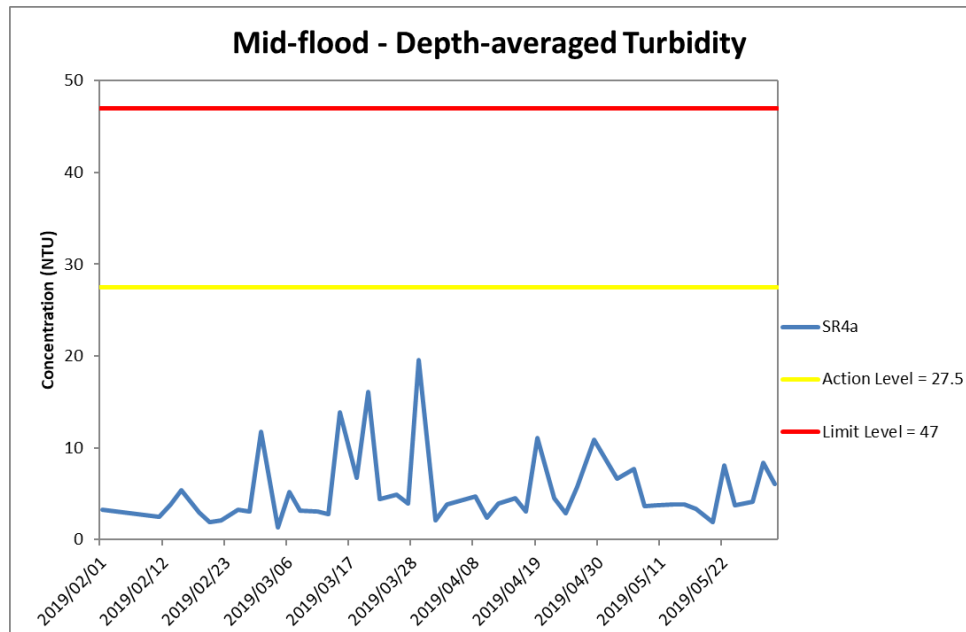
Figure H28 Impact Monitoring – Mean Level of depth-averaged Turbidity (NTU) during mid-flood tide between 1 February and 31 May 2019 at SR4a.

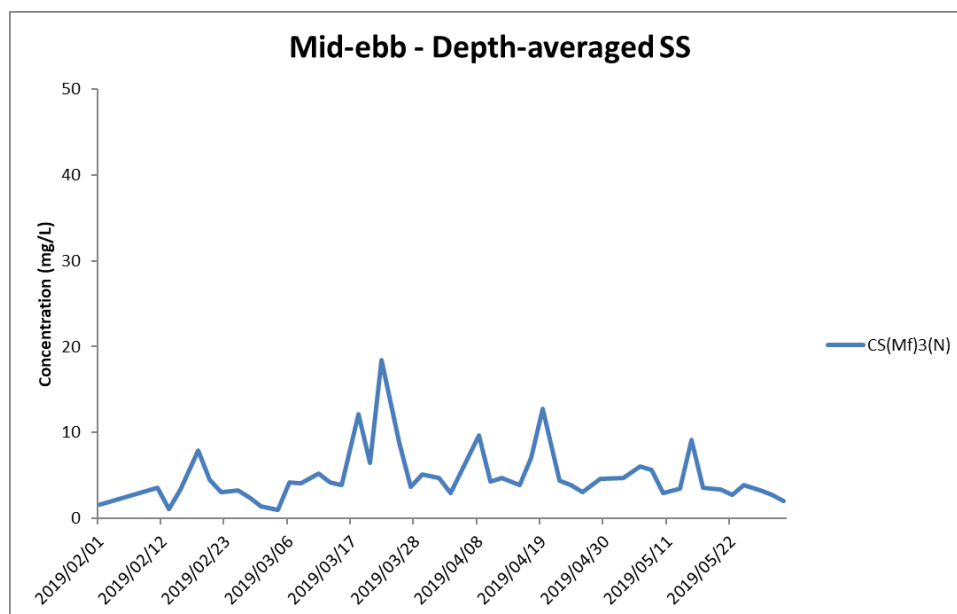
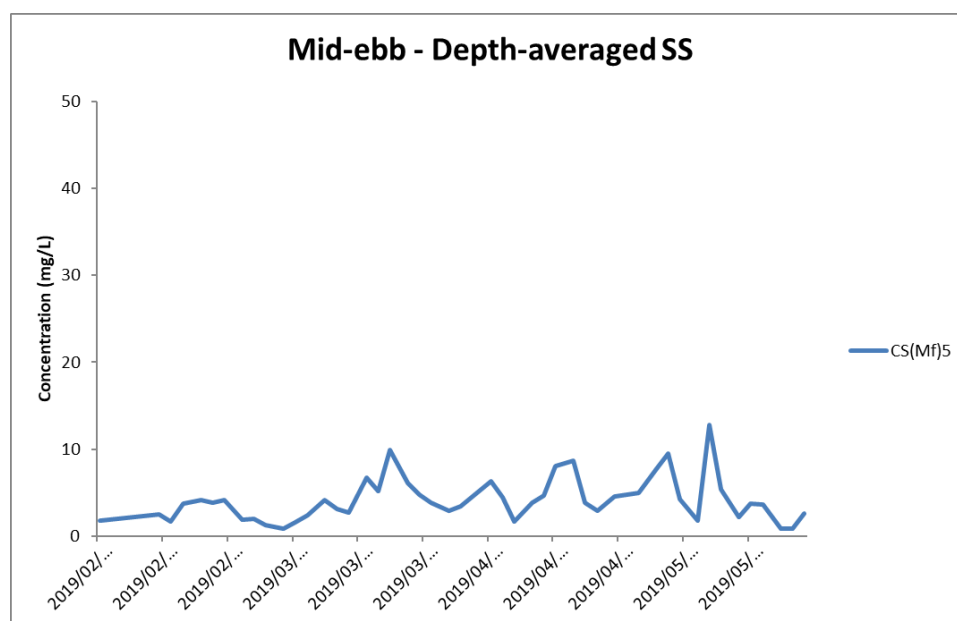
Figure H29 Impact Monitoring – Mean depth-averaged level of Suspended Solids (mg/L) during mid-ebb tide between 1 February and 31 May 2019 at CS(Mf)3(N) and CS(Mf)5.

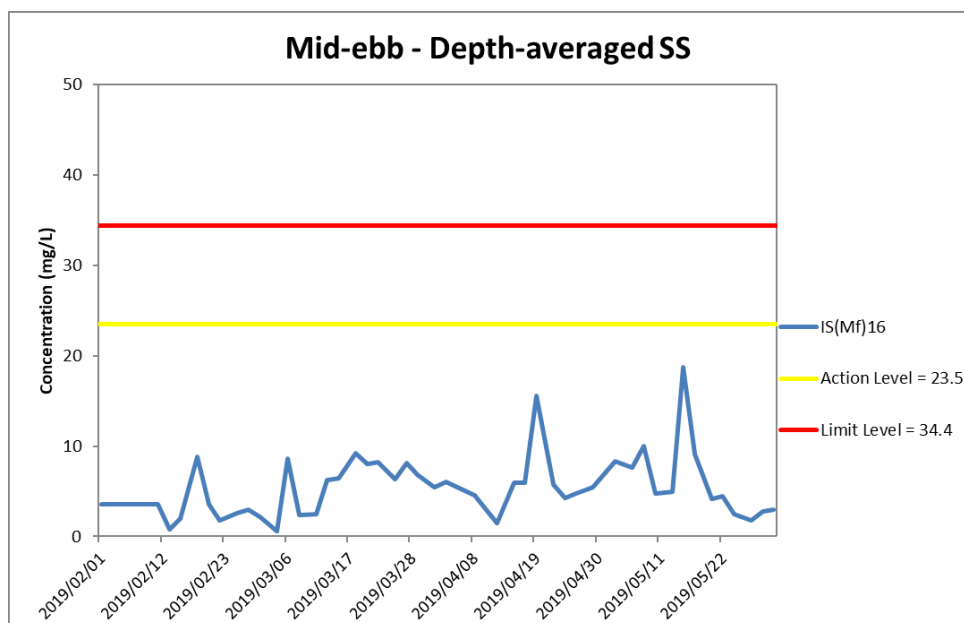
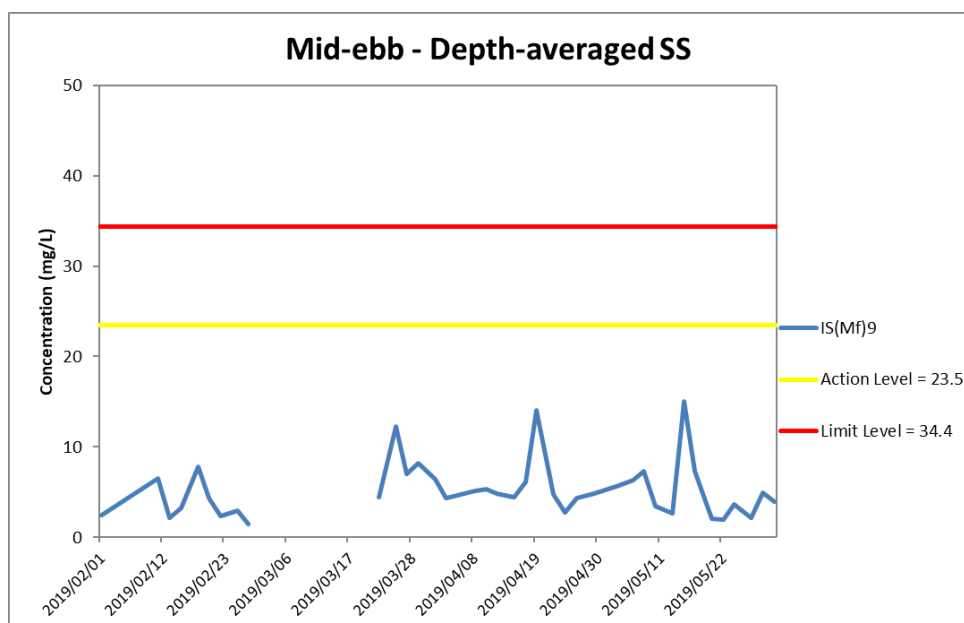
Figure H30 Impact Monitoring – Mean depth-averaged level of Suspended Solids (mg/L) during mid-ebb tide between 1 February and 31 May 2019 at IS(Mf)16 and IS(Mf)9.

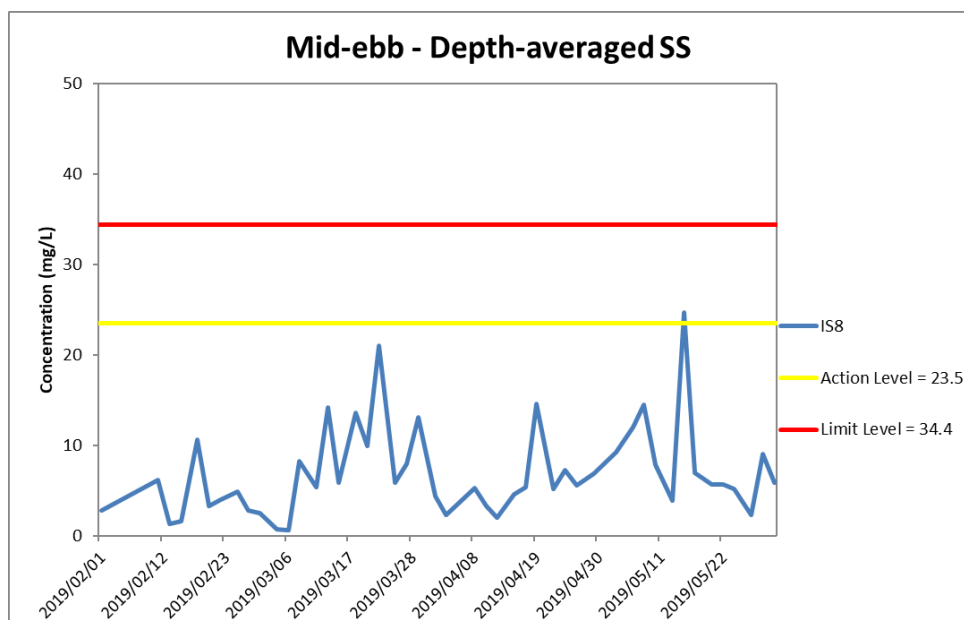
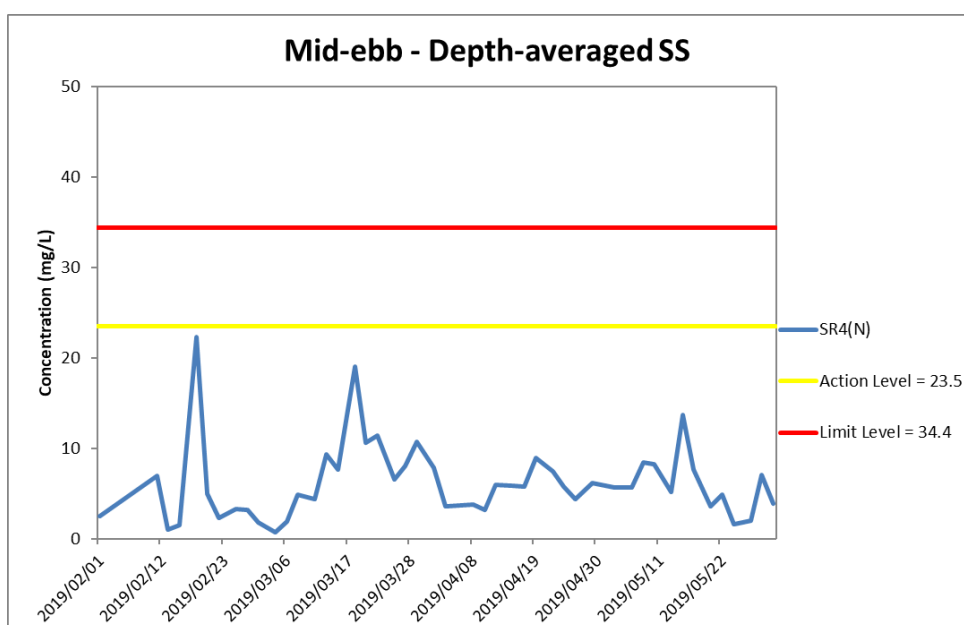
Figure H31 Impact Monitoring – Mean depth-averaged level of Suspended Solids (mg/L) during mid-ebb tide between 1 February and 31 May 2019 at IS8 and SR4(N).

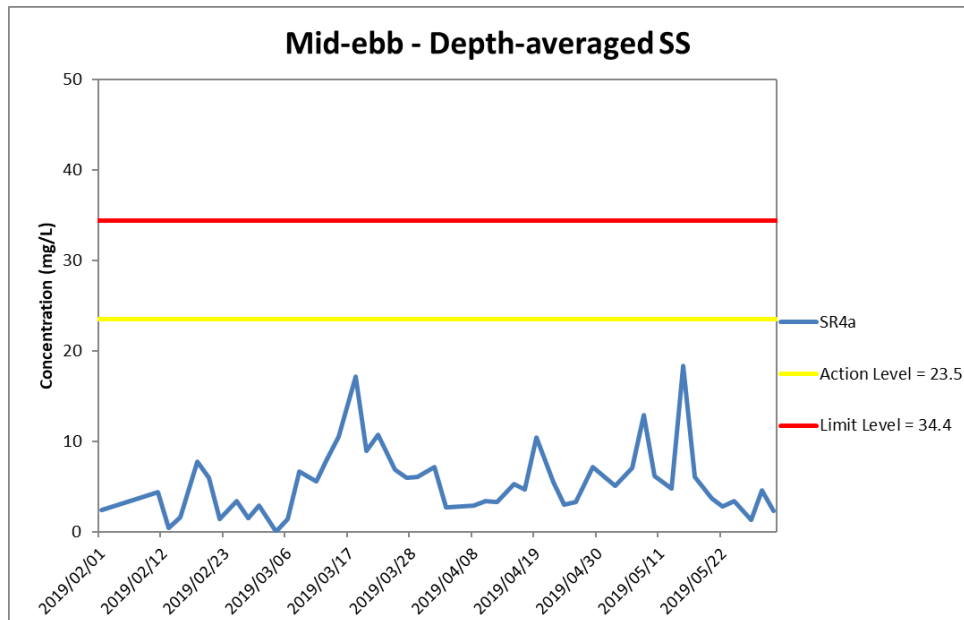
Figure H32 Impact Monitoring – Mean depth-averaged level of Suspended Solids (mg/L) during mid-ebb tide between 1 February and 31 May 2019 at SR4a.

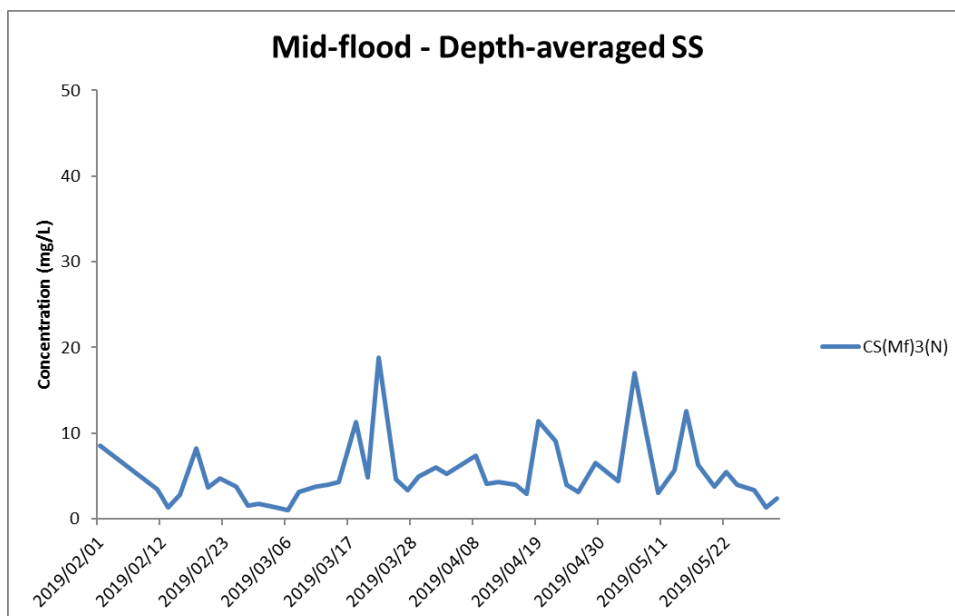
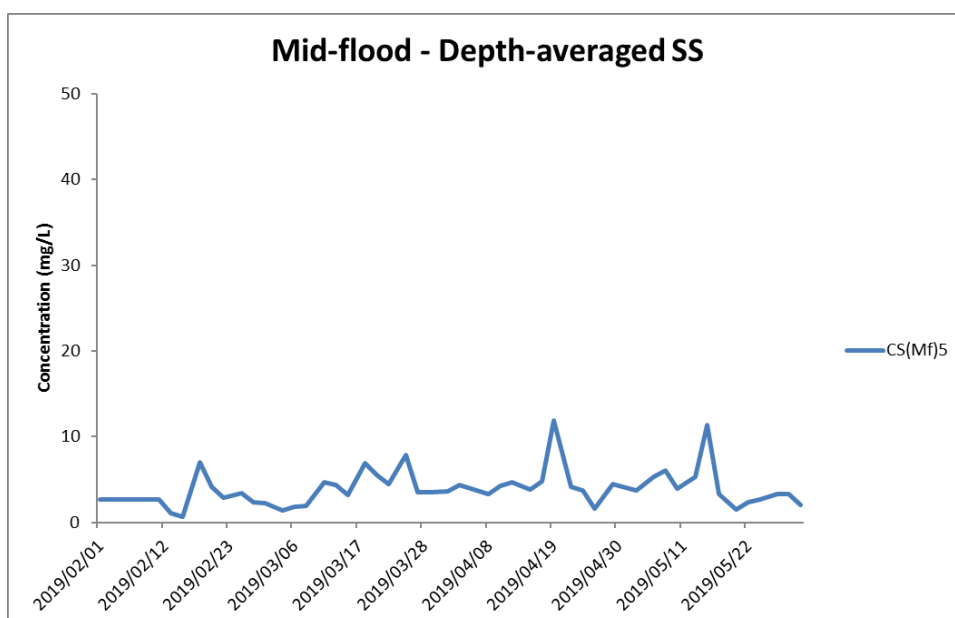
Figure H33 Impact Monitoring – Mean depth-averaged level of Suspended Solids (mg/L) during mid-flood tide between 1 February and 31 May 2019 at CS(Mf)3(N) and CS(Mf)5.

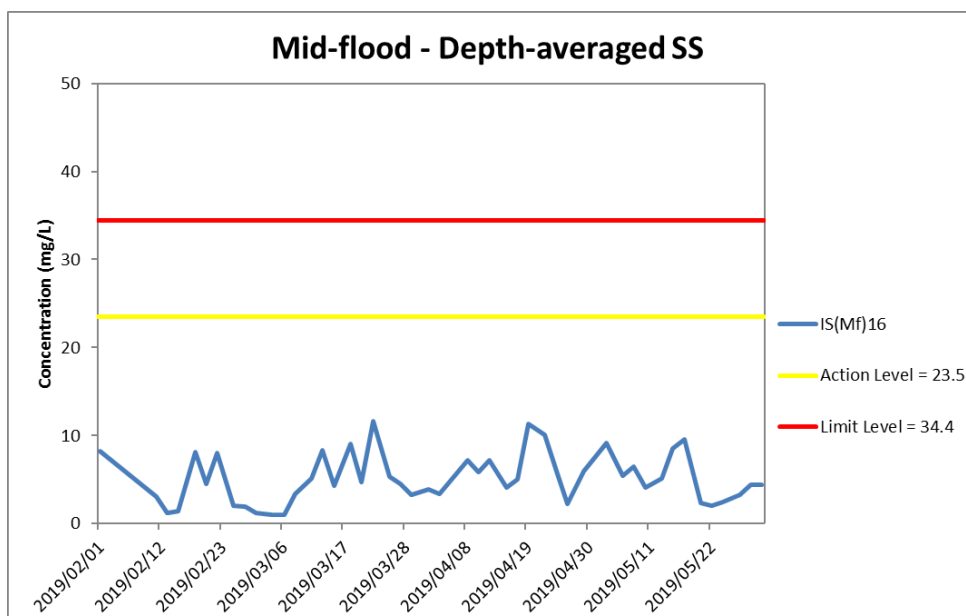
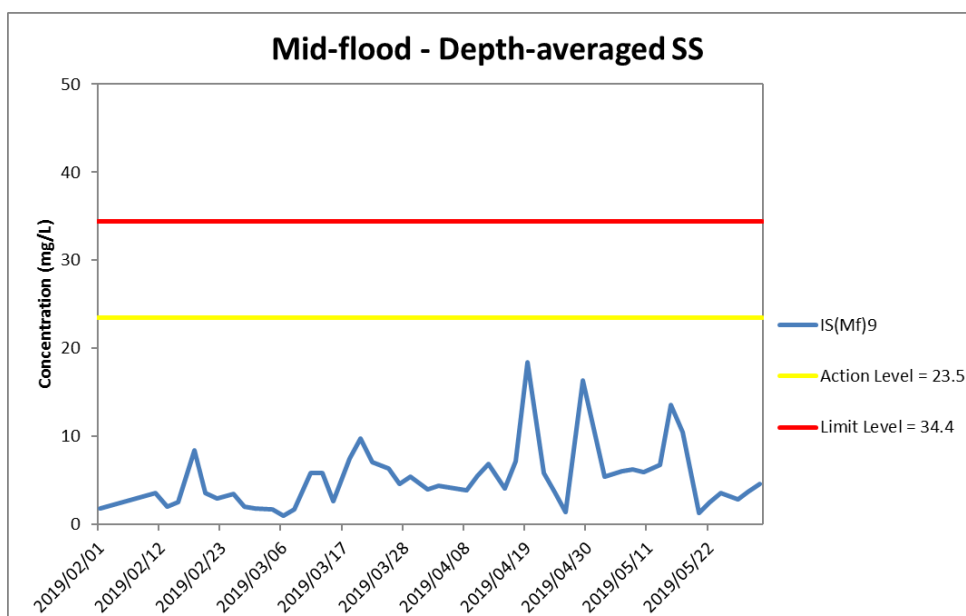
Figure H34 Impact Monitoring – Mean depth-averaged level of Suspended Solids (mg/L) during mid-flood tide between 1 February and 31 May 2019 at IS(Mf)16 and IS(Mf)9.

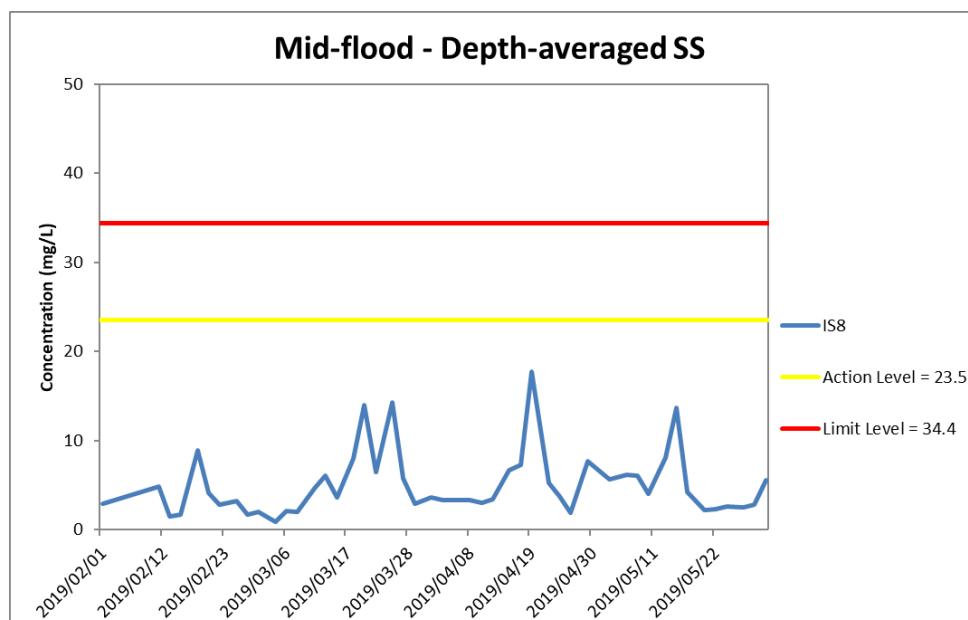
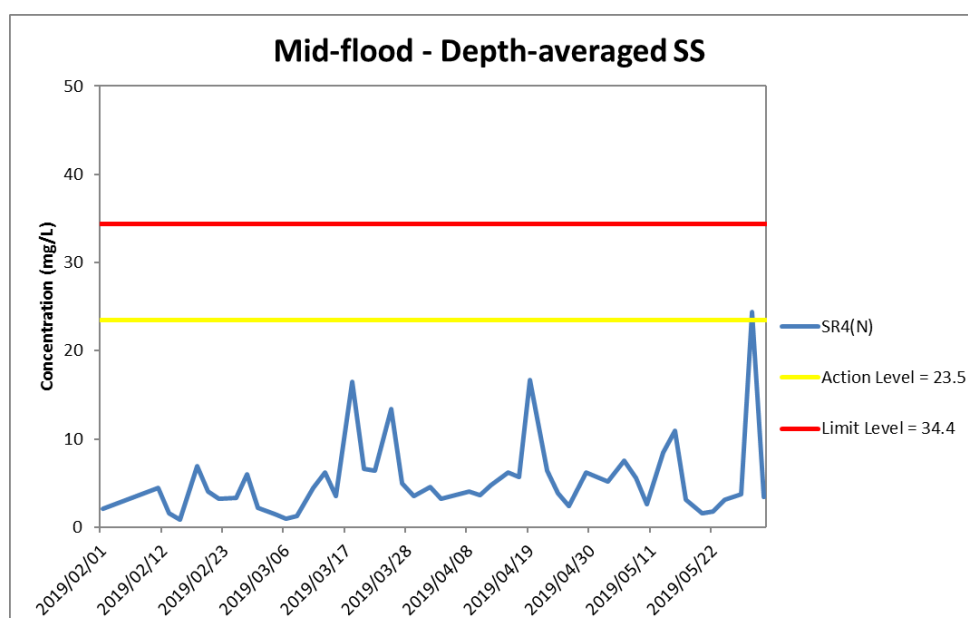
Figure H35 Impact Monitoring – Mean depth-averaged level of Suspended Solids (mg/L) during mid-flood tide between 1 February and 31 May 2019 at IS8 and SR4(N).

(Weather condition varied between sunny to rainy within the reporting period.)

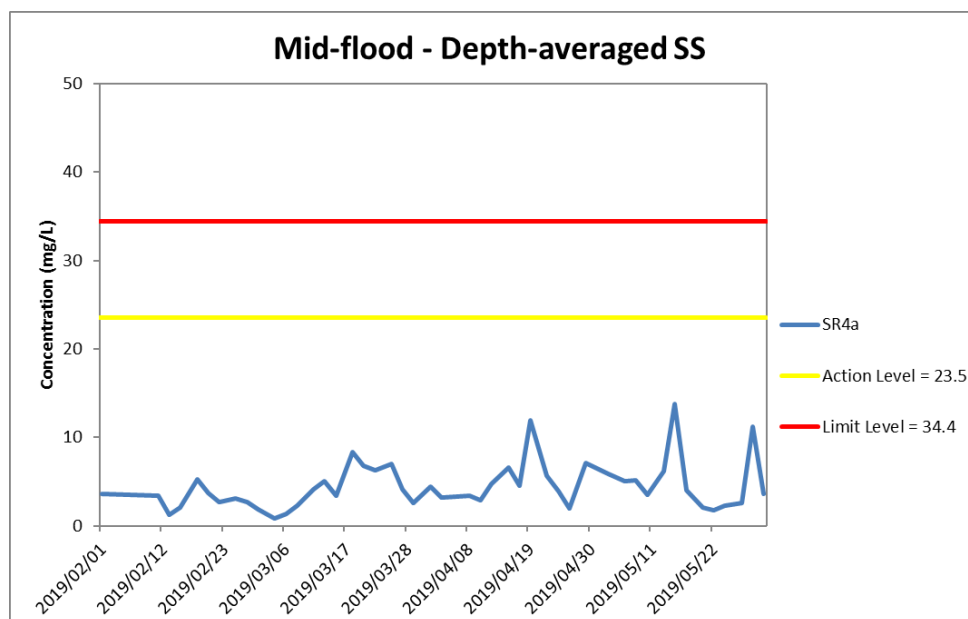
Figure H36 Impact Monitoring – Mean depth-averaged level of Suspended Solids (mg/L) during mid-flood tide between 1 February and 31 May 2019 at SR4a.
