**Contract No. HY/2012/07
Tuen Mun – Chek Lap Kok Link –
Southern Connection Viaduct Section**

***Fourth Quarterly Post-Translocation Coral
Monitoring Report***

10 November 2014

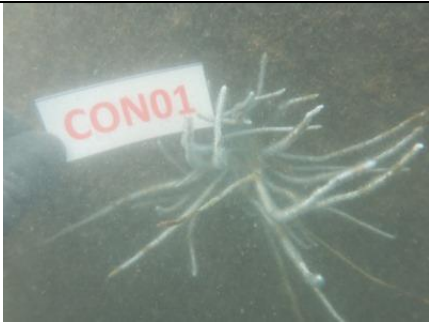
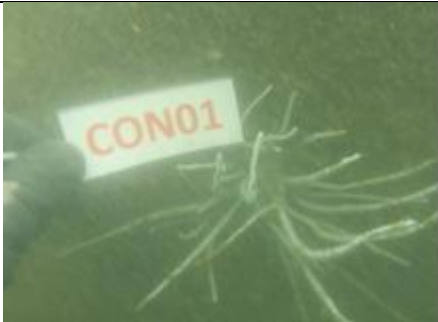
Coral #	Pre-Translocation Monitoring	4 th Quarterly Post-Translocation Monitoring
1

*Photographic Records of Tagged Natural Coral Colonies at Receptor Site,
Yam Tsui Wan*

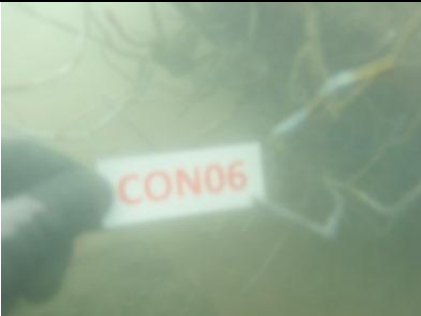
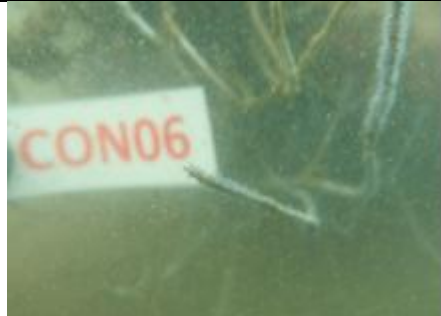
Coral #	Pre-Translocation Monitoring	4 th Quarterly Post-Translocation Monitoring
6

An underwater photograph showing a diver's gloved hand holding a white tag with the red text 'CON06'. The tag is positioned next to a piece of light-colored, branching coral against a dark, murky background.

An underwater photograph showing a white tag with the red text 'CON06' attached to a piece of coral. The coral appears slightly more settled or in a different orientation compared to the pre-translocation photo.
7

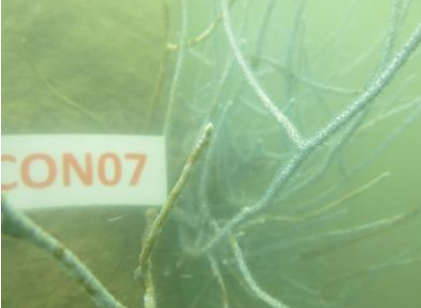
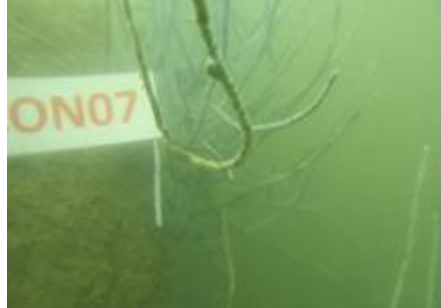
An underwater photograph of a diver's gloved hand holding a white tag labeled 'CON07' next to a branching coral specimen.

An underwater photograph showing the 'CON07' tag attached to the coral, with the coral's branching structure clearly visible.
8

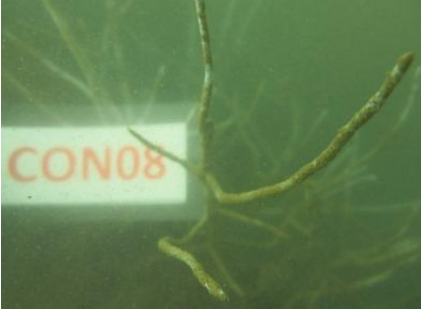
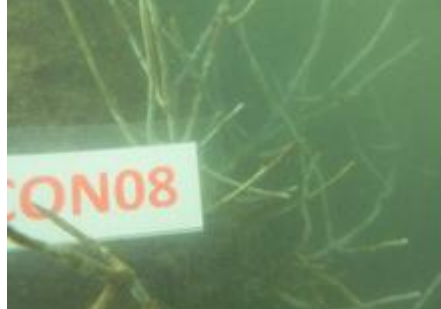
An underwater photograph of a diver's gloved hand holding a white tag labeled 'CON08' next to a coral specimen.

An underwater photograph showing the 'CON08' tag attached to the coral, with the coral's branching structure clearly visible.

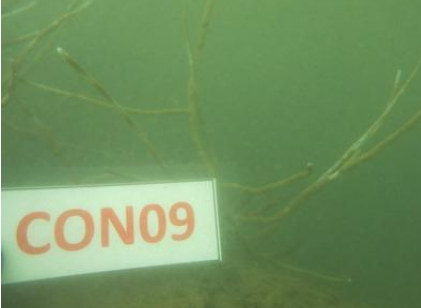
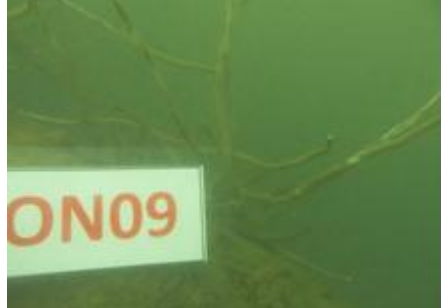
9

An underwater photograph of a diver's gloved hand holding a white tag labeled 'CON09' next to a coral specimen.

An underwater photograph showing the 'CON09' tag attached to the coral, with the coral's branching structure clearly visible.
10

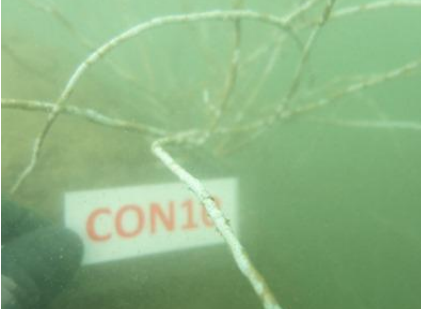
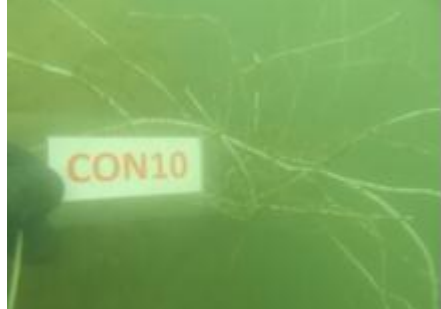
An underwater photograph of a diver's gloved hand holding a white tag labeled 'CON10' next to a coral specimen.

An underwater photograph showing the 'CON10' tag attached to the coral, with the coral's branching structure clearly visible.
