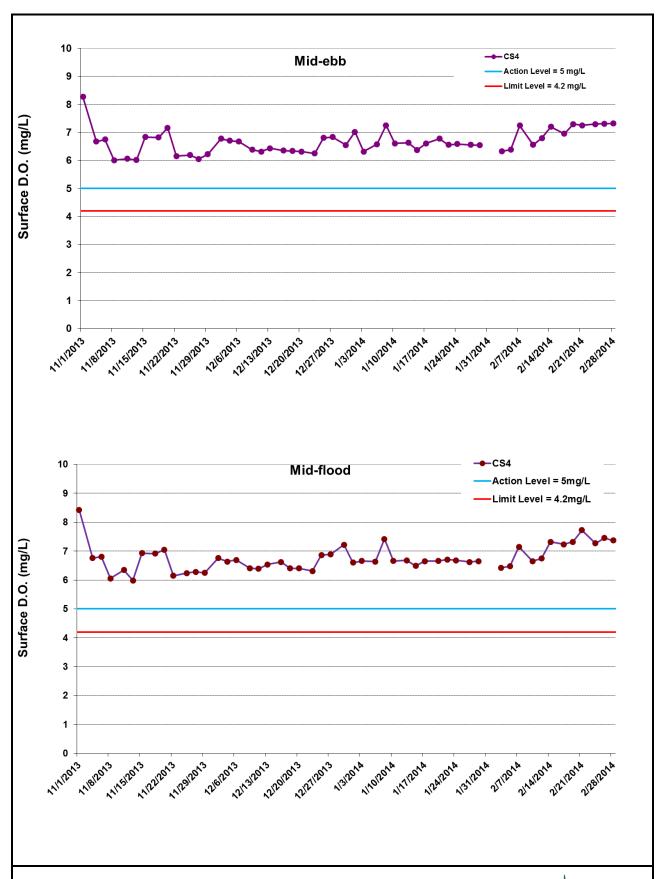
Figure H1 Impact Monitoring – Mean Level of Dissolved Oxygen (mg/L) in surface waters between 1 November 2013 and 28 February 2014 at CS4. The weather conditions during the monitoring period varied mostly from sunny to cloudy. Major marine construction activities: Dredging (11/1/2013 – 2/28/2014, except 1/31/2014); Construction of Temporary Seawalls (11/18/2013 – 2/28/2014); Sheet Piling (1/10/2014 – 2/28/2014).

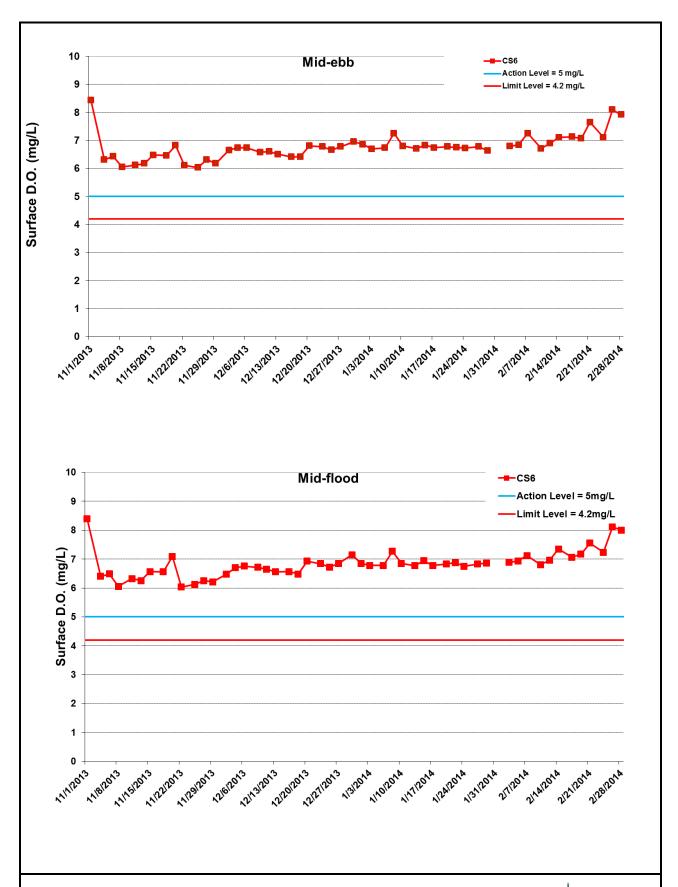
Figure H2 Impact Monitoring – Mean Level of Dissolved Oxygen (mg/L) in surface waters between 1 November 2013 and 28 February 2014 at CS6. The weather conditions during the monitoring period varied mostly from sunny to cloudy. Major marine construction activities: Dredging (11/1/2013 – 2/28/2014, except 1/31/2014); Construction of Temporary Seawalls (11/18/2013 – 2/28/2014); Sheet Piling (1/10/2014 – 2/28/2014).

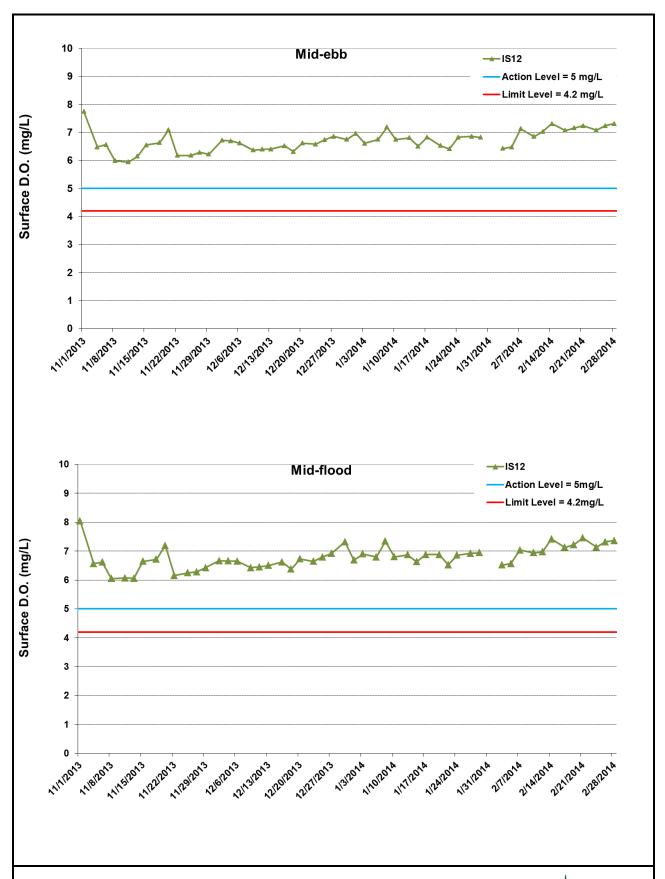
Figure H3 Impact Monitoring – Mean Level of Dissolved Oxygen (mg/L) in surface waters between 1 November 2013 and 28 February 2014 at IS12. The weather conditions during the monitoring period varied mostly from sunny to cloudy. Major marine construction activities: Dredging (11/1/2013 – 2/28/2014, except 1/31/2014); Construction of Temporary Seawalls (11/18/2013 – 2/28/2014); Sheet Piling (1/10/2014 – 2/28/2014).

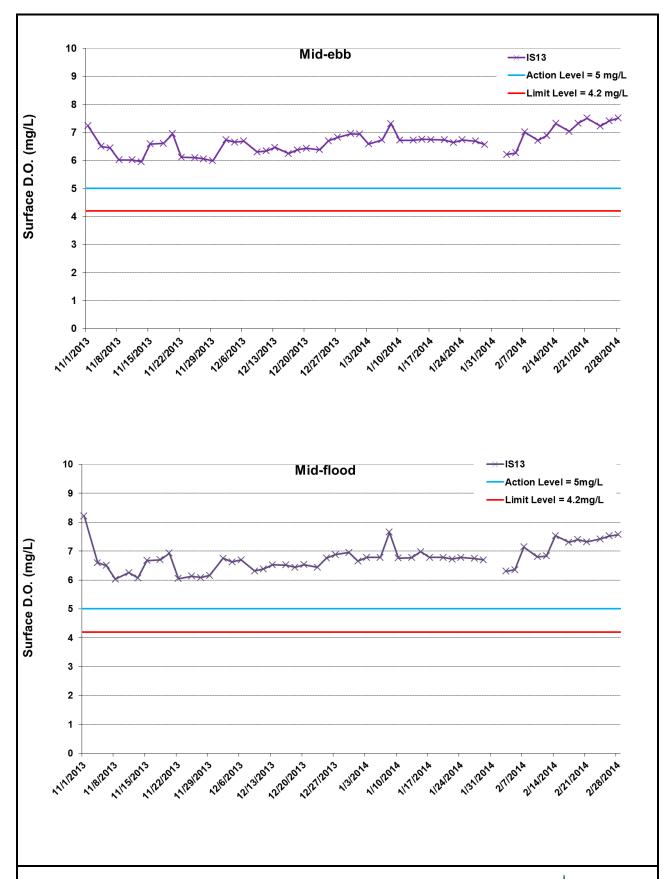
Figure H4 Impact Monitoring – Mean Level of Dissolved Oxygen (mg/L) in surface waters between 1 November 2013 and 28 February 2014 at IS13. The weather conditions during the monitoring period varied mostly from sunny to cloudy. Major marine construction activities: Dredging (11/1/2013 – 2/28/2014, except 1/31/2014); Construction of Temporary Seawalls (11/18/2013 – 2/28/2014); Sheet Piling (1/10/2014 – 2/28/2014).

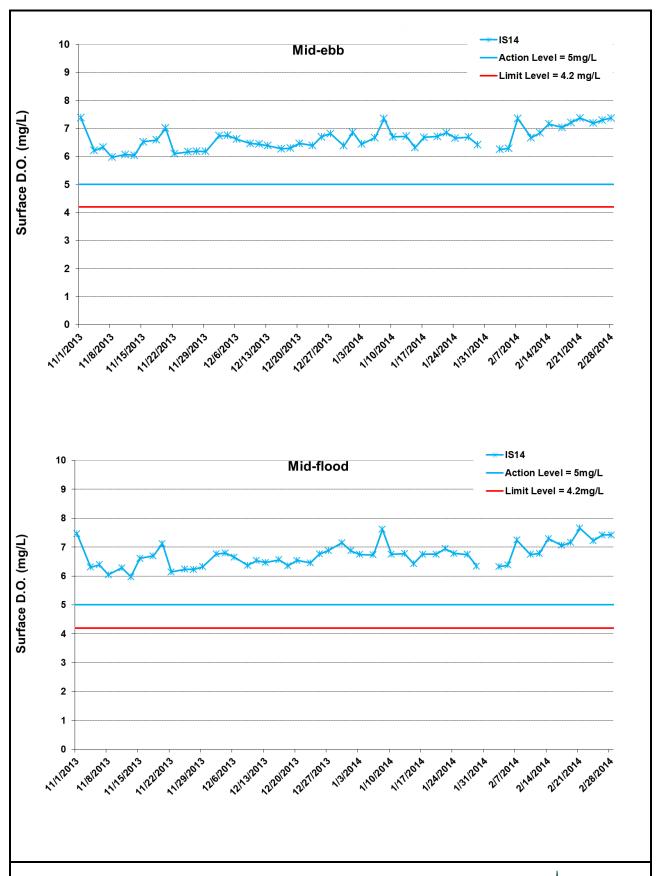
Figure H5 Impact Monitoring – Mean Level of Dissolved Oxygen (mg/L) in surface waters between 1 November 2013 and 28 February 2014 at IS14. The weather conditions during the monitoring period varied mostly from sunny to cloudy. Major marine construction activities: Dredging (11/1/2013 – 2/28/2014, except 1/31/2014); Construction of Temporary Seawalls (11/18/2013 – 2/28/2014); Sheet Piling (1/10/2014 – 2/28/2014).

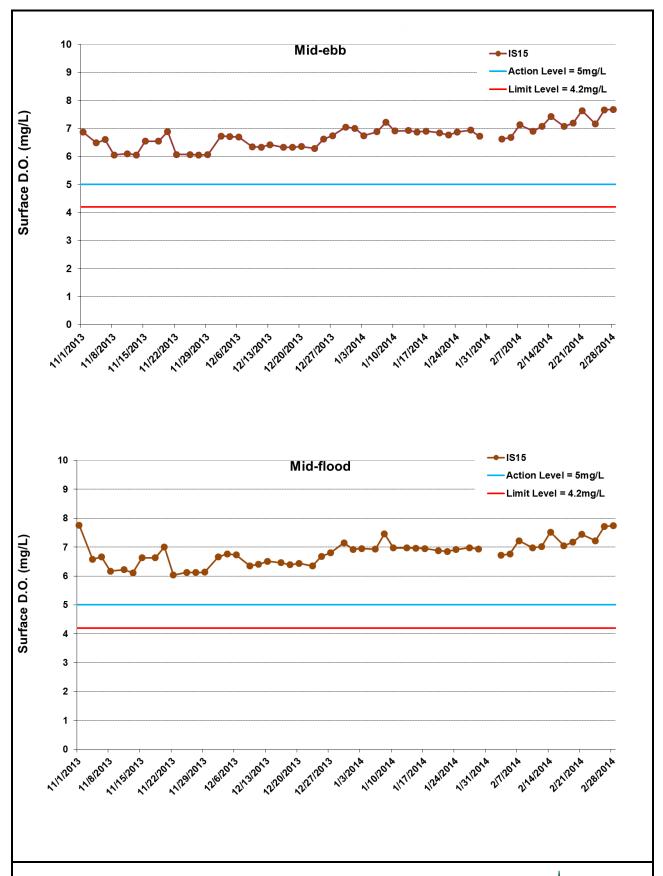
Figure H6 Impact Monitoring – Mean Level of Dissolved Oxygen (mg/L) in surface waters between 1 November 2013 and 28 February 2014 at IS15. The weather conditions during the monitoring period varied mostly from sunny to cloudy. Major marine construction activities: Dredging (11/1/2013 – 2/28/2014, except 1/31/2014); Construction of Temporary Seawalls (11/18/2013 – 2/28/2014); Sheet Piling (1/10/2014 – 2/28/2014).

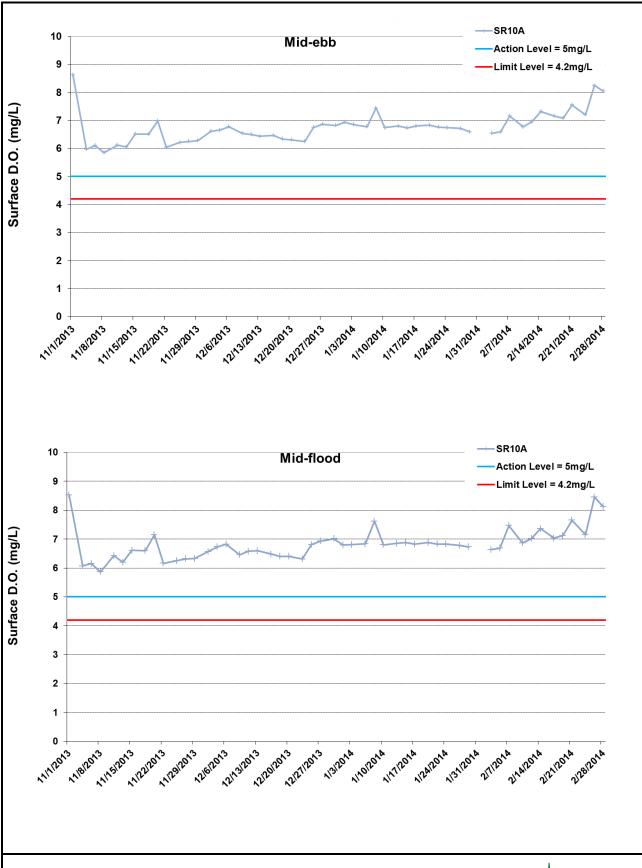
Figure H7 Impact Monitoring – Mean Level of Dissolved Oxygen (mg/L) in surface waters between 1 November 2013 and 28 February 2014 at SR10A. The weather conditions during the monitoring period varied mostly from sunny to cloudy. Major marine construction activities: Dredging (11/1/2013 – 2/28/2014, except 1/31/2014); Construction of Temporary Seawalls (11/18/2013 – 2/28/2014); Sheet Piling (1/10/2014 – 2/28/2014).

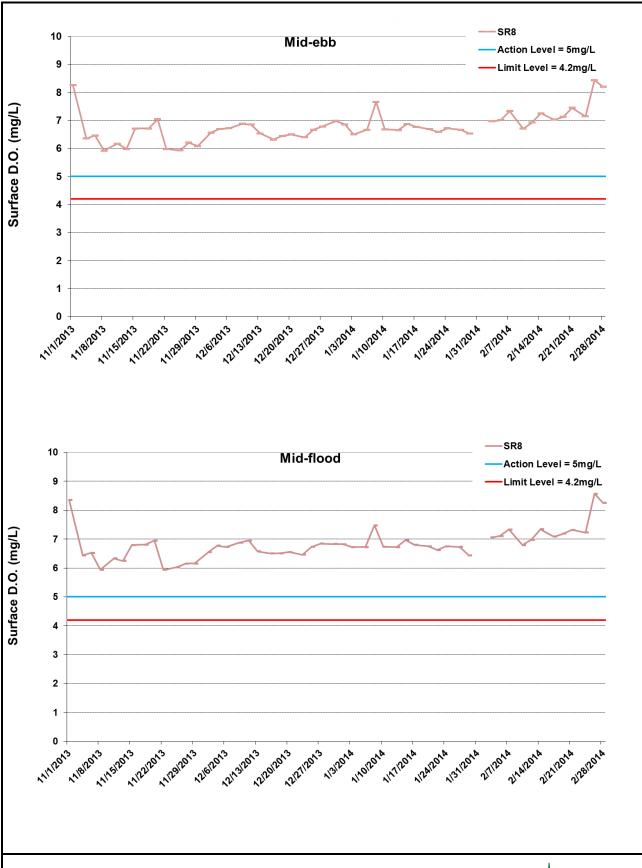
Figure H8 Impact Monitoring – Mean Level of Dissolved Oxygen (mg/L) in surface waters between 1 November 2013 and 28 February 2014 at SR8. The weather conditions during the monitoring period varied mostly from sunny to cloudy. Major marine construction activities: Dredging (11/1/2013 – 2/28/2014, except 1/31/2014); Construction of Temporary Seawalls (11/18/2013 – 2/28/2014); Sheet Piling (1/10/2014 – 2/28/2014).

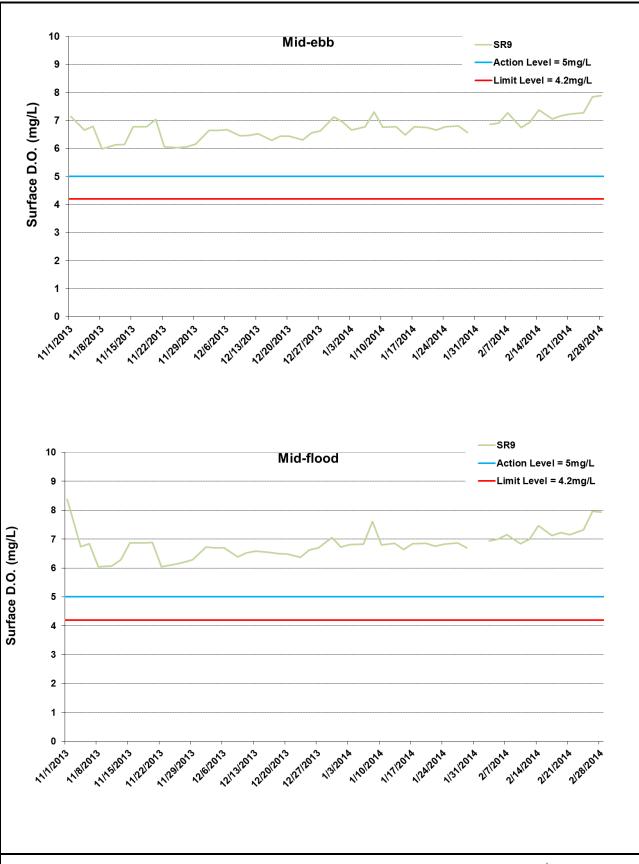
Figure H9 Impact Monitoring – Mean Level of Dissolved Oxygen (mg/L) in surface waters between 1 November 2013 and 28 February 2014 at SR9. The weather conditions during the monitoring period varied mostly from sunny to cloudy. Major marine construction activities: Dredging (11/1/2013 – 2/28/2014, except 1/31/2014); Construction of Temporary Seawalls (11/18/2013 – 2/28/2014); Sheet Piling (1/10/2014 – 2/28/2014).

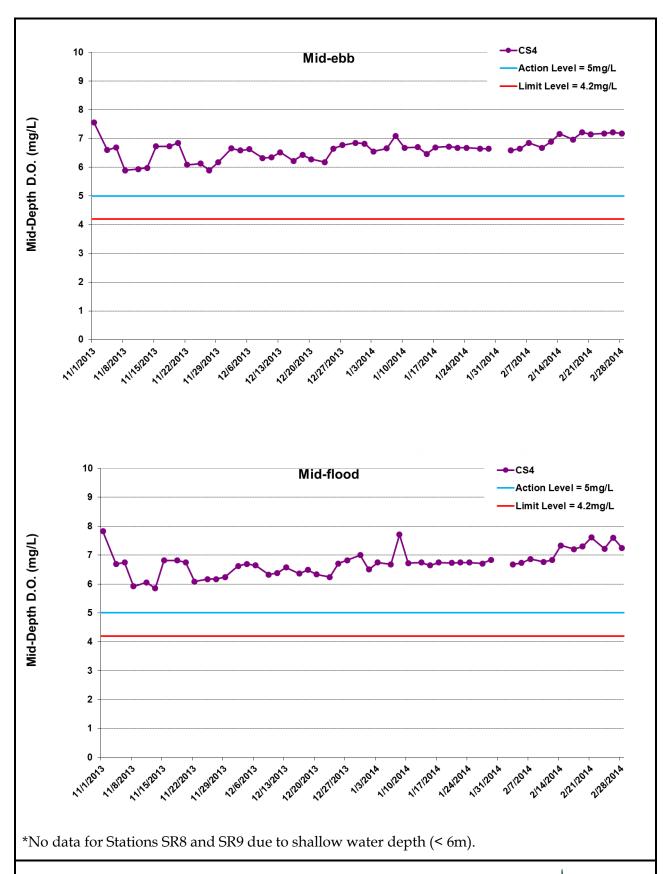
Figure H10 Impact Monitoring – Mean Level of Dissolved Oxygen (mg/L) in middepth waters between 1 November 2013 and 28 February 2014 at the CS4. The weather conditions during the monitoring period varied mostly from sunny to cloudy. Major marine construction activities: Dredging (11/1/2013 – 2/28/2014, except 1/31/2014); Construction of Temporary Seawalls (11/18/2013 – 2/28/2014); Sheet Piling (1/10/2014 – 2/28/2014).

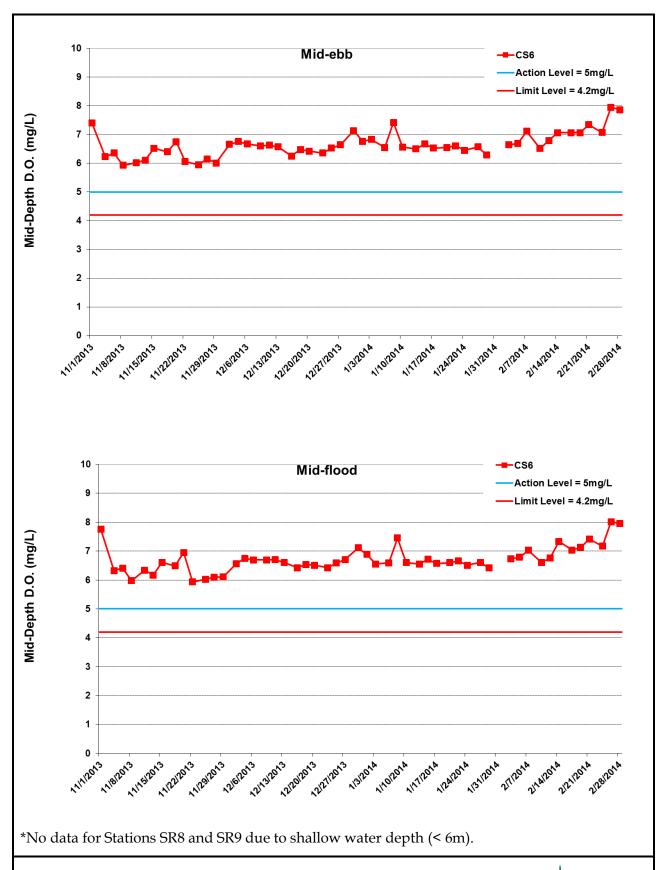
Figure H11 Impact Monitoring – Mean Level of Dissolved Oxygen (mg/L) in middepth waters between 1 November 2013 and 28 February 2014 at CS6. The weather conditions during the monitoring period varied mostly from sunny to cloudy. Major marine construction activities: Dredging (11/1/2013 – 2/28/2014, except 1/31/2014); Construction of Temporary Seawalls (11/18/2013 – 2/28/2014); Sheet Piling (1/10/2014 – 2/28/2014).

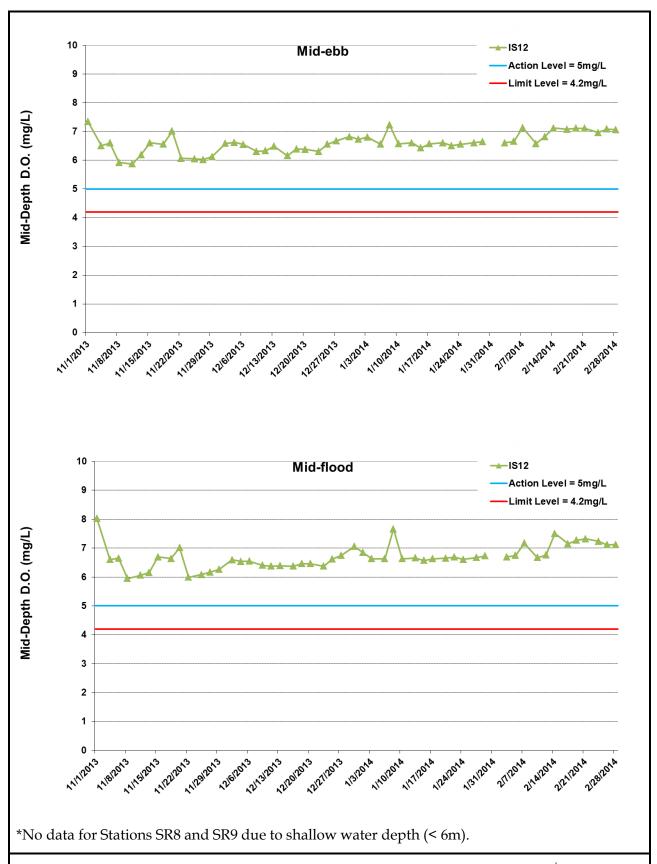
Figure H12 Impact Monitoring – Mean Level of Dissolved Oxygen (mg/L) in middepth waters between 1 November 2013 and 28 February 2014 at IS12. The weather conditions during the monitoring period varied mostly from sunny to cloudy. Major marine construction activities: Dredging (11/1/2013 – 2/28/2014, except 1/31/2014); Construction of Temporary Seawalls (11/18/2013 – 2/28/2014); Sheet Piling (1/10/2014 – 2/28/2014).

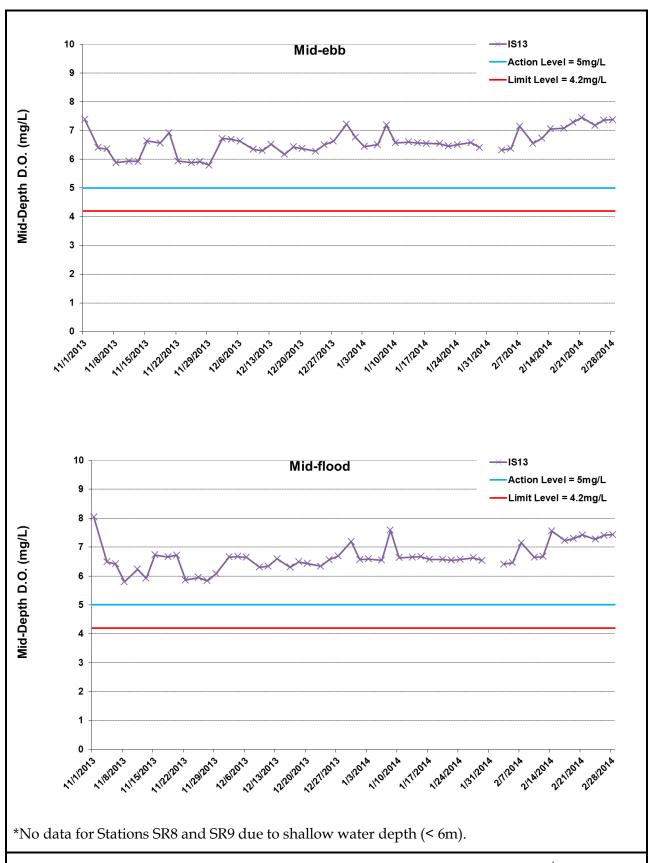
Figure H13 Impact Monitoring – Mean Level of Dissolved Oxygen (mg/L) in middepth waters between 1 November 2013 and 28 February 2014 at IS13. The weather conditions during the monitoring period varied mostly from sunny to cloudy. Major marine construction activities: Dredging (11/1/2013 – 2/28/2014, except 1/31/2014); Construction of Temporary Seawalls (11/18/2013 – 2/28/2014); Sheet Piling (1/10/2014 – 2/28/2014).

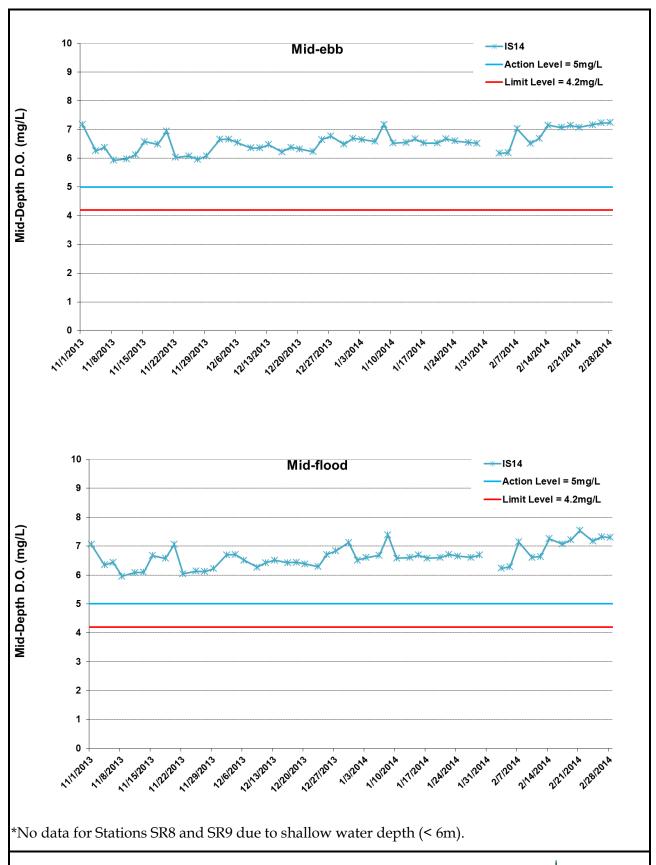
Figure H14 Impact Monitoring – Mean Level of Dissolved Oxygen (mg/L) in middepth waters between 1 November 2013 and 28 February 2014 at IS14. The weather conditions during the monitoring period varied mostly from sunny to cloudy. Major marine construction activities: Dredging (11/1/2013 – 2/28/2014, except 1/31/2014); Construction of Temporary Seawalls (11/18/2013 – 2/28/2014); Sheet Piling (1/10/2014 – 2/28/2014).

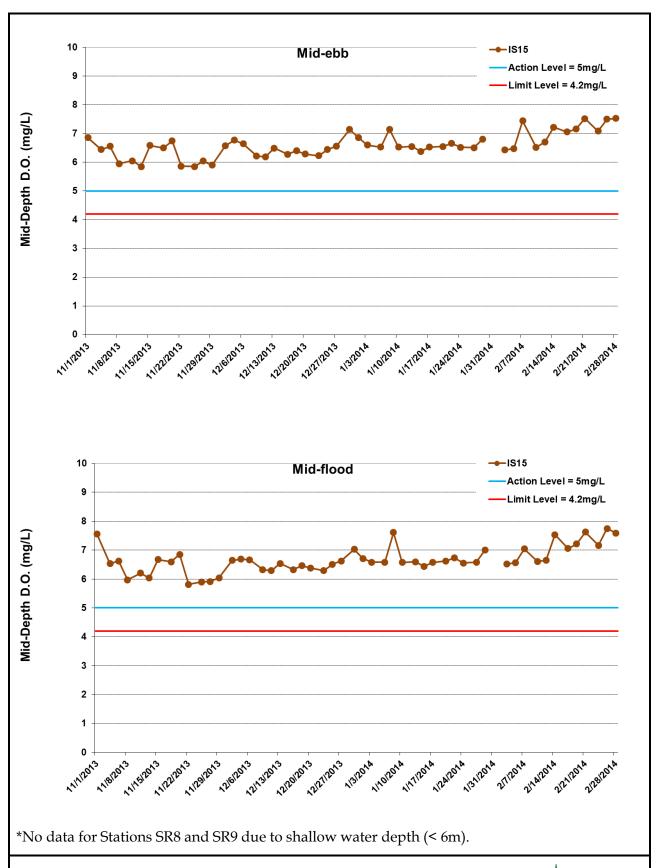
Figure H15 Impact Monitoring – Mean Level of Dissolved Oxygen (mg/L) in middepth waters between 1 November 2013 and 28 February 2014 at IS15. The weather conditions during the monitoring period varied mostly from sunny to cloudy. Major marine construction activities: Dredging (11/1/2013 – 2/28/2014, except 1/31/2014); Construction of Temporary Seawalls (11/18/2013 – 2/28/2014); Sheet Piling (1/10/2014 – 2/28/2014).

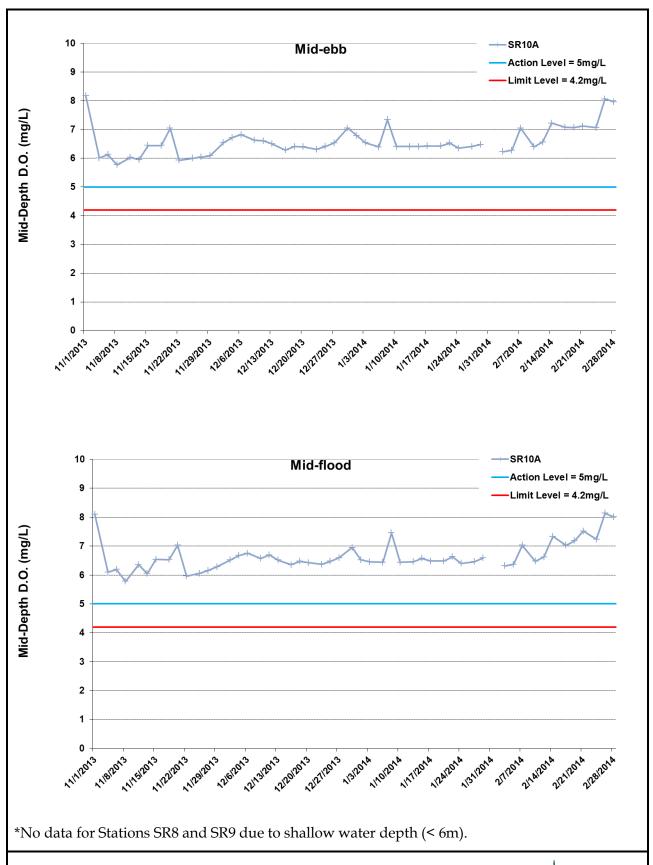
Figure H16 Impact Monitoring – Mean Level of Dissolved Oxygen (mg/L) in middepth waters between 1 November 2013 and 28 February 2014 at SR10A. The weather conditions during the monitoring period varied mostly from sunny to cloudy. Major marine construction activities: Dredging (11/1/2013 – 2/28/2014, except 1/31/2014); Construction of Temporary Seawalls (11/18/2013 – 2/28/2014); Sheet Piling (1/10/2014 – 2/28/2014).

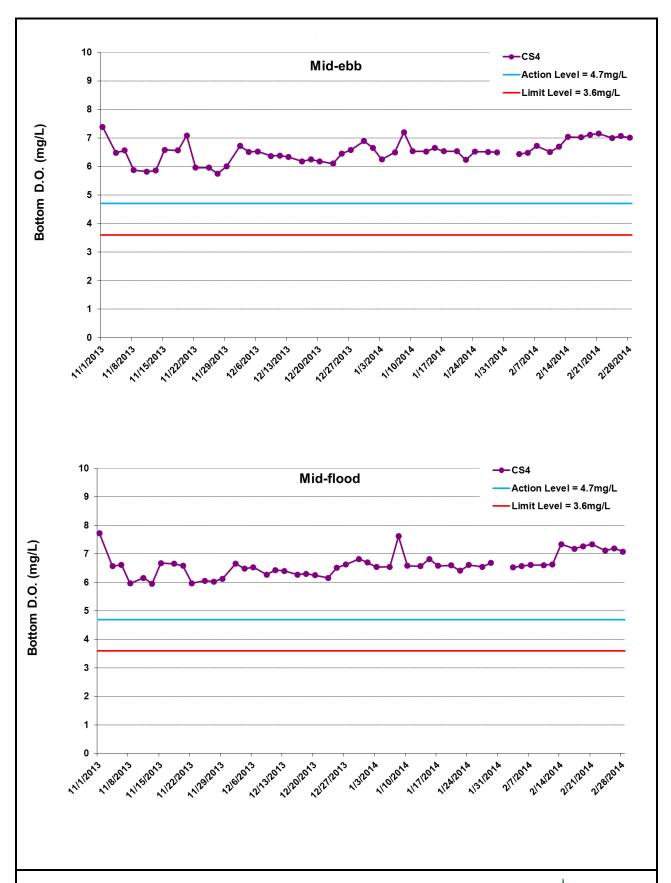
Figure H17 Impact Monitoring – Mean Level of Dissolved Oxygen (mg/L) in bottom waters between 1 November 2013 and 28 February 2014 at CS4. The weather conditions during the monitoring period varied mostly from sunny to cloudy. Major marine construction activities: Dredging (11/1/2013 – 2/28/2014, except 1/31/2014); Construction of Temporary Seawalls (11/18/2013 – 2/28/2014); Sheet Piling (1/10/2014 – 2/28/2014).

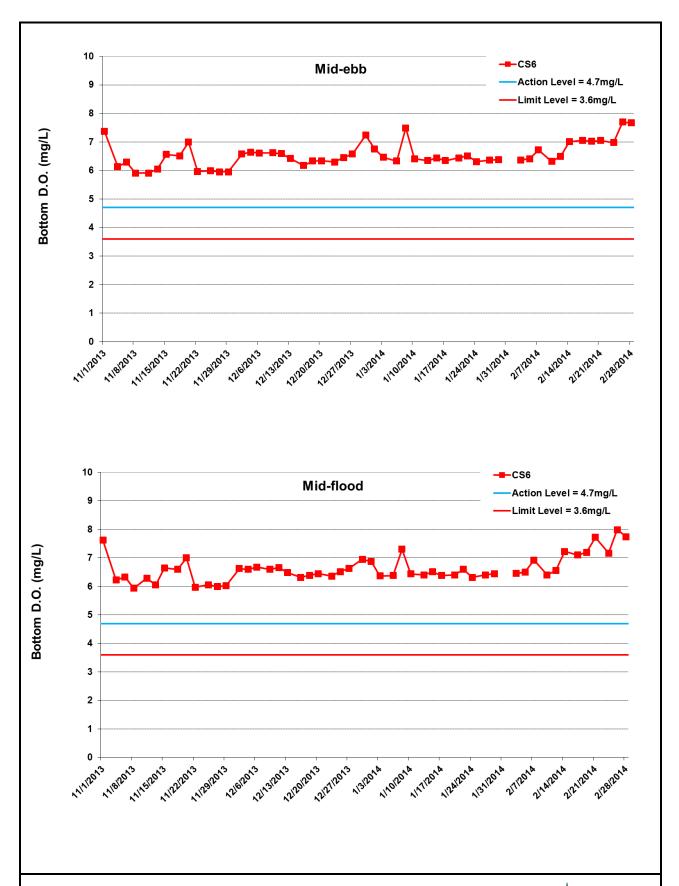
Figure H18 Impact Monitoring – Mean Level of Dissolved Oxygen (mg/L) in bottom waters between 1 November 2013 and 28 February 2014 at CS6. The weather conditions during the monitoring period varied mostly from sunny to cloudy. Major marine construction activities: Dredging (11/1/2013 – 2/28/2014, except 1/31/2014); Construction of Temporary Seawalls (11/18/2013 – 2/28/2014); Sheet Piling (1/10/2014 – 2/28/2014).

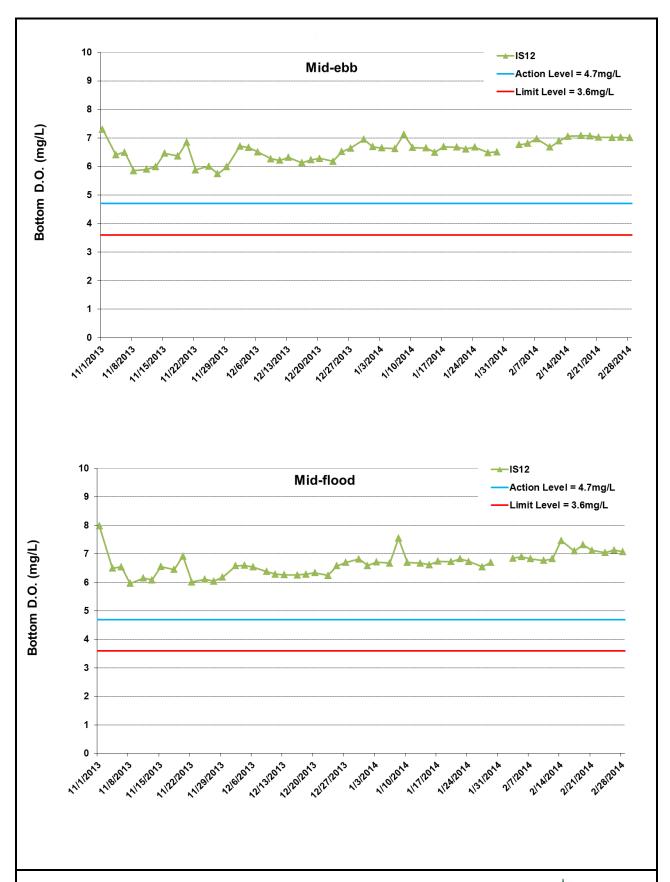
Figure H19 Impact Monitoring – Mean Level of Dissolved Oxygen (mg/L) in bottom waters between 1 November 2013 and 28 February 2014 at IS12. The weather conditions during the monitoring period varied mostly from sunny to cloudy. Major marine construction activities: Dredging (11/1/2013 – 2/28/2014, except 1/31/2014); Construction of Temporary Seawalls (11/18/2013 – 2/28/2014); Sheet Piling (1/10/2014 – 2/28/2014).

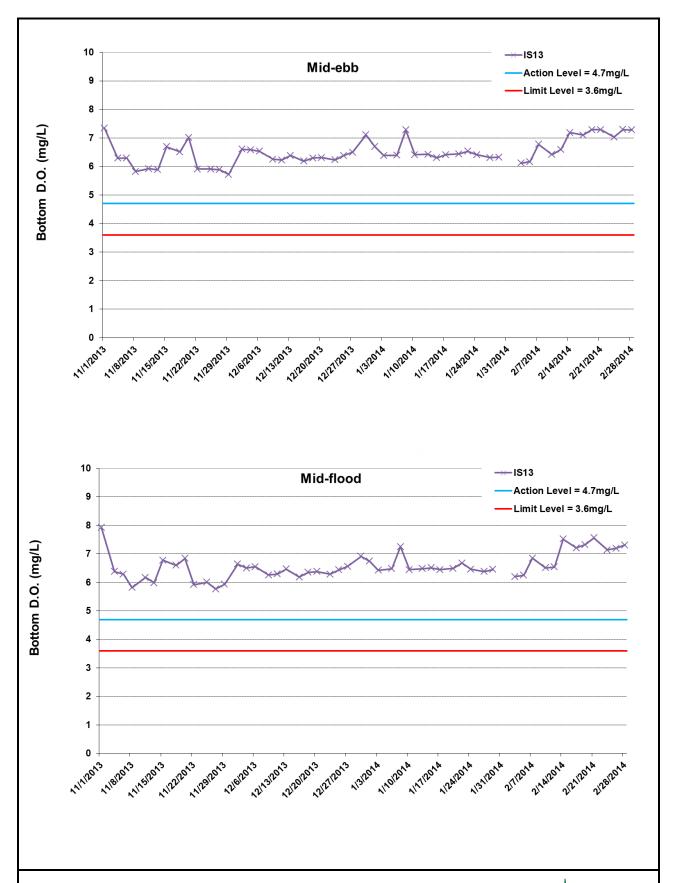
Figure H20 Impact Monitoring – Mean Level of Dissolved Oxygen (mg/L) in bottom waters between 1 November 2013 and 28 February 2014 at IS13. The weather conditions during the monitoring period varied mostly from sunny to cloudy. Major marine construction activities: Dredging (11/1/2013 – 2/28/2014, except 1/31/2014); Construction of Temporary Seawalls (11/18/2013 – 2/28/2014); Sheet Piling (1/10/2014 – 2/28/2014).

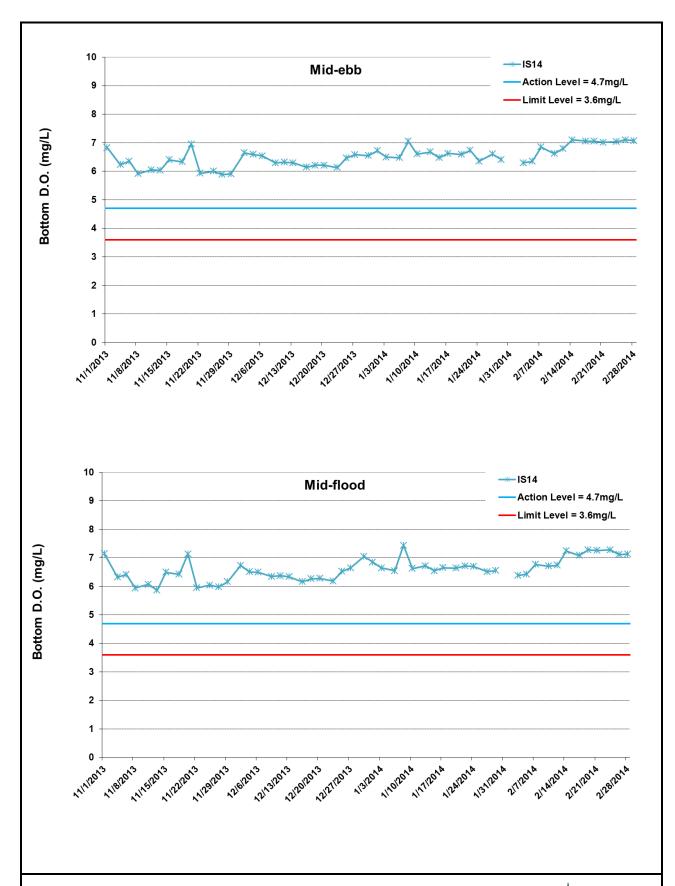
Figure H21 Impact Monitoring – Mean Level of Dissolved Oxygen (mg/L) in bottom waters between 1 November 2013 and 28 February 2014 at IS14. The weather conditions during the monitoring period varied mostly from sunny to cloudy. Major marine construction activities: Dredging (11/1/2013 – 2/28/2014, except 1/31/2014); Construction of Temporary Seawalls (11/18/2013 – 2/28/2014); Sheet Piling (1/10/2014 – 2/28/2014).

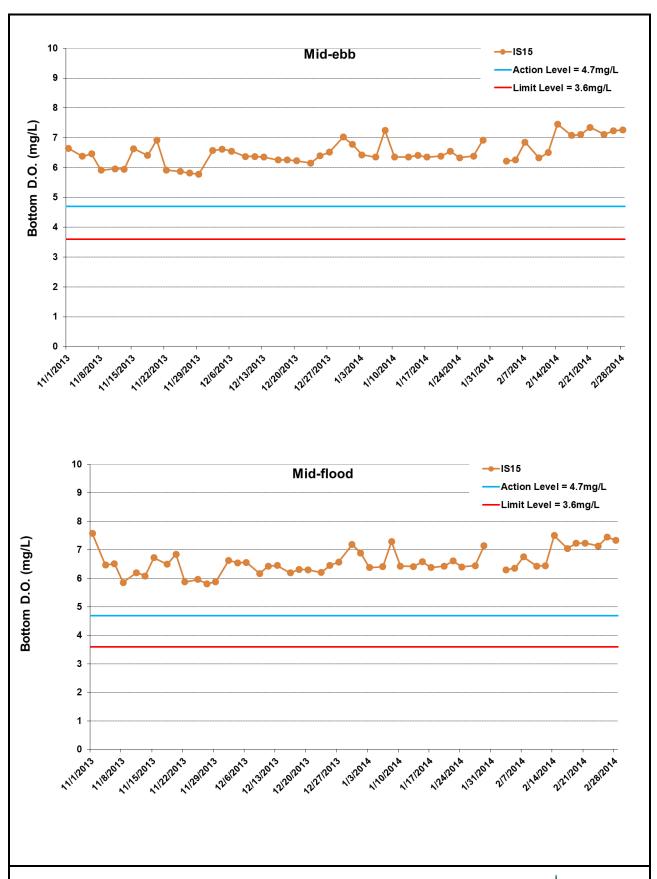
Figure H22 Impact Monitoring – Mean Level of Dissolved Oxygen (mg/L) in bottom waters between 1 November 2013 and 28 February 2014 at IS15. The weather conditions during the monitoring period varied mostly from sunny to cloudy. Major marine construction activities: Dredging (11/1/2013 – 2/28/2014, except 1/31/2014); Construction of Temporary Seawalls (11/18/2013 – 2/28/2014); Sheet Piling (1/10/2014 – 2/28/2014).

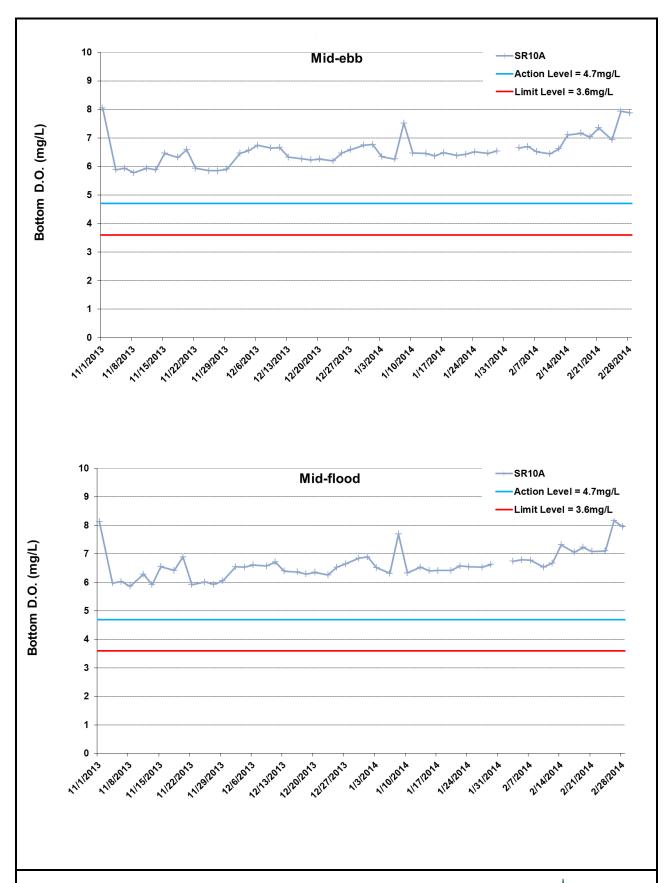
Figure H23 Impact Monitoring – Mean Level of Dissolved Oxygen (mg/L) in bottom waters between 1 November 2013 and 28 February 2014 at SR10A. The weather conditions during the monitoring period varied mostly from sunny to cloudy. Major marine construction activities: Dredging (11/1/2013 – 2/28/2014, except 1/31/2014); Construction of Temporary Seawalls (11/18/2013 – 2/28/2014); Sheet Piling (1/10/2014 – 2/28/2014).

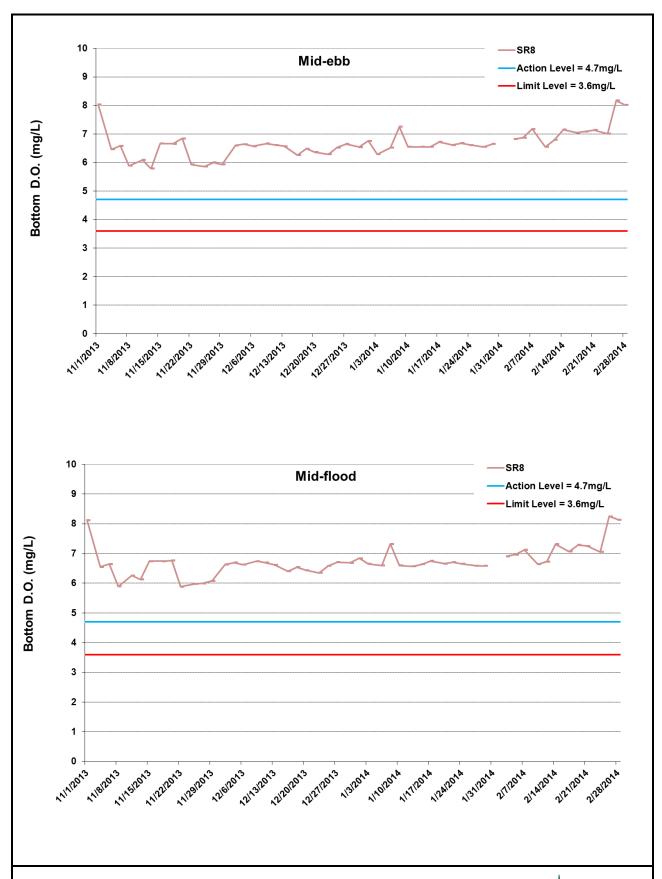
Figure H24 Impact Monitoring – Mean Level of Dissolved Oxygen (mg/L) in bottom waters between 1 November 2013 and 28 February 2014 at SR8. The weather conditions during the monitoring period varied mostly from sunny to cloudy. Major marine construction activities: Dredging (11/1/2013 – 2/28/2014, except 1/31/2014); Construction of Temporary Seawalls (11/18/2013 – 2/28/2014); Sheet Piling (1/10/2014 – 2/28/2014).

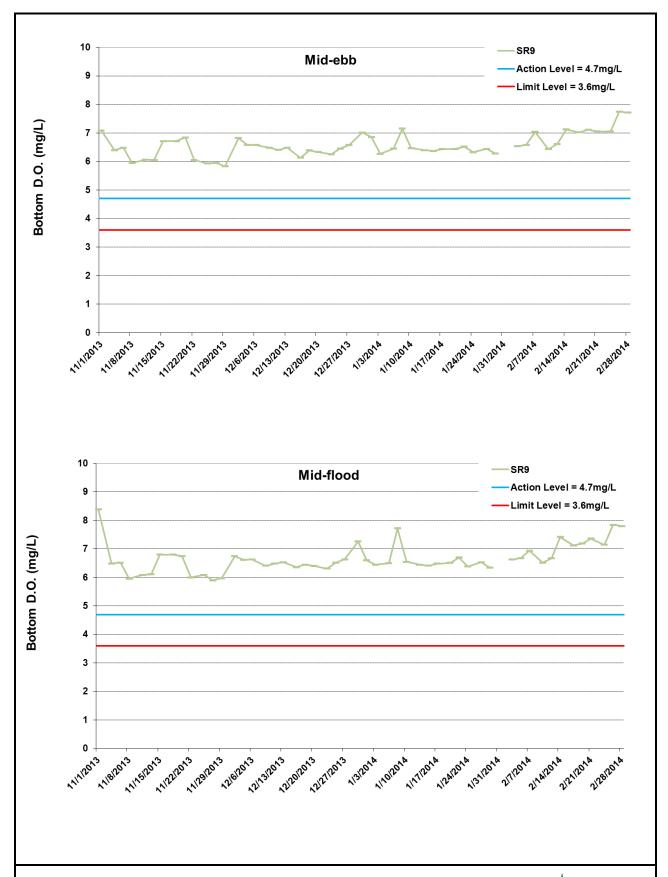
Figure H25 Impact Monitoring – Mean Level of Dissolved Oxygen (mg/L) in bottom waters between 1 November 2013 and 28 February 2014 at SR9. The weather conditions during the monitoring period varied mostly from sunny to cloudy. Major marine construction activities: Dredging (11/1/2013 – 2/28/2014, except 1/31/2014); Construction of Temporary Seawalls (11/18/2013 – 2/28/2014); Sheet Piling (1/10/2014 – 2/28/2014).

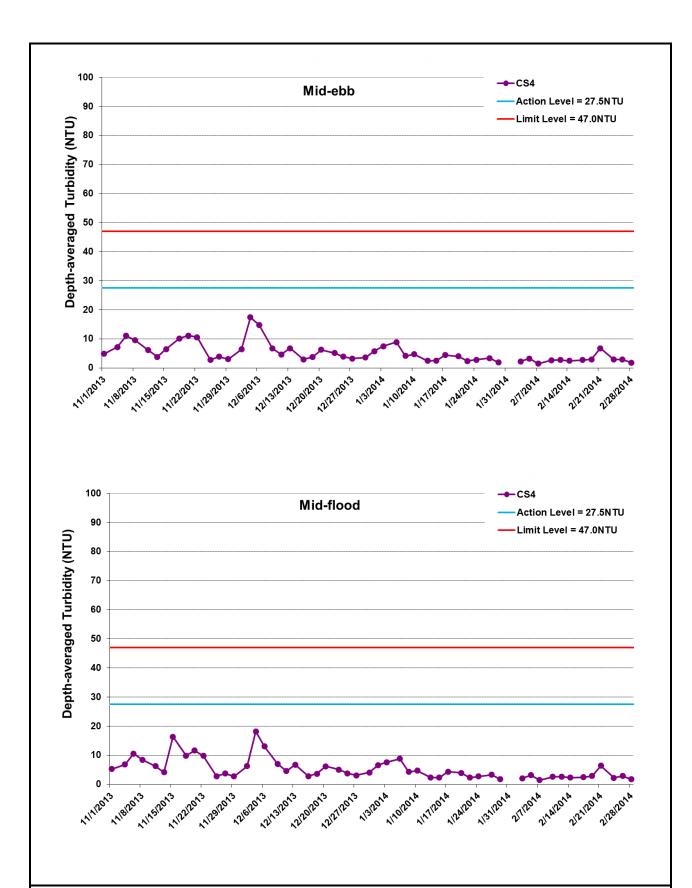
Figure H26 Impact Monitoring – Mean Depth-averaged Level of Turbidity (NTU) between 1 November 2013 and 28 February 2014 at CS4. The weather conditions during the monitoring period varied mostly from sunny to cloudy. Major marine construction activities: Dredging (11/1/2013 – 2/28/2014, except 1/31/2014); Construction of Temporary Seawalls (11/18/2013 – 2/28/2014); Sheet Piling (1/10/2014 – 2/28/2014).

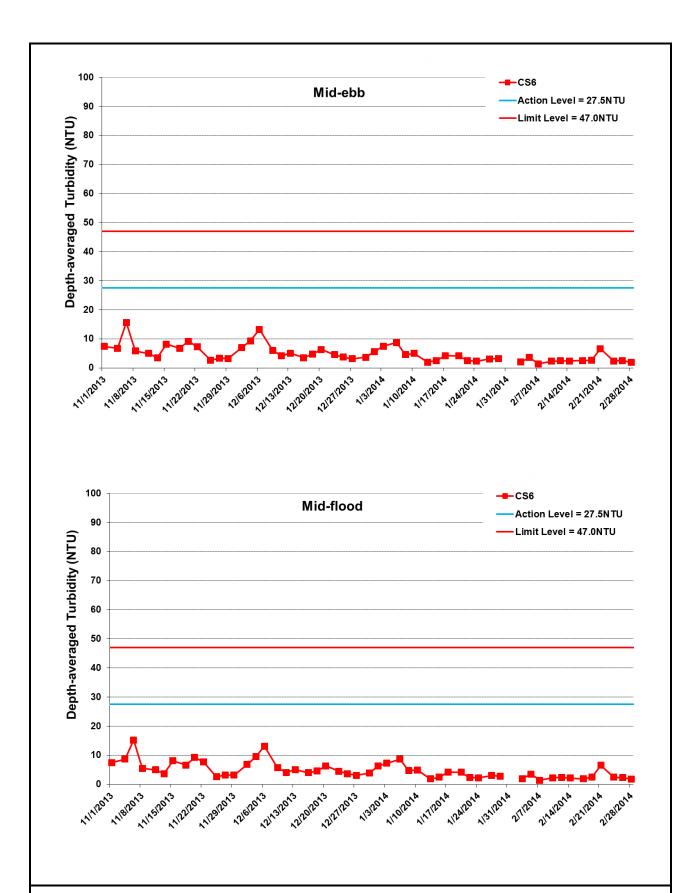
Figure H27 Impact Monitoring – Mean Depth-averaged Level of Turbidity (NTU) between 1 November 2013 and 28 February 2014 at CS6. The weather conditions during the monitoring period varied mostly from sunny to cloudy. Major marine construction activities: Dredging (11/1/2013 – 2/28/2014, except 1/31/2014); Construction of Temporary Seawalls (11/18/2013 – 2/28/2014); Sheet Piling (1/10/2014 – 2/28/2014).

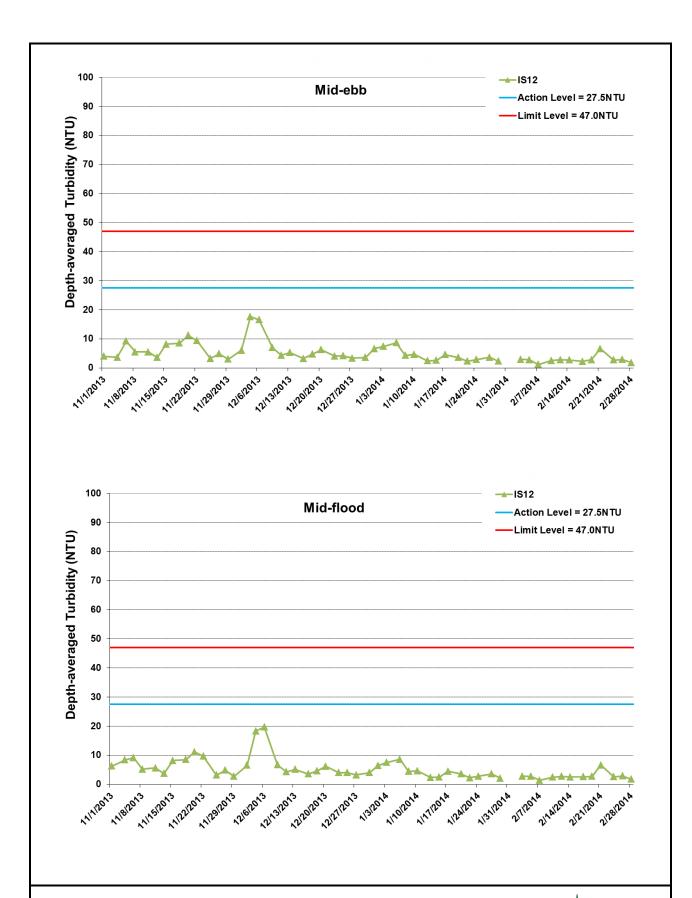
Figure H28 Impact Monitoring – Mean Depth-averaged Level of Turbidity (NTU) between 1 November 2013 and 28 February 2014 at IS12. The weather conditions during the monitoring period varied mostly from sunny to cloudy. Major marine construction activities: Dredging (11/1/2013 – 2/28/2014, except 1/31/2014); Construction of Temporary Seawalls (11/18/2013 – 2/28/2014); Sheet Piling (1/10/2014 – 2/28/2014).

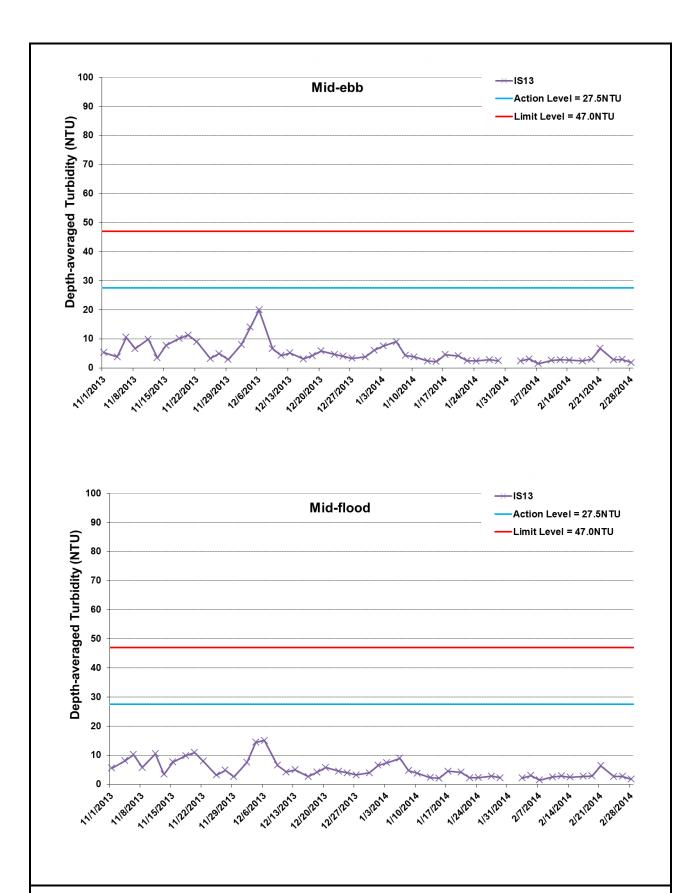
Figure H29 Impact Monitoring – Mean Depth-averaged Level of Turbidity (NTU) between 1 November 2013 and 28 February 2014 at IS13. The weather conditions during the monitoring period varied mostly from sunny to cloudy. Major marine construction activities: Dredging (11/1/2013 – 2/28/2014, except 1/31/2014); Construction of Temporary Seawalls (11/18/2013 – 2/28/2014); Sheet Piling (1/10/2014 – 2/28/2014).

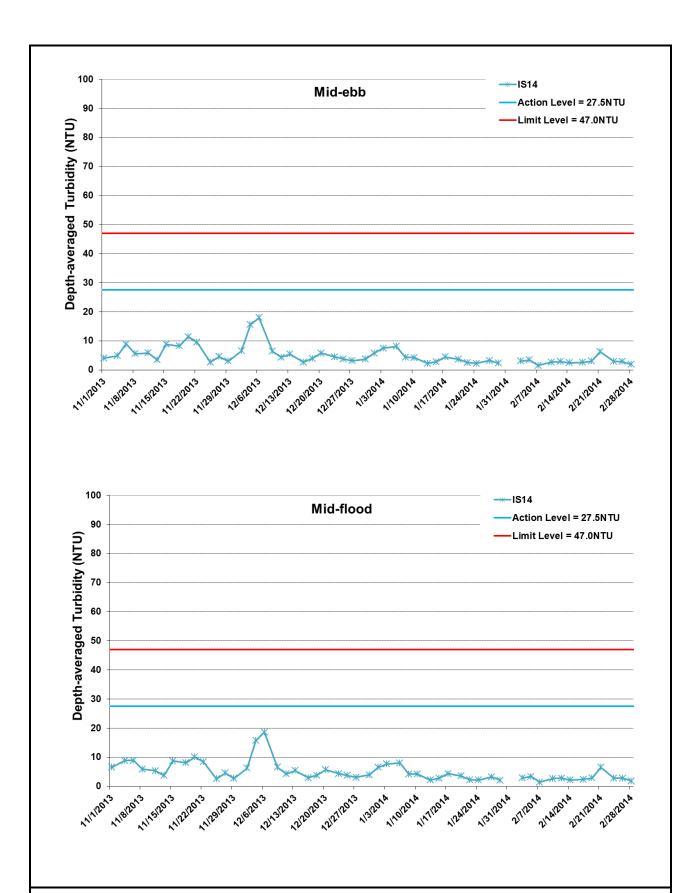
Figure H30 Impact Monitoring – Mean Depth-averaged Level of Turbidity (NTU) between 1 November 2013 and 28 February 2014 at IS14. The weather conditions during the monitoring period varied mostly from sunny to cloudy. Major marine construction activities: Dredging (11/1/2013 – 2/28/2014, except 1/31/2014); Construction of Temporary Seawalls (11/18/2013 – 2/28/2014); Sheet Piling (1/10/2014 – 2/28/2014).

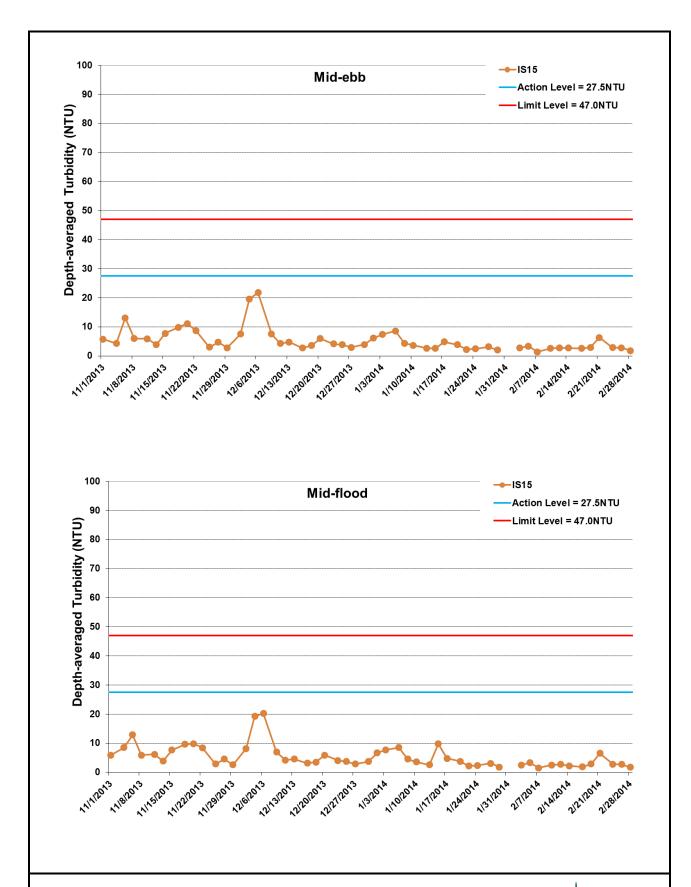
Figure H31 Impact Monitoring – Mean Depth-averaged Level of Turbidity (NTU) between 1 November 2013 and 28 February 2014 at IS15. The weather conditions during the monitoring period varied mostly from sunny to cloudy. Major marine construction activities: Dredging (11/1/2013 – 2/28/2014, except 1/31/2014); Construction of Temporary Seawalls (11/18/2013 – 2/28/2014); Sheet Piling (1/10/2014 – 2/28/2014).

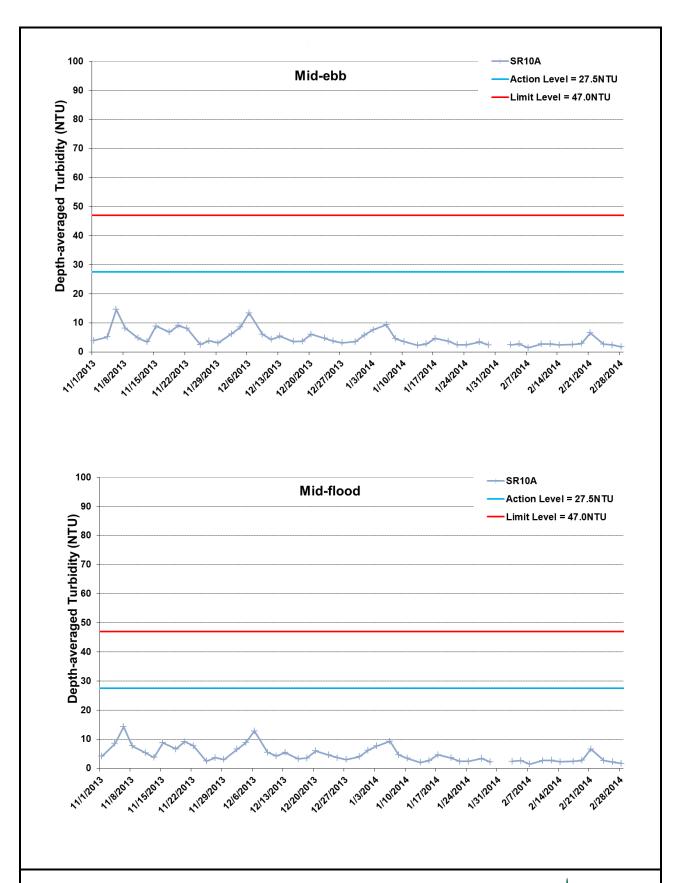
Figure H32 Impact Monitoring – Mean Depth-averaged Level of Turbidity (NTU) between 1 November 2013 and 28 February 2014 at SR10A. The weather conditions during the monitoring period varied from sunny to cloudy. The weather conditions during the monitoring period varied mostly from sunny to cloudy. Major marine construction activities: Dredging (11/1/2013 – 2/28/2014, except 1/31/2014); Construction of Temporary Seawalls (11/18/2013 – 2/28/2014); Sheet Piling (1/10/2014 – 2/28/2014).
