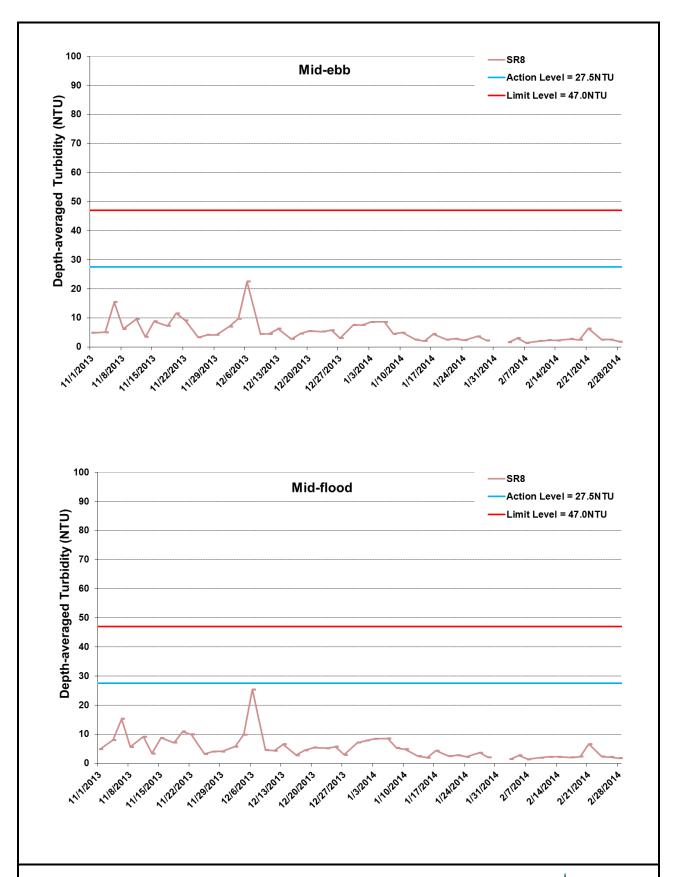
Figure H33 Impact Monitoring – Mean Depth-averaged Level of Turbidity (NTU) between 1 November 2013 and 28 February 2014 at SR8. The weather conditions during the monitoring period varied mostly from sunny to cloudy. Major marine construction activities: Dredging (11/1/2013 – 2/28/2014, except 1/31/2014); Construction of Temporary Seawalls (11/18/2013 – 2/28/2014); Sheet Piling (1/10/2014 – 2/28/2014).

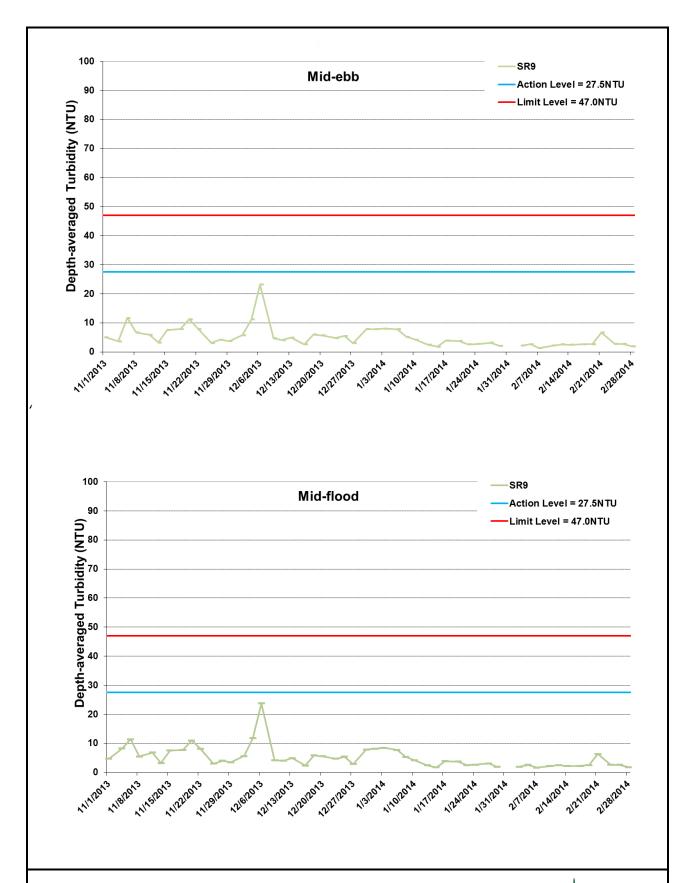
Figure H34 Impact Monitoring – Mean Depth-averaged Level of Turbidity (NTU) between 1 November 2013 and 28 February 2014 at SR9. The weather conditions during the monitoring period varied mostly from sunny to cloudy. Major marine construction activities: Dredging (11/1/2013 – 2/28/2014, except 1/31/2014); Construction of Temporary Seawalls (11/18/2013 – 2/28/2014); Sheet Piling (1/10/2014 – 2/28/2014).

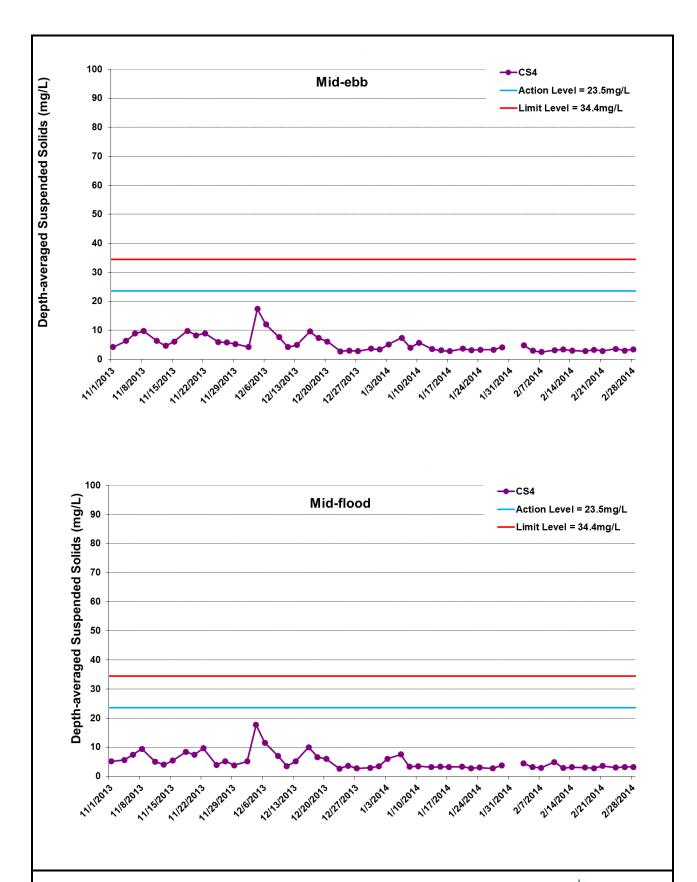
Figure H35 Impact Monitoring – Mean Depth-averaged Level of Suspended Solids (mg/L) between 1 November 2013 and 28 February 2014 at CS4. The weather conditions during the monitoring period varied mostly from sunny to cloudy. Major marine construction activities: Dredging (11/1/2013 – 2/28/2014, except 1/31/2014); Construction of Temporary Seawalls (11/18/2013 – 2/28/2014); Sheet Piling (1/10/2014 – 2/28/2014).

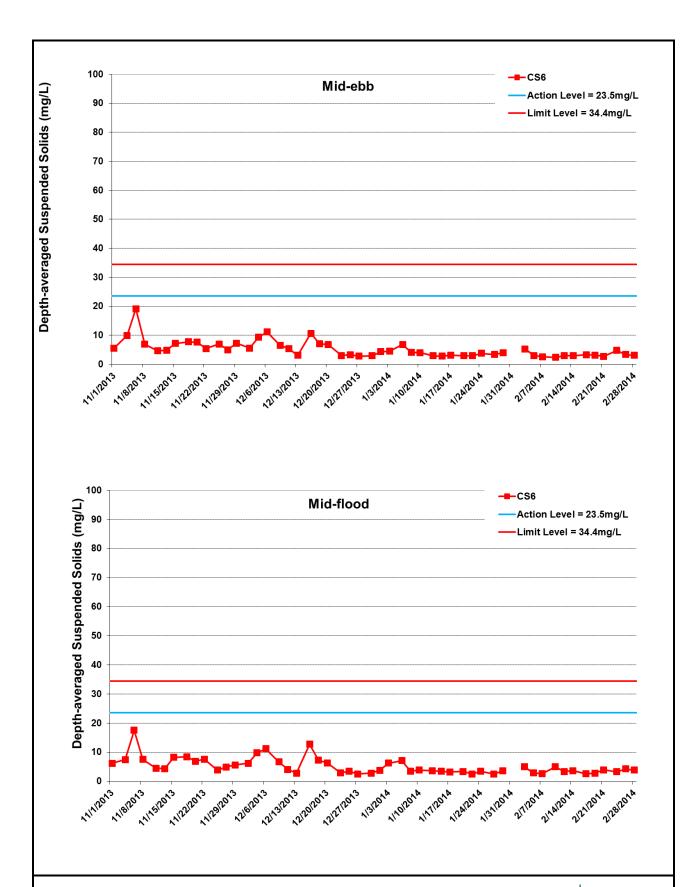
Figure H36 Impact Monitoring – Mean Depth-averaged Level of Suspended Solids (mg/L) between 1 November 2013 and 28 February 2014 at CS6. The weather conditions during the monitoring period varied mostly from sunny to cloudy. Major marine construction activities: Dredging (11/1/2013 – 2/28/2014, except 1/31/2014); Construction of Temporary Seawalls (11/18/2013 – 2/28/2014); Sheet Piling (1/10/2014 – 2/28/2014).

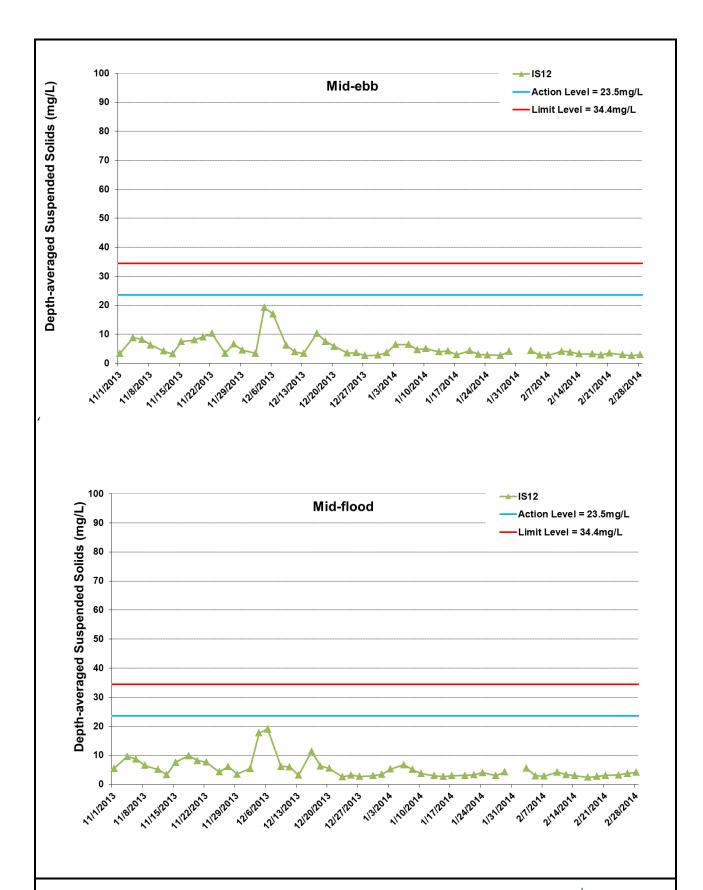
Figure H37 Impact Monitoring – Mean Depth-averaged Level of Suspended Solids (mg/L) between 1 November 2013 and 28 February 2014 at IS12. The weather conditions during the monitoring period varied mostly from sunny to cloudy. Major marine construction activities: Dredging (11/1/2013 – 2/28/2014, except 1/31/2014); Construction of Temporary Seawalls (11/18/2013 – 2/28/2014); Sheet Piling (1/10/2014 – 2/28/2014).

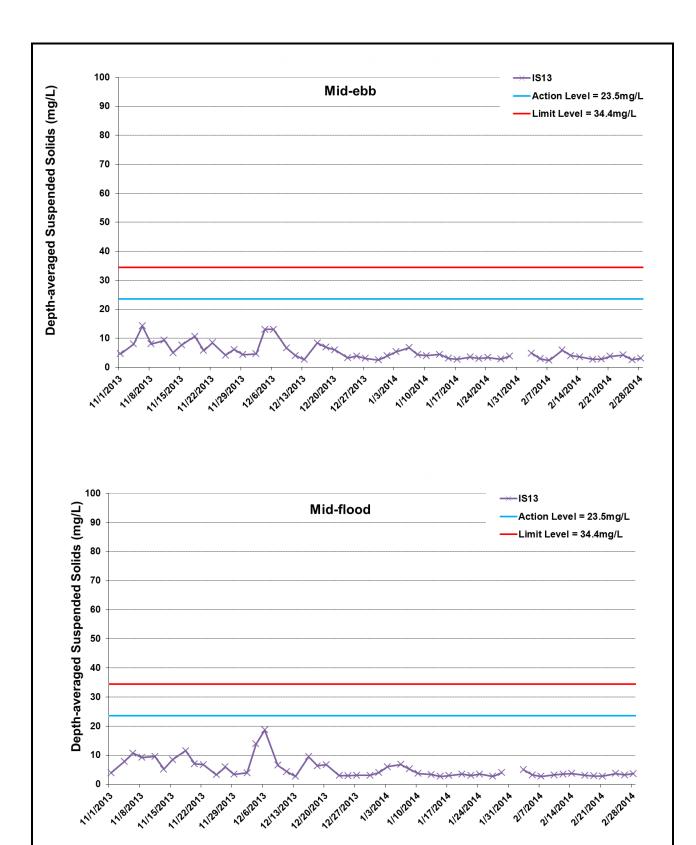
Figure H38 Impact Monitoring – Mean Depth-averaged Level of Suspended Solids (mg/L) between 1 November 2013 and 28 February 2014 at IS13. The weather conditions during the monitoring period varied mostly from sunny to cloudy. Major marine construction activities: Dredging (11/1/2013 – 2/28/2014, except 1/31/2014); Construction of Temporary Seawalls (11/18/2013 – 2/28/2014); Sheet Piling (1/10/2014 – 2/28/2014).

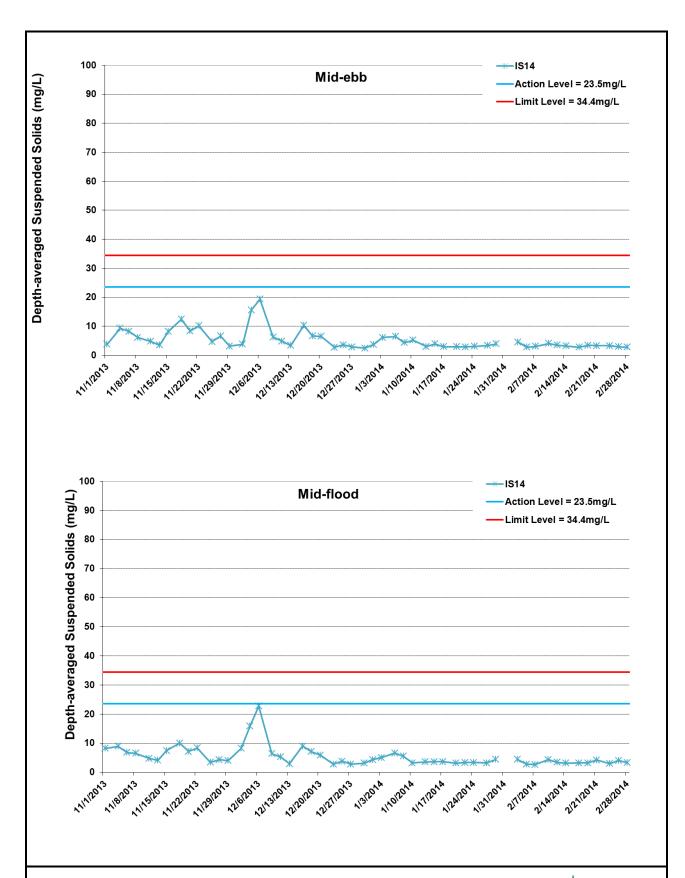
Figure H39 Impact Monitoring – Mean Depth-averaged Level of Suspended Solids (mg/L) between 1 November 2013 and 28 February 2014 at IS14. The weather conditions during the monitoring period varied mostly from sunny to cloudy. Major marine construction activities: Dredging (11/1/2013 – 2/28/2014, except 1/31/2014); Construction of Temporary Seawalls (11/18/2013 – 2/28/2014); Sheet Piling (1/10/2014 – 2/28/2014).

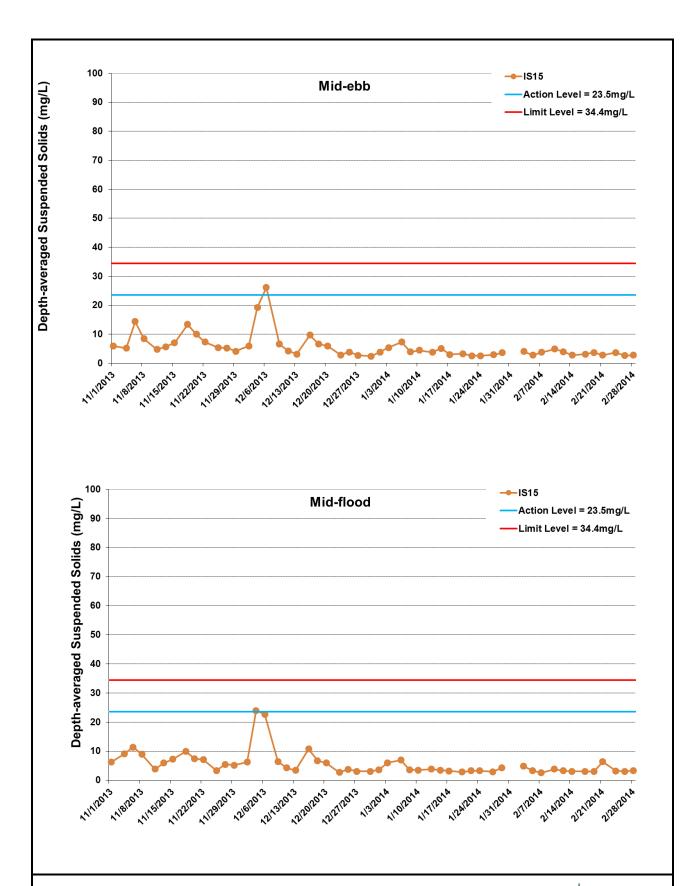
Figure H40 Impact Monitoring – Mean Depth-averaged Level of Suspended Solids (mg/L) between 1 November 2013 and 28 February 2014 at IS15. The weather conditions during the monitoring period varied mostly from sunny to cloudy. Major marine construction activities: Dredging (11/1/2013 – 2/28/2014, except 1/31/2014); Construction of Temporary Seawalls (11/18/2013 – 2/28/2014); Sheet Piling (1/10/2014 – 2/28/2014).

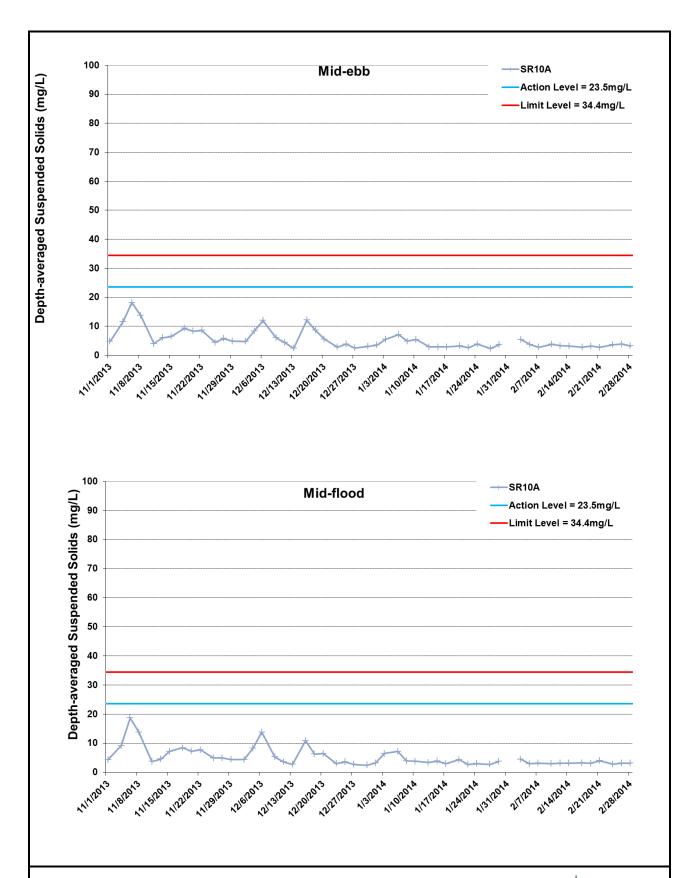
Figure H41 Impact Monitoring – Mean Depth-averaged Level of Suspended Solids (mg/L) between 1 November 2013 and 28 February 2014 at SR10A. The weather conditions during the monitoring period varied mostly from sunny to cloudy. Major marine construction activities: Dredging (11/1/2013 – 2/28/2014, except 1/31/2014); Construction of Temporary Seawalls (11/18/2013 – 2/28/2014); Sheet Piling (1/10/2014 – 2/28/2014).

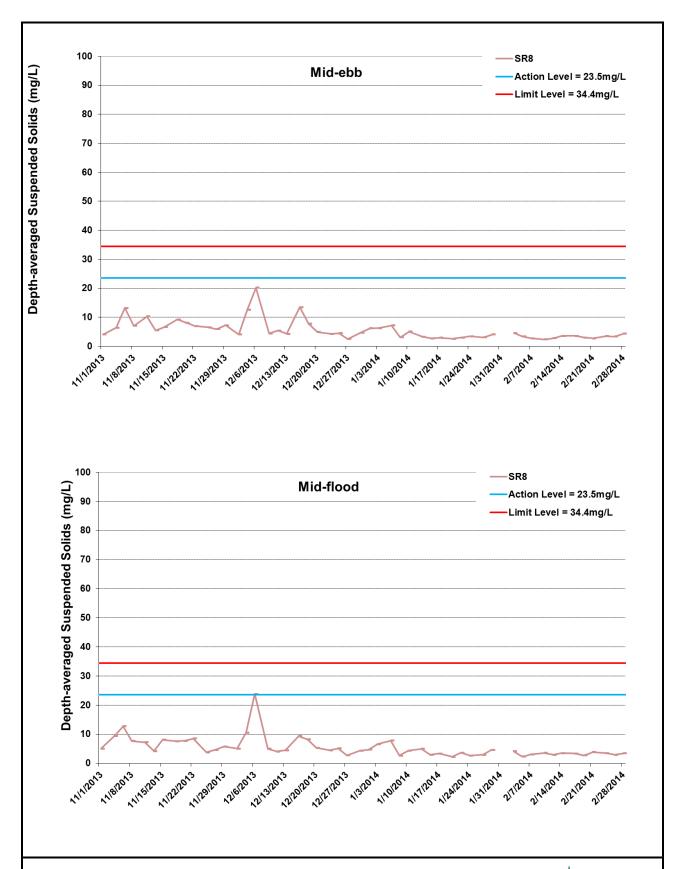
Figure H42 Impact Monitoring – Mean Depth-averaged Level of Suspended Solids (mg/L) between 1 November 2013 and 28 February 2014 at SR8. The weather conditions during the monitoring period varied mostly from sunny to cloudy. Major marine construction activities: Dredging (11/1/2013 – 2/28/2014, except 1/31/2014); Construction of Temporary Seawalls (11/18/2013 – 2/28/2014); Sheet Piling (1/10/2014 – 2/28/2014).

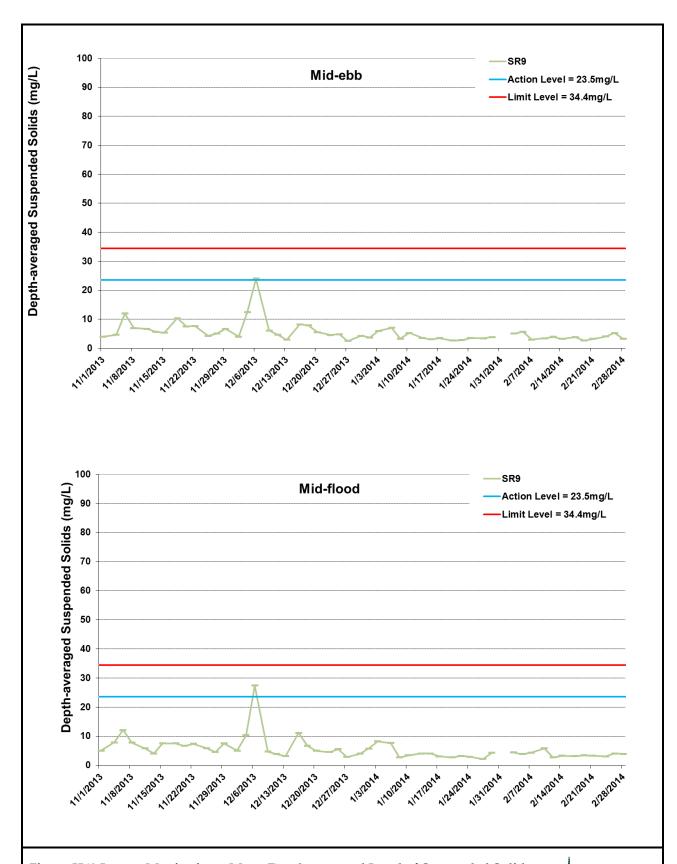
Figure H43 Impact Monitoring – Mean Depth-averaged Level of Suspended Solids (mg/L) between 1 November 2013 and 28 February 2014 at SR9. The weather conditions during the monitoring period varied mostly from sunny to cloudy. Major marine construction activities: Dredging (11/1/2013 – 2/28/2014, except 1/31/2014); Construction of Temporary Seawalls (11/18/2013 – 2/28/2014); Sheet Piling (1/10/2014 – 2/28/2014).
