TUEN MUN - CHEK LAP KOK LINK
CONTRACT NO. HMWSD 2/2020 (HY) –
ESTABLISHMENT OF LANDSCAPE SOFTWORKS FOR
THE TUEN MUN - CHEK LAP KOK LINK

2ND MONTHLY ENVIRONMENTAL MONITORING AND AUDIT (EM&A) REPORT—MAY 2021

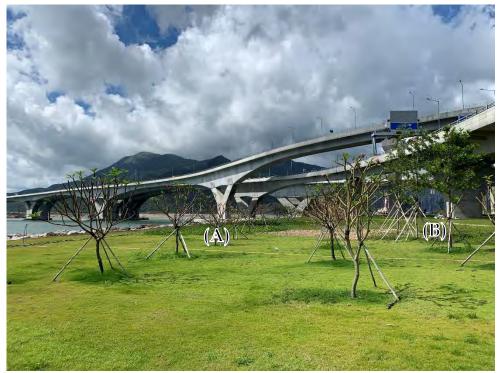
Photo 1: (A): *Plumeria rubra*; and (B): *Grevillea robusta* within Zone 2 (Taken on: 18 May 2021)

| Location | Photo | Information Information |
|---|---|---|
| Zone 2 | | Date: 18 May 2021 Observation 3: The tree, <i>Grevillea robusta</i> , planted with tree support systems in the vicinity of E14-A (pier mark) was leant. The tree health condition in terms of leaning should be closely monitored and reviewed, and the tree support systems with strength should be utilised, as necessary. Species: <i>Grevillea robusta</i> |
| Zone 2 | | Date: 18 May 2021 Observation 4: The tree, <i>Plumeria rubra</i> , planted in the vicinity of E14-A (pier mark) was in wilting. The tree health condition should be closely monitored and reviewed, and tree re-planting works should be undertaken in accordance with the latest planting plans if the tree has to be removed from site eventually. Species: <i>Plumeria rubra</i> |

- Tree health condition should be closely monitored and reviewed.
- Tree re-planting and grass planting works should be undertaken in accordance with the latest planting plans.
