Appendix E – Approval Letter of Tree Removal Application and Tree Schedule

Contract No. HY/2013/02
Hong Kong-Zhuhai-Macau Bridge (HZMB)
Hong Kong Boundary Crossing Facilities (HKBCF) –
Infrastructure Works Stage I (Western Portion)
Tree Removal Application

Tree Schedule

TREE ASSESSMENT SCHEDULE

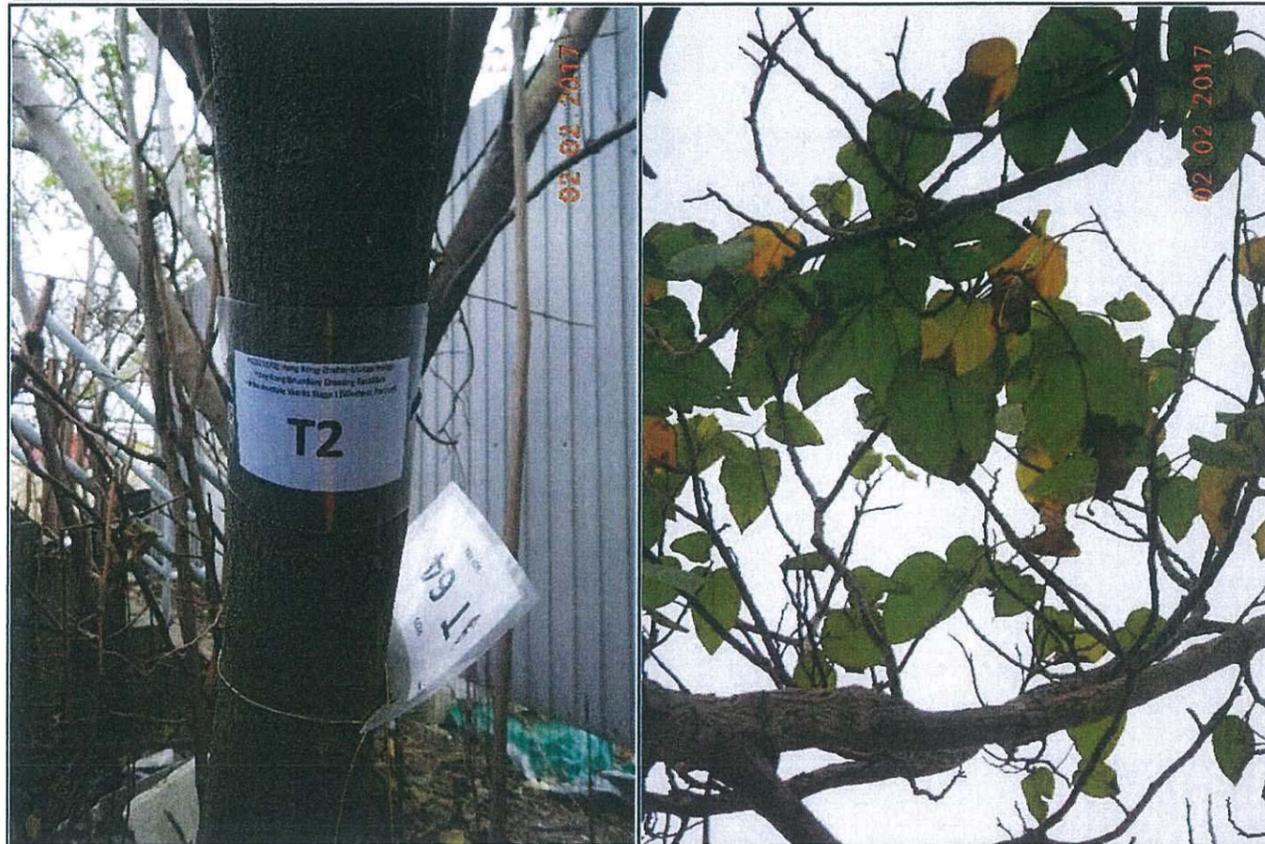
T2	<i>Broussonetia papyrifera</i>	構樹
Description :	Tree tag	
T2	<i>Broussonetia papyrifera</i>	構樹
Description :	Feature for identification

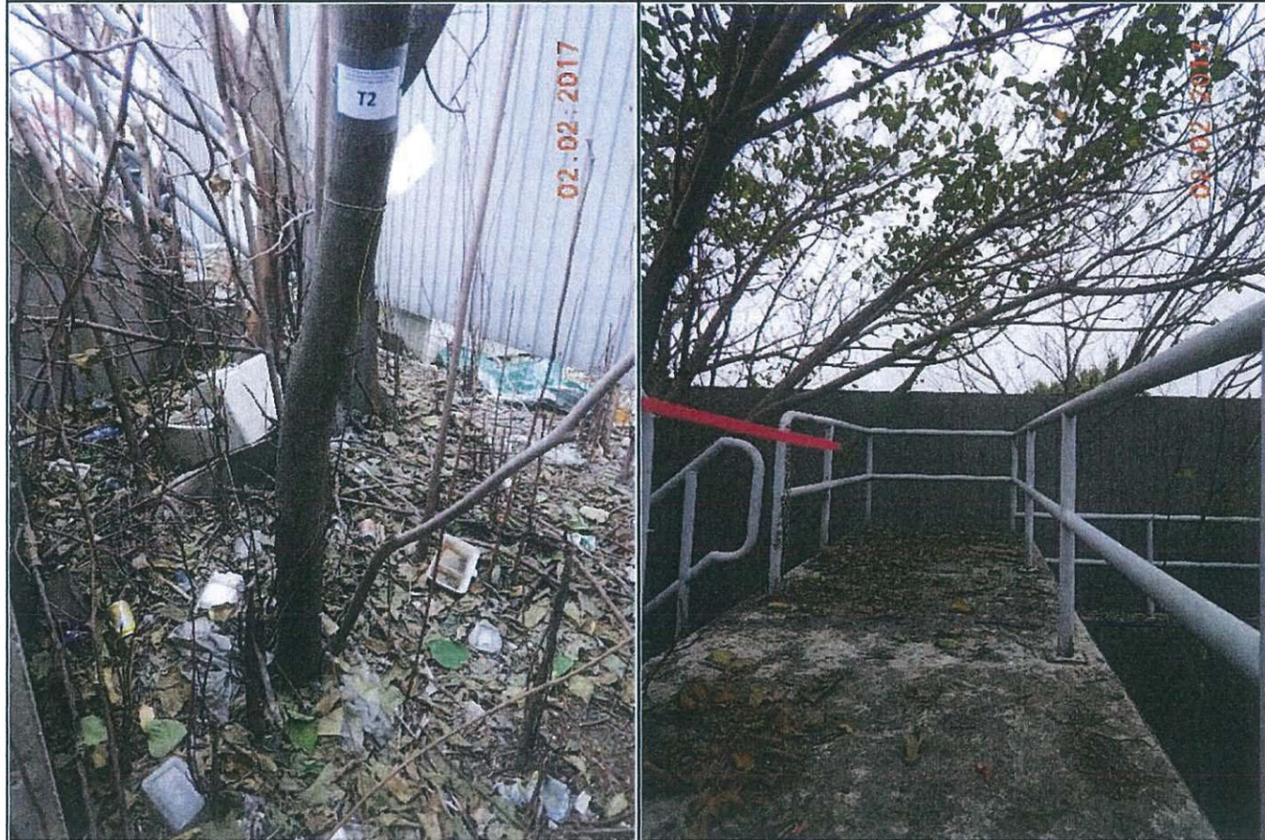
T2	<i>Broussonetia papyrifera</i>	構樹
Description :	Root collar condition	
T2	<i>Broussonetia papyrifera</i>	構樹
Description :	General view

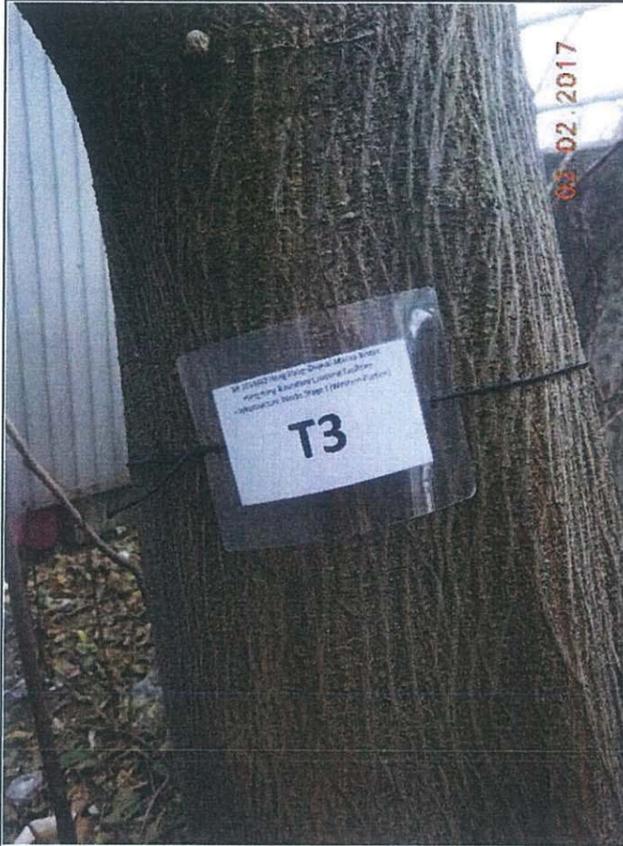
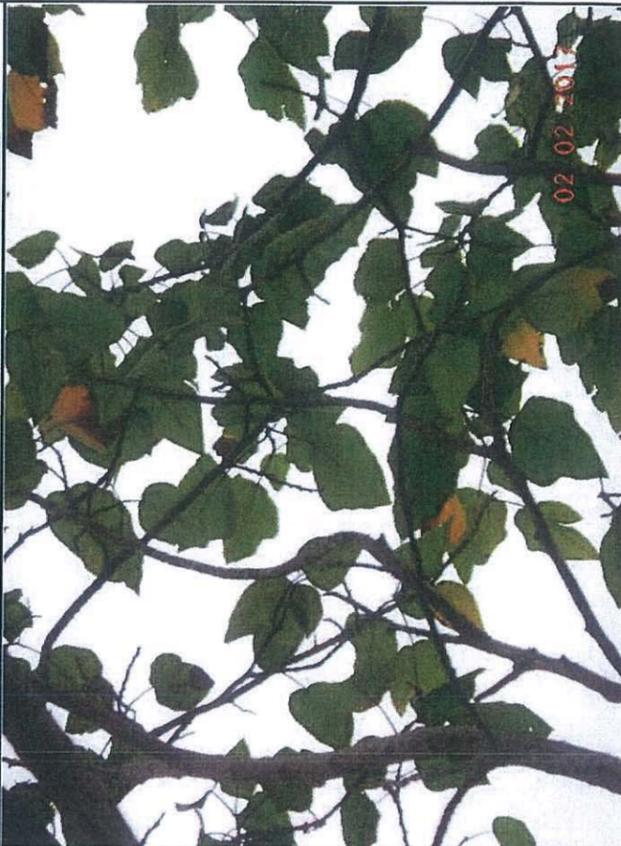
T3 <i>Broussonetia papyrifera</i> 構樹 Description : Tree tag	T3 <i>Broussonetia papyrifera</i> 構樹 Description : Feature for identification

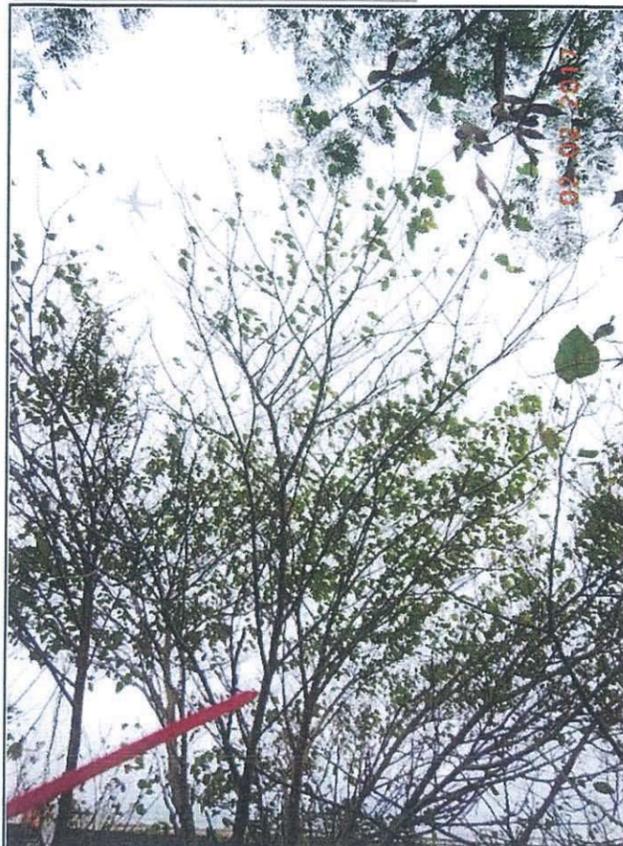
T3 <i>Broussonetia papyrifera</i> 構樹 Description : Root collar condition Included bark	T3 <i>Broussonetia papyrifera</i> 構樹 Description : General view

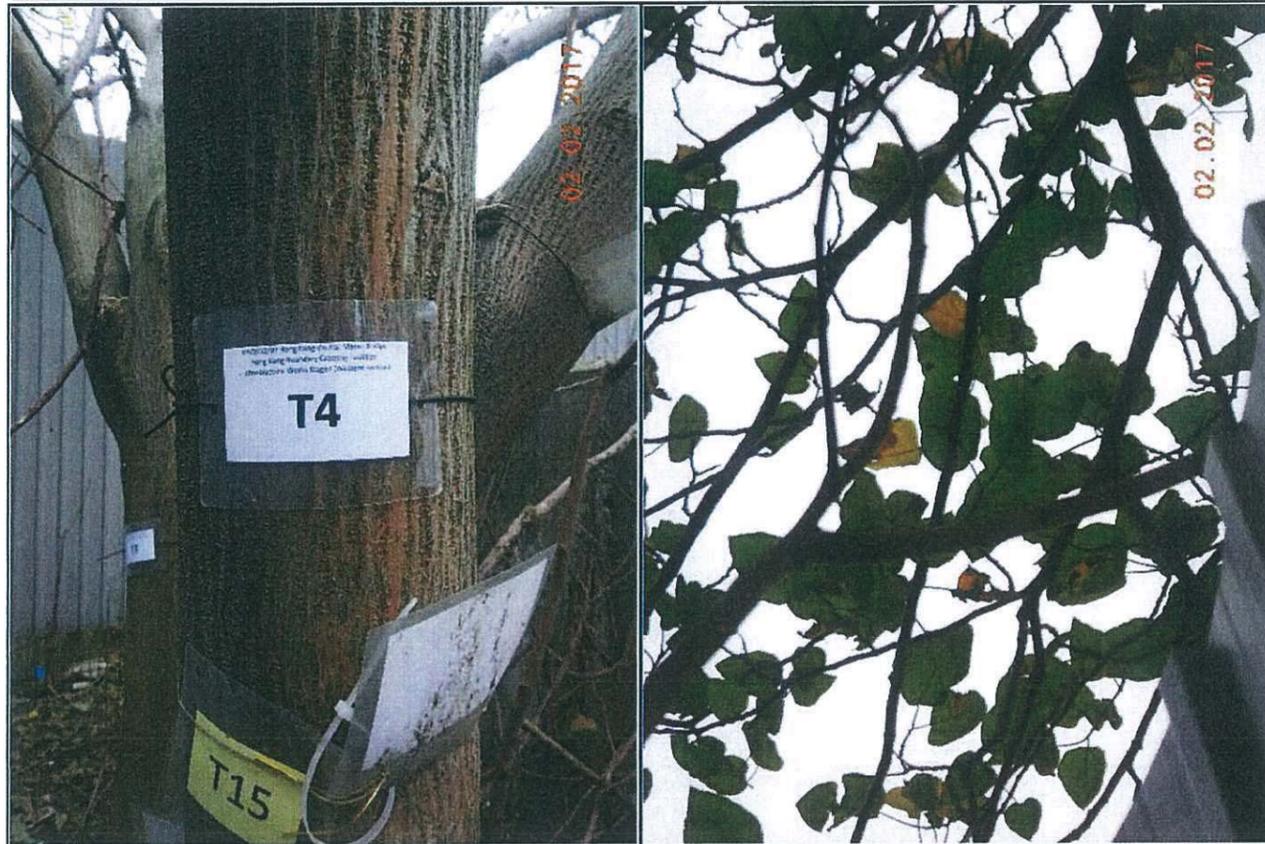
T4 *Broussonetia papyrifera* 構樹
 Description : Tree tag

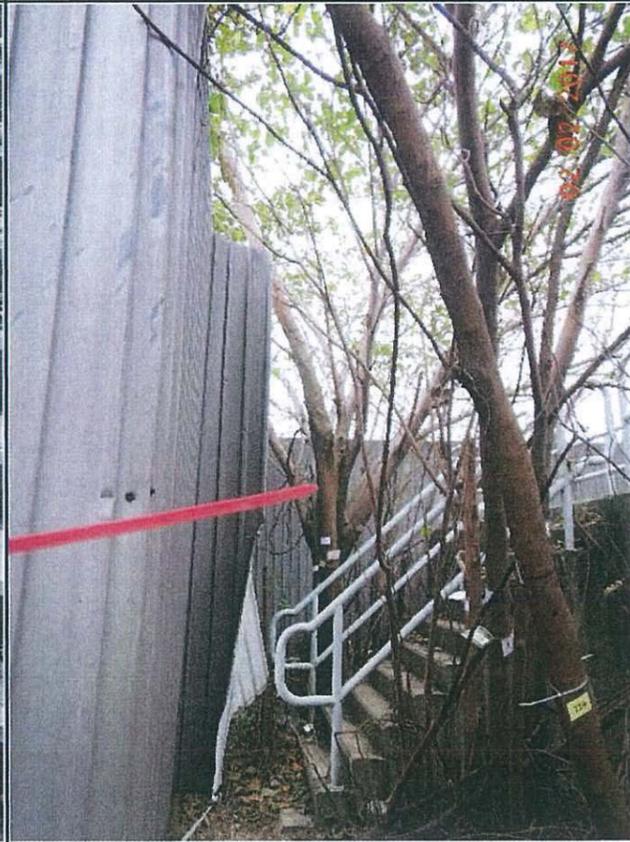
T4 *Broussonetia papyrifera* 構樹
 Description : General view

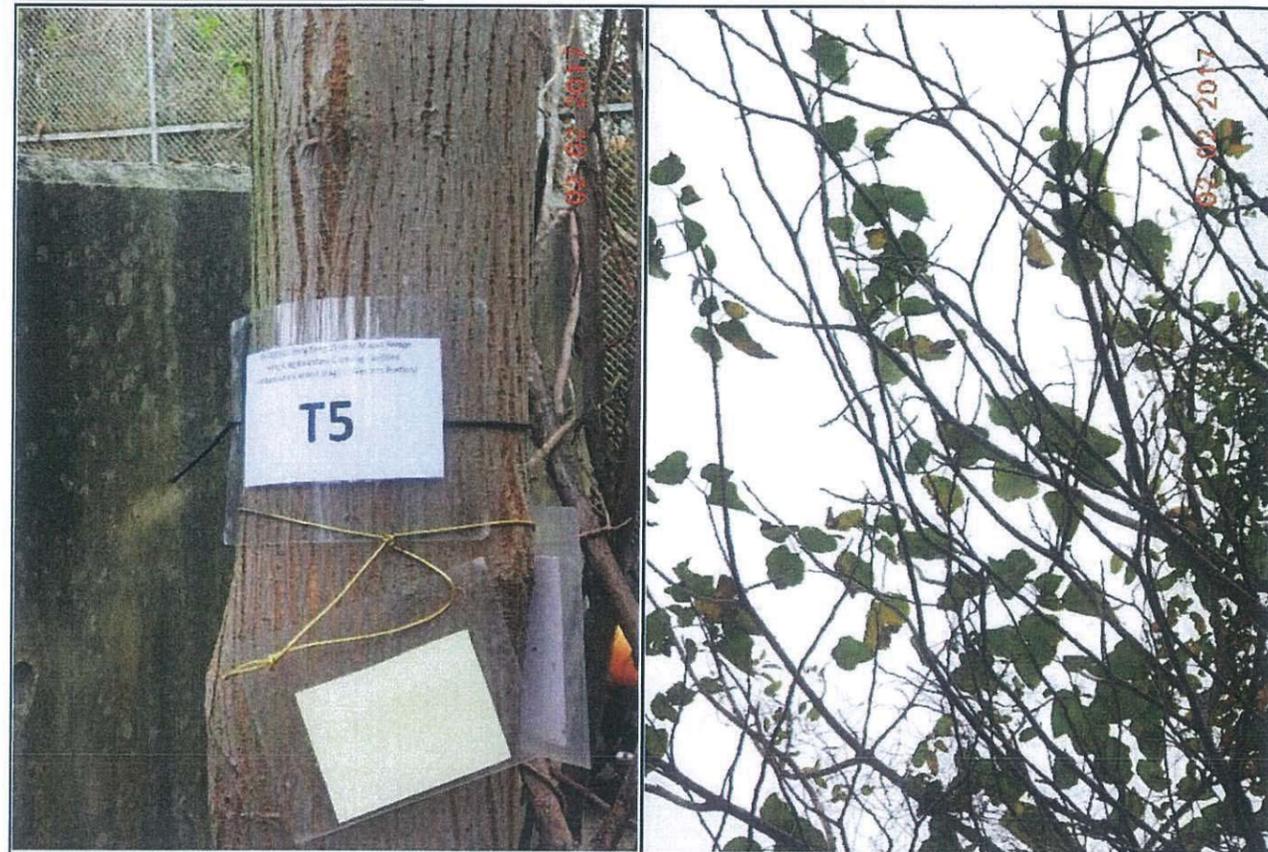
T5	<i>Broussonetia papyrifera</i>	構樹	T5	<i>Broussonetia papyrifera</i>	構樹
Description :	Tree tag		Description :	Feature for identification

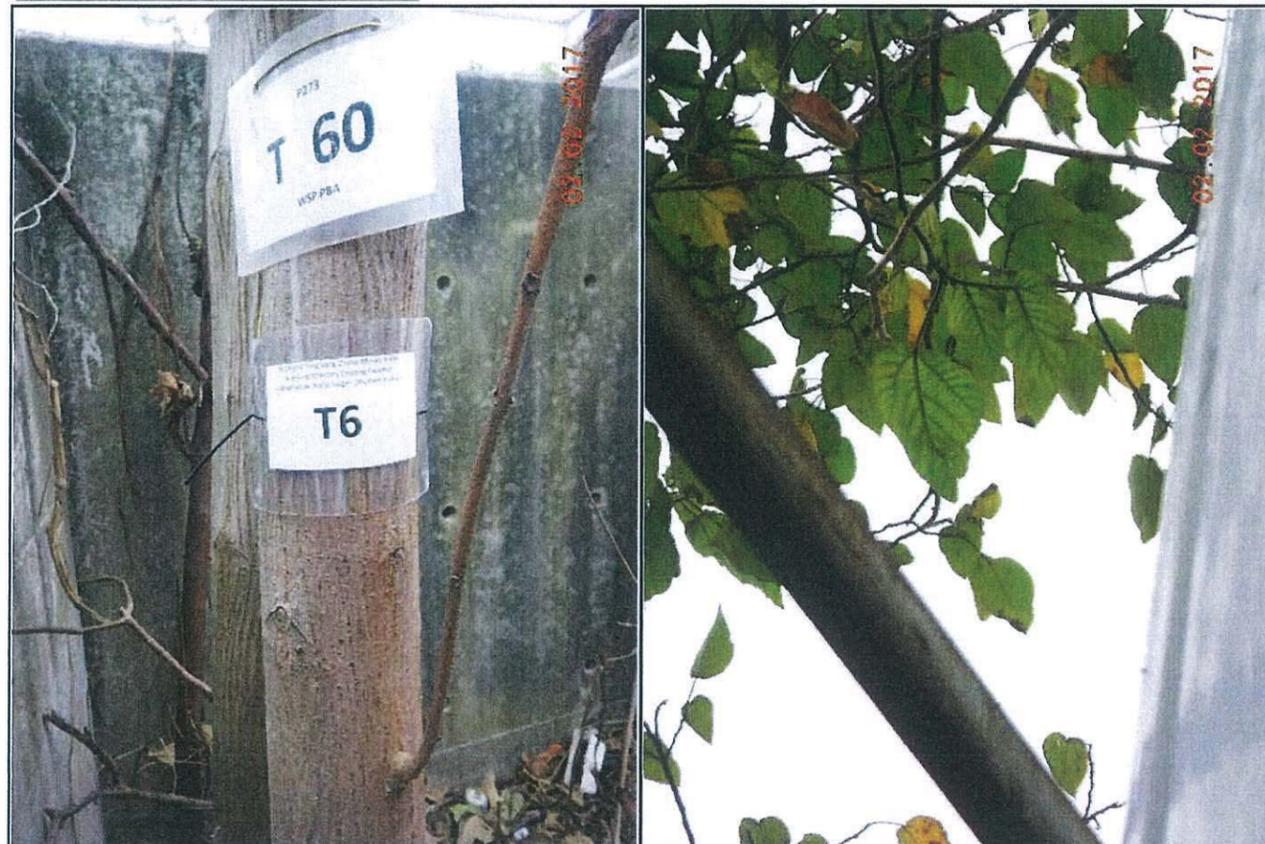
T6 *Broussonetia papyrifera* 構樹
 Description : Tree tag

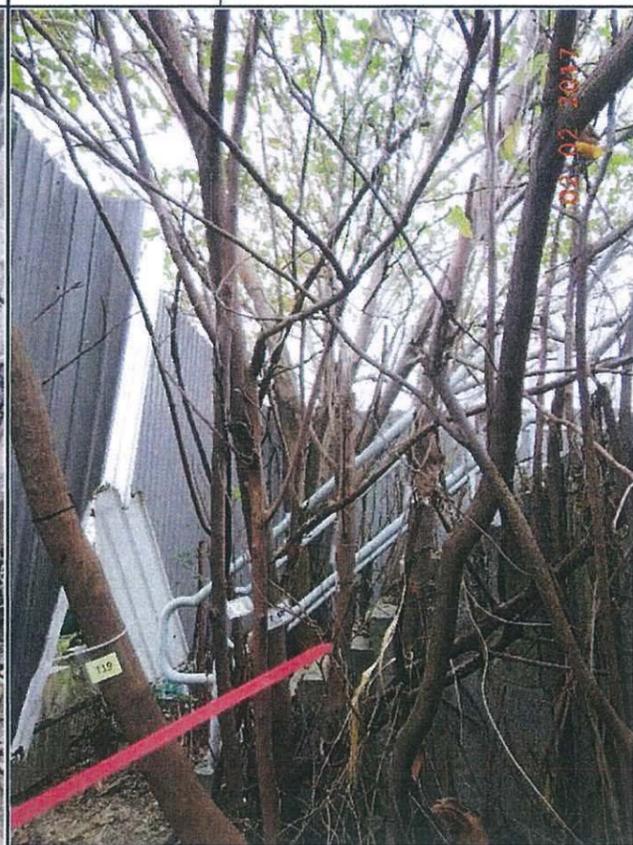
T6 *Broussonetia papyrifera* 構樹
 Description : General view

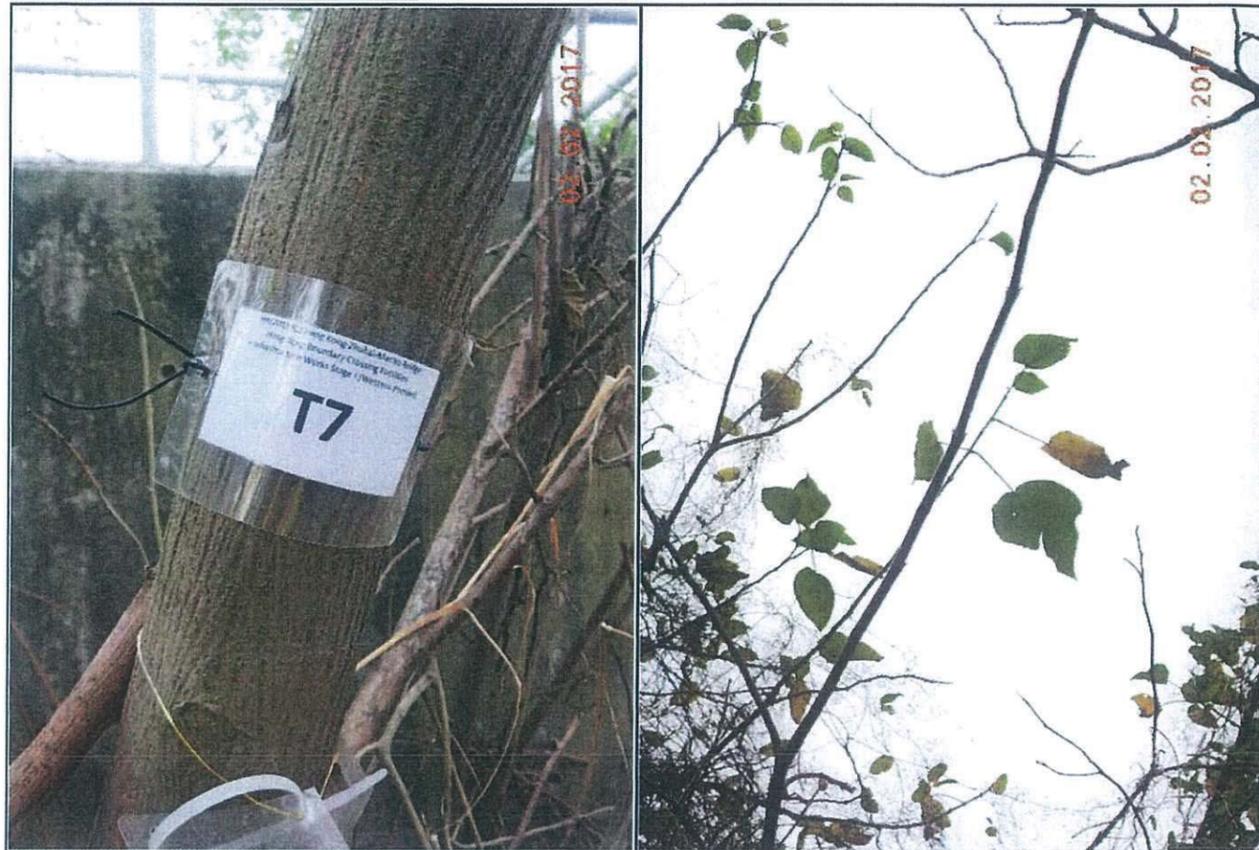
T7	<i>Broussonetia papyrifera</i>	構樹
Description :	Tree tag	
T7	<i>Broussonetia papyrifera</i>	構樹
Description :	Feature for identification

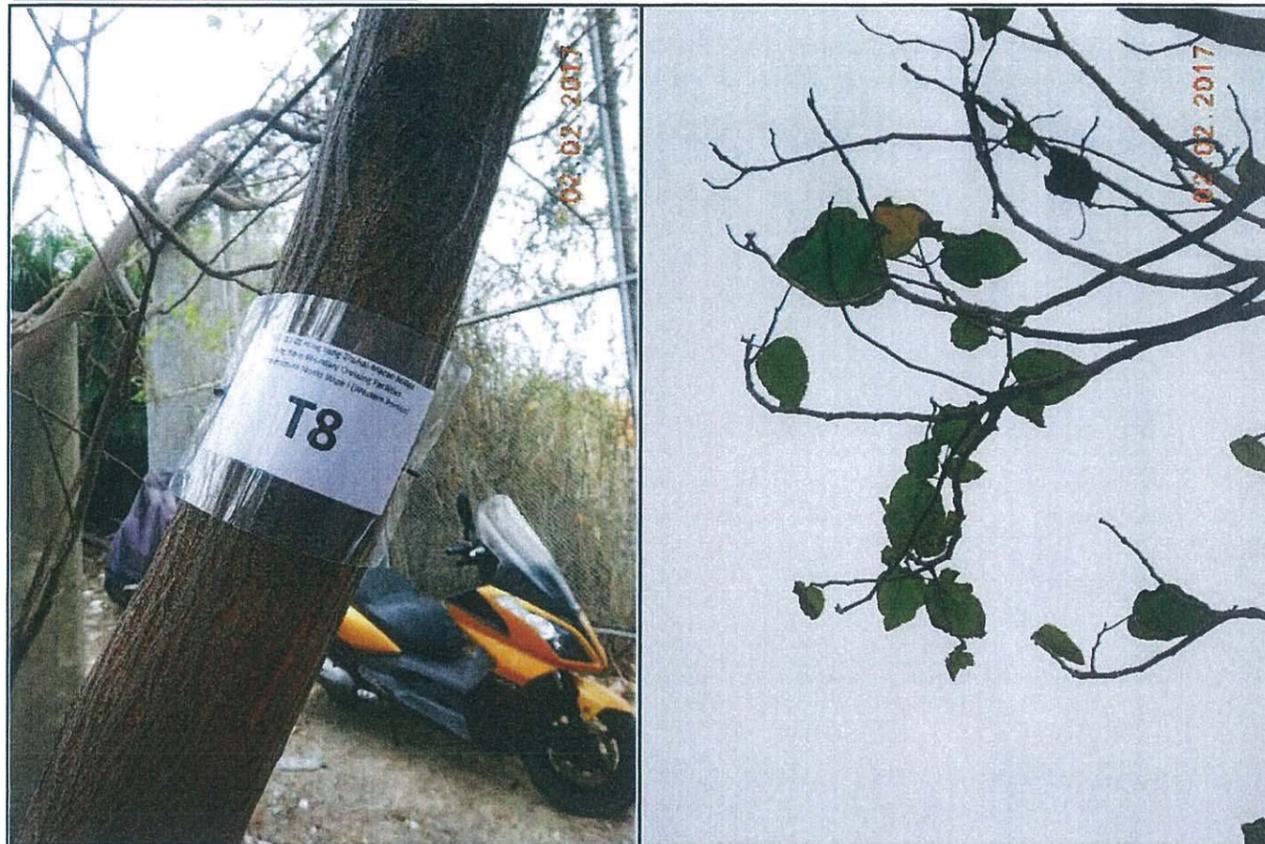
T8 *Broussonetia papyrifera* 構樹
 Description : Tree tag

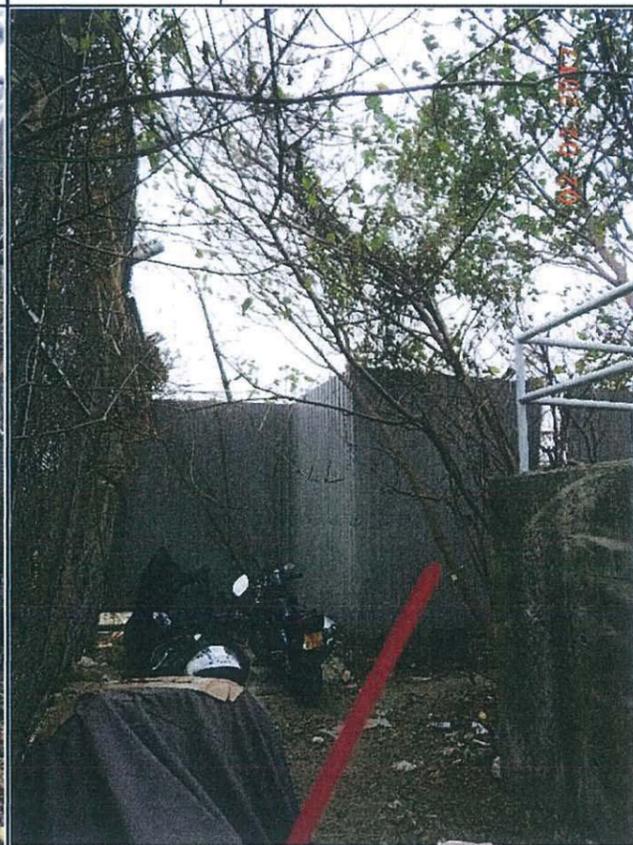
T8 *Broussonetia papyrifera* 構樹
 Description : Root collar condition
 Leaned trunk

T8 *Broussonetia papyrifera* 構樹
 Description : General view

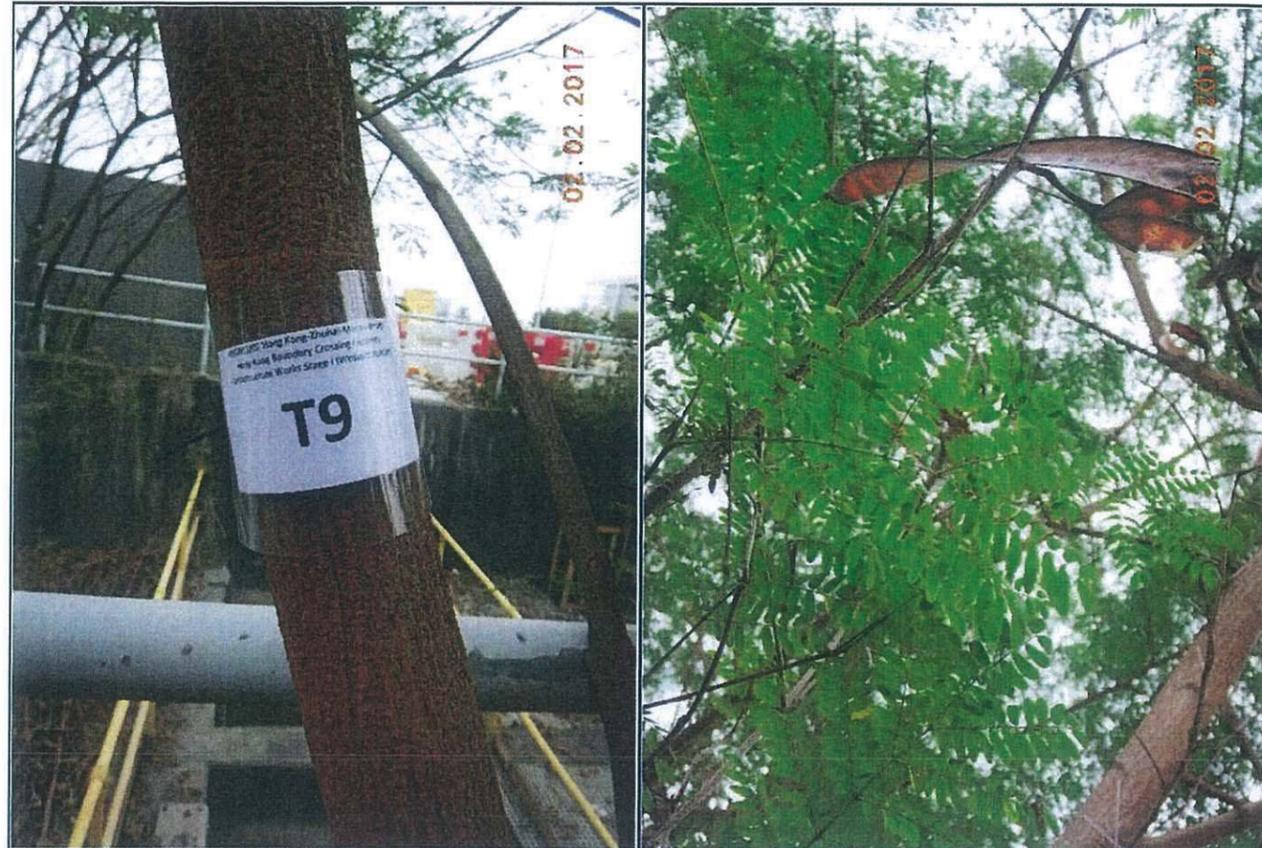
T9	<i>Leucaena leucocephala</i>	銀合歡
Description :	Tree tag	
T9	<i>Leucaena leucocephala</i>	銀合歡
Description :	Feature for identification

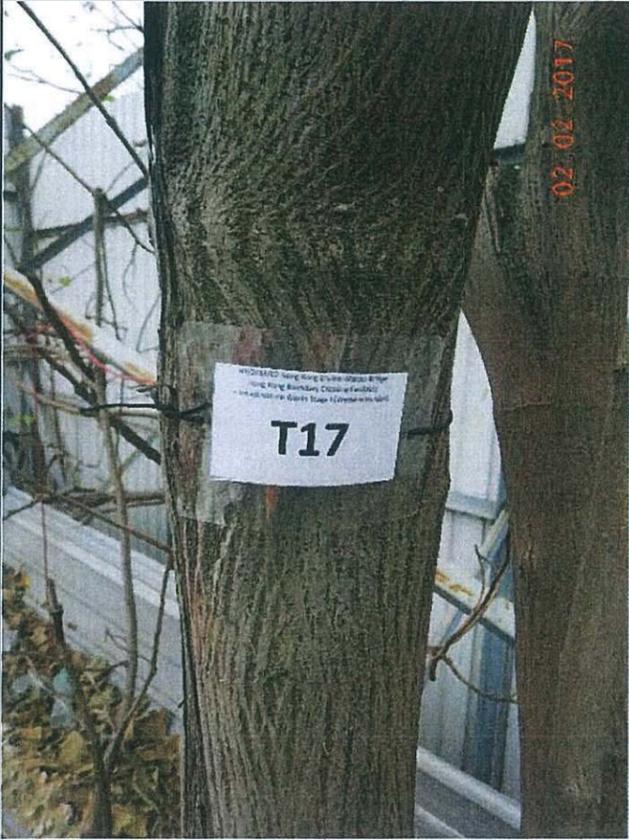
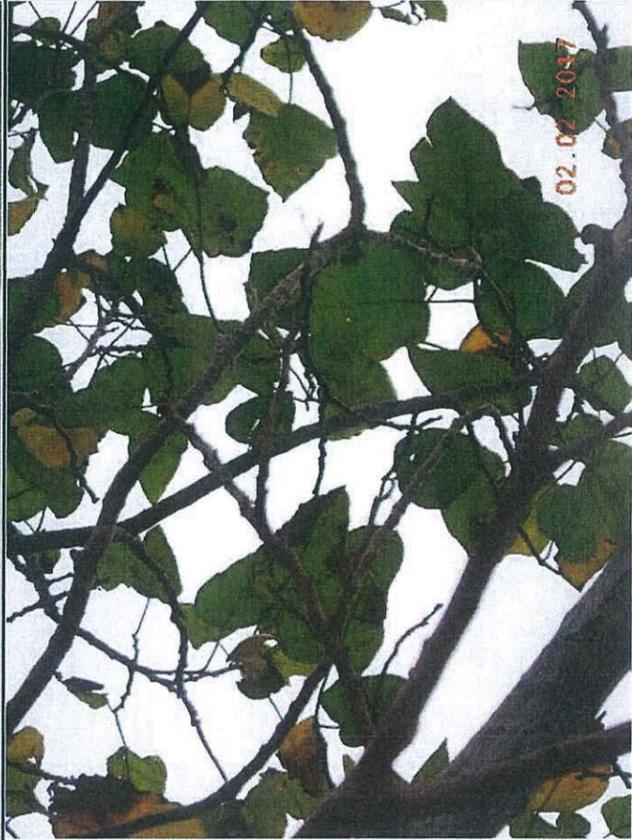
T17 <i>Broussonetia papyrifera</i> 構樹 Description : Tree tag		T17 <i>Broussonetia papyrifera</i> 構樹 Description : Feature for identification
