Contract No. HY/2010/02

**Hong Kong – Zhuhai – Macao Bridge  
Hong Kong Boundary Crossing  
Facilities –  
Reclamation Works**

**Monthly EM&A Report for November 2013**

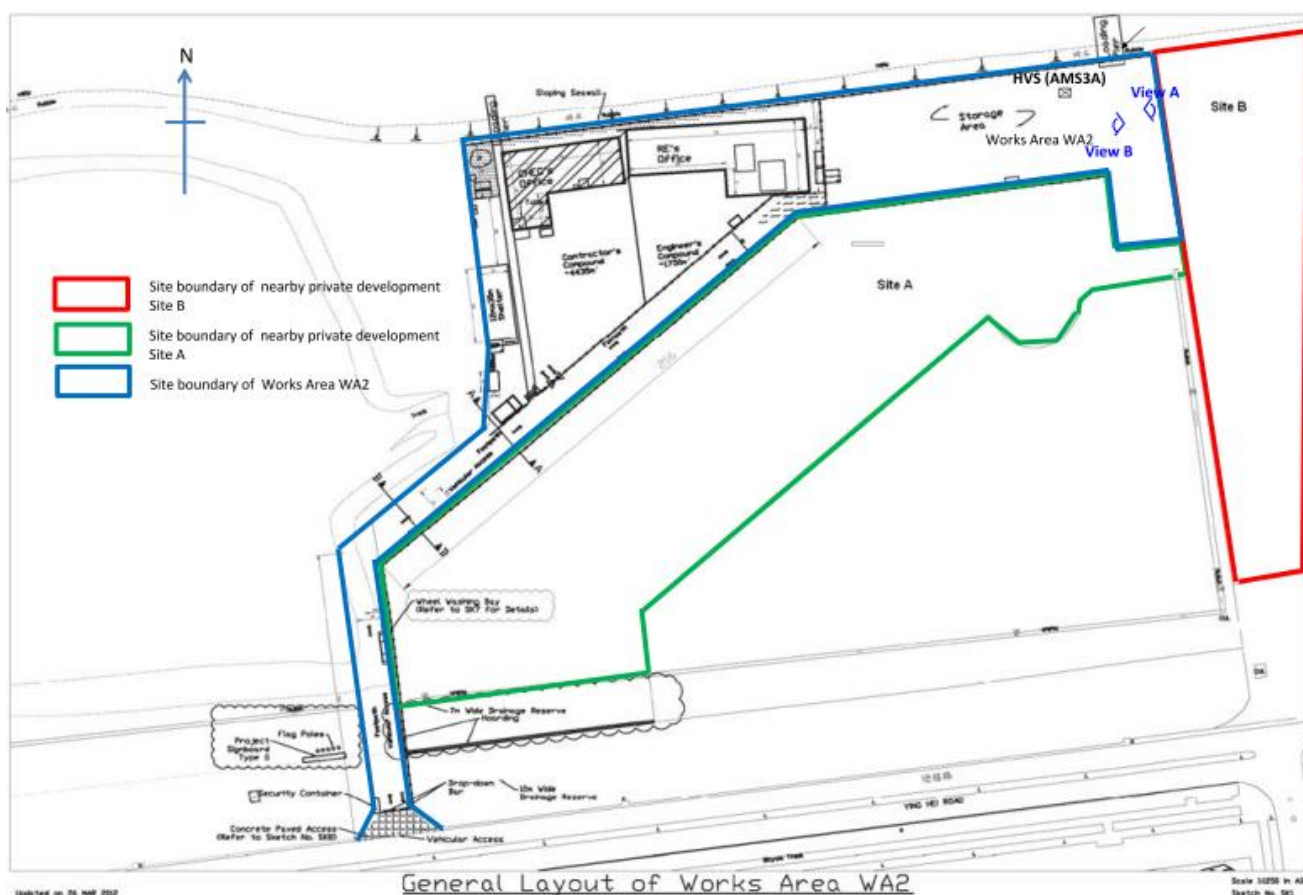
- 2.7.4.3 Photo records shows vehicle parking activities were observed inside an area at construction sites of nearby private development project which are close to the monitoring station AMS3A but beyond the site boundary of Works Area WA2. (Please also see photo and layout map attached for reference of site conditions (View A.))

**Conditions of the construction sites near Works Area WA2:**

View A: (Parking lot observed at nearby construction site which do not belongs to this Contract):

View B (Hard paved surface observed at Works Area WA2)

- 2.7.4.8 The dust exceedance was therefore considered not to be due to the Project works.
- 2.7.4.9 The Contractor was recommended to continue implementing existing dust mitigation measures.

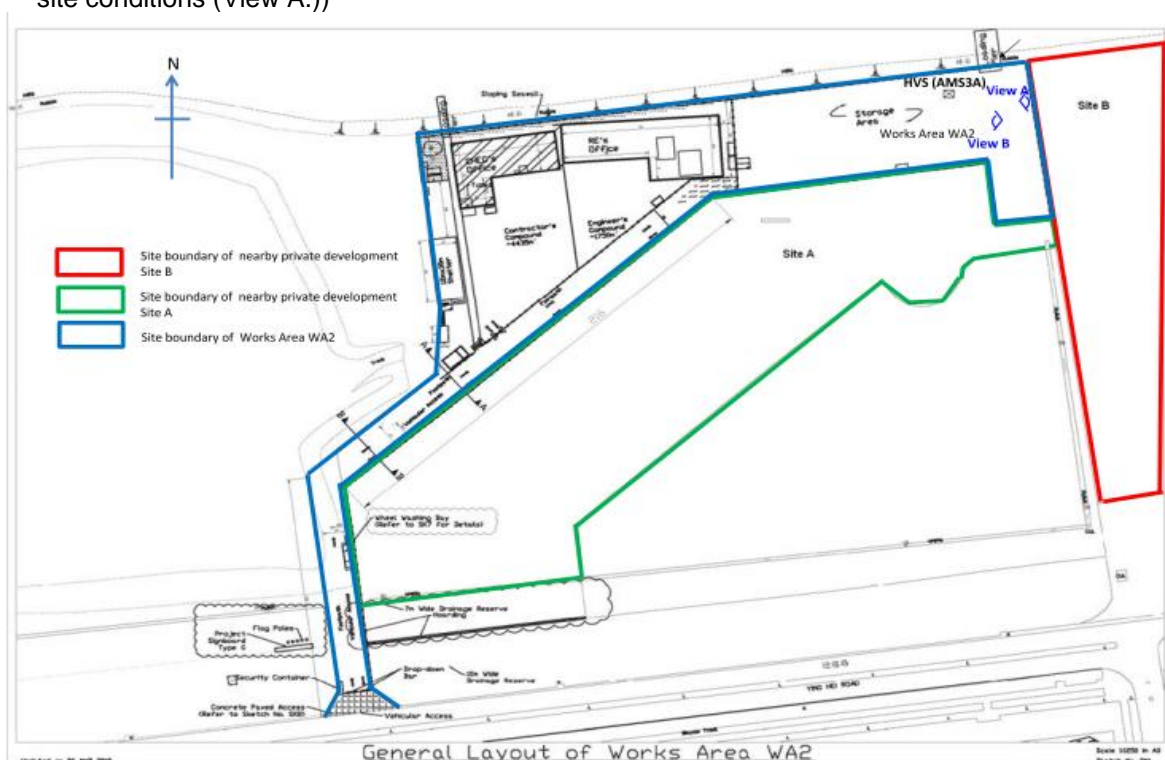
- 2.7.5.3 Photo records shows vehicle parking activities were observed inside an area at construction sites of nearby private development project which are close to the monitoring station AMS3A but beyond the site boundary of Works Area WA2. (Please also see photo and layout map attached for reference of site conditions (View A.))

**Photo record:**

View A (parking lot observed at nearby construction site which do not belongs to this Contract)

View B (Hard paved surface observed at Works Area WA2)

- 2.7.5.8 The dust exceedance was therefore considered not to be due to the Project works.
- 2.7.5.9 The Contractor was recommended to continue implementing existing dust mitigation measures.

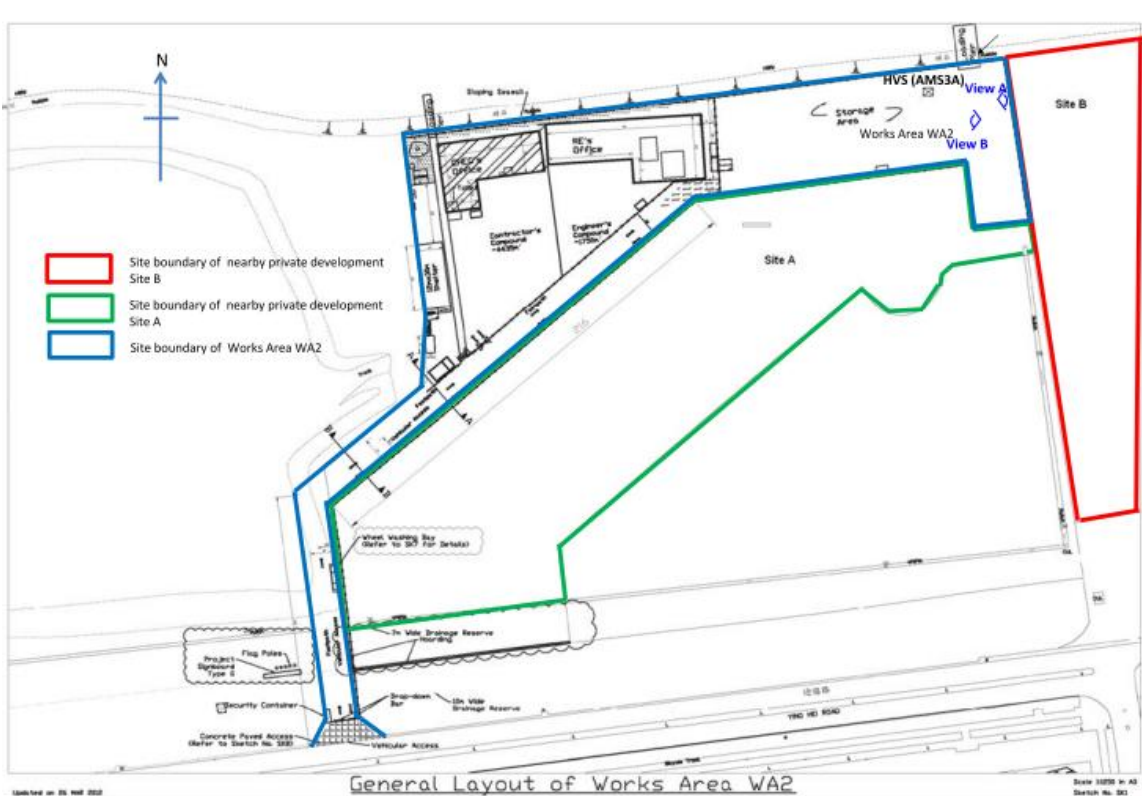
- 2.7.6.3 Photo records shows vehicle parking activities were observed inside an area at construction sites of nearby private development project which are close to the monitoring station AMS3A but beyond the site boundary of Works Area WA2. (Please also see photo and layout map attached for reference of site conditions (View A.))

**Photo record:**

View A (parking lot observed at nearby construction site which do not belongs to this Contract)

View B (Hard paved surface observed at Works Area WA2)

- 2.7.6.8 The dust exceedance was therefore considered not to be due to the Project works.
- 2.7.6.9 The Contractor was recommended to continue implementing existing dust mitigation measures.

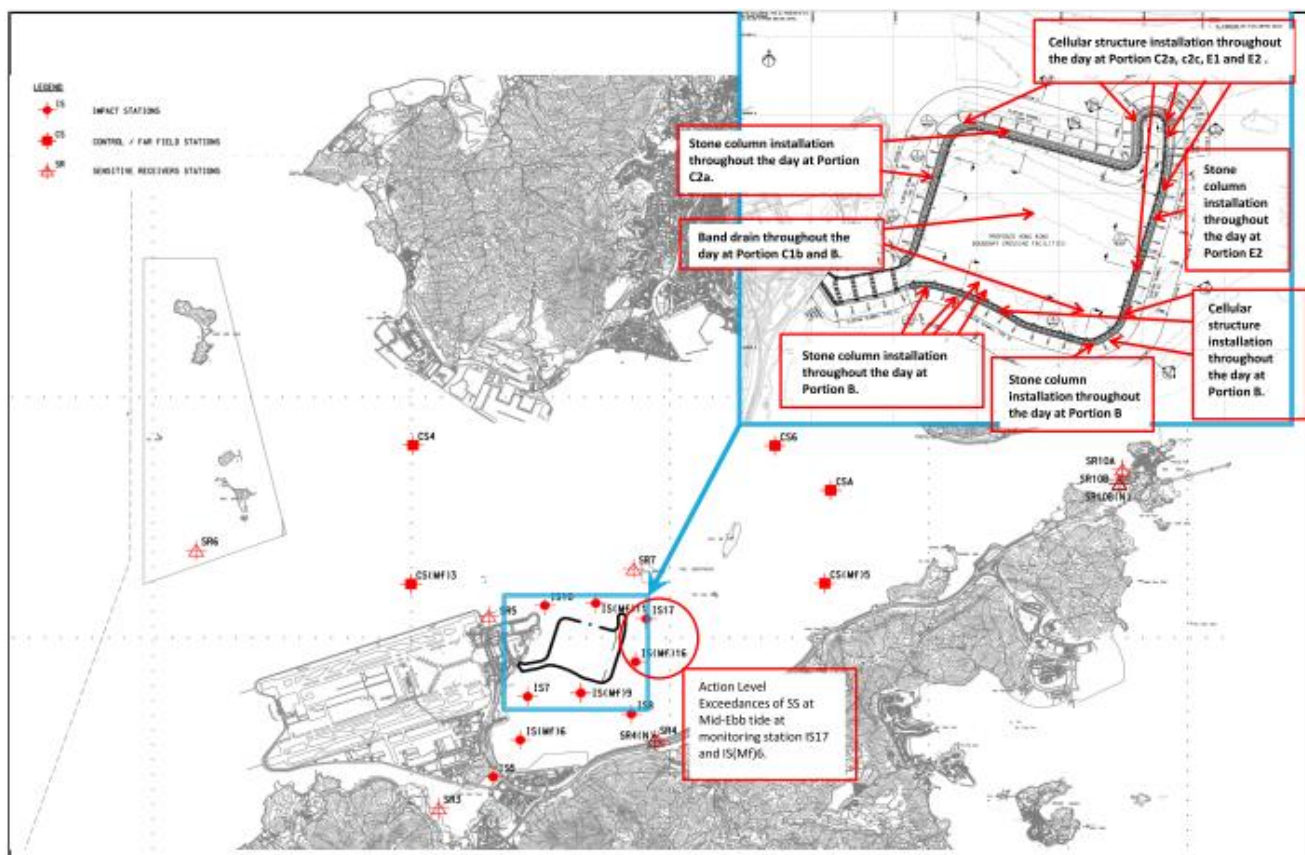
4.7.5 Two (2) Action Level exceedances at measured Suspended Solids (mg/L) were recorded on 04 Nov 2013 at monitoring station IS(Mf) 16 and IS(17 at Mid-Ebb tide and Mid-Flood tide respectively. For Action Level exceedances at measured Suspended Solids (mg/L), 24.3 mg/L and 31.6 mg/L was recorded at Monitoring Station IS(Mf)16 and IS(Mf)9 respectively.

- 4.7.5.1 For locations and type of active works carried out on 4 Nov 13, please refer to the above layout map.
- 4.7.5.2 For action level exceedance of suspended solid recorded at IS(Mf)16 and IS17 during mid ebb tide, active works were carried out at almost the same locations on 1, 4 and 6 Nov 13, but all Suspended Solids results recorded at all monitoring location on 1 and 6 Nov 13 are all below the Action and Limit Level during the same tide on the same day which indicates active works is unlikely to adversely affect the water quality at IS(Mf)16 and IS17

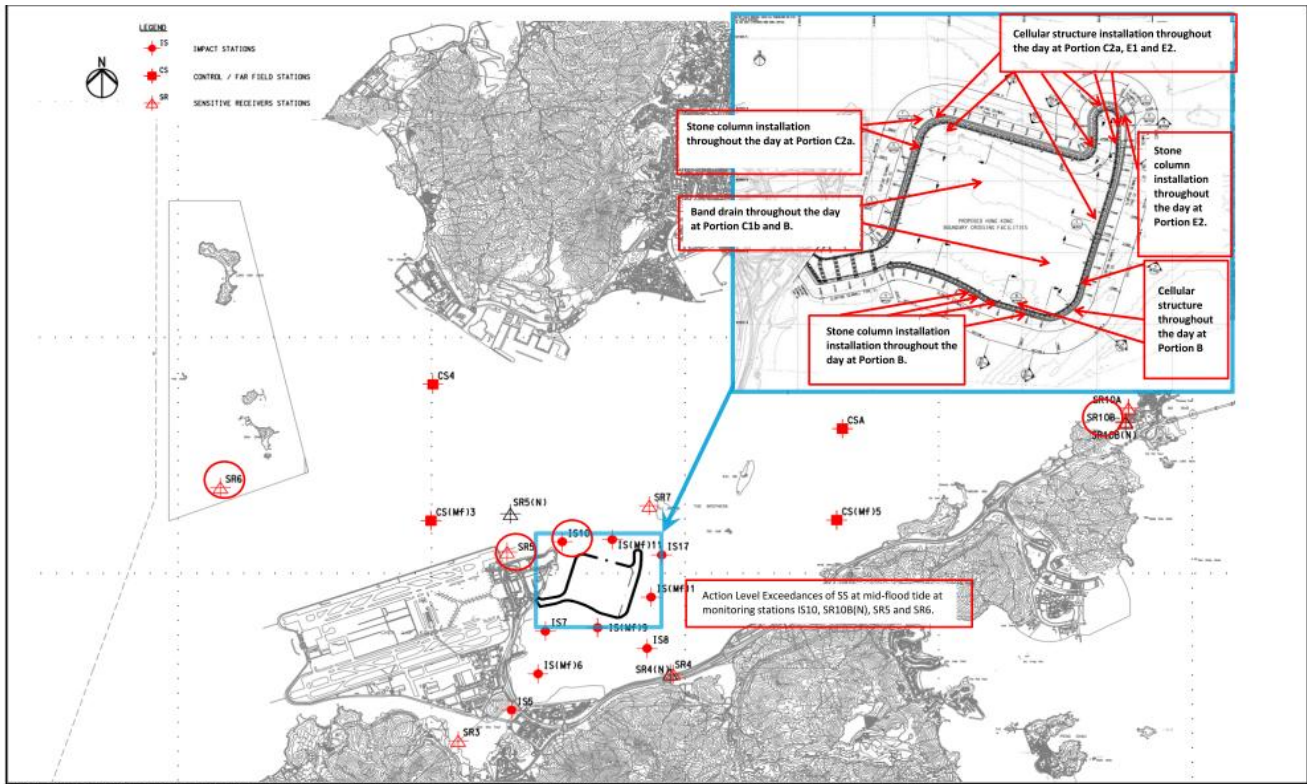
4.7.6 Four (4) Action Level exceedances at measured Suspended Solids (mg/L) were recorded on 06 Nov 2013 during mid-flood tide at monitoring station IS10 and SR5. For Action Level exceedances at measured Suspended Solids (mg/L), 30.8 mg/L, 27.0 mg/L, 31.9 mg/L and 25.2 mg/L were recorded at Monitoring Station IS10, SR10B(N), SR5 and SR6 respectively.

- 4.7.6.1 Active works like stone column and cellular structure installation were carried out at Portion C2a, E1, E2 and B but no exceedance was recorded at IS(Mf)11 which IS(Mf)11 is considered downstream and closer to active works of Portion E1 and E2. No exceedance was recorded at IS7 which IS7 is considered downstream to active works of Portion B.

- 4.7.6.2 Exceedances (IS10, SR5 and SR6) recorded at stations which are considered located downstream and closest to active works at Portion C2a during flood tide.

- 4.7.6.10 As such, the exceedances recorded at IS10, SR5, SR6 and SR10B(N) were considered as non-Project related.
- 4.7.6.11 Nevertheless, the Contractor was reminded to ensure provision of ongoing maintenance to the silt curtains and to carry out maintenance work once defects were found.

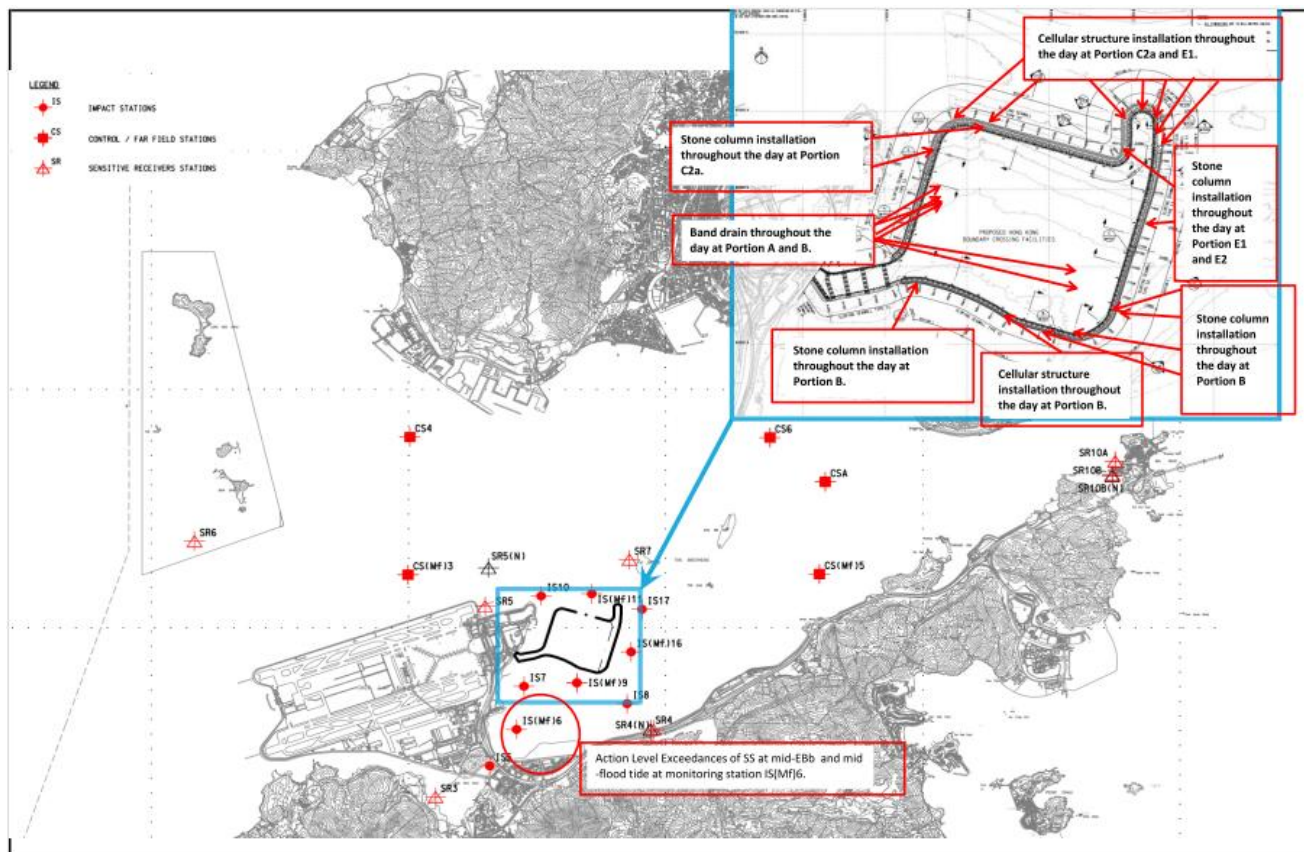
4.7.7 Two (3) Action Level exceedances at measured Suspended Solids (mg/L) were recorded on 11 Nov 13 2013 during mid-flood tide and mid-ebb tide at monitoring station IS(Mf)16. For Action Level exceedance at measured Suspended Solids (mg/L), 27.9mg/L and 26.4mg/L was recorded at Monitoring Station IS(Mf)16

4.7.7.1 Please refer the above layout map for activity carried out on 11 Nov 13.

4.7.7.2 Suspended Solids values recorded at Impact Station IS(Mf)9 and IS7 which are closer to the works than monitoring station IS(Mf)6 are all below the Action and Limit Level during the same tide on the same day. This indicates that active works is unlikely to cause the exceedances at IS(Mf)6.

4.7.7.9 Nevertheless, the Contractor was reminded to ensure provision of ongoing maintenance to the silt curtains and to carry out maintenance work once defects were found.

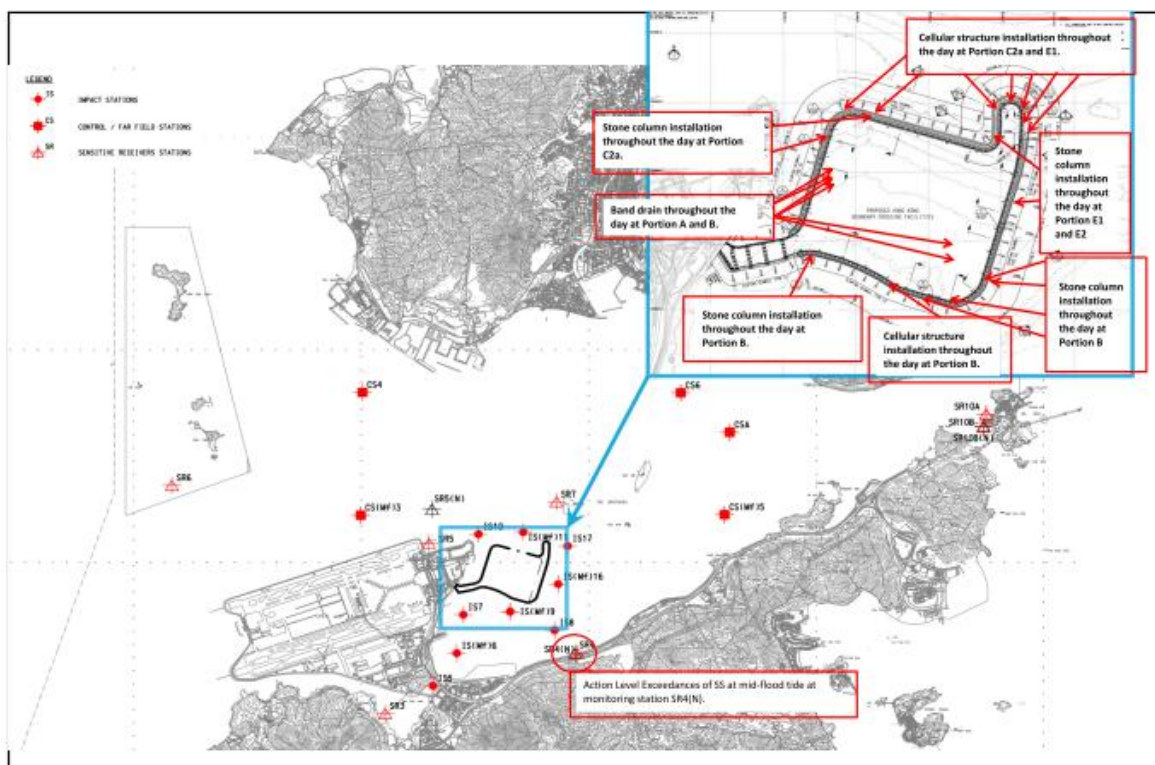
4.7.8 One (1) Action Level exceedance at measured Suspended Solids (mg/L) was recorded on 13 Nov 13 during mid-flood tide at monitoring station SR4(N). For Action Level exceedance at measured Suspended Solids (mg/L), 3 mg/L was recorded.

- 4.7.8.1 Please refer the above layout map for activity carried out on 13 Nov13.
- 4.7.8.2 IS(Mf)9, IS8 and IS(Mf)16 are located closer to the active works than monitoring station SR4(N). Depth Averaged Suspended Solids (SS) values (in mg/L) recorded during the flood tide on the same day at IS(Mf)9, IS8 and IS(Mf)16 were below the Action and Limit Level which indicates project works is unlikely to contribute to the action level exceedance recorded at SR4(N).

- 4.7.8.3 The monitoring location of monitoring station SR4(N) are considered upstream to the active works of this project during flood tide. Therefore it was unlikely that the exceedance recorded at SR4(N) was due to active construction activities of this project.

- 4.7.8.4 The exceedance was likely due to local effects in the vicinity of SR4(N).
- 4.7.8.5 Nevertheless, the Contractor was reminded to ensure provision of ongoing maintenance to the silt curtains and to carry out maintenance work once defects were found.

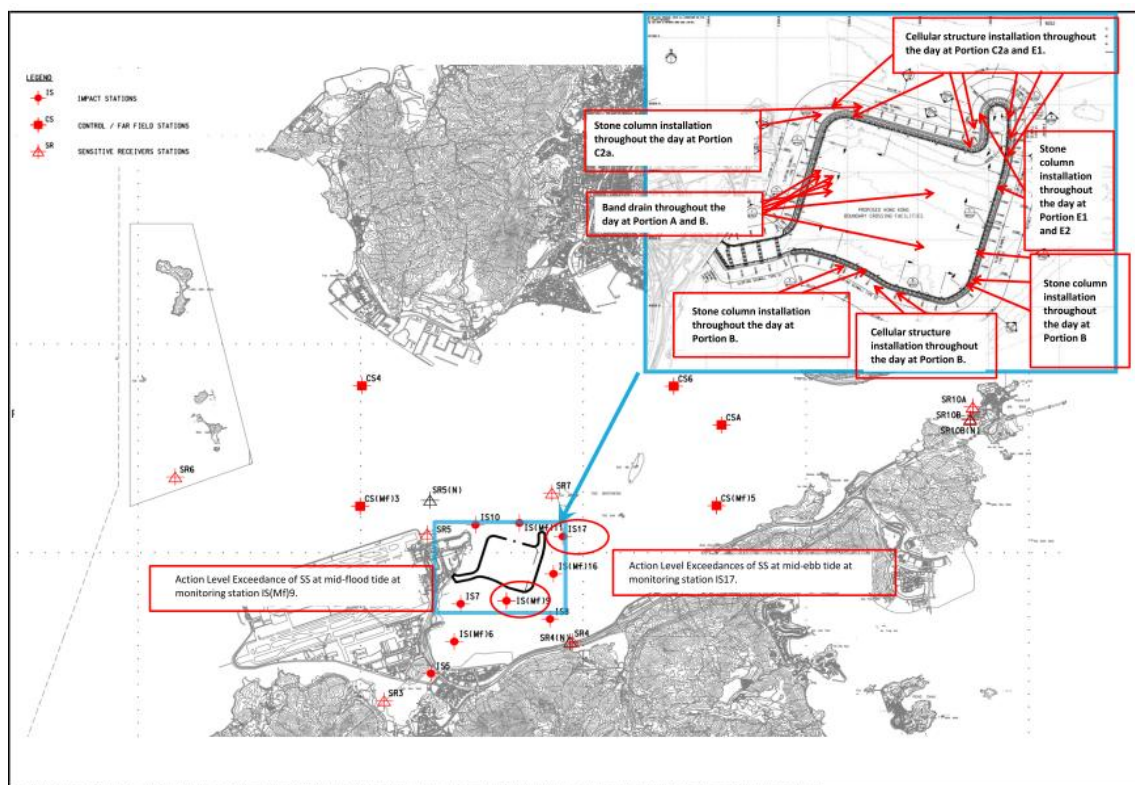
4.7.9 Two (2) action level exceedance of SS was recorded on 15 Nov 13 at monitoring station SR10(B)N and SS level of 23.8 mg/L was recorded.

4.7.9.1 Please refer the below layout map for activity carried out on 15 Nov 13.

4.7.9.4 Refer to the attached layout map, active works were noted directly upstream to IS(Mf)9 during flood tide and IS17 during ebb tide, but no defects at south alignment (Nearby IS(Mf)9 and the northwest alignment of the perimeter silt curtain (nearby S117) when monitoring was conducted on 15 Nov 13.

4.7.9.7 Nevertheless, the Contractor was reminded to ensure provision of ongoing maintenance to the silt curtains and to carry out maintenance work once defects were found.

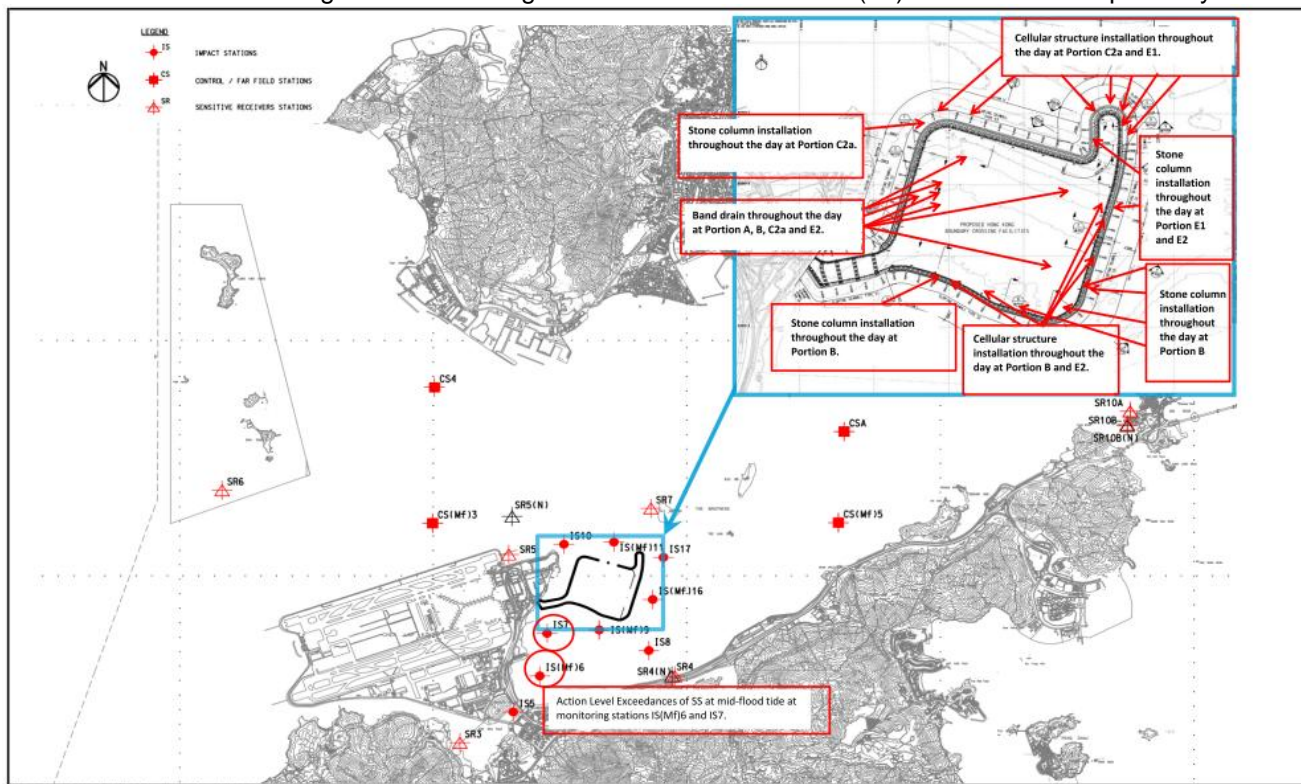
4.7.10 Two (2) Action level exceedance of SS was recorded on 20 Nov 13 at monitoring station IS(Mf)6 and IS7 SS level of 31.5mg/L and 23.7mg/L was recorded for IS(Mf)6 and IS7 respectively.

4.7.10.1 Please refer attached Layout Maps for work activity carried out on 22 Nov 13.

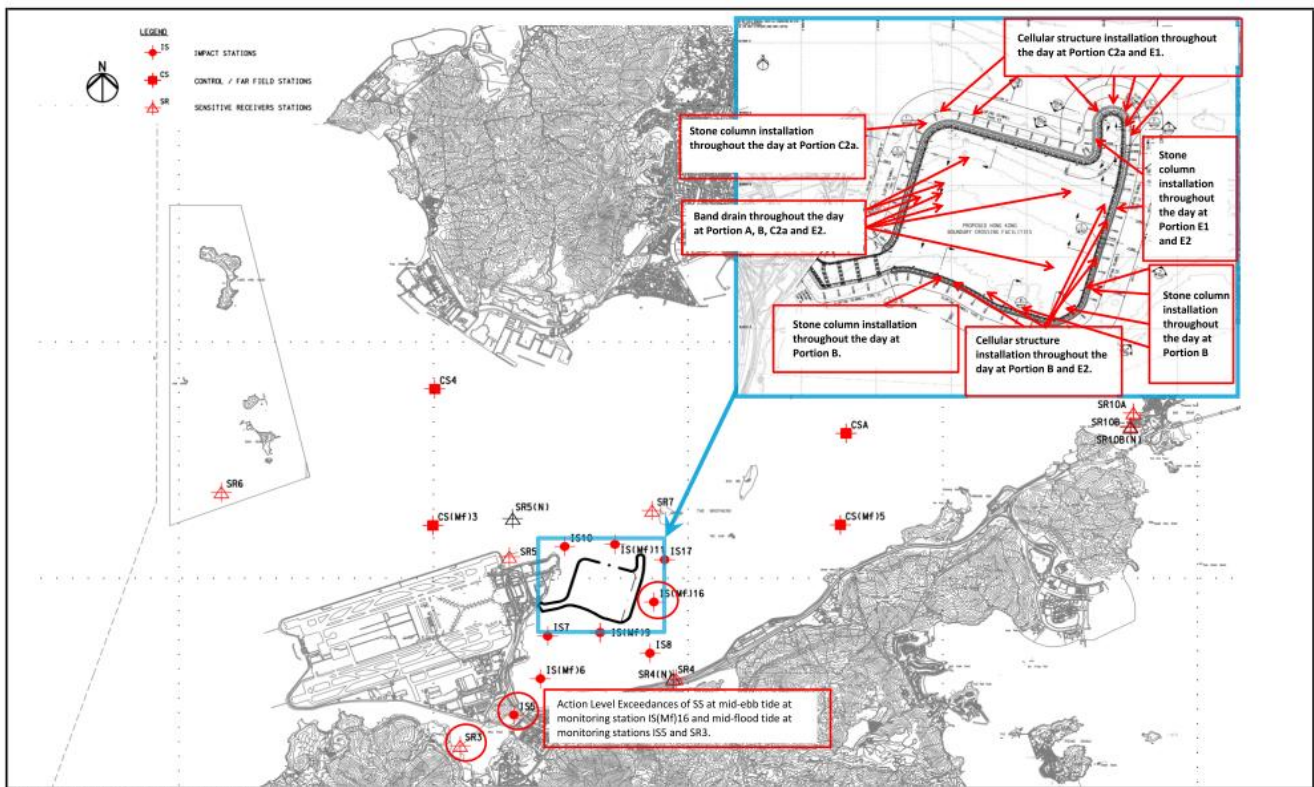
4.7.11 Two (2) Action level exceedance of SS was recorded on 22 Nov 13 at monitoring station IS5 and SR3. SS level of 24.6mg/L and 23.7mg/L was recorded for IS5 and SR3 respectively.

4.7.11.1 Please refer attached Layout Maps for work activity carried out on 22 Nov 13.
