Contract No. HY/2010/02

**Hong Kong – Zhuhai – Macao Bridge  
Hong Kong Boundary Crossing  
Facilities –  
Reclamation Works**

**Monthly EM&A Report for December 2013**

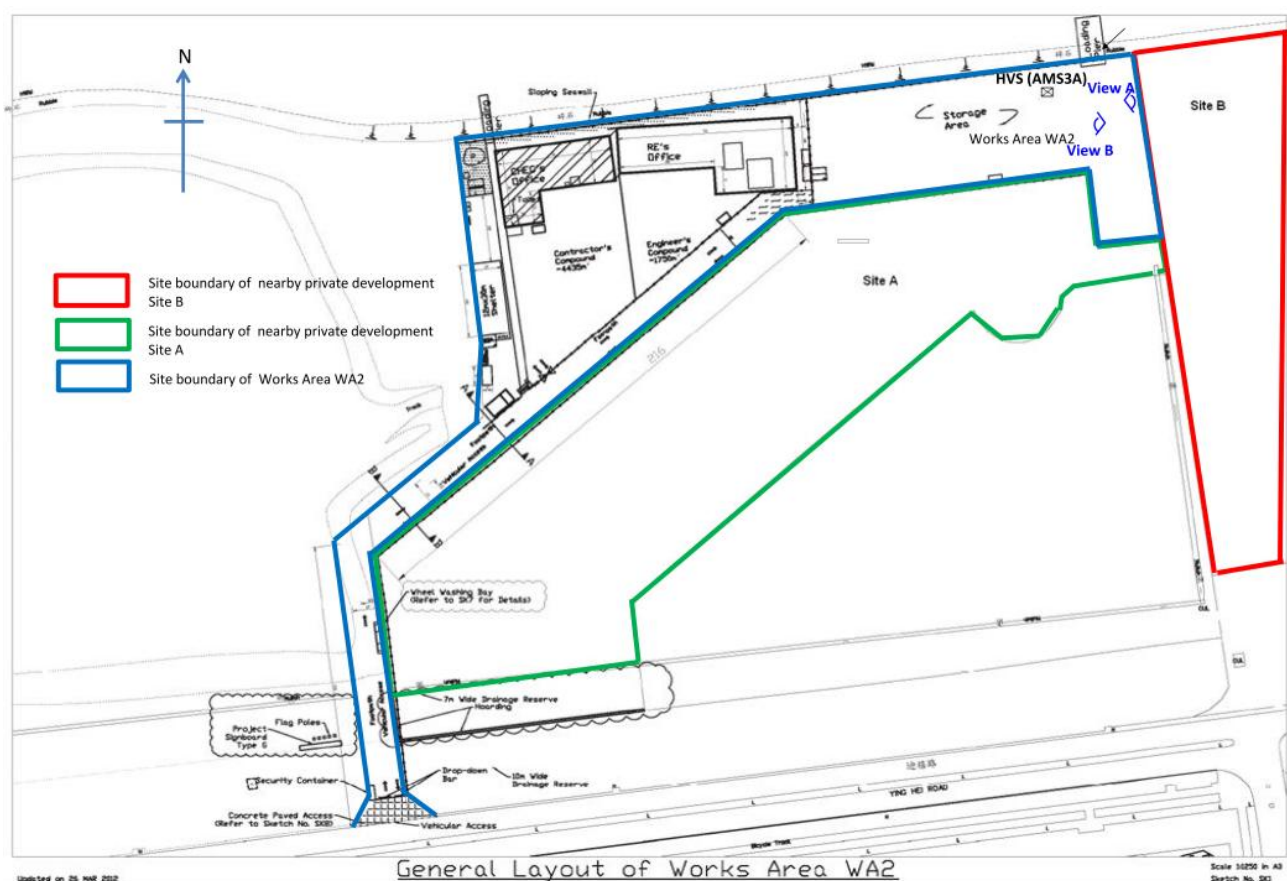
- 2.7.4.3 Photo records shows vehicle parking activities were observed inside an area at construction sites of nearby private development project which are close to the monitoring station AMS3A but beyond the site boundary of Works Area WA2. (Please also see photo and layout map attached for reference of site conditions (View A.))

- 2.7.4.4 As refer to the wind data collected at wind station at Works Area WA2 during the monitoring period on 10 and 11 Dec 13 (as attached) east winds was prevailing during the monitoring period. Traffic activities at construction sites of nearby private development project which are close to the monitoring station AMS3A but beyond the site boundary of Works Area WA 2 may contribute to the measured dust levels at the monitoring station AMS3A.

**Conditions of the construction sites near Works Area WA2:**

View A: (Parking lot observed at nearby construction site which do not belongs to this Contract):

View B (Hard paved surface observed at Works Area WA2)

- 2.7.4.8 The dust exceedance was therefore considered not to be due to the Project works.
- 2.7.4.9 The Contractor was recommended to continue implementing existing dust mitigation measures.
