Contract No. HY/2010/02

**Hong Kong – Zhuhai – Macao Bridge
Hong Kong Boundary Crossing
Facilities –
Reclamation Works**

Monthly EM&A Report for January 2014

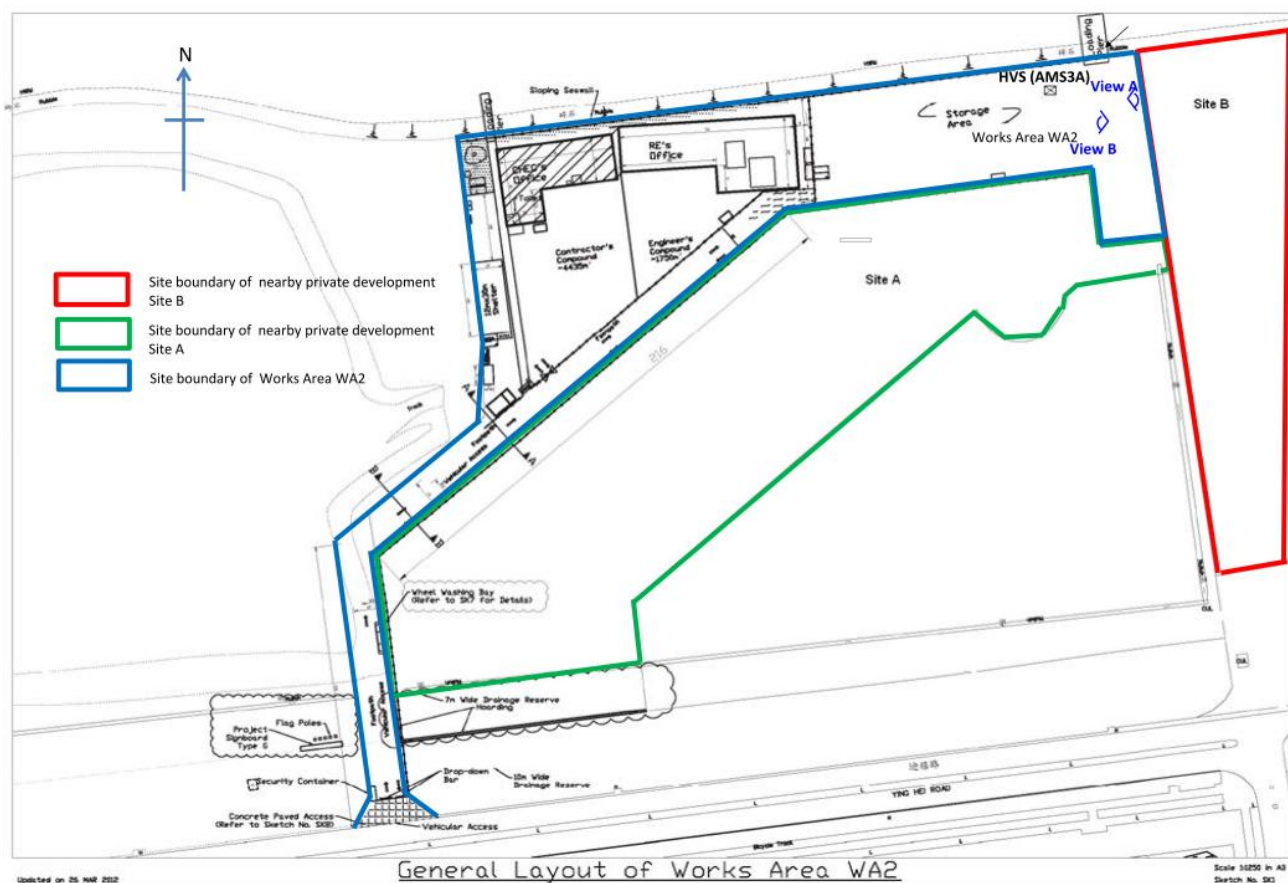
- 2.7.6.3 Photo records shows vehicle parking activities were observed inside an area at construction sites of nearby private development project which are close to the monitoring station AMS3A but beyond the site boundary of Works Area WA2. (Please also see photo and layout map attached for reference of site conditions (View A.))

View A (parking lot observed at nearby construction site which do not belongs to this Contract)

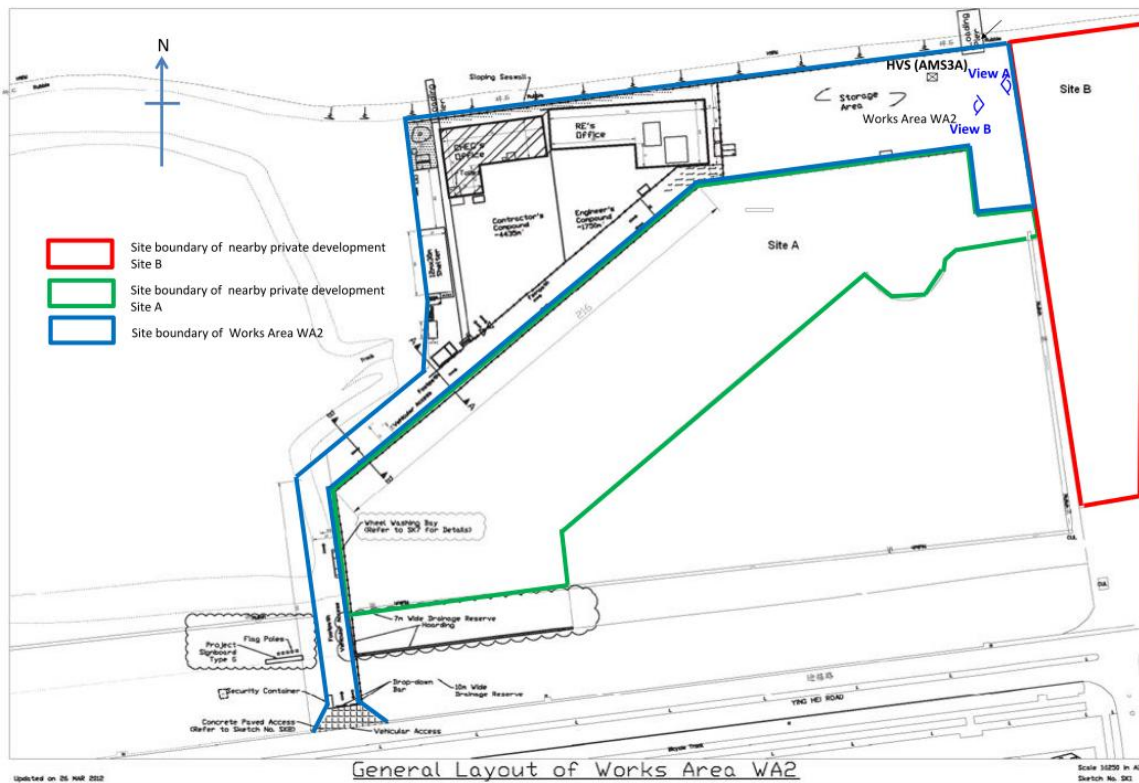
- 2.7.8.3 Photo records shows vehicle parking activities were observed inside an area at construction sites of nearby private development project which are close to the monitoring station AMS3A but beyond the site boundary of Works Area WA2. (Please also see photo and layout map attached for reference of site conditions (View A.))

View A (parking lot observed at nearby construction site which do not belongs to this Contract)

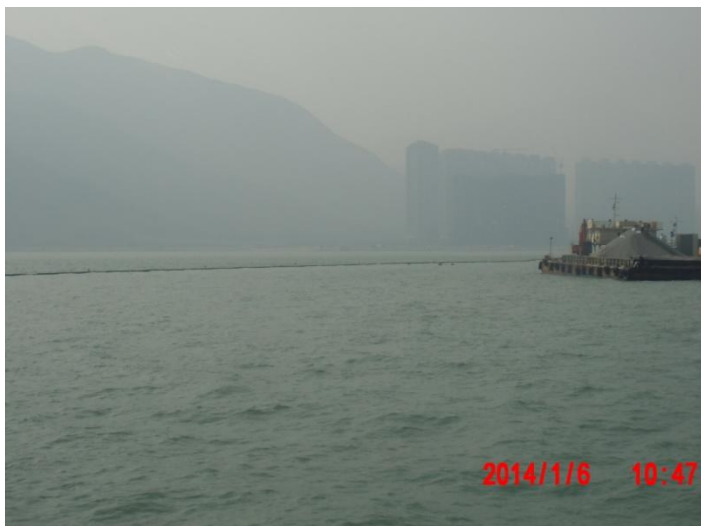
4.7.5.3 The turbidity level (in NTU) at IS(Mf)9, IS8, IS7 and IS(Mf)16 were below the action and limit level and no silt plume was observed when monitoring was conducted IS(Mf)9 and IS8, this indicates that the turbidity level (in NTU) at IS(Mf)9, IS8, IS7 and IS(Mf)16 were not adversely affected.

- 4.7.5.4 Also, with refer to the silt curtain condition on 06 Jan 14, no defects of the perimeter silt curtain was observed at south and southeast of the construction site.
- 4.7.5.5 The exceedances were likely due to local effects in the vicinity of IS(Mf)9 and IS8.
- 4.7.5.6 As such, the exceedances recorded at IS(Mf)9 and IS8 are considered non-project related.
- 4.7.5.7 The Contractor was reminded to ensure provision of ongoing maintenance to the silt curtains and to carry out maintenance work once defects were found.
- 4.7.5.8 Maintenance work of the silt curtain was carried out by the Contractor on a daily basis except Sunday and public holiday.

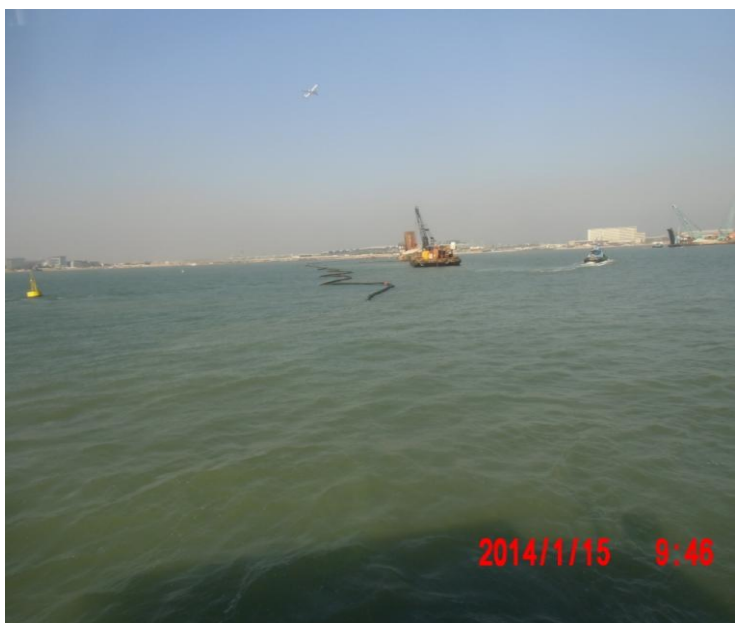
4.7.7.2 Since the turbidity level (in NTU) at IS(Mf)9, IS8, IS7 and IS(Mf)16 were below the action and limit level and no silt plume was observed when monitoring was conducted at IS(Mf)9, this indicates that the turbidity level (in NTU) at IS(Mf)9, IS8, IS7 and IS(Mf)16 were not adversely affected. Please refer to the photo record attached for sea condition recorded on 15 Jan 14 at southeast vessel entrance of the perimeter silt curtain (near monitoring station IS(Mf)9).

- 4.7.7.3 Also, with refer to the silt curtain condition on 15 Jan 14, no defects of the perimeter silt curtain was observed at south and southeast of the construction site.
- 4.7.7.4 The exceedance was likely due to local effects in the vicinity of IS(Mf)9.
- 4.7.7.5 As such, the action level exceedance recorded at IS(Mf)9 is considered non-project related.
- 4.7.7.6 The Contractor was reminded to ensure provision of ongoing maintenance to the silt curtains and to carry out maintenance work once defects were found.
- 4.7.7.7 The Contractor was reminded that, with reference to EM&A manual Clause 9.1.1, the vessel access opening of the perimeter silt curtain would be formed by two piece of silt-curtain with overlapping length of 150 minimum and a separation distance of about 50m.
