Contract No. HY/2010/02

**Hong Kong – Zhuhai – Macao Bridge
Hong Kong Boundary Crossing
Facilities –
Reclamation Works**

Monthly EM&A Report for March 2014

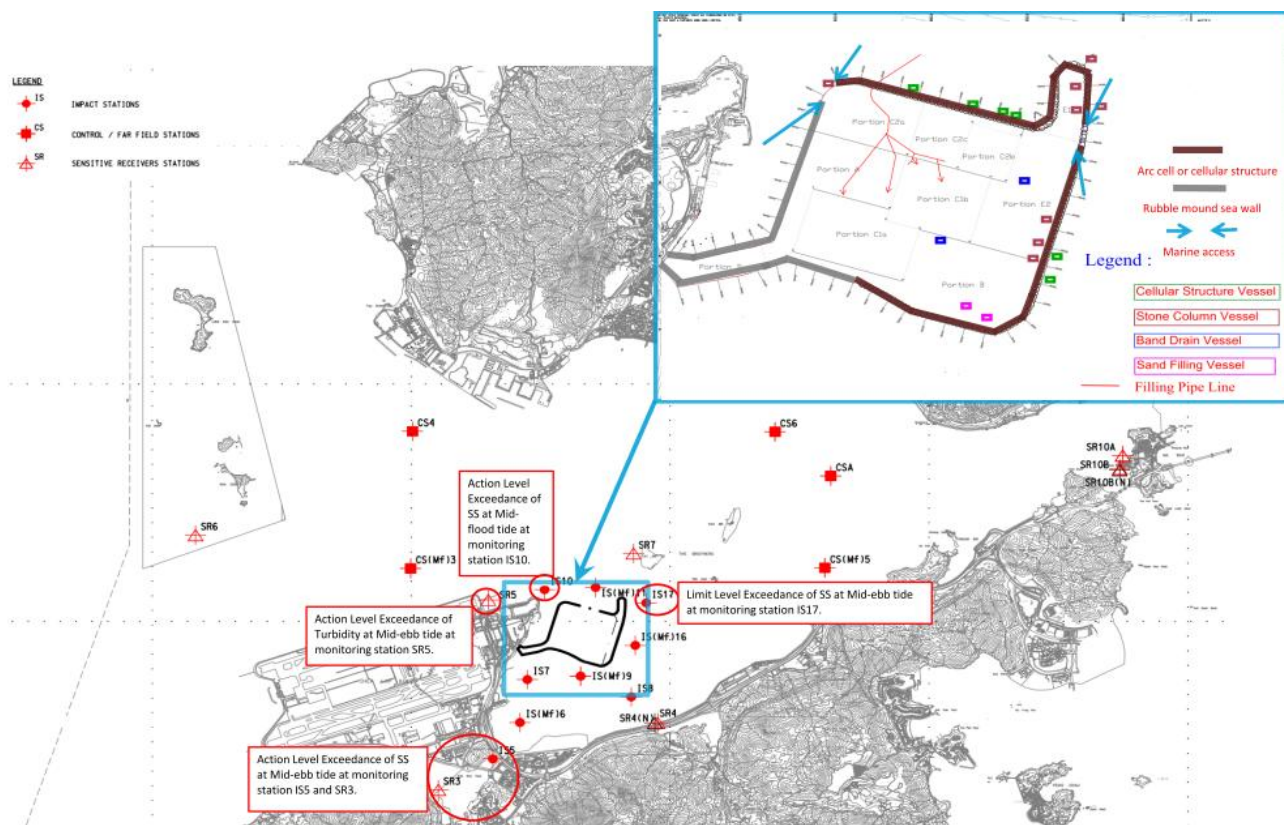
4.7.6 One (1) Limit level exceedance of SS was recorded at IS17; three (3) Action Level exceedances of SS were recorded at IS5, SR3 and IS10; one (1) Action Level Exceedance on Turbidity was recorded at SR5 on 19 March 14.

4.7.6.1 Please see above layout map for work activities carried out on 19 March 14.

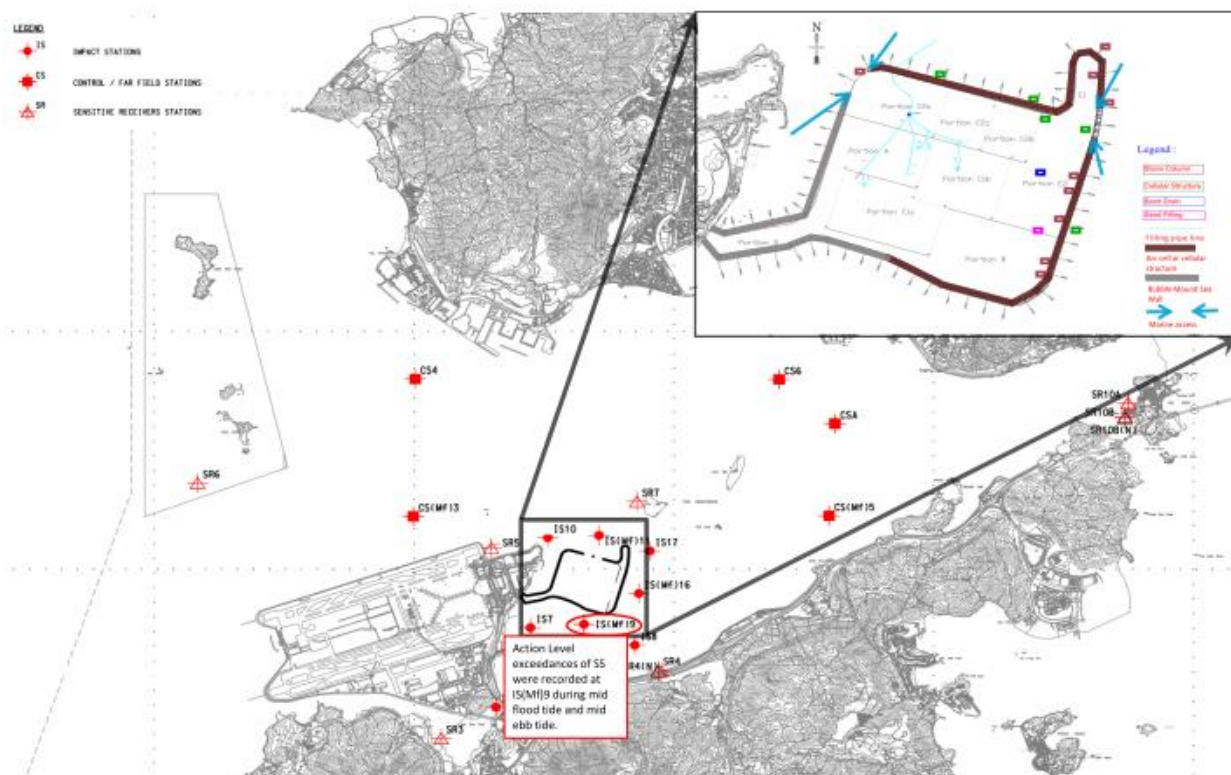
4.7.7 Two (2) Action Level exceedances of SS were recorded at IS(Mf)9 were recorded during mid flood tide and mid ebb tide respectively on 24 March 14.

4.7.7.1 Please see above layout map for work activities carried out on 24 March 14.

4.7.7.2 In accordance with the silt curtain integrity checking record, deficiency such as missing segments at one end of the perimeter silt curtain at the southern marine access was noted. This part of the perimeter silt curtain is close to IS(Mf)9. The Contractor was reminded to ensure provision of ongoing maintenance to the silt curtains and to carry out maintenance work once defects were found and maintenance work of the silt curtain was carried out by the Contractor on a daily basis except Sunday and public holiday.

4.7.7.12 Nonetheless, the Contractor was reminded to ensure provision of ongoing maintenance to the silt curtains and to carry out maintenance work once defects were found.

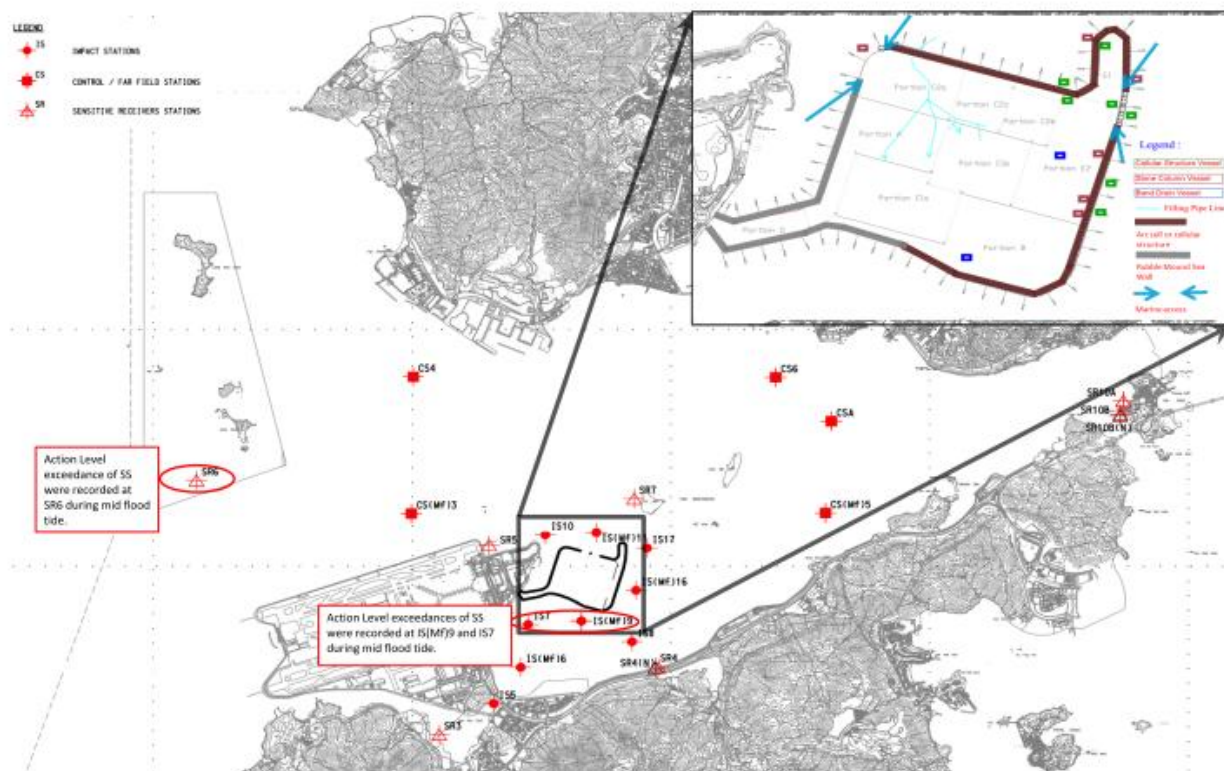
4.7.8 Three (3) Action Level exceedances of SS were recorded at IS(Mf)9, IS7 and SR6 during mid flood tide on 31 March 2014.

4.7.8.1 Please see above layout map for work activities carried out on 31 March 14.

4.7.8.4 With reference to layout map attached, construction activity close to IS(Mf)9 and IS7 such as band drain installation was conducted at southeast part of portion B, since band drain is considered unlikely to cause silt plume. Therefore, the exceedances are unlikely attributed to construction activity close to IS(Mf)9 and IS7.

4.7.8.5 In accordance with the silt curtain integrity checking record, defects such as missing segments at southern marine access at one end of the perimeter silt curtain was noted. This part of the perimeter silt curtain is close to IS(Mf)9. The Contractor was reminded to ensure provision of ongoing maintenance to the silt curtains and to carry out maintenance work once defects were found and maintenance work of the silt curtain was carried out by the Contractor on a daily basis except Sunday and public holiday.

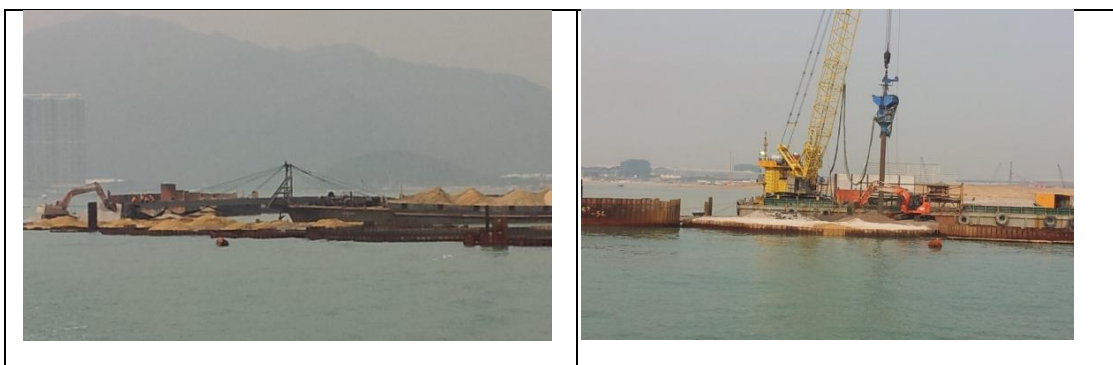
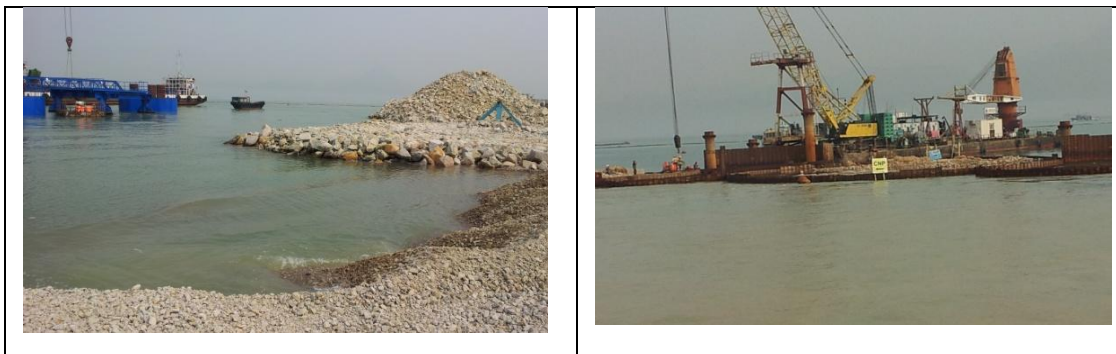
- 6.6.1 The Environmental Complaint Handling Procedure is annexed in Figure 6.
- 6.6.2 EPD referred a complaint on 17 March 2014 from complainant who advised that there was sea water colored in blue observed in vicinity of Hong Kong-Zhuhai-Macao Bridge Hong Kong Boundary Facilities (HKBCF) where stone column installation was taking place. The complainant suspected that the filling material was stained and contaminated the sea water after being filled into the sea.
 - 6.6.2.1 Staining material, stained filling material or blue colored sea water was not observed during a follow-up site inspection audit conducted with the representatives of the Contractor, Residential Engineer and IEC/ENPO on 20 Mar 14. The photo record taken during the joint site inspection audit was attached.
