Contract No. HY/2010/02

## Hong Kong – Zhuhai – Macao Bridge Hong Kong Boundary Crossing Facilities – Reclamation Works

Monthly EM&A Report for October 2014

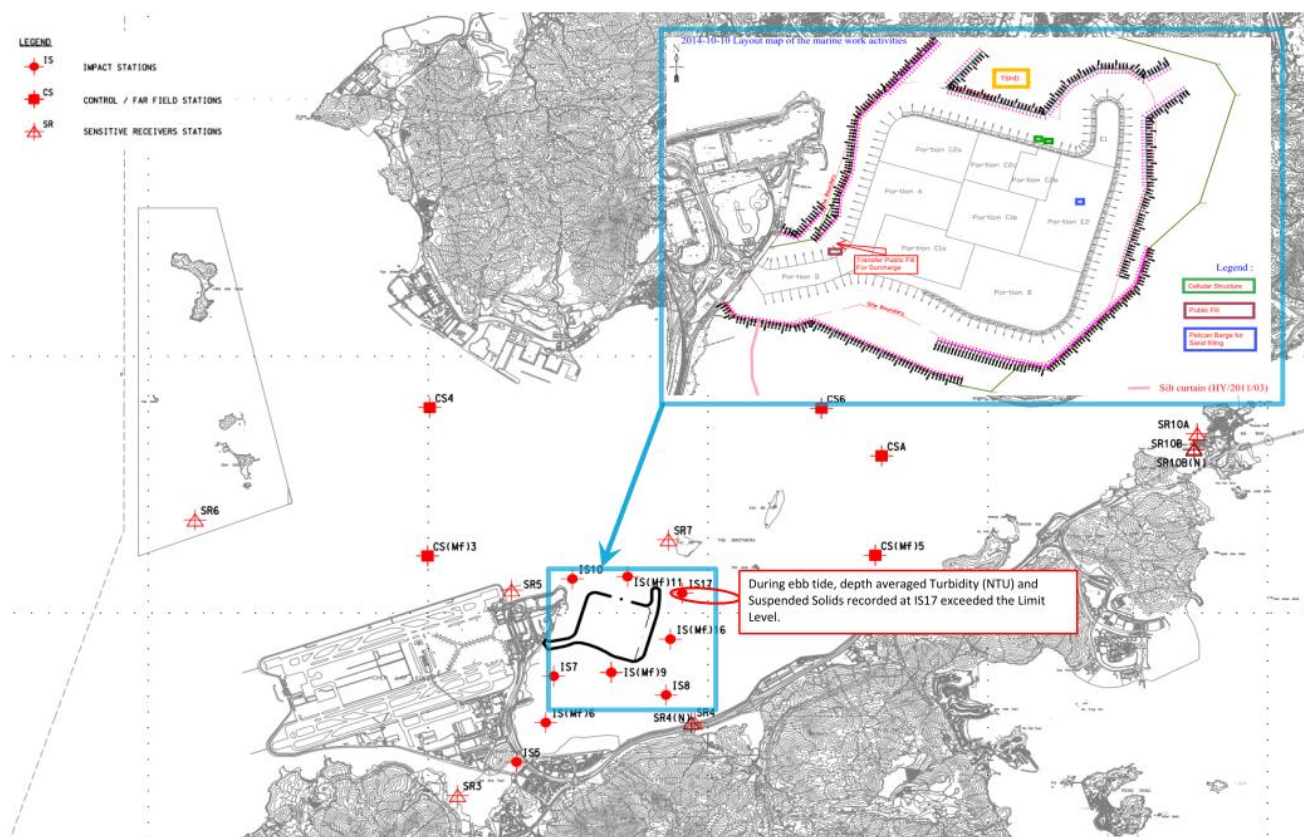
4.7.3.1 With refer to monitoring record, appearance of water was relatively more turbid at IS17 when compared with the appearance of water at IS(Mf)11, IS10 and IS(Mf)16 during monitoring at ebb tide on 10 Oct 14.

4.7.3.2 As informed by the Contractor, sand filling was carried out at Portion E2 on 8, 10 and 13 Oct 14 at almost the same location but no exceedance was recorded at monitoring station IS17 on 8 and 13 Oct 14 during mid ebb tide. This indicates filling works were unlikely to cause the exceedance in turbidity at monitoring station IS17.

4.7.3.3 The source of impact is likely due pelican barge's propeller movement at shallow water during ebb tide when the position of the barge was adjusted at portion E. In addition, with refer to the silt curtain condition on 10 Oct 14, defects of the perimeter silt curtain was observed at northwest of the construction site. The dispersion of turbid water from the inside of the perimeter silt curtain to the outside of the perimeter silt curtain is potentially due to defects of northwest part of the perimeter silt curtain.

6. Mitigation measures such as perimeter silt curtain was implemented by the Contractor, however defects of the perimeter silt curtain was observed, the Contractor was reminded to ensure swift provision of maintenance to the silt curtains once defects were found. With refer to the maintenance record provided by the Contractor, maintenance work for the defects of the northwest part of the perimeter silt curtain was conducted on 28 October 2014.

- 4.7.3.7 With refer to the maintenance record provided by the Contractor, maintenance work for the defects of the northwest part of the perimeter silt curtain was conducted on 28 October 2014.

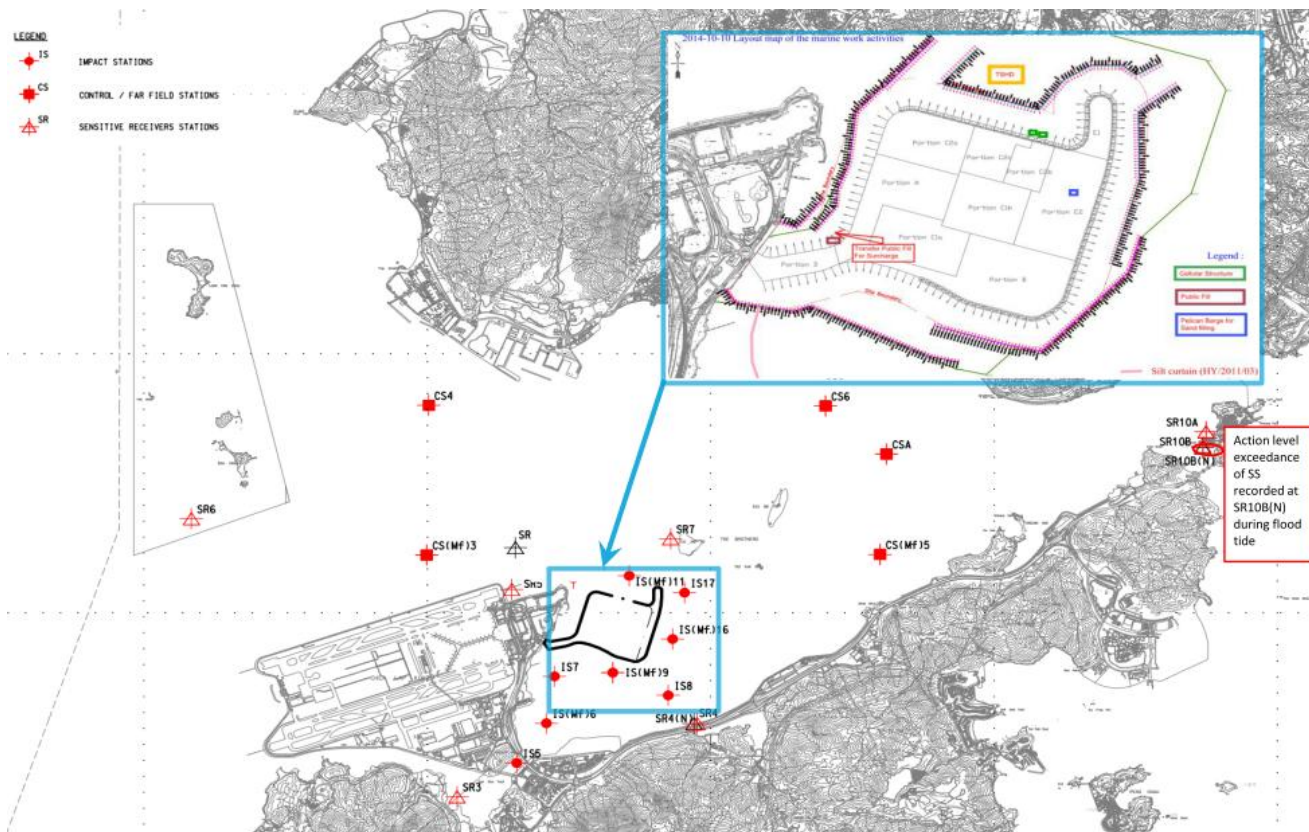
4.7.4.1 IS(Mf)11 and IS10 are located downstream and closer to the active works than monitoring station SR10B(N) during flood tide. Depth Averaged Suspended Solids (SS) values (in mg/L) recorded during flood tide on the same day at IS(Mf)11 and IS10 were below the Action and Limit Level which indicates project work is unlikely to contribute to the action level exceedance recorded at SR10B(N).

4.7.4.2 The monitoring location of monitoring station SR10B(N) are considered upstream and remote to the active works of this project during flood tide. Therefore it was unlikely that the exceedance recorded at SR10B(N) during flood tide was due to active construction activities of this project.

4.7.4.3 The exceedance was likely due to local effects in the vicinity of SR10B(N).

4.7.4.4 ET's conclusions and recommendations for mitigation: Exceedance was not due to marine based construction works of the Project. Nevertheless, the Contractor was reminded to ensure provision of ongoing maintenance to the silt curtains and to carry out maintenance work once defects were found.

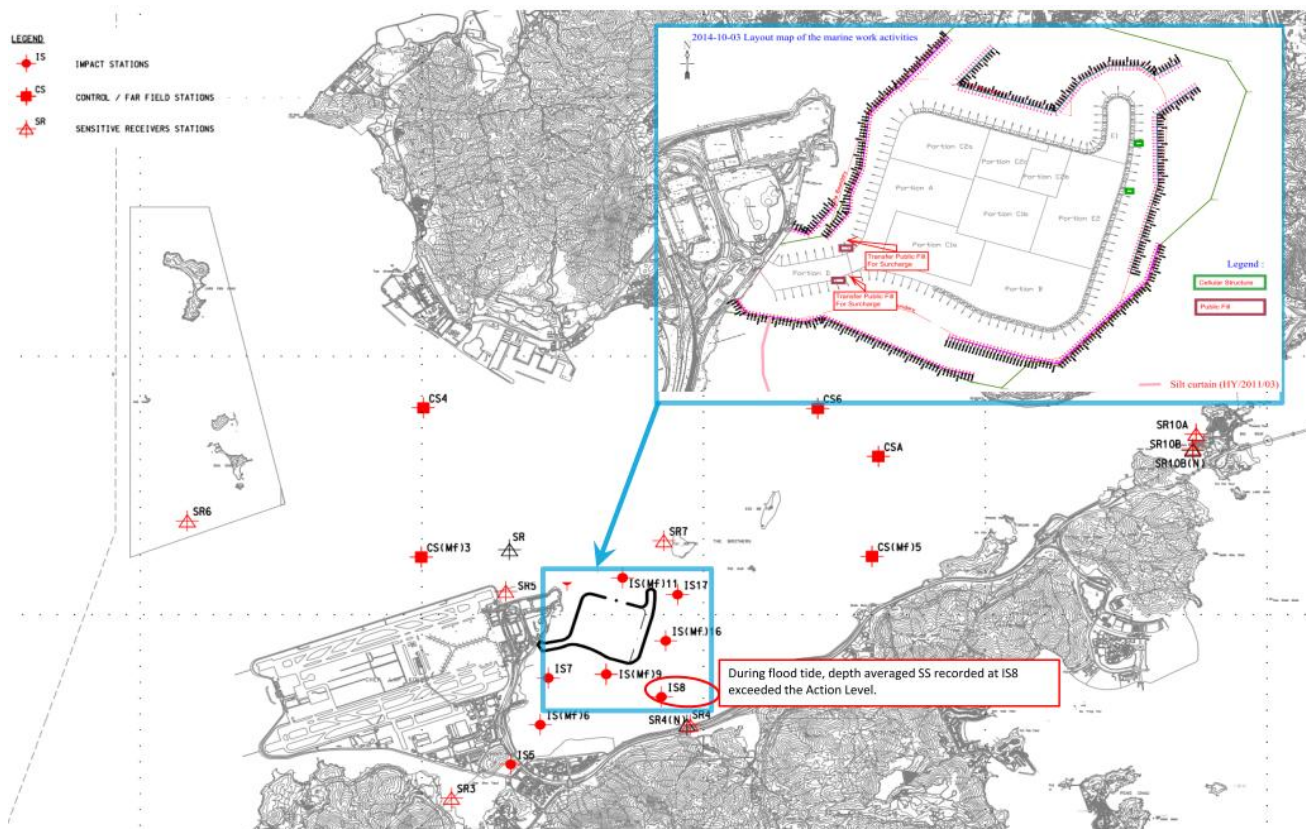
4.7.5.1 Layout map for work activities carried out on 03 October 14 is showed below:

4.7.5.2 Exceedance recorded at IS8 during mid-flood tide is unlikely due to marine based construction activities of the Project because:

4.7.5.3 With reference to the information provided by the Contractor, only cellular structure installation was conducted at the northeast part of the HKBCF reclamation works during mid flood tide, but cellular structure installation is unlikely to cause silt plume and contribute to the elevation of SS at IS8 during flood tide.

4.7.5.5 In accordance with the silt curtain integrity checking record of 3 October 2014, disconnection of the perimeter silt curtain was observed at the southeast part of HKBCF Reclamation Works, but with referred to monitoring record and photo record below, no sediment plume has been observed to flow from the inside of the perimeter silt curtain to the outside of the perimeter silt curtain and no discoloration of sea water has been observed. (Please refer to below photo). In accordance with the silt curtain integrity checking record, the observed disconnection was rectified on 6 October 2014

4.7.5.11 ET's conclusions and recommendations for mitigation: Nevertheless, the Contractor was reminded to ensure provision of ongoing maintenance to the silt curtains and to carry out maintenance work once defects were found.

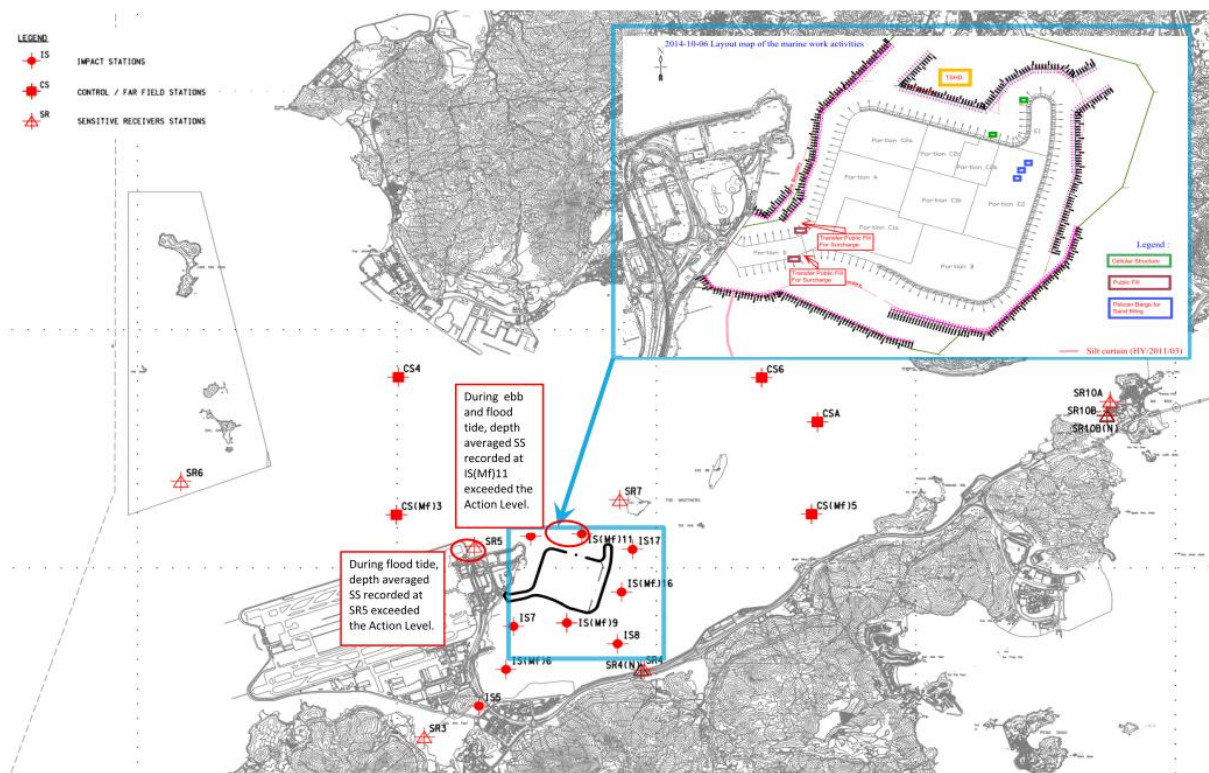
4.7.6.1 Layout map below shows active works conducted on 6-Oct-14. Works such as cellular structure installation was conducted at north part of the HKBCF Reclamation Works and sand filling was conducted at Portion E2 when monitoring was conducted.

4.7.6.2 Exceedance recorded at SR5 during mid-flood tide are unlikely due to marine based construction activities of the Project because:

4.7.6.3 With reference to the silt curtain checking record defects was observed at parts of the perimeter silt curtain which are close to the SR5.

- 4.7.6.11 With reference to the silt curtain checking record defects was observed at parts of the perimeter silt curtain which are close to the IS(Mf)11. As informed by the Contractor, maintenance work of the silt curtain is on-going and carried out by the Contractor on a daily basis.

- 4.7.6.17 ET's conclusions and recommendations for mitigation: Mitigation measures such as perimeter silt curtain was implemented by the Contractor, however defects of the perimeter silt curtain was observed, the Contractor was reminded to ensure swift provision of maintenance to the silt curtains once defects were found.

- 4.7.6.18 Contractor's actions to implement the mitigation: With refer to the maintenance record provided by the Contractor, maintenance work for the defects of the northwest part of the perimeter silt curtain was conducted on 28 October 2014.

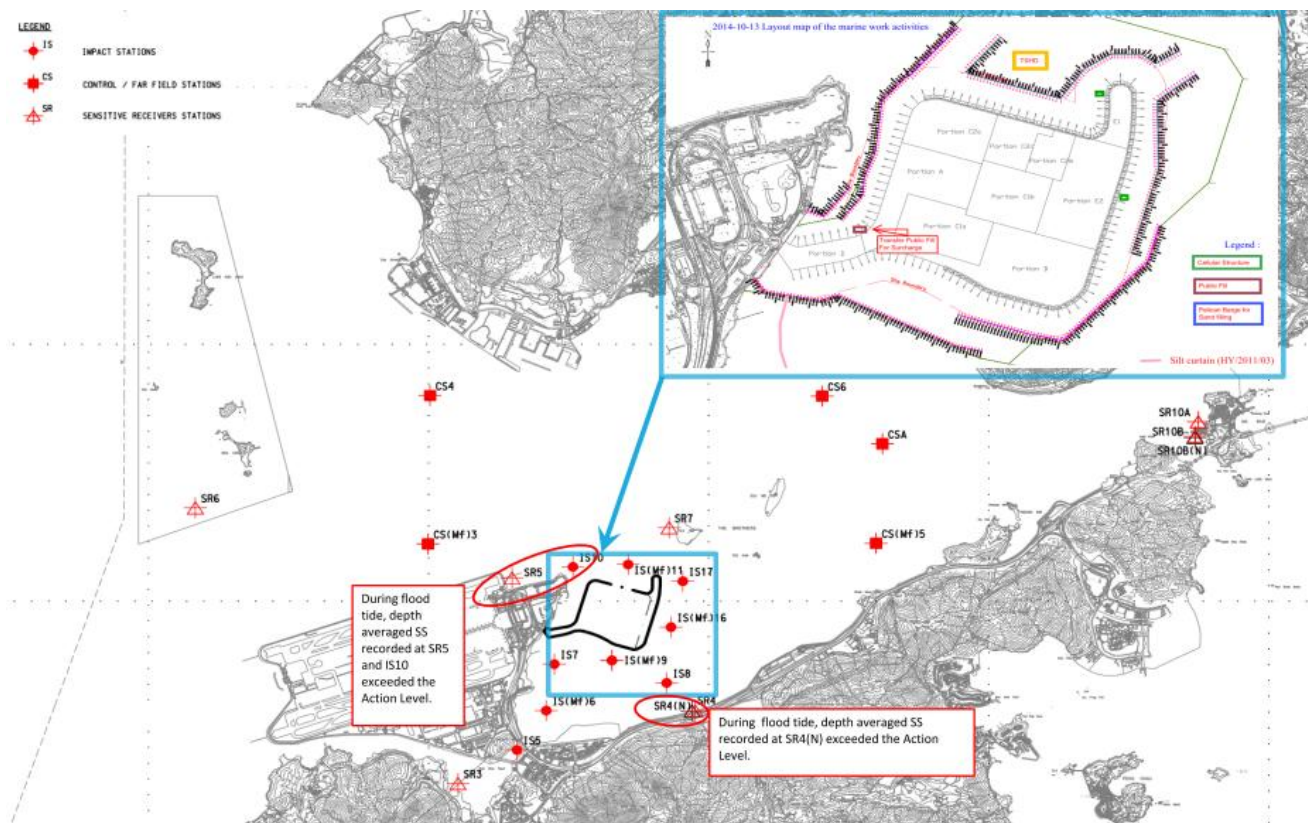
4.7.7.1 Layout map below shows active works conducted on 13-Oct-14. Works such as construction works for cellular structure were conducted at northeast part of the HKBCF Reclamation Works.

4.7.7.2 Exceedance recorded at IS10 and SR5 during mid-flood tide are unlikely due to marine based construction activities of the Project because:

4.7.7.3 With reference to the silt curtain checking record, defects was observed at parts of the perimeter silt curtain which are close to the IS10 and SR5.

4.7.7.5 Relative more turbid water were observed at IS10 and SR5 during flood tide but no filling activities was observed in progress and no silt plume was observed to flow from the inside of the perimeter silt curtain to the outside of the perimeter silt curtain when monitoring was conducted at IS10 and SR5.

- 4.7.7.15 ET's conclusions and recommendations for mitigation: Mitigation measures such as perimeter silt curtain was implemented by the Contractor, however defects of the perimeter silt curtain was observed, the Contractor was reminded to ensure swift provision of maintenance to the silt curtains once defects were found.

- 4.7.7.16 Contractor's actions to implement the mitigation: With refer to the maintenance record provided by the Contractor, maintenance work for the defects of the northwest part of the perimeter silt curtain was conducted on 28 October 2014.

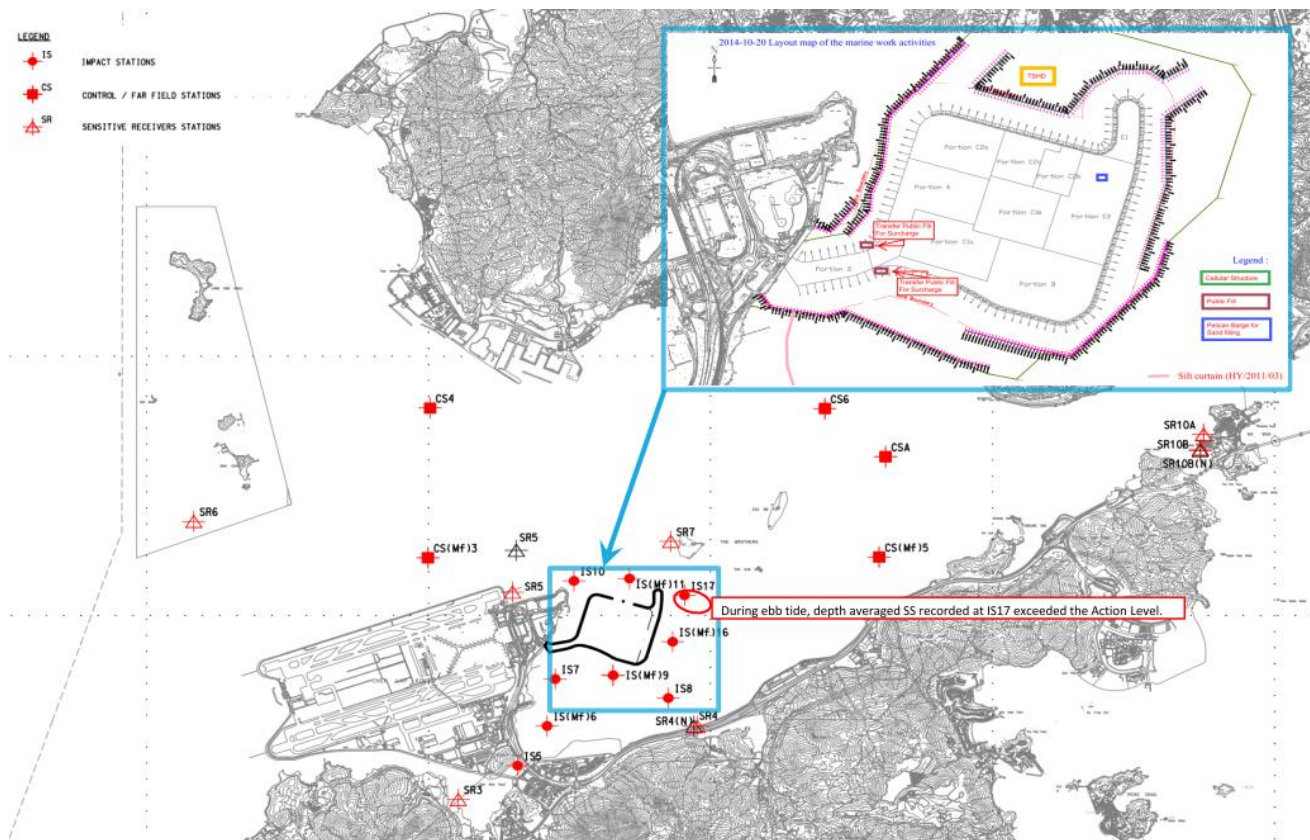
4.7.8 (1) One Action Level Exceedance of SS was recorded at IS17 on 20 October 2014 during ebb tide, layout map below shows active works conducted on 20-Oct-14 during ebb tide:

4.7.8.1 Exceedance recorded at IS17 is likely due to marine based construction activities of the Project because:

4.7.8.2 With refer to monitoring record, appearance of water was relatively more turbid at IS17 when compared with the appearance of water at IS(Mf)11, IS10 and IS(Mf)16 during monitoring at ebb tide on 20-Oct-14.

4.7.8.4 The source of impact is likely due pelican barge's propeller movement at shallow water during ebb tide when the position of the barge was adjusted at Portion E. In addition, with refer to the silt curtain condition on 20-Oct-14, defects of the perimeter silt curtain was observed at Northeastern of the construction site. The turbid water observed at IS17 is likely due to the dispersion of turbid water from the inside of the perimeter silt curtain to the outside of the perimeter silt curtain through the defective part of the perimeter silt curtain.

4.7.8.6 ET's conclusions and recommendations for mitigation: Exceedances recorded at IS17 are likely to be related to vessel movement at shallow water during ebb tide. The Contractor was further reminded to control the vessel traffic at this area and ensure swift provision of maintenance to the silt curtains once defect was found.

4.7.8.8 With refer to the maintenance record provided by the Contractor, maintenance work for the defects of the Northeastern part of the perimeter silt curtain was conducted on 28-Oct-14.

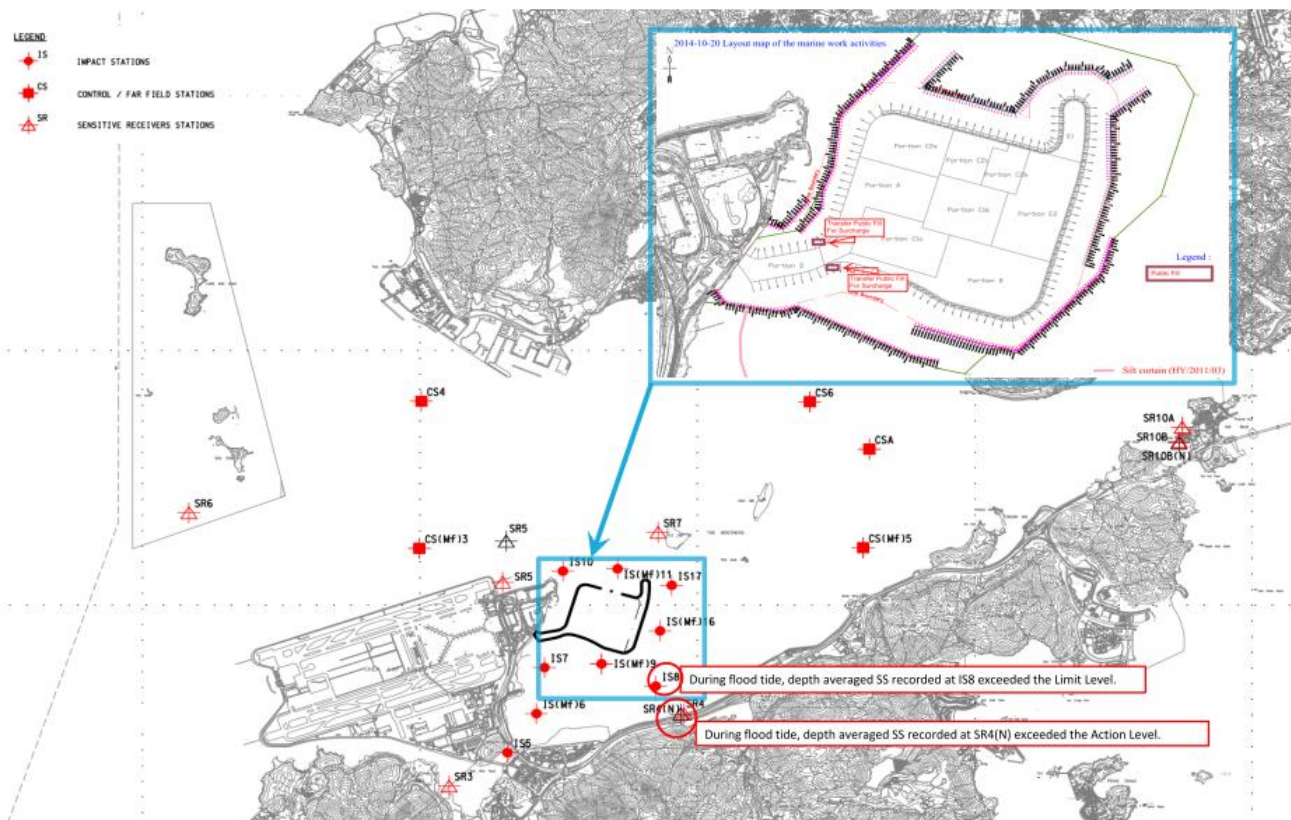
4.7.9.1 Layout map below shows active works conducted on 20-Oct-14 during flood tide.

4.7.9.2 With reference to the information provided by the Contractor, only public fill was transferred at Portion D for surcharge on 20 October 2014 during flood tide and no active marine construction activity from this Contract was conducted near IS8, as such, it is unlikely to cause silt plume and contribute to the elevation of SS at IS8 during flood tide.

4.7.9.3 IS(Mf)9 is located closer to the construction site than monitoring station IS8. Depth Averaged Suspended Solids (SS) values (in mg/L) recorded during the flood tide on the same day at IS(Mf)9 was below the Action and Limit Level which shows that the water quality closer to construction site was not adversely affected.

4.7.9.4 In accordance with the silt curtain integrity checking record of 20 October 2014, no defect of the perimeter silt curtain was observed at the southeast part of HKBCF Reclamation Works. In addition, with referred to monitoring record, no sediment plume has been observed to flow from the inside of the perimeter silt curtain to the outside of the perimeter silt curtain and no discoloration of sea water has been observed at IS8.

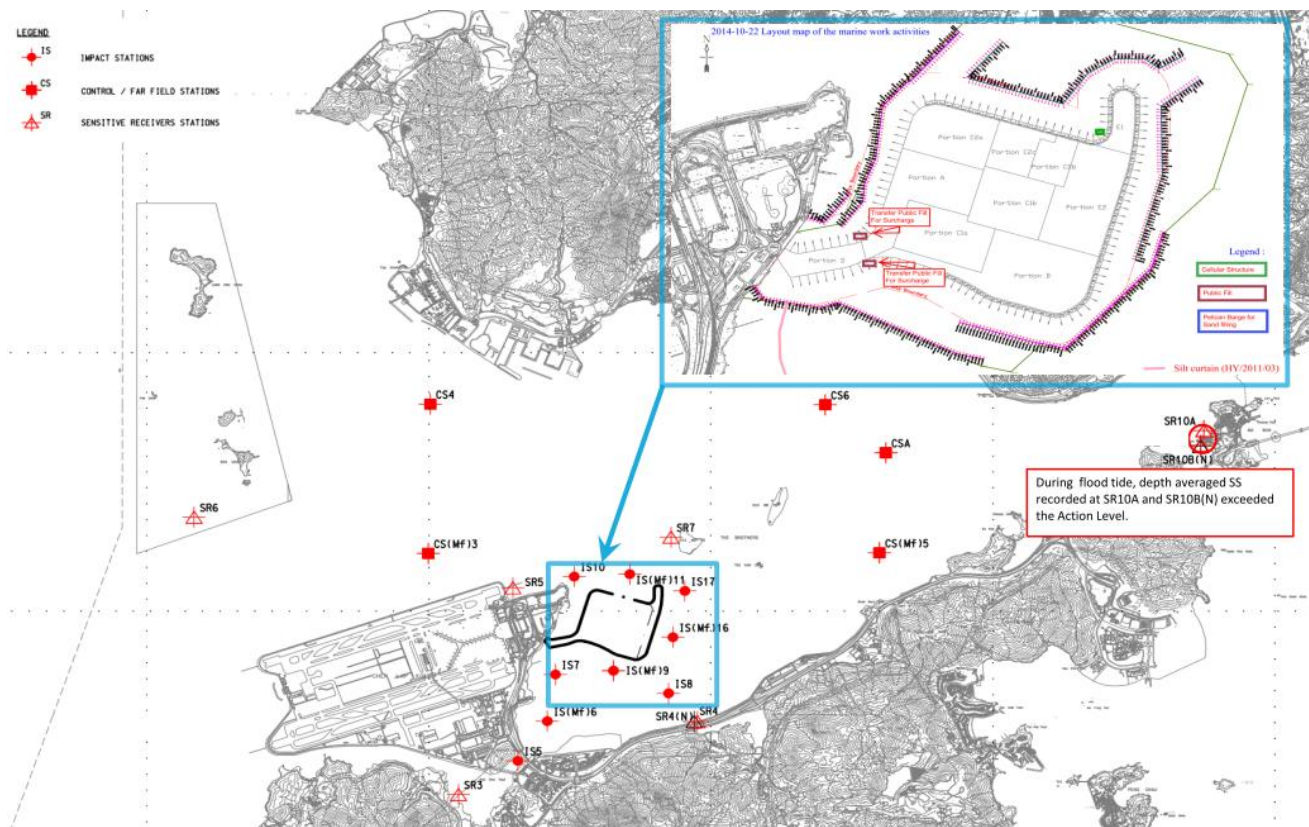
4.7.10.1 For marine works, works involve cellular structure was conducted at portion E1 during flood tide on 22 October 2014. Also refer to layout map below:

4.7.10.2 Exceedances were not due to marine based construction works of the Project because:

4.7.10.3 IS(Mf)11 and IS10 are located downstream and closer to the active works than monitoring station SR10B(N) and SR10A during flood tide on 22 October 2014. Depth Averaged Suspended Solids (SS) values (in mg/L) recorded during flood tide on the same day at IS(Mf)11 and IS10 were below the Action and Limit Level which indicates project work is unlikely to contribute to the action level exceedance recorded at SR10B(N) and SR10A.

- 4.7.10.7 Nevertheless, the Contractor was reminded to ensure provision of ongoing maintenance to the silt curtains and to carry out maintenance work once defects were found.
- 4.7.10.8 As informed by the Contractor, maintenance work of the silt curtain is on-going and carried out by the Contractor on a daily basis.

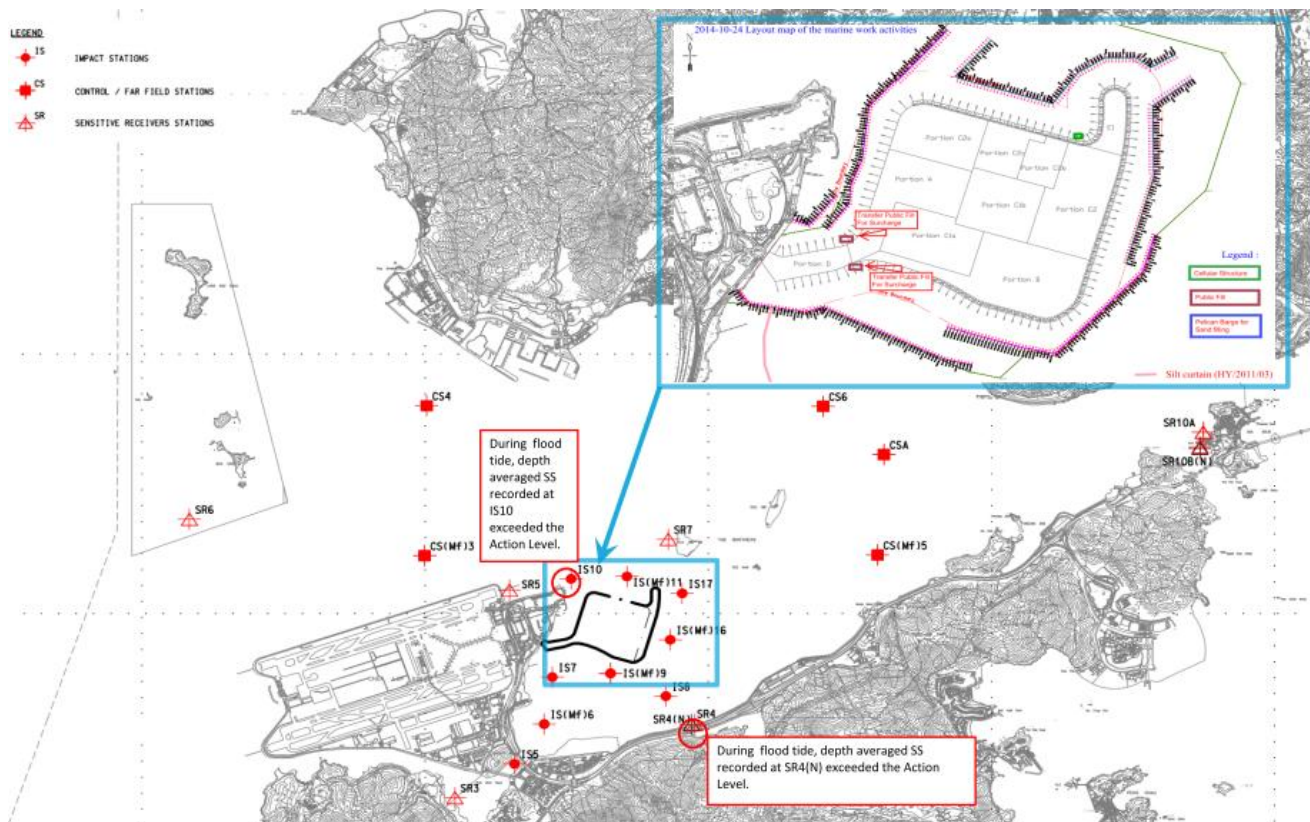
4.7.11 (2) Two Action Level Exceedances of SS were recorded at IS10 and SR4(N) during flood tide on 24 October 2014. Layout map below shows active works conducted on 24-Oct-14.

- 4.7.11.1 Exceedance recorded at IS10 during mid-flood tide is unlikely due to marine based construction activities of the Project because:
- 4.7.11.2 With reference to the silt curtain checking record, defects was observed at parts of the perimeter silt curtain which are close to the IS10.

- 4.7.11.3 With reference to the information provided by the Contractor, active construction works for cellular structure was carried out northeast part of the perimeter silt curtain. Almost the same active construction works was carried out on 22 and 27 October 2014 during the same tide, impact water quality monitoring data recorded on 22 and 27 October 2014 IS10 are all below the Action and Limit Level which indicate exceedance recorded at IS10 was unlikely due to active construction works for cellular structure.

- 4.7.11.15 Contractor's actions to implement the mitigation: With refer to the maintenance record provided by the Contractor, maintenance work for the defects of the northwest part of the perimeter silt curtain was conducted on 28 October 2014.

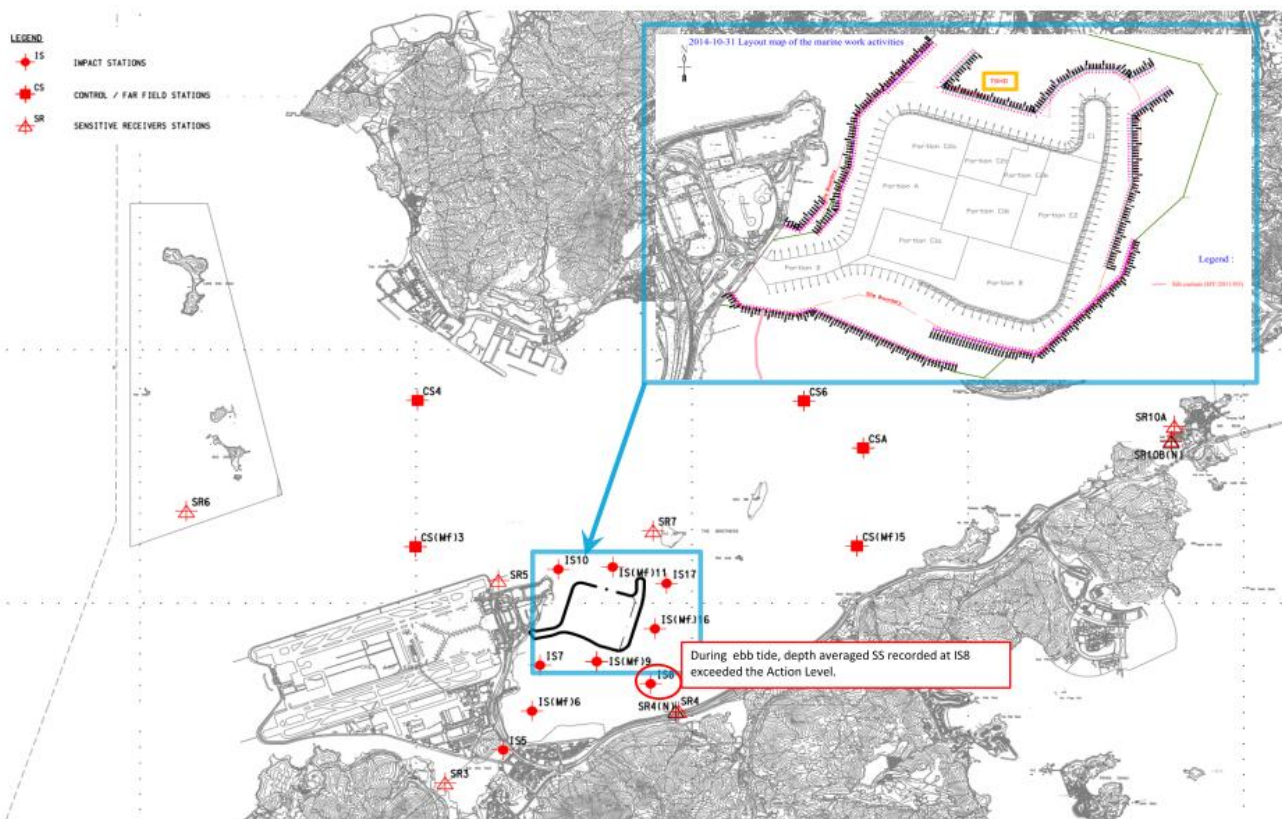
4.7.12 For the action level exceedance of SS noted at IS8 during ebb tide on 31 October 2014. Layout map below shows active works conducted on 31-Oct-14 during ebb tide.

4.7.12.1 Exceedance recorded at IS8 during ebb tide is unlikely due to marine based construction activities of the Project because:

4.7.12.2 With reference to the information provided by the Contractor, no marine works was conducted during ebb tide, it is unlikely to cause silt plume and contribute to the elevation of SS at IS8 during ebb tide.
