Contract No. HY/2010/02

**Hong Kong – Zhuhai – Macao Bridge
Hong Kong Boundary Crossing
Facilities –
Reclamation Works**

**Quarterly EM&A Report for
September 2013- November 2013**

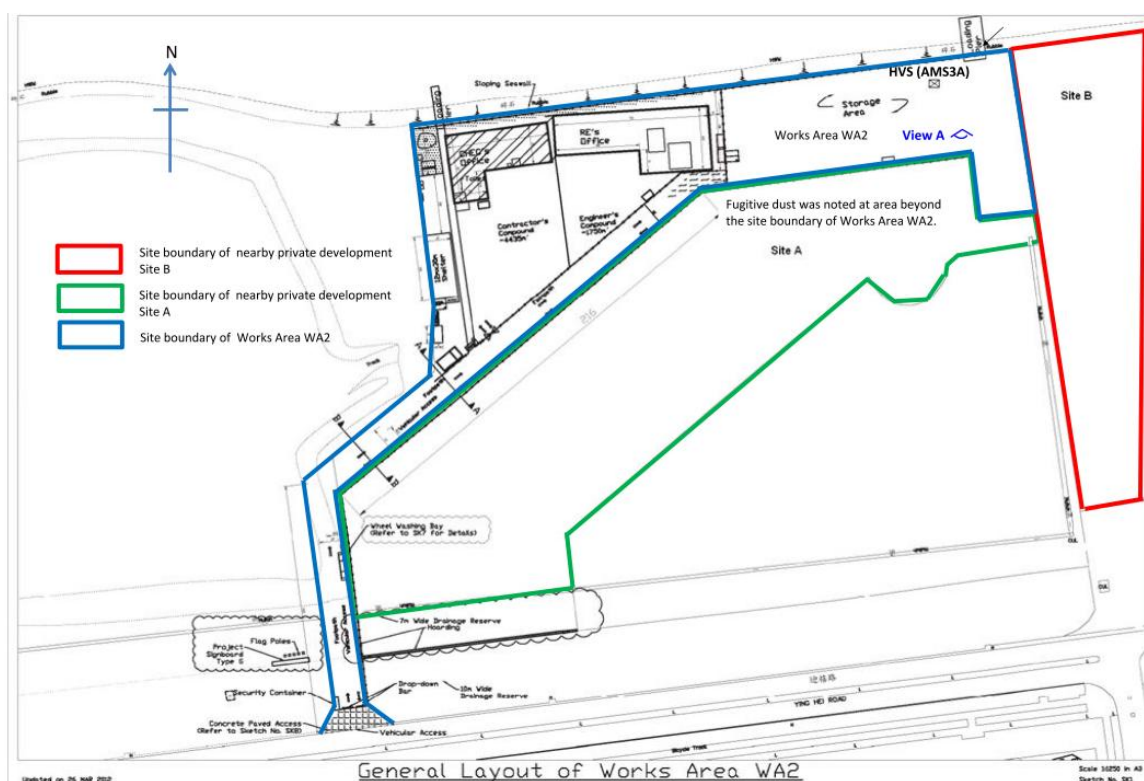
- 3.1.6.4 Photo record shows that fugitive dust was emitted from the construction sites of nearby private development project located close to the monitoring station AMS3A but beyond the site boundary of Works Area WA2. With reference to the prevailing East South East wind direction, construction works carried out at construction sites of nearby private development project may contribute to the measured dust levels at the monitoring station AMS3A. (Please also see photo and layout map below for reference of site conditions.)

Conditions of the construction sites near Works Area WA2:

View of Works Area WA2 : the hard paved ground next to monitoring station AMS3A (View A on layout map)

- 3.1.6.8 The dust exceedance was therefore considered not to be due to the Project works.
- 3.1.6.9 The Contractor was recommended to continue implementing existing dust mitigation measures.

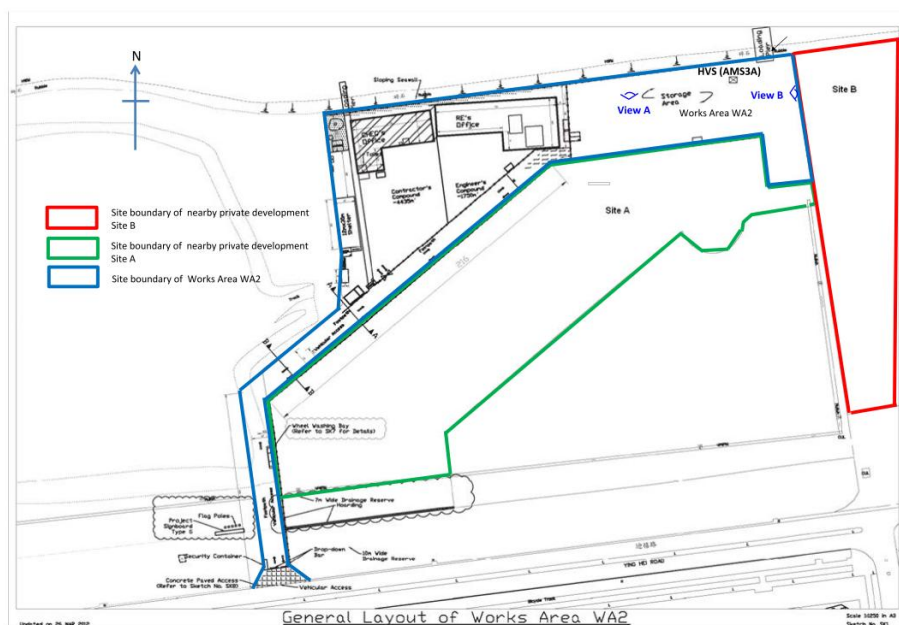
- 3.1.9.3 Photo records shows that vehicle would travel on exposed soil surfaces at those construction sites of nearby private development project which are close to the monitoring station AMS3A but beyond the site boundary of Works Area WA2. (Please also see photo and layout map attached for reference of site conditions.)

- 3.1.9.4 As refer to the wind data collected at wind station at Works Area WA2 during the monitoring period on 15 and 16 Oct 13 (as attached) East South East winds was prevailing during the monitoring period. Traffics at construction sites of nearby private development project which are close to the monitoring station AMS3A but beyond the site boundary of Works Area WA 2 may contribute to the measured dust levels at the monitoring station AMS3A.

Conditions of the construction sites near Works Area WA2:

View A: (Canvas was used to cover sand material stored at WA2):

View B: (Traffic on dusty surface observed at nearby construction site which do not belongs to this Contract)

1. Canvas/tarpaulin sheet was used to cover sand material stored at WA2 (please refer to photo record – View A above)
 2. Works Area WA2's surface was hard-paved, compacted or hydro-seeded
 3. Vehicle washing facility was provided at vehicle exit points,
- 3.1.9.8 The dust exceedance was therefore considered not to be due to the Project works.
- 3.1.9.9 The Contractor was recommended to continue implementing existing dust mitigation measures.

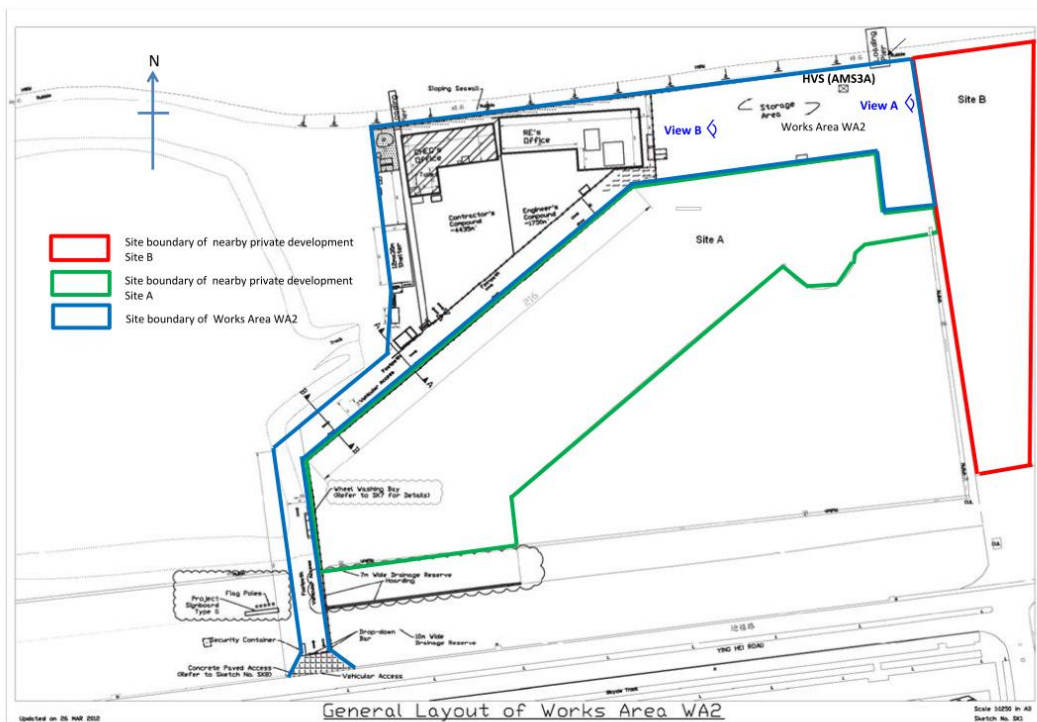
- 3.1.8.3 Photo records shows that vehicle would travel on exposed soil surfaces at those construction sites of nearby private development project which are close to the monitoring station AMS3A but beyond the site boundary of Works Area WA2. (Please also see photo and layout map attached for reference of site conditions (View A.)

Photo record:

View A (Traffic on dusty surface observed at nearby construction site which do not belongs to this Contract)

View B (Hard paved surface observed at Works Area WA2)

- 3.1.8.8 The dust exceedance was therefore considered not to be due to the Project works.
- 3.1.8.9 The Contractor was recommended to continue implementing existing dust mitigation measures.

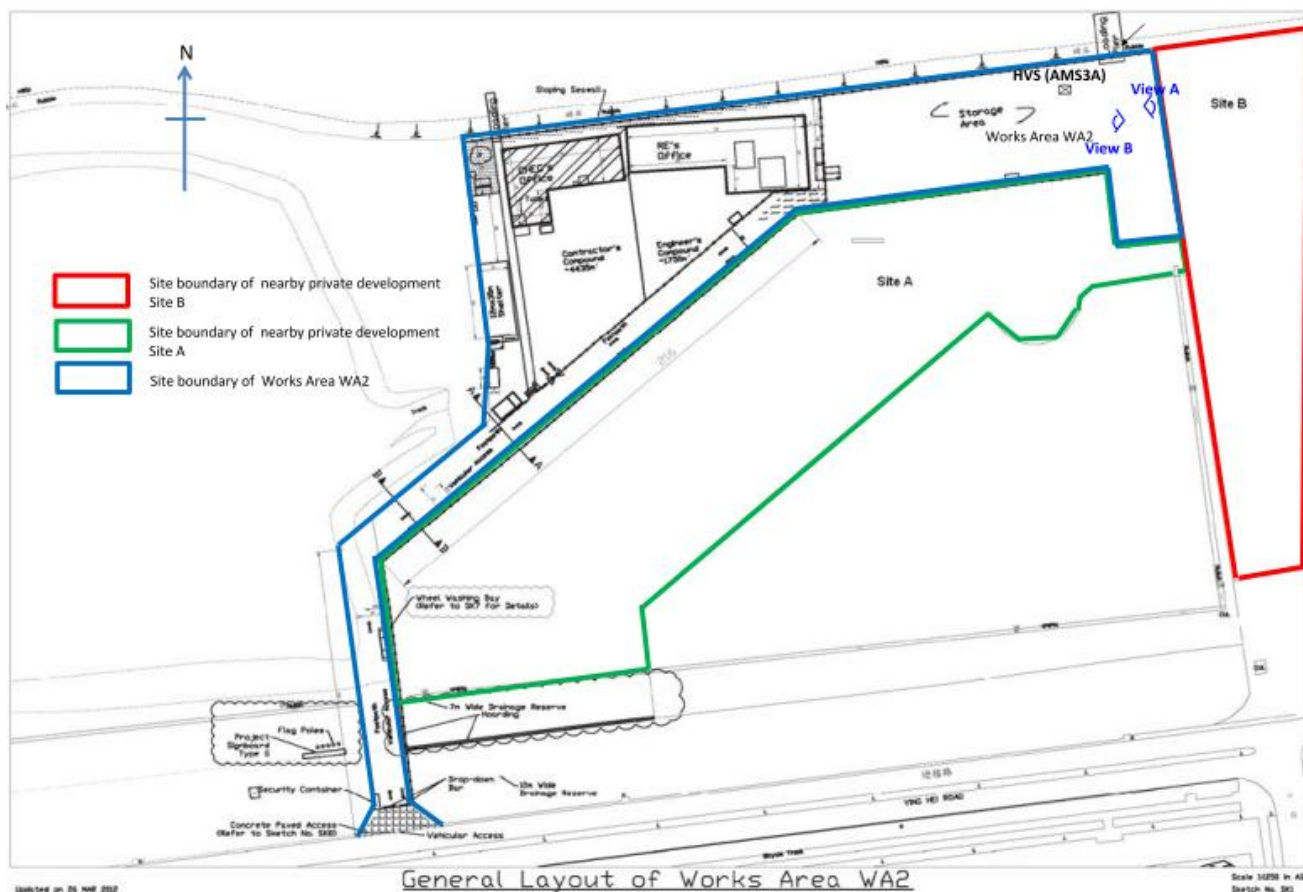
- 3.1.9.3 Photo records shows vehicle parking activities were observed inside an area at construction sites of nearby private development project which are close to the monitoring station AMS3A but beyond the site boundary of Works Area WA2. (Please also see photo and layout map attached for reference of site conditions (View A.))

- 3.1.9.4 As refer to the wind data collected at wind station at Works Area WA2 during the monitoring period on 11 and 12 Nov 13 (as attached) southeast winds was prevailing during the monitoring period. Traffic activities at construction sites of nearby private development project which are close to the monitoring station AMS3A but beyond the site boundary of Works Area WA 2 may contribute to the measured dust levels at the monitoring station AMS3A.

Conditions of the construction sites near Works Area WA2:

View A: (Parking lot observed at nearby construction site which do not belongs to this Contract):

View B (Hard paved surface observed at Works Area WA2)

- 3.1.9.8 The dust exceedance was therefore considered not to be due to the Project works.
- 3.1.9.9 The Contractor was recommended to continue implementing existing dust mitigation measures.

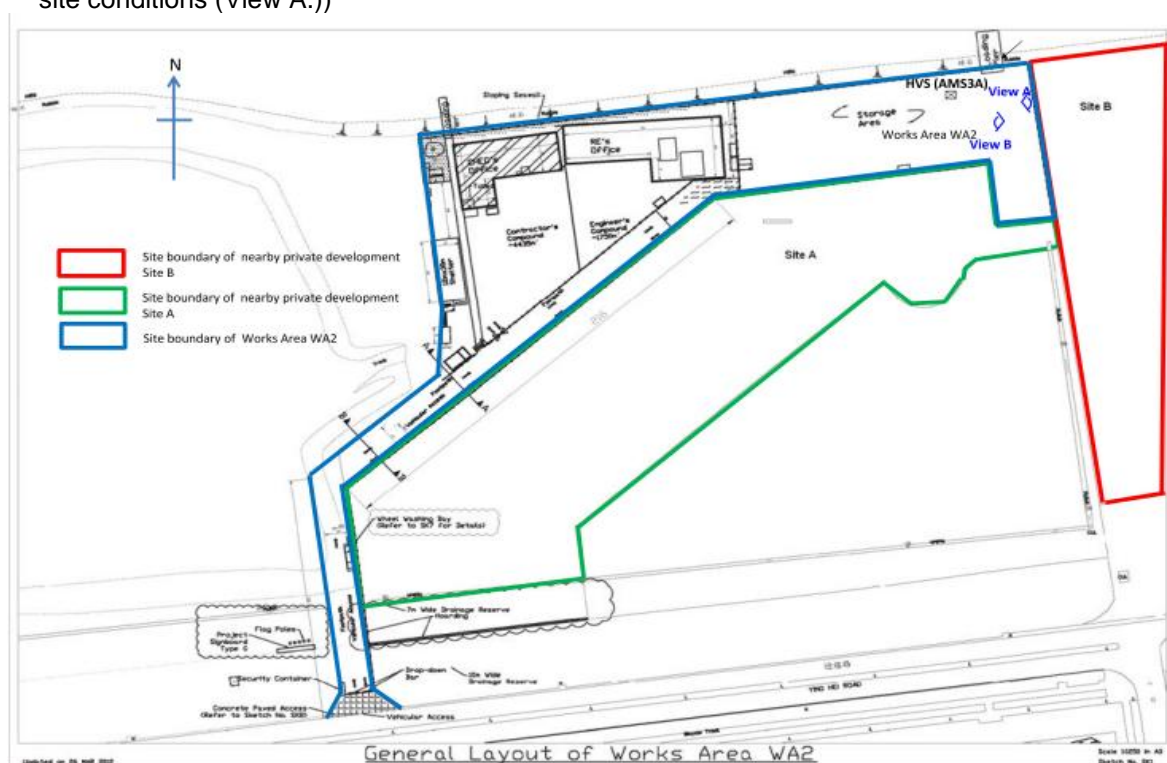
- 3.1.10.3 Photo records shows vehicle parking activities were observed inside an area at construction sites of nearby private development project which are close to the monitoring station AMS3A but beyond the site boundary of Works Area WA2. (Please also see photo and layout map attached for reference of site conditions (View A.))

Photo record:

View A (parking lot observed at nearby construction site which do not belongs to this Contract)

View B (Hard paved surface observed at Works Area WA2)

- 3.1.10.8 The dust exceedance was therefore considered not to be due to the Project works.
- 3.1.10.9 The Contractor was recommended to continue implementing existing dust mitigation measures.

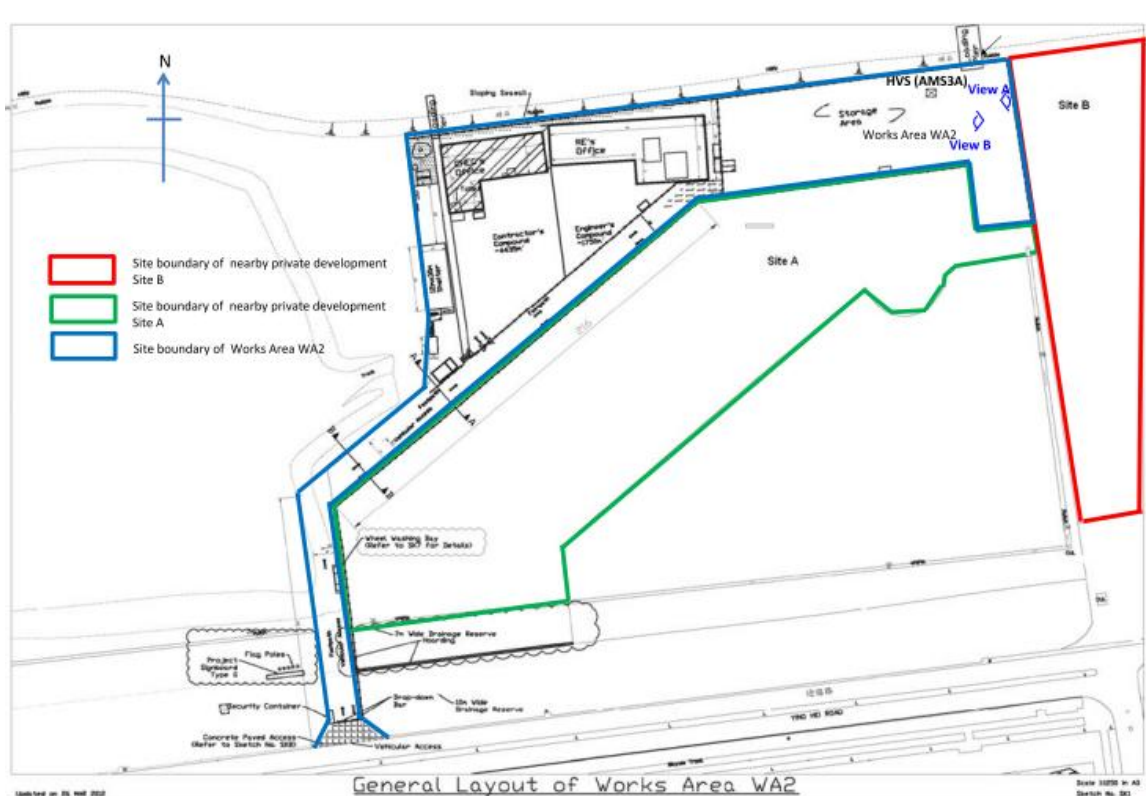
- 3.1.11.3 Photo records shows vehicle parking activities were observed inside an area at construction sites of nearby private development project which are close to the monitoring station AMS3A but beyond the site boundary of Works Area WA2. (Please also see photo and layout map attached for reference of site conditions (View A.))

Photo record:

View A (parking lot observed at nearby construction site which do not belongs to this Contract)

View B (Hard paved surface observed at Works Area WA2)

- 3.1.11.8 The dust exceedance was therefore considered not to be due to the Project works.
- 3.1.11.9 The Contractor was recommended to continue implementing existing dust mitigation measures.

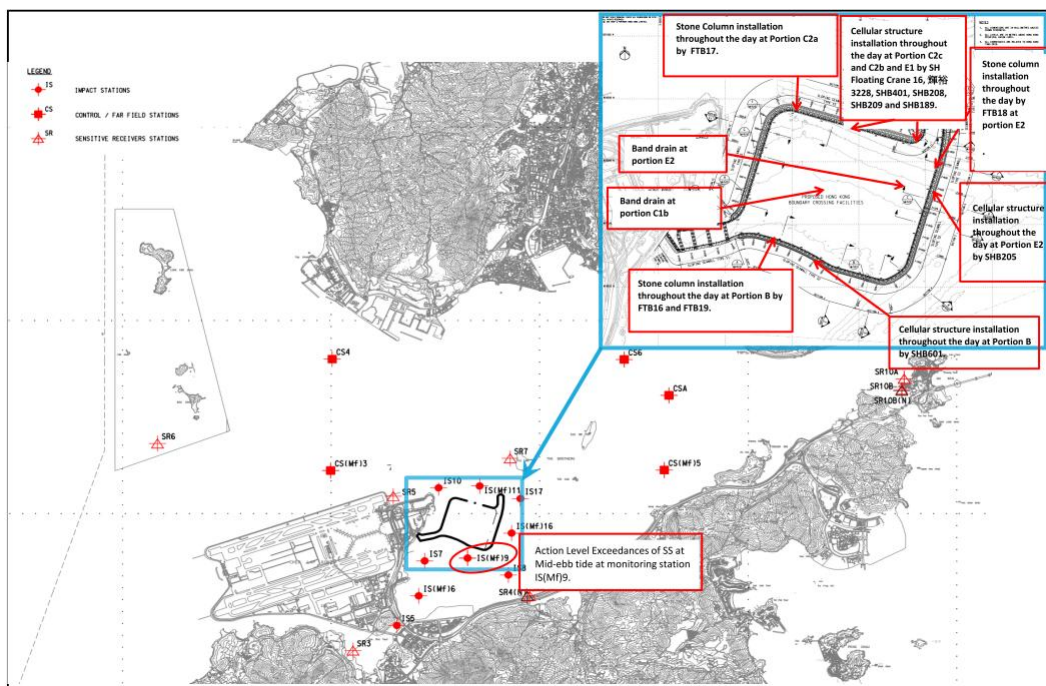
3.3.3 One (1) Action Level exceedance at measured Suspended Solids (mg/L) where recorded on 06 September 2013 during mid-flood tide at monitoring station IS(Mf)9. For Action Level exceedance at measured Suspended Solids (mg/L), 30.3 mg/L was recorded at Monitoring Station IS(Mf)9.

- 3.3.3.1 For locations and type of active works carried out on 6 Sept 13, please refer to the above layout map.
- 3.3.3.2 For action level exceedance of depth averaged SS (in mg/L) recorded at IS(Mf)9 during mid flood tide, active works were carried out at almost the same locations on 4, 6 and 9 Sept 13, but all depth averaged SS (in mg/L) results recorded at all monitoring location on 4 and 9 Sept 13 were all below the Action and Limit Level, which indicates that active works are unlikely to contribute to the action level exceedance recorded at IS(Mf)9.

- 3.3.3.3 Monitoring results of depth averaged suspended solid (mg/L) at IS10 and IS(Mf)11 which are located downstream to active works during flood tide were 6.2 mg/L and 7.6 mg/L which are below active and limit level and shows that depth averaged suspended solid (mg/L) at downstream to active works were not adversely affected.

- 3.3.3.5 When impact water quality monitoring was carried out during mid flood tide at monitoring location IS(Mf)9, no discoloration of sea water was observed and no silty plume were observed to flow from the inside to the outside of the site boundary.

- 3.3.3.6 The exceedance was likely due to local effects in the vicinity of IS(Mf)9.
- 3.3.3.7 The exceedance was considered as non-Project related.
- 3.3.3.8 Nevertheless, the Contractor was reminded to ensure provision of ongoing maintenance to the silt curtains and to carry out maintenance work once defects were found.

- 3.3.3.9 Maintenance work of the silt curtain was carried out by the Contractor on a daily basis except Sunday and public holiday.

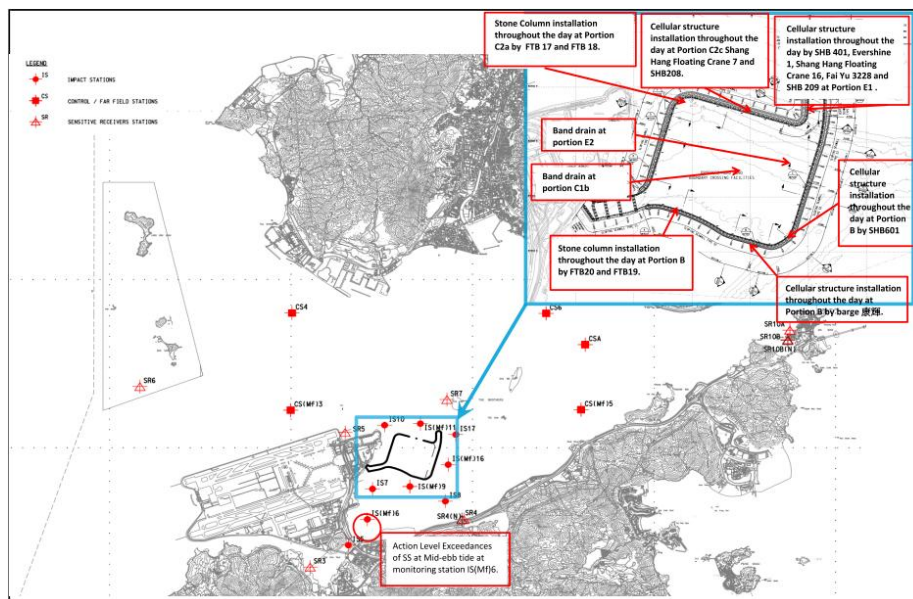
3.3.4 One (1) Action Level exceedance at measured Suspended Solids (mg/L) where recorded on 16 September 2013 during mid-ebb tide at monitoring station IS(Mf)6. For Action Level exceedances at measured Suspended Solids (mg/L), 25 mg/L was recorded at Monitoring Station IS(Mf)6.

3.3.4.1 For locations and type of active works carried out on 16 Sept 13, please refer to the above layout map.

3.3.4.2 For action level exceedance of depth averaged SS (in mg/L) recorded at IS(Mf)6 during mid ebb tide, Suspended solids values recorded at Impact Station IS7, IS(Mf)9 and IS8 located downstream to and closer to active works than IS(Mf)6 during Mid-Ebb tide were below the Action and Limit Level during the same tide on the same day. This indicates project works is unlikely to contribute to the action level exceedance recorded at IS(Mf)6.

3.3.4.7 Nevertheless, the Contractor was reminded to ensure provision of ongoing maintenance to the silt curtains and to carry out maintenance work once defects were found.

3.3.4.8 Maintenance work of the silt curtain was carried out by the Contractor on a daily basis except Sunday and public holiday.

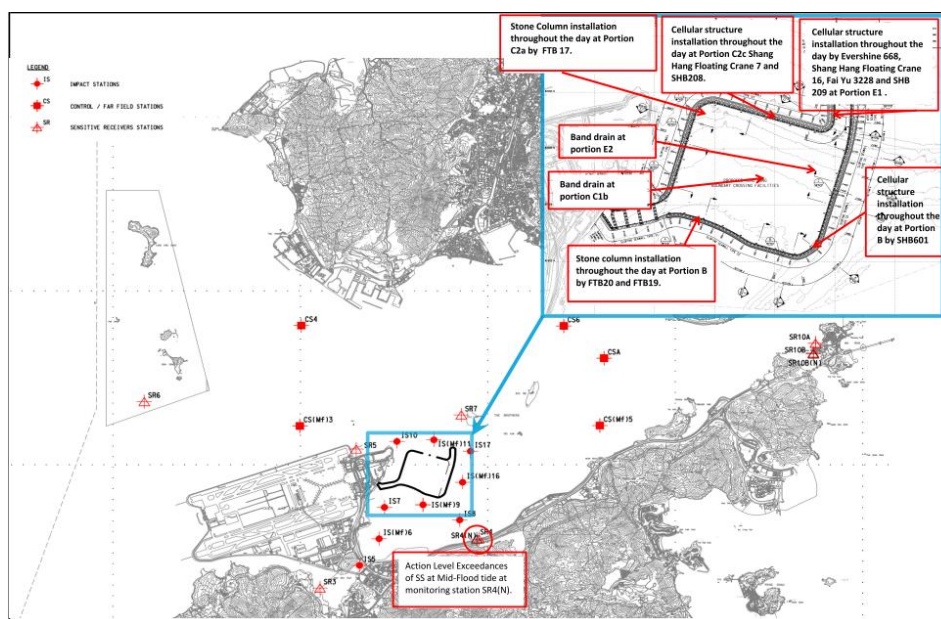
3.3.5 One (1) Action Level exceedance at measured Suspended Solids (mg/L) where recorded on 18 September 2013 during mid-flood tide at monitoring station SR4(N). For Action Level exceedance at measured Suspended Solids (mg/L), 24 mg/L was recorded at Monitoring Station SR4(N)

3.3.5.1 Please refer the above layout map for activity carried out on 18 Sept 13.

3.3.5.2 IS(Mf)9 and IS(Mf)16 are located closer to the active works than monitoring station SR4(N). Depth Averaged Suspended Solids (SS) values (in mg/L) recorded during the flood tide on the same day at IS(Mf)9 and IS(Mf)16 were below the Action and Limit Level which indicates project works is unlikely to contribute to the action level exceedance recorded at SR4(N).

3.3.5.6 Nevertheless, the Contractor was reminded to ensure provision of ongoing maintenance to the silt curtains and to carry out maintenance work once defects were found.

3.3.5.7 Maintenance work of the silt curtain was carried out by the Contractor on a daily basis except Sunday and public holiday.

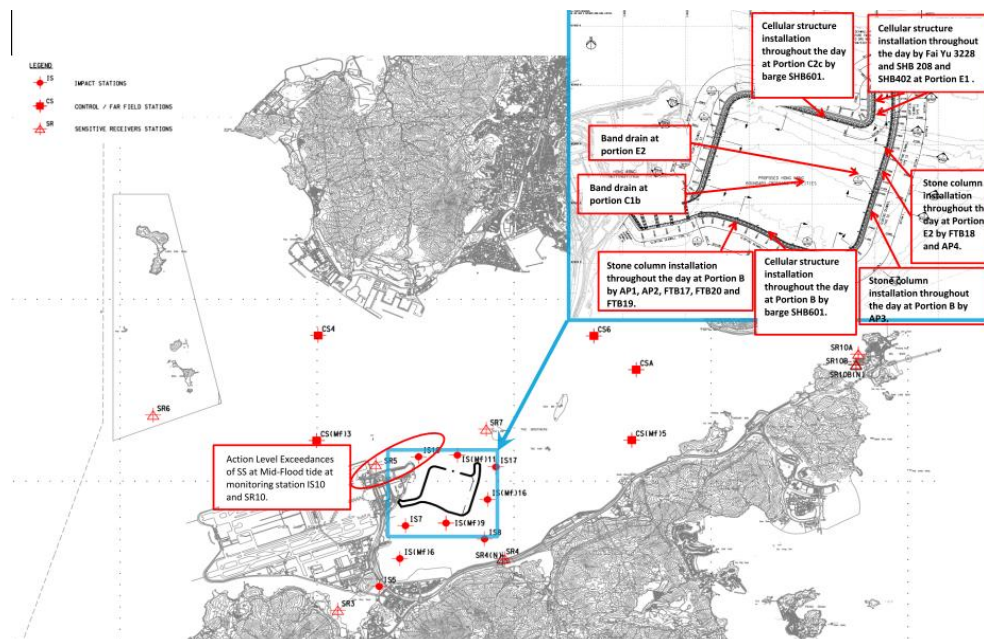
3.3.6 Two (2) Action Level exceedance at measured Suspended Solids (mg/L) were recorded on 30 Sept 13 during mid-flood tide at monitoring station SR5 and IS (10). For Action Level exceedance at measured Suspended Solids (mg/L), 24.5 mg/L were recorded at Monitoring Station SR5 and IS(10).

3.3.6.1 Please refer the above layout map for activity carried out on 30 Sept 13.

3.3.6.2 No active works were carried out portion C2a, Portion A and Portion C1a. Installation of band drain was carried out at Portion C1b and Cellular Structure installation was carried out at Portion C2c and E1 on 30 Sept 13. These works were unlikely to generate silt plumes or suspended solid. Stone column installation was conducted at Portion B and E2 which is far away from IS10 and SR5. (For location of each portion please refer to below Layout - Portion of Marine Work)

3.3.6.3 Suspended solids values recorded at Impact Stations IS(Mf)11 and IS7 which is closer to the active works at Portion E2 and Portion B respectively than monitoring station IS10 and SR5 were below the action and limit level which indicates that active works from portion E2 and B is unlikely to cause SS exceedance at monitoring station IS10 and SR5.

3.3.6.5 When impact water quality monitoring was carried out during mid flood tide at monitoring location IS10 and SR5, no discoloration of sea water was observed and no silty plume were observed to flow from the inside to the outside of the site boundary.

3.3.6.7 Nevertheless, the Contractor was reminded to ensure provision of ongoing maintenance to the silt curtains and to carry out maintenance work once defects were found.

3.3.6.8 Maintenance work of the silt curtain was carried out by the Contractor on a daily basis except Sunday and public holiday.

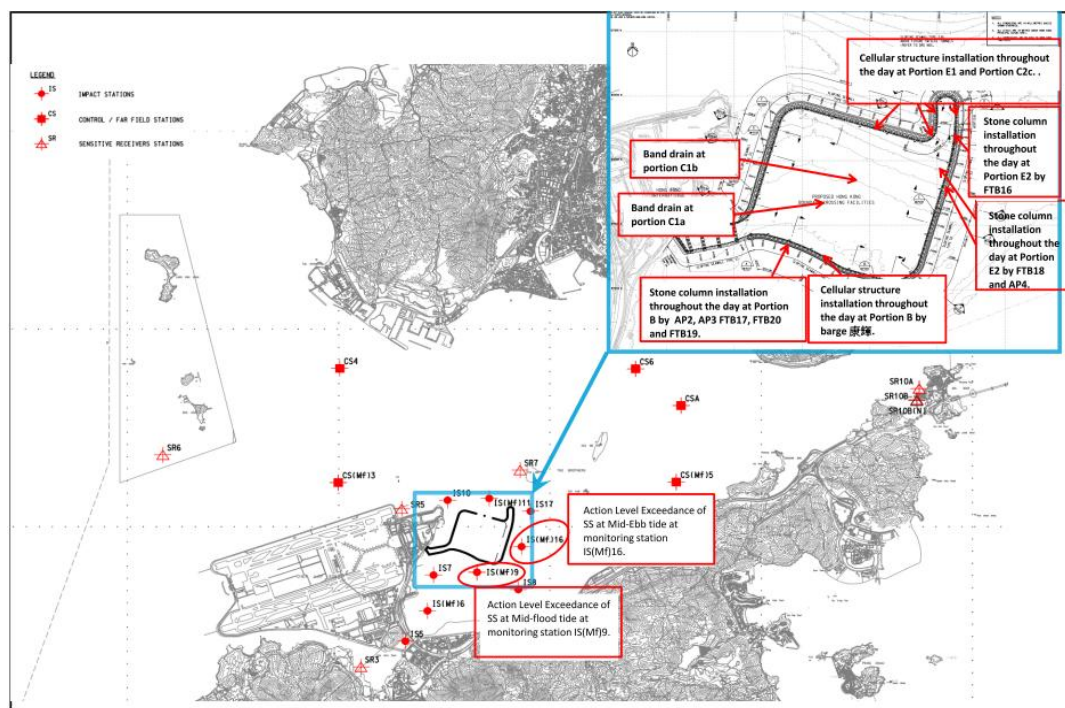
3.3.7 Two (2) Action Level exceedances at measured Suspended Solids (mg/L) were recorded on 04 Oct 2013 at monitoring station IS(Mf) 16 and IS(Mf)9 at Mid-Ebb tide and Mid-Flood tide respectively. For Action Level exceedances at measured Suspended Solids (mg/L), 32.9 mg/L and 25.4 mg/L was recorded at Monitoring Station IS(Mf)16 and IS(Mf)9 respectively.

- 3.3.7.1 For locations and type of active works carried out on 4 Oct 13, please refer to the above layout map.
- 3.3.7.2 Impact Stations IS10 and IS(Mf)11 are downstream and closer to the active works at Portion E1 and E2 than monitoring station IS(Mf)9 during flood tide. Suspended solids value recorded on 4 Oct 13 at Impact Stations IS10 and IS(Mf)11 is 9.1mg/L and 7.5mg/L during flood tide respectively which were below the action and limit level. Hence active works from portion E1 and E2 were unlikely to cause SS exceedance at monitoring station IS(Mf)9 during mid flood tide.

- 3.3.7.3 IS(Mf)9 was considered upstream to active works at Portion B during flood tide which SS level were unlikely to be adversely affected by active works at Portion B.

- 3.3.7.6 When impact water quality monitoring was carried out at IS(Mf)16 during mid ebb tide and at IS(Mf)9 during mid flood tide, no discoloration of sea water was observed and no silty plume were observed to flow from the inside to the outside of the site boundary.

- 3.3.7.7 The recorded suspended solids values recorded on 4 Oct 13 at monitoring station IS7, IS8 & IS17 during both tide were below the action and limit level which shows that the water quality nearby IS(Mf)16 during ebb tide and IS(Mf)9 during flood tide were not adversely affected.
- 3.3.7.8 The exceedances were likely due to local effects in the vicinity of IS(Mf)16 and IS(Mf)9.
- 3.3.7.9 The exceedance was considered as non-Project related.
- 3.3.7.10 Nevertheless, the Contractor was reminded to ensure provision of ongoing maintenance to the silt curtains and to carry out maintenance work once defects were found.
- 3.3.7.11 Maintenance work of the silt curtain was carried out by the Contractor on a daily basis except Sunday and public holiday.

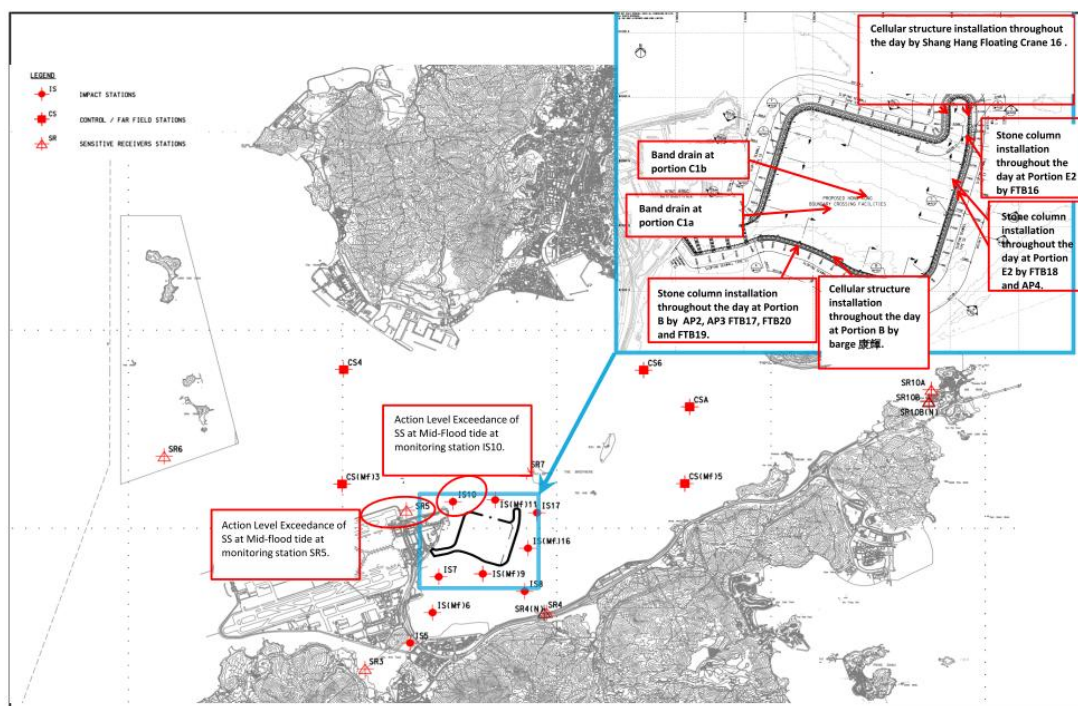
3.3.8 Two (2) Action Level exceedances at measured Suspended Solids (mg/L) were recorded on 7 Oct 2013 during mid-flood tide at monitoring station IS10 and SR5. For Action Level exceedances at measured Suspended Solids (mg/L), 25 mg/L and 24.8 mg/L were recorded at Monitoring Station IS10 and SR5 respectively.

3.3.8.1 Please refer attached Layout Map for work activity carried out on 7 Oct 13.

3.3.8.2 No active works were carried out at portion C2a, C2c and Portion A. Installation of band drain was carried out at Portion C1b & Portion C1a and Cellular Structure installation was carried out at Portion E1 and C2b on 7 Oct 13. These works were unlikely to generate silt plumes or suspended solid. Stone column installation was conducted at Portion B, E1 and E2 which are far away from IS10 and SR5. (For location of each portion please refer to attached Layout - Portion of Marine Work)

3.3.8.3 IS(Mf)11 and IS17 which are closer to the active works at Portion E2 than it is for monitoring station IS10 and SR5 and the suspended solid value of IS(Mf)11 and IS17 at mid flood tide were below the action and limit level which indicates that active works from portion E2 were unlikely to cause SS exceedance at monitoring station IS10 and SR5.

3.3.8.4 IS7 which is closer to the active works at portion B than it is for monitoring station IS10 and SR5 and the suspended solids level of IS7 at mid flood tide were below the action and limit level which indicates that active works from portion B were unlikely to cause SS exceedance at monitoring station IS10 and SR5.

3.3.8.10 Nevertheless, the Contractor was reminded to ensure provision of ongoing maintenance to the silt curtains and to carry out maintenance work once defects were found.

3.3.8.11 Maintenance work of the silt curtain was carried out by the Contractor on a daily basis except Sunday and public holiday.

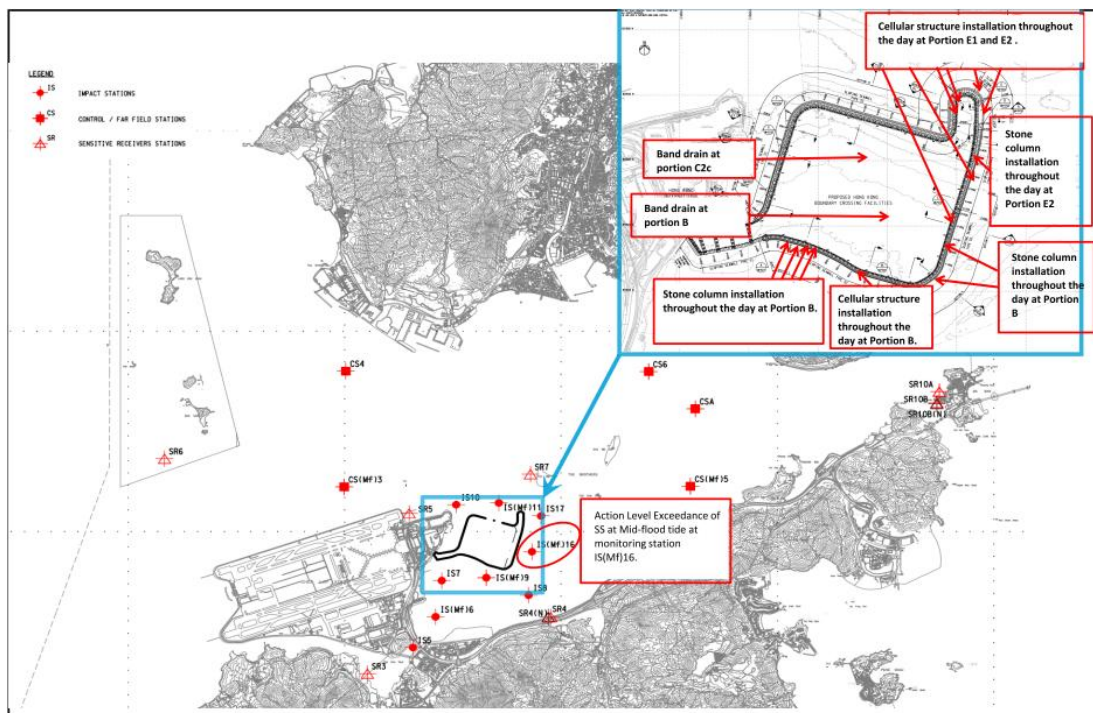
3.3.9 One (1) Action Level exceedance at measured Suspended Solids (mg/L) where recorded on 16 Oct 13 2013 during mid-flood tide at monitoring station IS(Mf)16. For Action Level exceedance at measured Suspended Solids (mg/L), 32 mg/L was recorded at Monitoring Station IS(Mf)16

- 3.3.10.1 Please refer the above layout map for activity carried out on 16 Oct 13.
- 3.3.10.2 Impact Stations IS10 and IS(Mf)11 are downstream and closer to the active works at Portion E1 and E2 than monitoring station IS(Mf)16 during flood tide. Suspended solids value recorded on 16 Oct 13 at Impact Stations IS10 and IS(Mf)11 is 4.2mg/L and 6.4mg/L during flood tide respectively. The recorded suspended solids values are below the action and limit level which indicate that active works at Portion E1 and E2 on 16 Oct 13 were unlikely to cause SS exceedance at monitoring station IS(Mf)16 during mid flood tide.

- 3.3.10.3 IS(Mf)16 is considered upstream to active works during flood tide, therefore active works is unlikely to cause SS exceedance at monitoring station IS(Mf)16 during mid flood tide.

- 3.3.10.5 When impact water quality monitoring was carried out at IS(Mf)16 during mid flood tide, no discoloration of sea water was observed and no silty plume were observed to flow from the inside to the outside of the site boundary.
- 3.3.10.6 No defect was observed on the perimeter silt curtain during monitoring conducted at nearby IS(Mf)16 on 16 Oct 13.
- 3.3.10.7 The exceedances were likely due to local effects in the vicinity of IS(Mf)16.
- 3.3.10.8 The exceedances were considered as Non-project related
- 3.3.10.9 Nevertheless, the Contractor was reminded to ensure provision of ongoing maintenance to the silt curtains and to carry out maintenance work once defects were found.
- 3.3.10.10 Maintenance work of the silt curtain was carried out by the Contractor on a daily basis except Sunday and public holiday

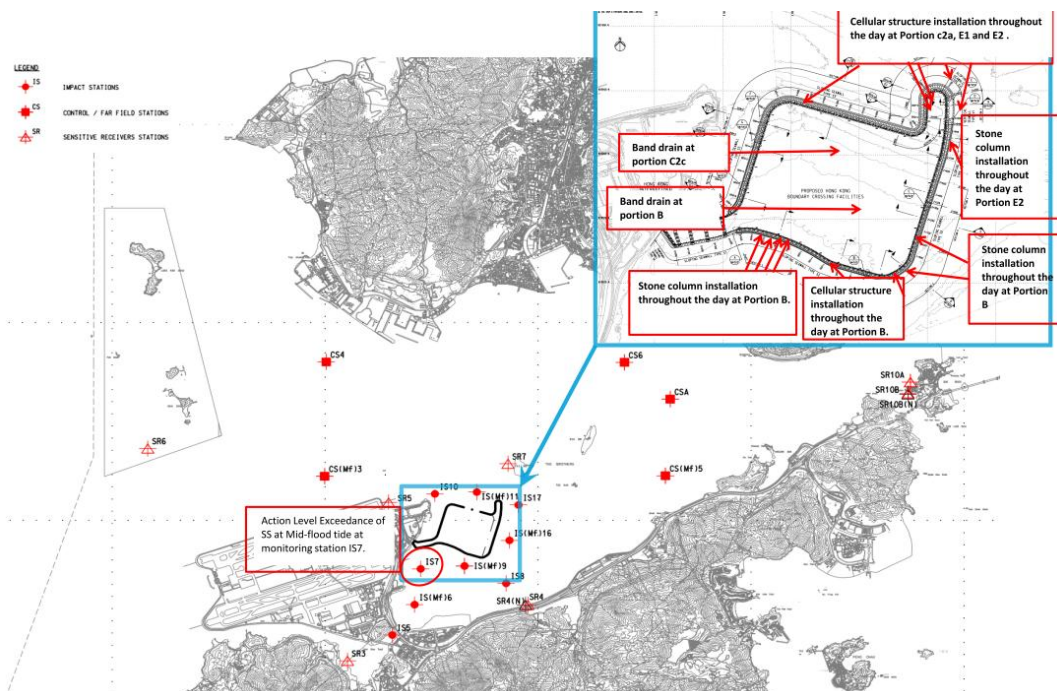
3.3.10 One (1) Action Level exceedance at measured Suspended Solids (mg/L) was recorded on 18 Oct 2013 at monitoring station IS7 at Mid-Flood tide. For Action Level exceedance at measured Suspended Solids (mg/L) at IS17, 27.6 mg/L were recorded.

- 3.3.10.1 For locations and type of active works carried out on 18 Oct 13, please refer to the above layout map.
- 3.3.10.2 Same type of works were carried out at the same location on 16 and 21 Oct 13 but Suspended Solids values recorded at IS7 on 16 and 21 Oct 13 are all below the Action and Limit Level during the same tide.

- 3.3.10.6 The exceedances were likely due to local effects in the vicinity of IS7.
- 3.3.10.7 The exceedances were considered as Non-project related.
- 3.3.10.8 Nevertheless, the Contractor was reminded to ensure provision of ongoing maintenance to the silt curtains and to carry out maintenance work once defects were found.
- 3.3.10.9 Maintenance work of the silt curtain was carried out by the Contractor on a daily basis except Sunday and public holiday.

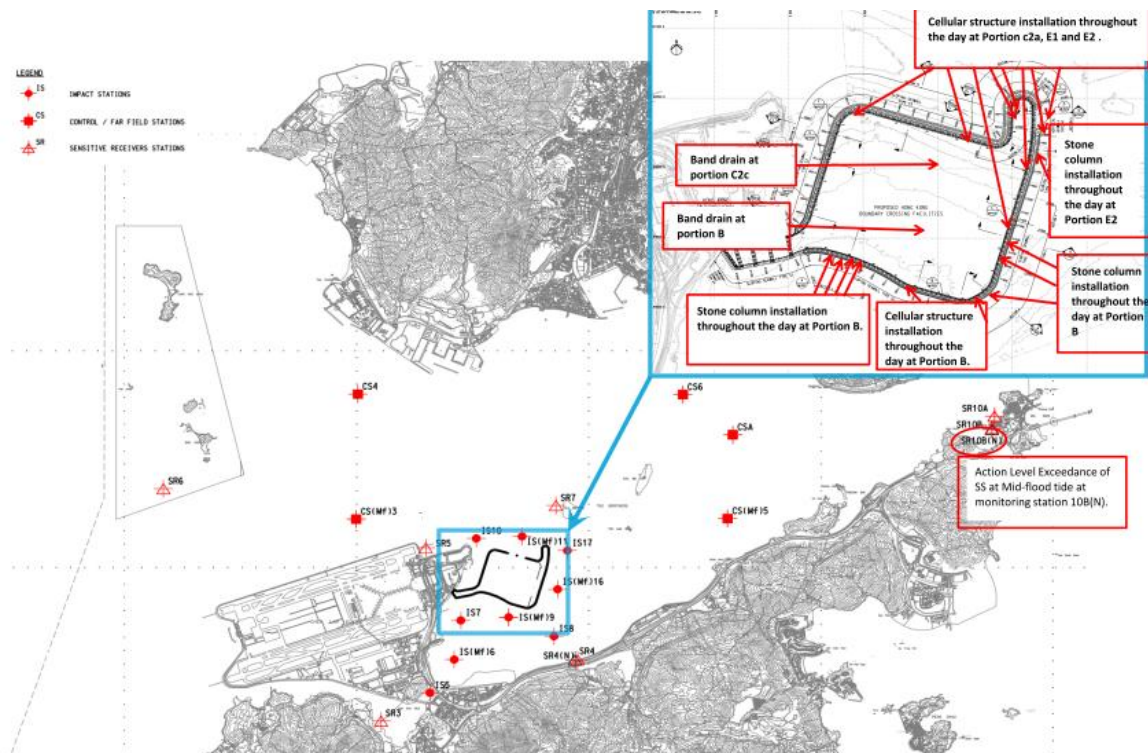
3.3.11 One (1) Action Level exceedances at measured Suspended Solids (mg/L) were recorded on 21 Oct 2013 at monitoring station SR10B(N) at Mid-Flood tide. For Action Level exceedance at measured Suspended Solids (mg/L), 23.8 mg/L were recorded at Monitoring Station SR10B(N).

- 3.3.11.1 For locations and type of active works carried out on 21 Oct 13, please refer to the above layout map.
- 3.3.11.2 IS(Mf)11 and IS10 are located downstream and closer to the active works than monitoring station SR10B(N) during flood tide. Depth Averaged Suspended Solids (SS) values (in mg/L) recorded during flood tide on the same day at IS(Mf)11 and IS10 were below the Action and Limit Level which indicates project work is unlikely to contribute to the action level exceedance recorded at SR10B(N).

- 3.3.11.3 The monitoring location of monitoring station SR10B(N) are considered upstream and remote to the active works of this project during flood tide. Therefore it was unlikely that the exceedance recorded at SR10B(N) during flood tide was due to active construction activities of this project.

- 3.3.11.4 The exceedance was likely due to local effects in the vicinity of SR10B(N).
- 3.3.11.5 Nevertheless, the Contractor was reminded to ensure provision of ongoing maintenance to the silt curtains and to carry out maintenance work once defects were found.

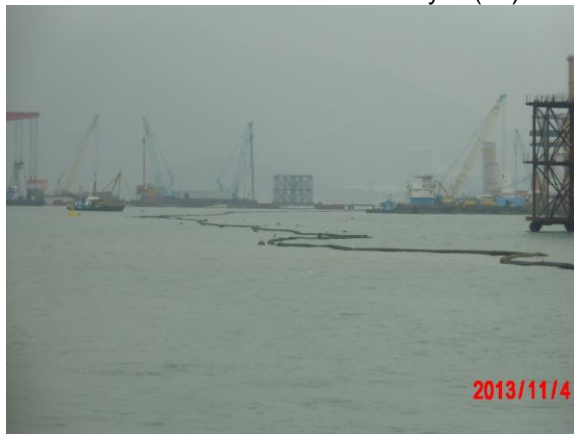
- 3.3.13.5 Photo record shows that no defect was observed on the perimeter silt curtain nearby IS(Mf)16 and IS17. (Please see attached photo record)
- 3.3.13.6 When impact water quality monitoring was carried out at IS(Mf)16 during mid ebb tide and at IS(Mf)9 during mid flood tide, no discoloration of sea water was observed and no silty plume were observed to flow from the inside to the outside of the site boundary.

Photo record of site condition nearby IS(Mf)6

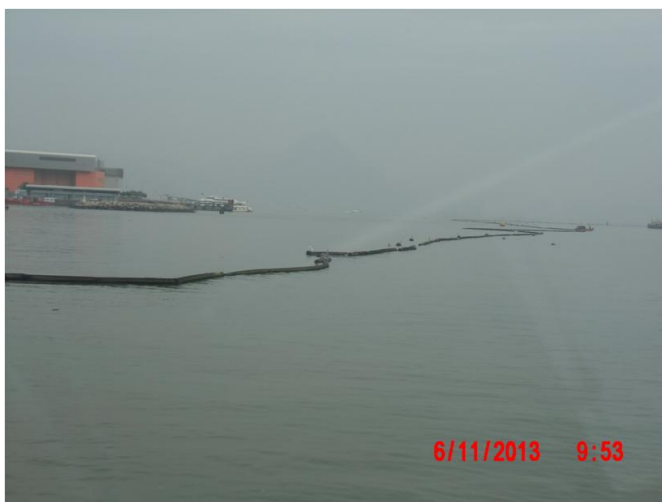
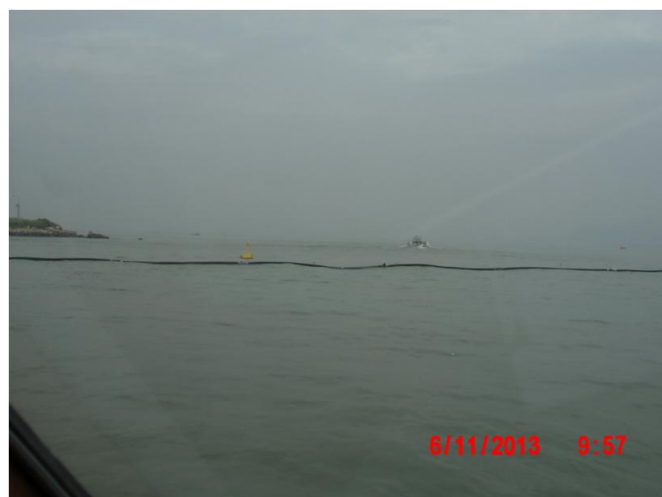
- 3.3.14.6 However, with refer to the silt curtain condition on 6 and 8 Nov 13, defects of the perimeter silt curtain was observed at southwest and northwest of the construction site but no exceedance was observed on 8 Nov 13 at IS10, SR5, SR6 and SR10B(N).

Condition of sea and silt curtain on 6 November 2013 (the northwest side of BCF)

- 3.3.14.10 As such, the exceedances recorded at IS10, SR5, SR6 and SR10B(N) were considered as non-Project related.
- 3.3.14.11 Nevertheless, the Contractor was reminded to ensure provision of ongoing maintenance to the silt curtains and to carry out maintenance work once defects were found.

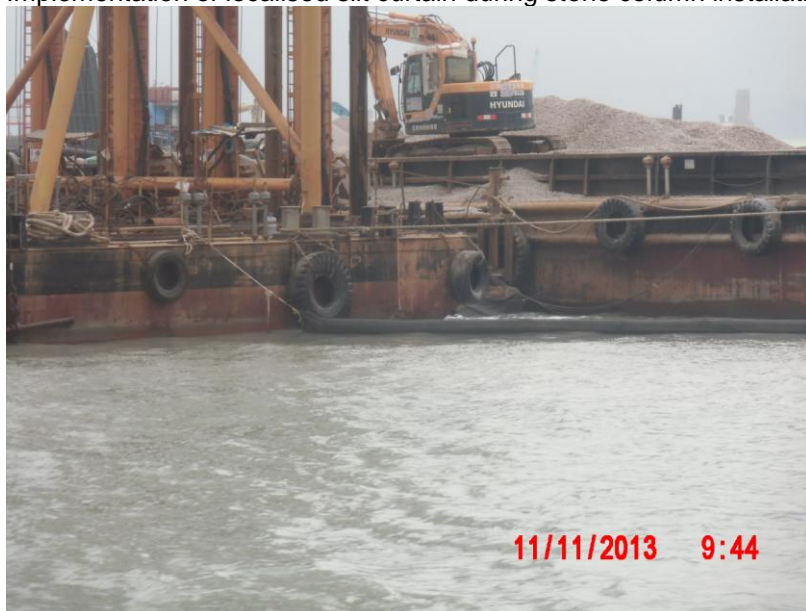
- 3.3.15.5 Localised silt curtain was implemented during stone column installation. (Please refer to the photo record attached)
- 3.3.15.6 No defects of perimeter silt curtain was observed at the proximity of IS(Mf)6. (Please refer to the photo record attached)

Implementation of localised silt curtain during stone column installation

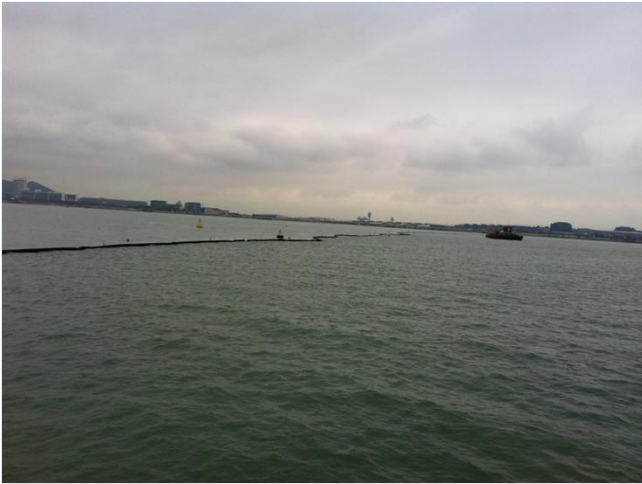
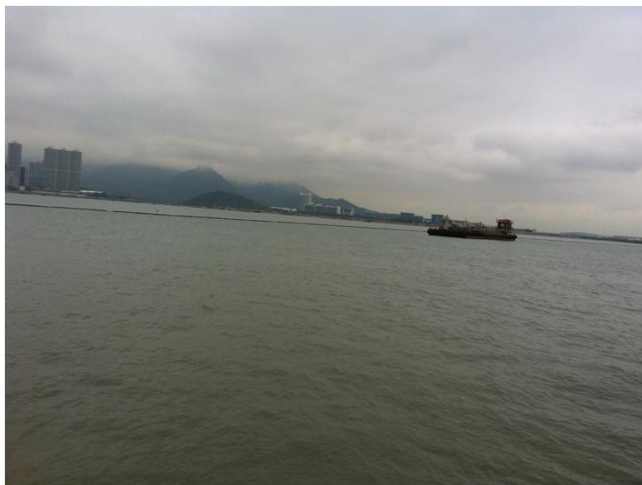
3.3.16.7 Photo record of the sea condition taken on 13 Nov 13

Condition of silt curtain near the monitoring station SR4(N).

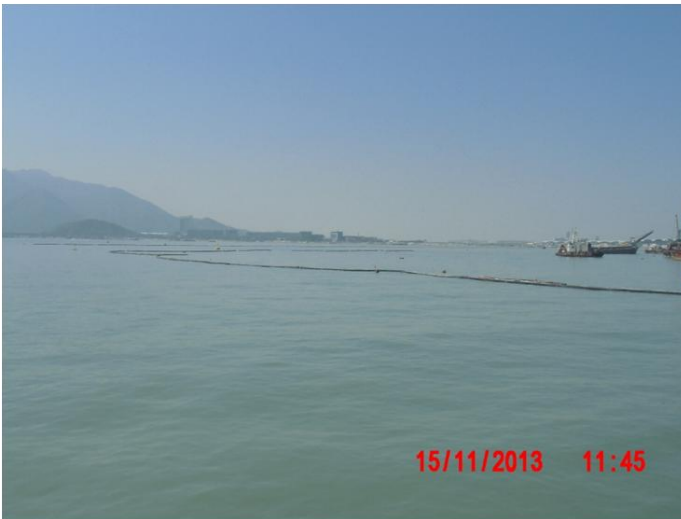
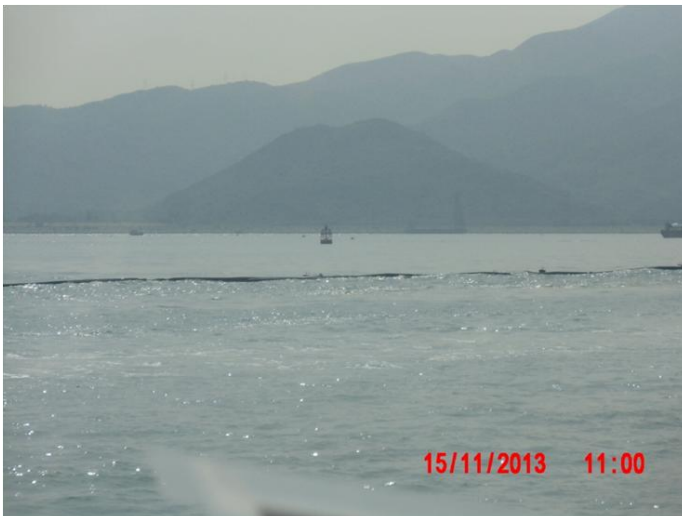
3.3.17.11 Photo record of the sea condition taken on 15 Nov 13

- 3.3.17.6 Refer to the attached layout map, active works were noted directly upstream to IS(Mf)9 during flood tide and IS17 during ebb tide, but no defects at south alignment (Nearby IS(Mf)9 and the northwest alignment of the perimeter silt curtain (nearby S117) when monitoring was conducted on 15 Nov 13.

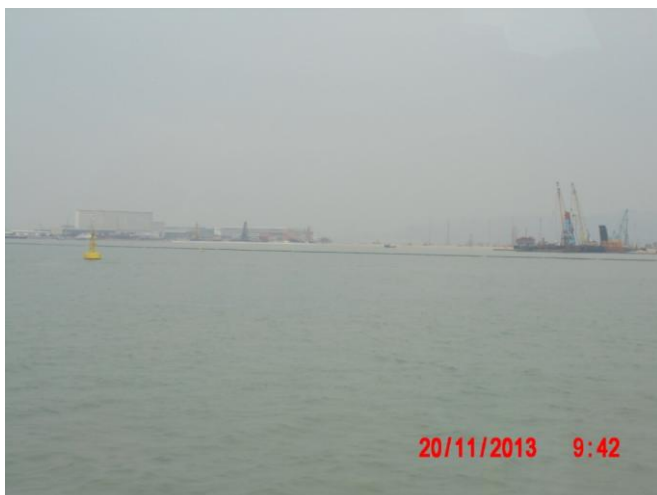
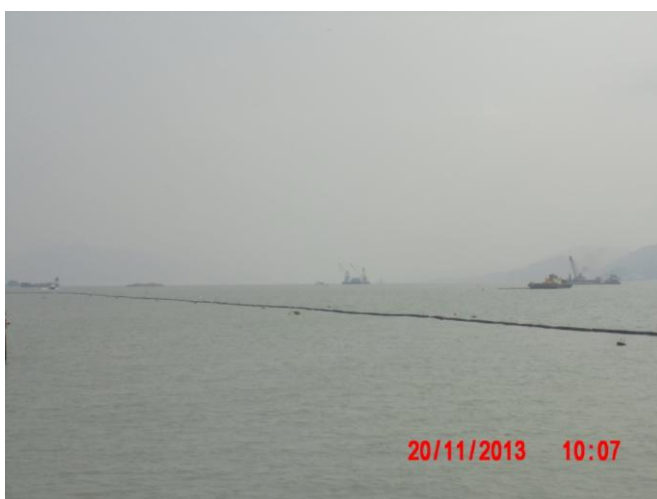
- 3.3.18.6 No defects of perimeter silt curtain was observed at the proximity of IS(Mf)6 and IS7. (Please refer to the photo record attached)

3.3.18.7 Condition of silt curtain near the monitoring station IS(Mf)6 and IS7.

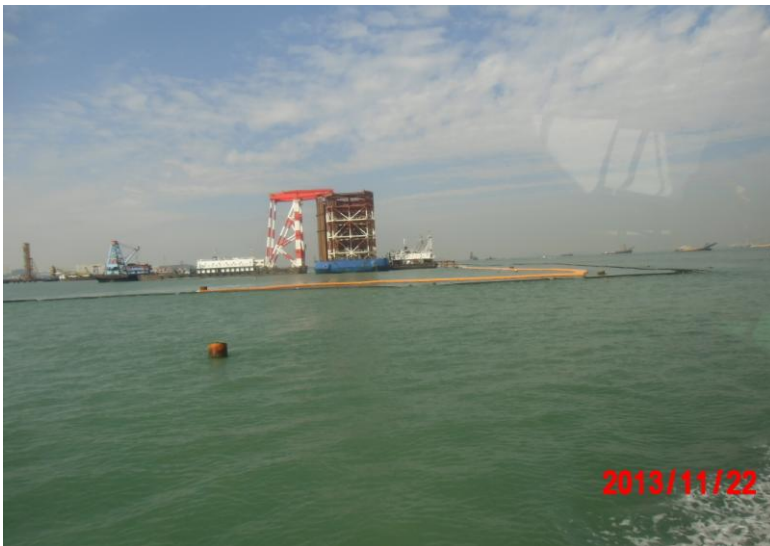
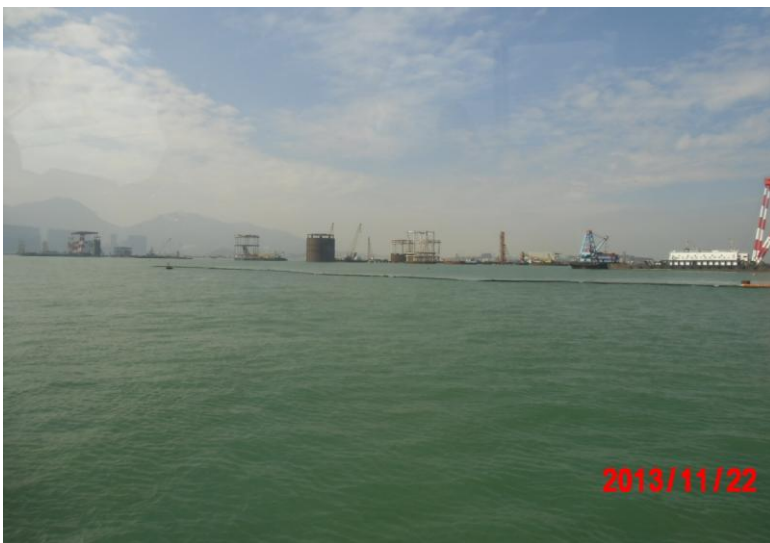
3.3.19.5 Localised silt curtain was implemented during stone column installation.

3.3.19.6 No defects of perimeter silt curtain was observed at the proximity of IS(Mf)16. (Please refer to the photo record attached)
