Contract No. HY/2010/02

**Hong Kong – Zhuhai – Macao Bridge
Hong Kong Boundary Crossing
Facilities –
Reclamation Works**

**Quarterly EM&A Report for
June 2014- August 2014**

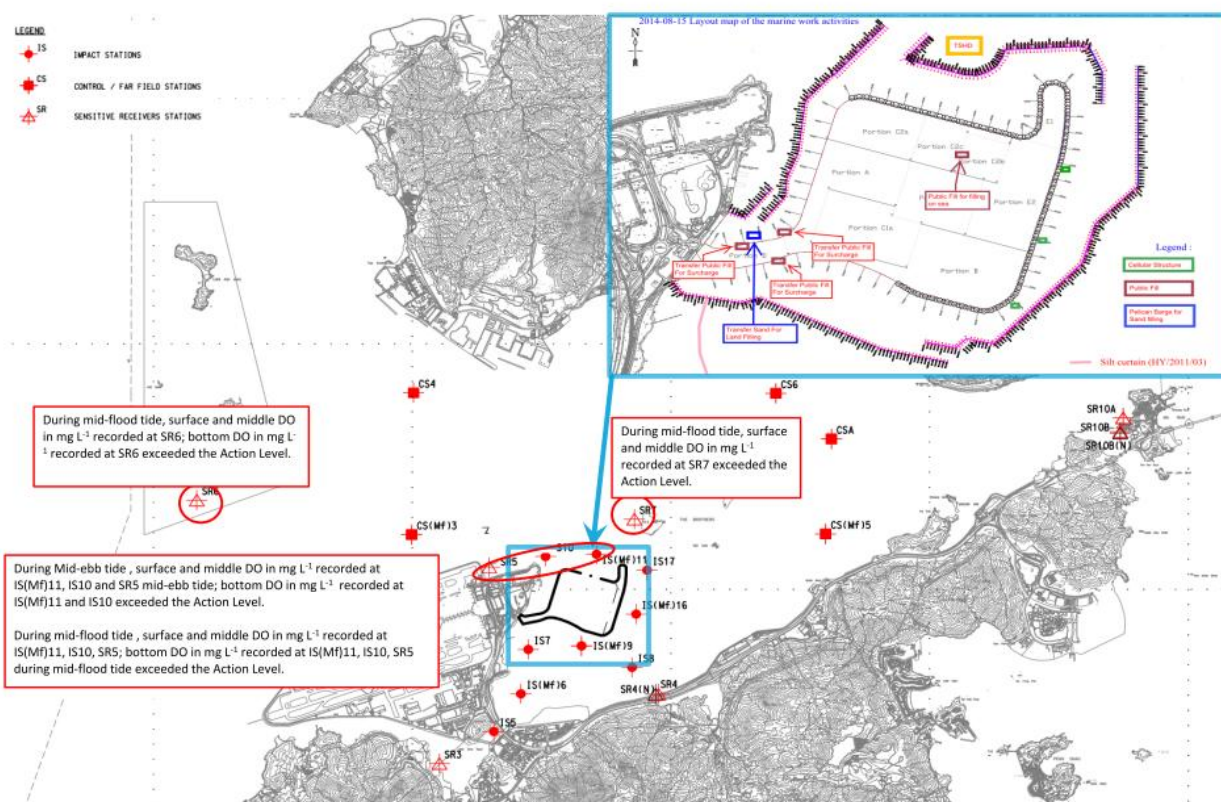
3.3.3 Fourteen (14) Action Level Exceedances were recorded at measured dissolved oxygen (DO) value (mg L^{-1}) on 15 August 2014. During Mid-ebb tide on, surface and middle DO in mg L^{-1} recorded at IS(Mf)11, IS10 and SR5; bottom DO in mg L^{-1} recorded at IS(Mf)11 and IS10 exceeded the Action Level. During mid-flood tide on 15 August 2014, surface and middle DO in mg L^{-1} recorded at IS(Mf)11, IS10, SR5, SR6 and SR7; bottom DO in mg L^{-1} recorded at IS(Mf)11, IS10, SR5 and SR6 exceeded the Action Level.

3.3.3.1 For marine works, marine filling was conducted at portion C2b during flood and ebb tide at area behind cellular structures on 15 Aug 2014. Also refer to above layout map.

3.3.3.3 With reference to the silt curtain checking record defects was observed at north parts of the perimeter silt curtain and at southwest entrance of the perimeter silt curtain.

3.3.3.4 As informed by the Contractor, filling was conducted on 13, 15 and 18 August 2014 at Portion C2b, but with referred to monitoring record and photo record attached, no sediment plume has been observed to flow from the inside of the perimeter silt curtain to the outside of the perimeter silt curtain and no discoloration of sea water has been observed. Please refer to the photo attached for reference of the sea condition during ebb tide and flood tide on 15 August 2014.

3.3.3.12 Nevertheless, the Contractor was reminded to ensure provision of ongoing maintenance to the silt curtains and to carry out maintenance work once defects were found.
