Contract No. HY/2010/02

**Hong Kong – Zhuhai – Macao Bridge  
Hong Kong Boundary Crossing  
Facilities –  
Reclamation Works**

**Quarterly EM&A Report for  
September 2014- November 2014**

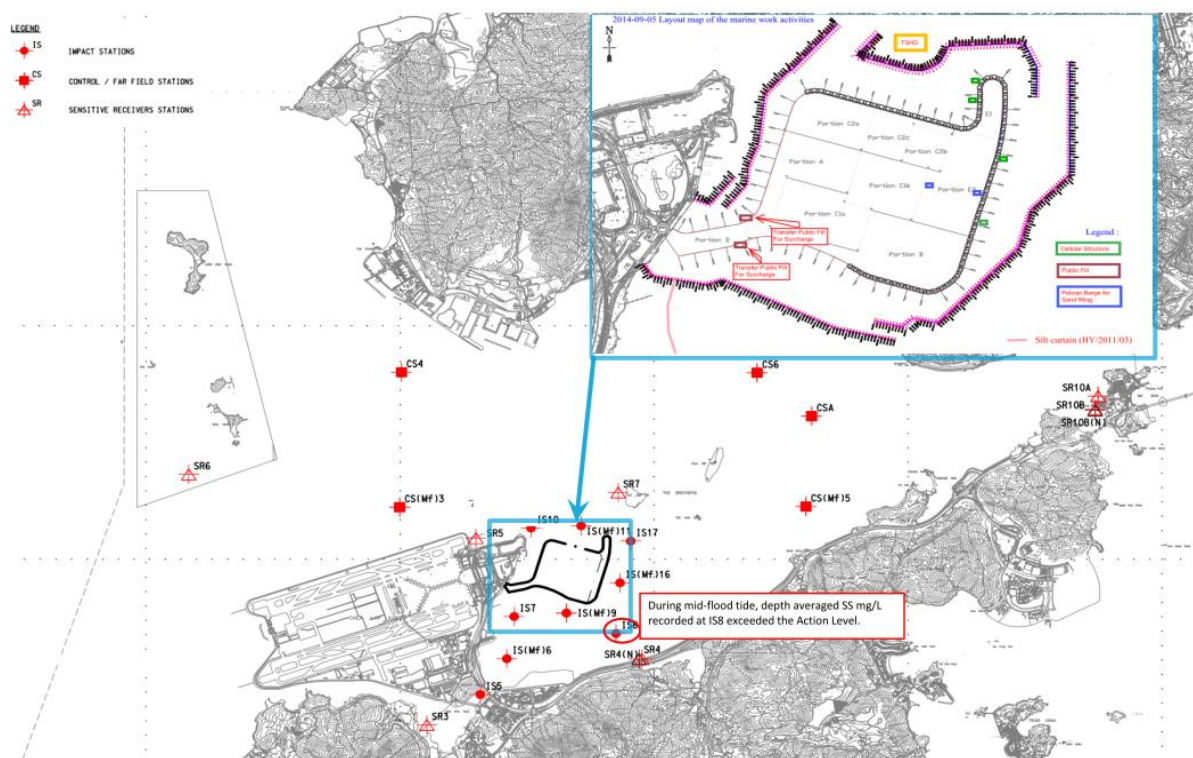
3.3.4 (1) One Action Level Exceedance of SS (27.4mg/L) was recorded at IS8 during flood tide on 5 September 2014. The exceedance was confirmed after checking against relevant control station(s) during flood tide i.e. CS6, CSA and CS(Mf)5 following the Action and Limit Levels for Water Quality.

3.3.4.1 For marine works, marine filling was conducted at portion E2 during flood at area behind cellular structures on 5 September 2014. Also refer to layout map above.

3.3.4.3 As informed by the Contractor, filling was conducted on 3, 5 and 8 September 2014 at Portion E2, but with referred to monitoring record and photo record attached, no sediment plume has been observed to flow from the inside of the perimeter silt curtain to the outside of the perimeter silt curtain and no discoloration of sea water has been observed.

- 3.3.4.12 Nevertheless, the Contractor was reminded to ensure provision of ongoing maintenance to the silt curtains and to carry out maintenance work once defects were found.

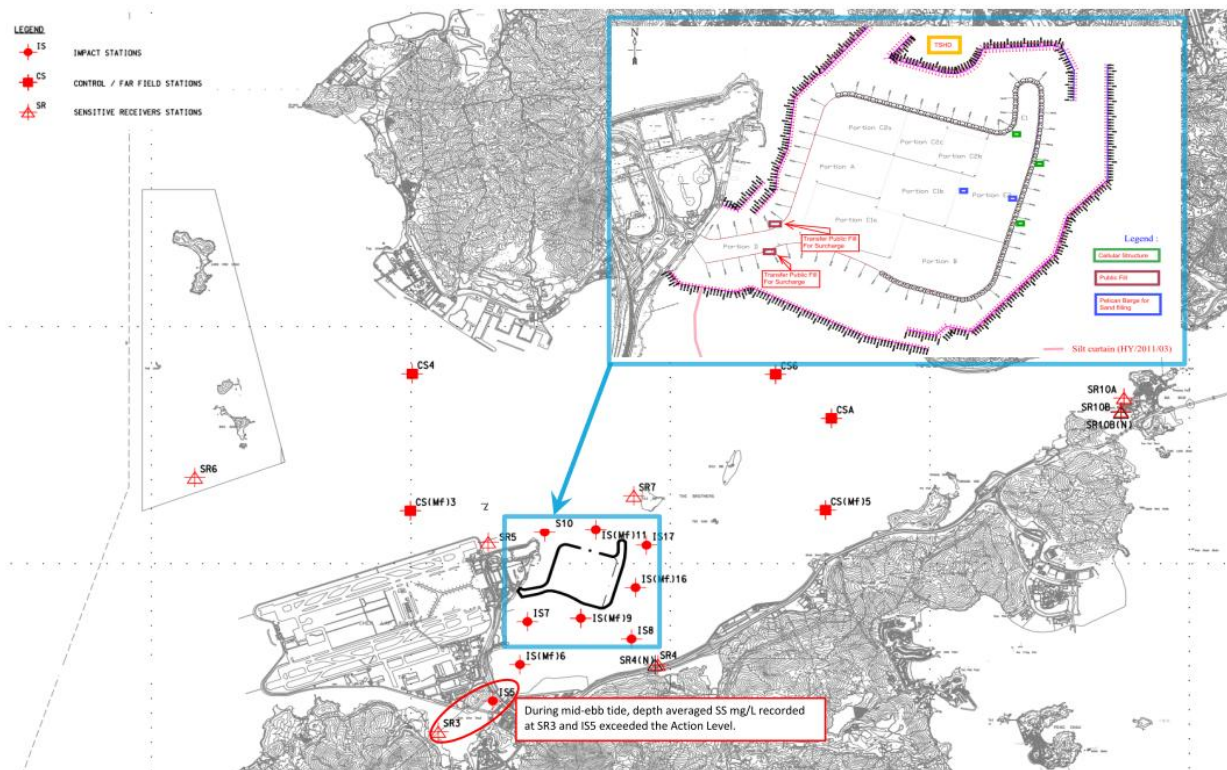
3.3.5 (2) Two Action Level Exceedances of SS (26mg/L and 32.3mg/L) were recorded at IS5 and SR3 during ebb tide on 10 September 2014. The exceedances were confirmed after checking against relevant control station(s) during ebb tide i.e. CS4 and CS(Mf)3 following the Action and Limit Levels for Water Quality.

3.3.5.1 For marine works, marine filling was conducted at portion E2 during ebb tide at area behind cellular structures on 10 September 2014.

3.3.5.3 As informed by the Contractor, filling was conducted on 8, 10 and 12 September 2014 at Portion E2, but with referred to monitoring record and photo record attached, no sediment plume has been observed to flow from the inside of the perimeter silt curtain to the outside of the perimeter silt curtain and no discoloration of sea water has been observed.

- 3.3.5.10 Nevertheless, the Contractor was reminded to ensure provision of ongoing maintenance to the silt curtains and to carry out maintenance work once defects were found.

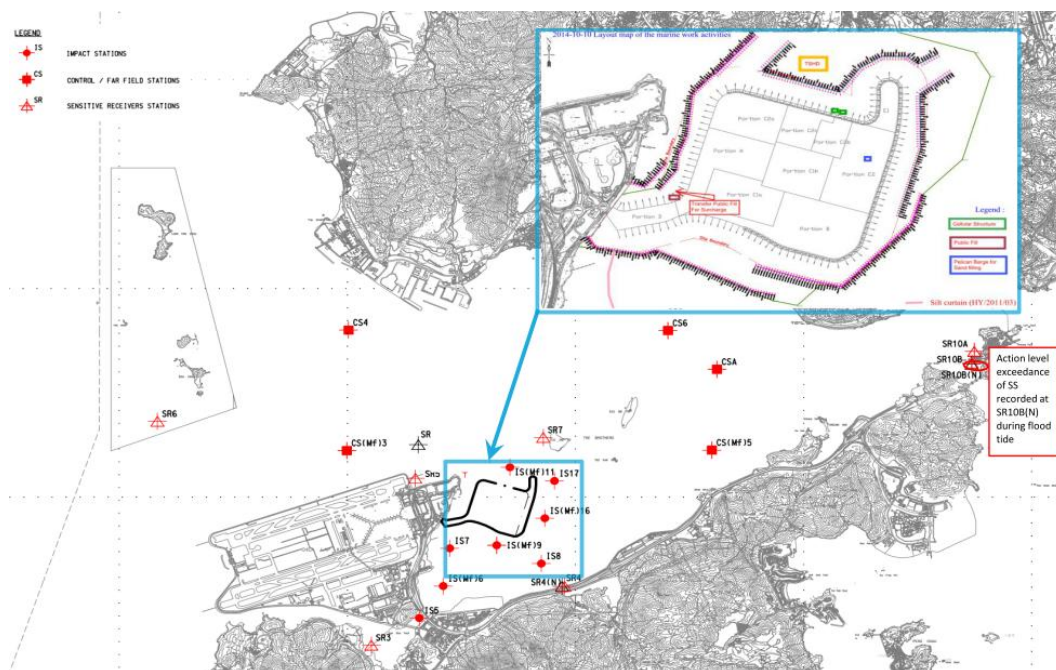
3.3.8.2 IS(Mf)11 and IS10 are located downstream and closer to the active works than monitoring station SR10B(N) during flood tide. Depth Averaged Suspended Solids (SS) values (in mg/L) recorded during flood tide on the same day at IS(Mf)11 and IS10 were below the Action and Limit Level which indicates project work is unlikely to contribute to the action level exceedance recorded at SR10B(N).

3.3.8.3 The monitoring location of monitoring station SR10B(N) are considered upstream and remote to the active works of this project during flood tide. Therefore it was unlikely that the exceedance recorded at SR10B(N) during flood tide was due to active construction activities of this project.

3.3.8.4 The exceedance was likely due to local effects in the vicinity of SR10B(N).

3.3.8.6 ET's conclusions and recommendations for mitigation: Exceedance was not due to marine based construction works of the Project. Nevertheless, the Contractor was reminded to ensure provision of ongoing maintenance to the silt curtains and to carry out maintenance work once defects were found.

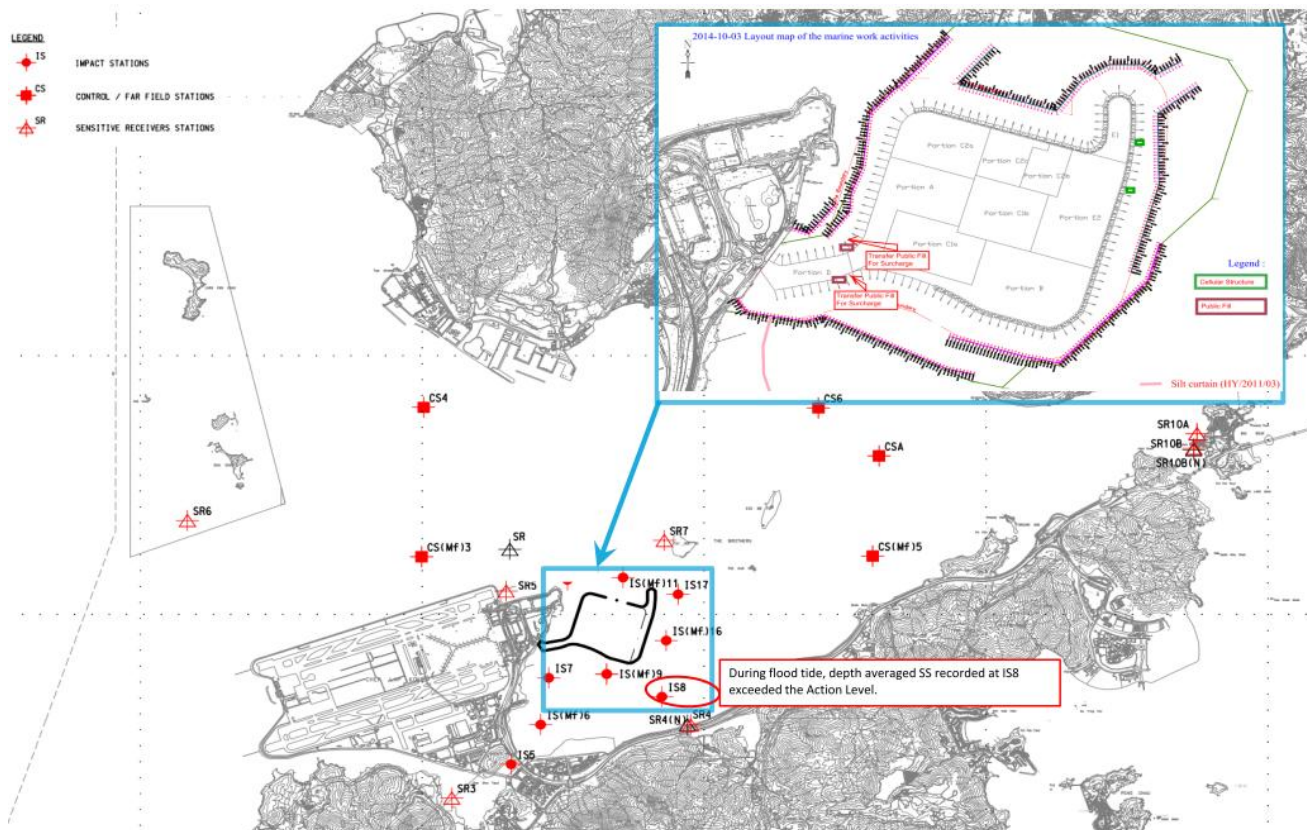
3.3.9.1 Layout map for work activities carried out on 03 October 14 is showed below:

3.3.9.3 With reference to the information provided by the Contractor, only cellular structure installation was conducted at the northeast part of the HKBCF reclamation works during mid flood tide, but cellular structure installation is unlikely to cause silt plume and contribute to the elevation of SS at IS8 during flood tide.

3.3.9.5 In accordance with the silt curtain integrity checking record of 3 October 2014, disconnection of the perimeter silt curtain was observed at the southeast part of HKBCF Reclamation Works, but with referred to monitoring record and photo record below, no sediment plume has been observed to flow from the inside of the perimeter silt curtain to the outside of the perimeter silt curtain and no discoloration of sea water has been observed. (Please refer to below photo). In accordance with the silt curtain integrity checking record, the observed disconnection was rectified on 6 October 2014.

- 3.3.9.11 ET's conclusions and recommendations for mitigation: Nevertheless, the Contractor was reminded to ensure provision of ongoing maintenance to the silt curtains and to carry out maintenance work once defects were found.

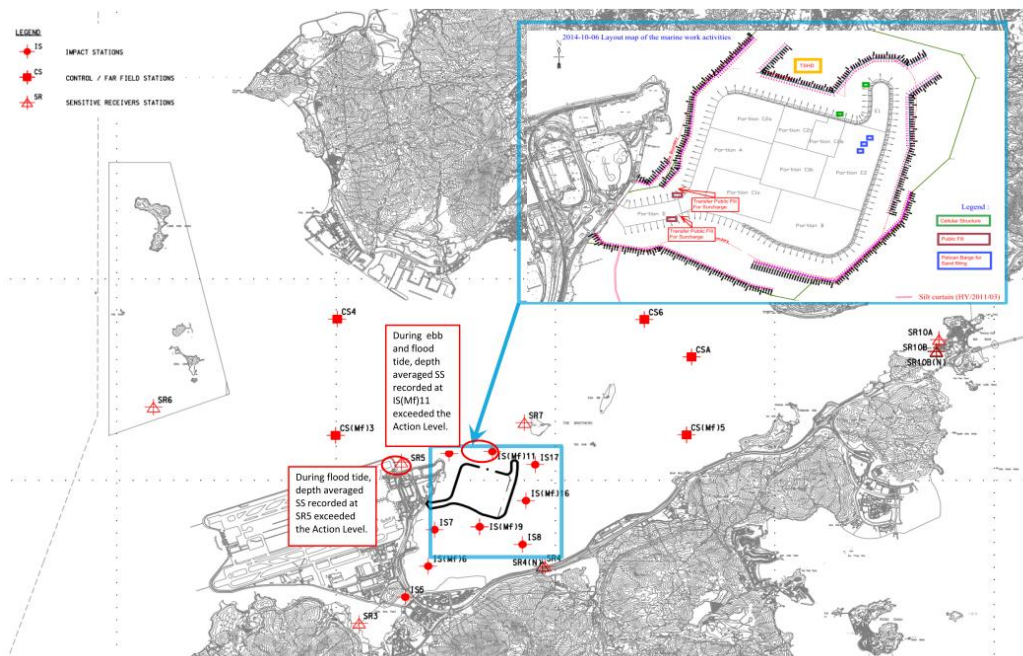
3.3.10.1 Layout map below shows active works conducted on 6-Oct-14. Works such as cellular structure installation was conducted at north part of the HKBCF Reclamation Works and sand filling was conducted at Portion E2 when monitoring was conducted.

3.3.10.3 With reference to the silt curtain checking record defects was observed at parts of the perimeter silt curtain which are close to the SR5.

- 3.3.10.11 With reference to the silt curtain checking record defects was observed at parts of the perimeter silt curtain which are close to the IS(Mf)11. As informed by the Contractor, maintenance work of the silt curtain is on-going and carried out by the Contractor on a daily basis.

- 3.3.10.17 ET's conclusions and recommendations for mitigation: Mitigation measures such as perimeter silt curtain was implemented by the Contractor, however defects of the perimeter silt curtain was observed, the Contractor was reminded to ensure swift provision of maintenance to the silt curtains once defects were found.

- 3.3.10.18 Contractor's actions to implement the mitigation: With refer to the maintenance record provided by the Contractor, maintenance work for the defects of the northwest part of the perimeter silt curtain was conducted on 28 October 2014.

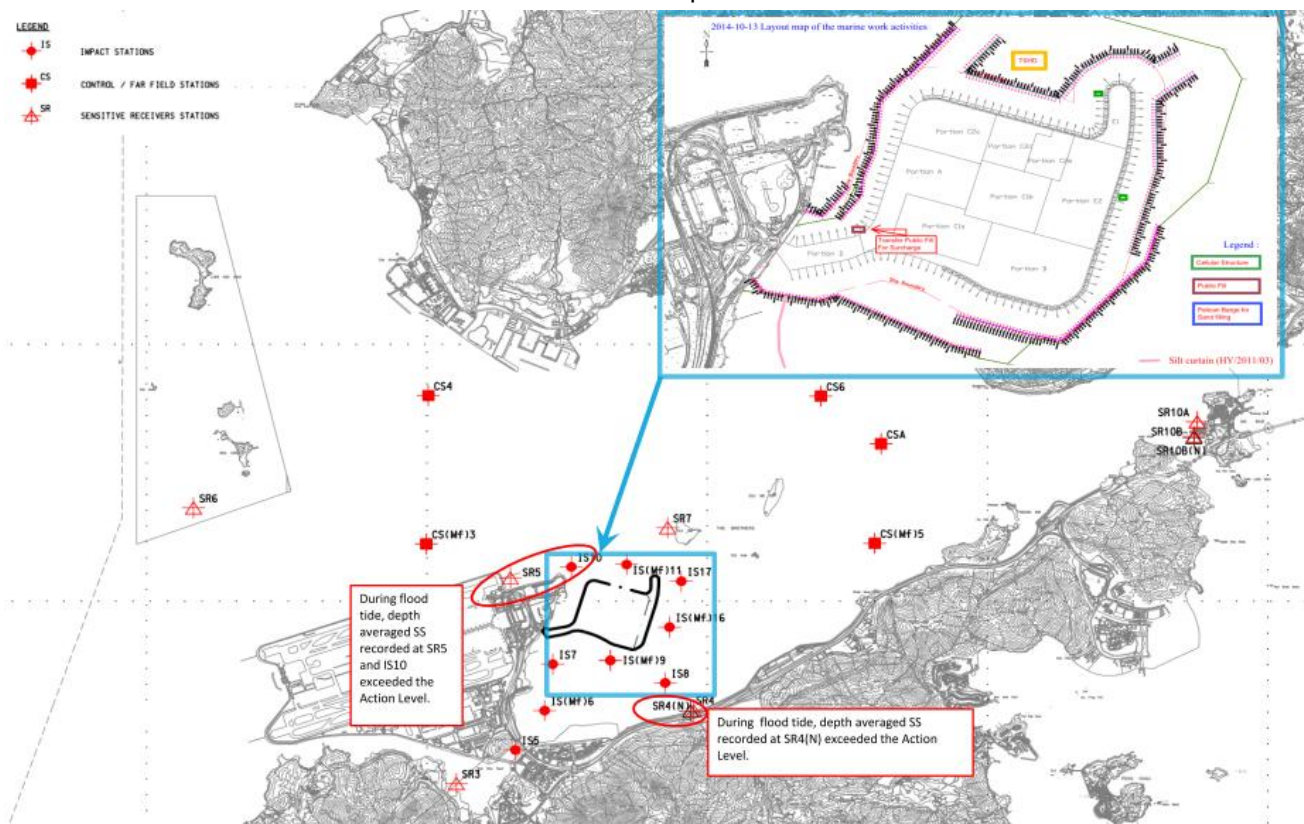
3.3.11.1 Layout map below shows active works conducted on 13-Oct-14. Works such as construction works for cellular structure were conducted at northeast part of the HKBCF Reclamation Works.

3.3.11.3 With reference to the silt curtain checking record, defects was observed at parts of the perimeter silt curtain which are close to the IS10 and SR5.

3.3.11.5 Relative more turbid water were observed at IS10 and SR5 during flood tide but no filling activities was observed in progress and no silt plume was observed to flow from the inside of the perimeter silt curtain to the outside of the perimeter silt curtain when monitoring was conducted at IS10 and SR5.

- 3.3.11.15 ET's conclusions and recommendations for mitigation: Mitigation measures such as perimeter silt curtain was implemented by the Contractor, however defects of the perimeter silt curtain was observed, the Contractor was reminded to ensure swift provision of maintenance to the silt curtains once defects were found.

- 3.3.11.16 Contractor's actions to implement the mitigation: With refer to the maintenance record provided by the Contractor, maintenance work for the defects of the northwest part of the perimeter silt curtain was conducted on 28 October 2014.

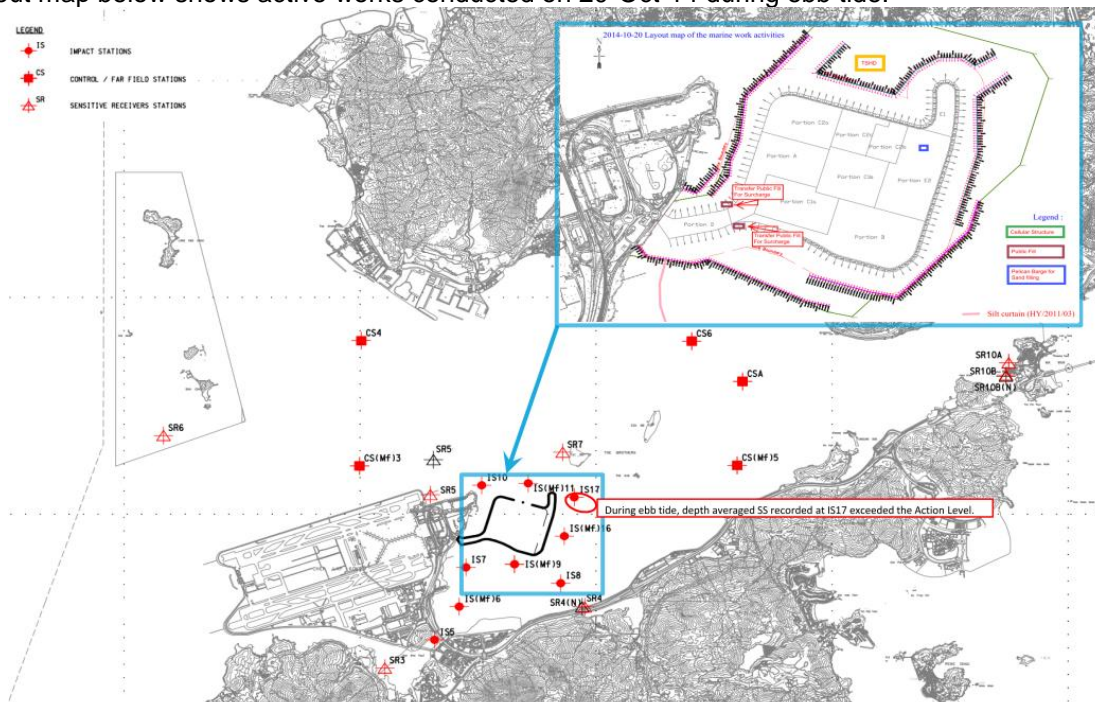
3.3.12.1 Layout map below shows active works conducted on 20-Oct-14 during ebb tide:

3.3.12.3 With refer to monitoring record, appearance of water was relatively more turbid at IS17 when compared with the appearance of water at IS(Mf)11, IS10 and IS(Mf)16 during monitoring at ebb tide on 20-Oct-14.

3.3.12.5 The source of impact is likely due pelican barge's propeller movement at shallow water during ebb tide when the position of the barge was adjusted at Portion E. In addition, with refer to the silt curtain condition on 20-Oct-14, defects of the perimeter silt curtain was observed at Northeastern of the construction site. The turbid water observed at IS17 is likely due to the dispersion of turbid water from the inside of the perimeter silt curtain to the outside of the perimeter silt curtain through the defective part of the perimeter silt curtain.

the maintenance record provided by the Contractor, maintenance work for the defects of the Northeastern part of the perimeter silt curtain was conducted on 28-Oct-14.

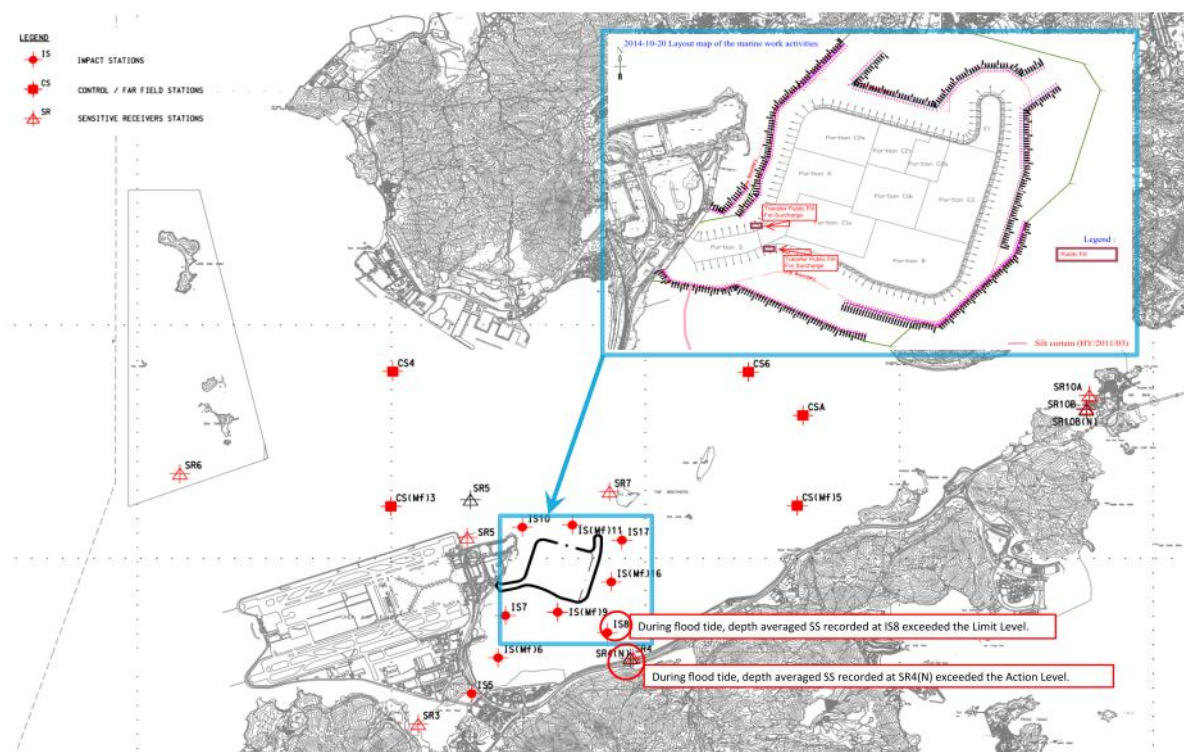
3.3.13.1 Layout map below shows active works conducted on 20-Oct-14 during flood tide.

3.3.13.2 With reference to the information provided by the Contractor, only public fill was transferred at Portion D for surcharge on 20 October 2014 during flood tide and no active marine construction activity from this Contract was conducted near IS8, as such, it is unlikely to cause silt plume and contribute to the elevation of SS at IS8 during flood tide.

3.3.13.3 IS(Mf)9 is located closer to the construction site than monitoring station IS8. Depth Averaged Suspended Solids (SS) values (in mg/L) recorded during the flood tide on the same day at IS(Mf)9 was below the Action and Limit Level which shows that the water quality closer to construction site was not adversely affected.

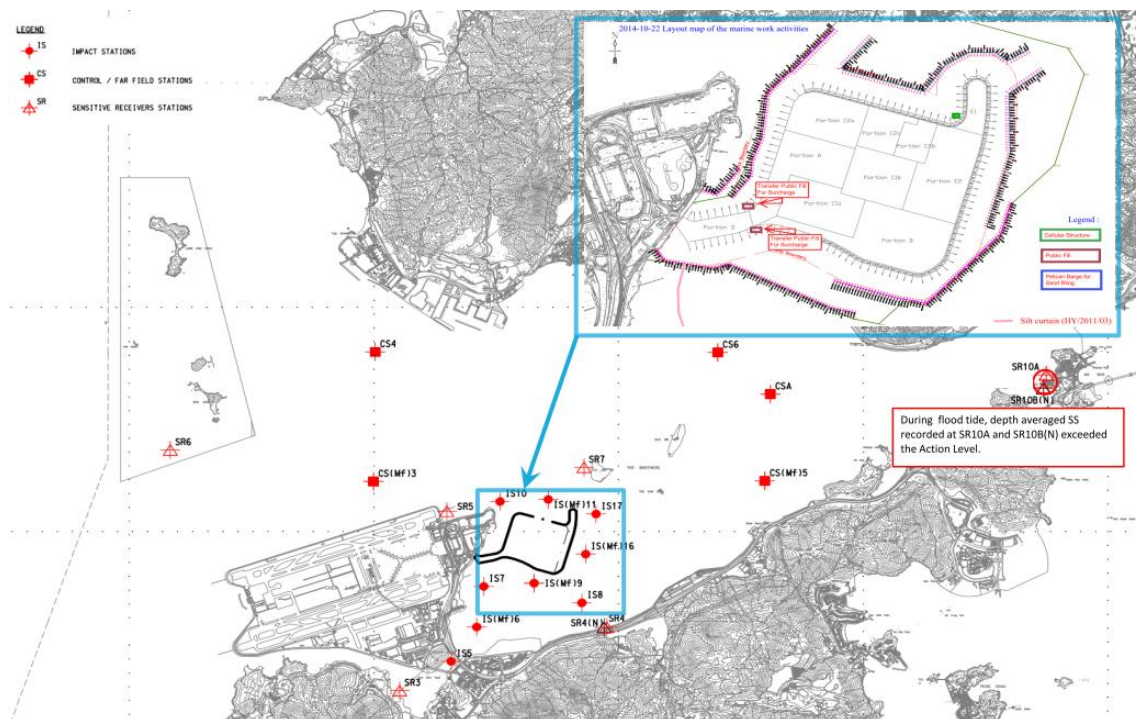
3.3.14.1 For marine works, works involve cellular structure was conducted at portion E1 during flood tide on 22 October 2014. Also refer to layout map below:

3.3.14.3 IS(Mf)11 and IS10 are located downstream and closer to the active works than monitoring station SR10B(N) and SR10A during flood tide on 22 October 2014. Depth Averaged Suspended Solids (SS) values (in mg/L) recorded during flood tide on the same day at IS(Mf)11 and IS10 were below the Action and Limit Level which indicates project work is unlikely to contribute to the action level exceedance recorded at SR10B(N) and SR10A.

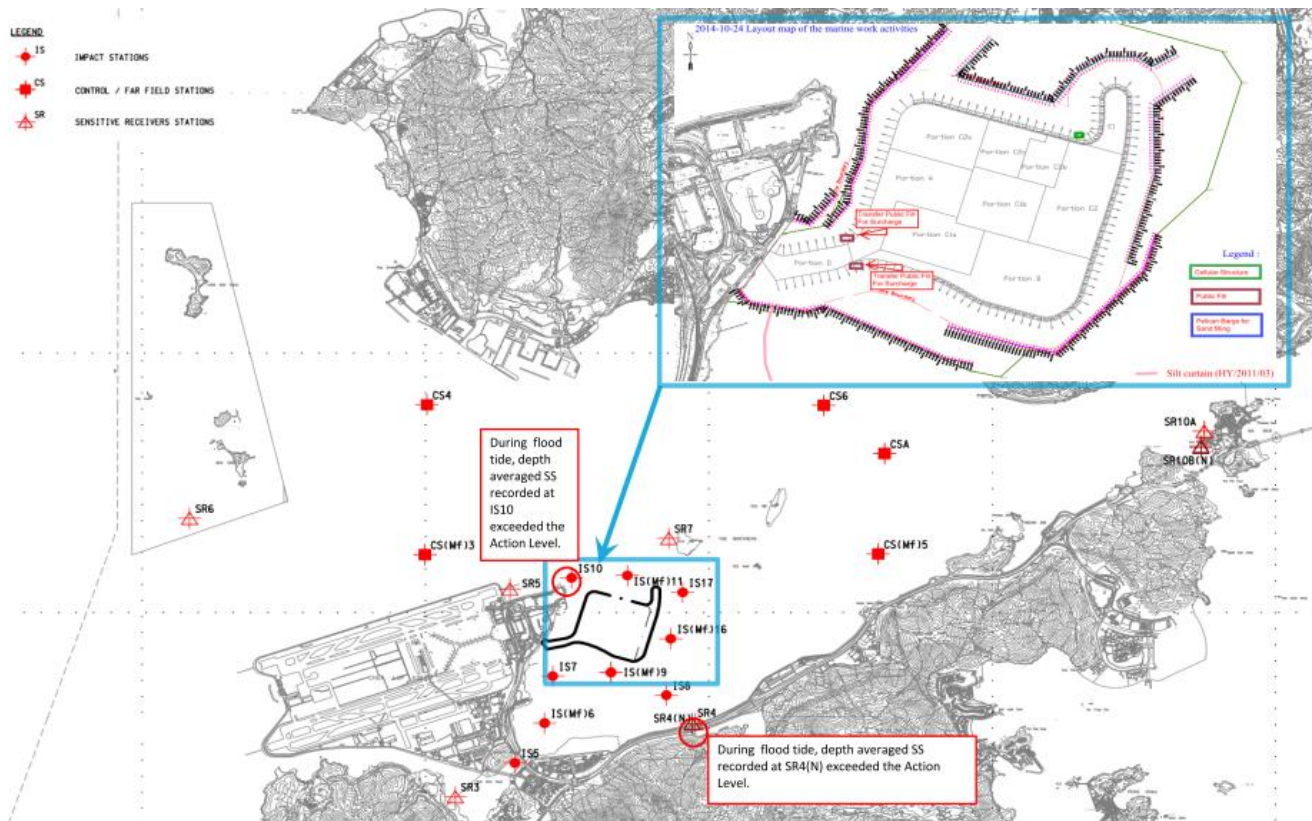
3.3.15.1 Layout map below shows active works conducted on 24-Oct-14.

3.3.15.3 With reference to the silt curtain checking record, defects was observed at parts of the perimeter silt curtain which are close to the IS10.

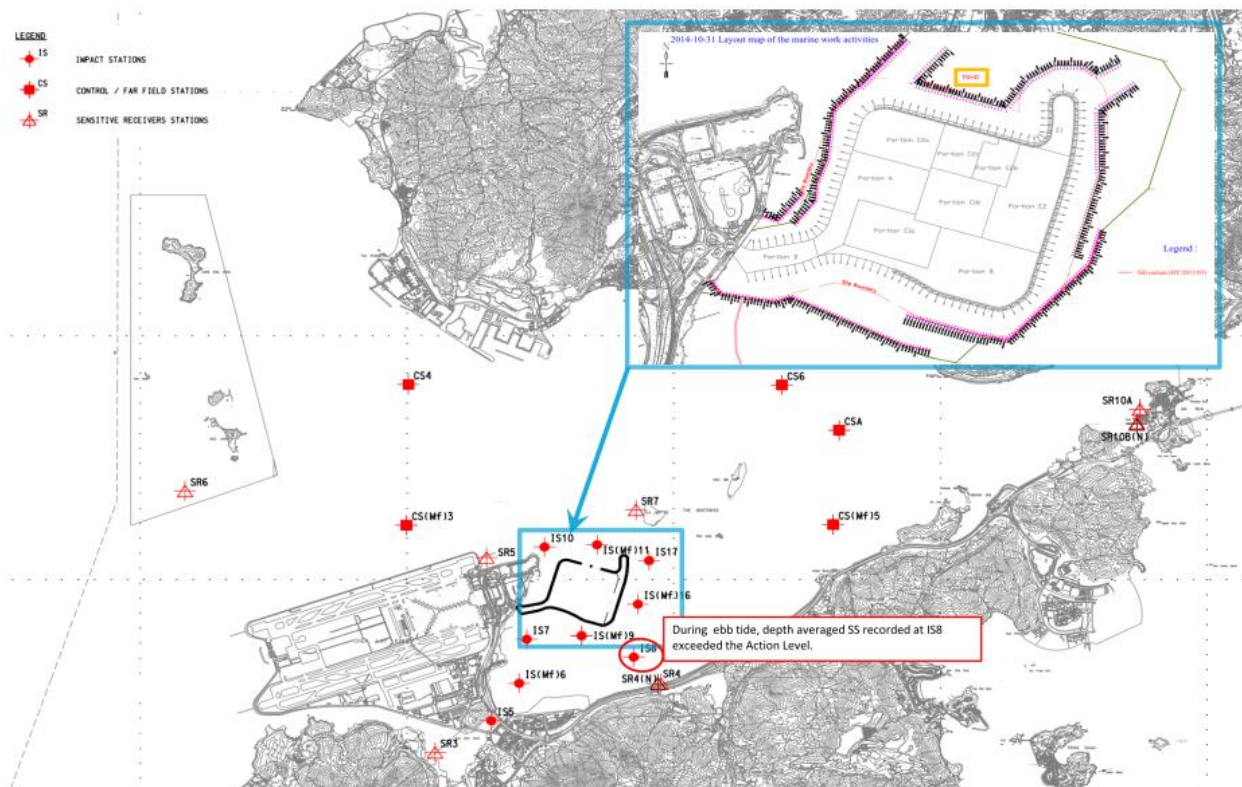
3.3.17 Layout map below shows active works conducted on 31-Oct-14 during ebb tide.

- 3.3.17.1 Exceedance recorded at IS8 during ebb tide is unlikely due to marine based construction activities of the Project because:
- 3.3.17.2 With reference to the information provided by the Contractor, no marine works was conducted during ebb tide, it is unlikely to cause silt plume and contribute to the elevation of SS at IS8 during ebb tide.

- 3.3.17.3 IS(Mf)9 is located closer to the construction site than monitoring station IS8. Depth Averaged Suspended Solids (SS) values (in mg/L) recorded during the ebb tide on 31 October 2014 at IS(Mf)9 was below the Action and Limit Level which shows that the water quality closer to construction site was not adversely affected.

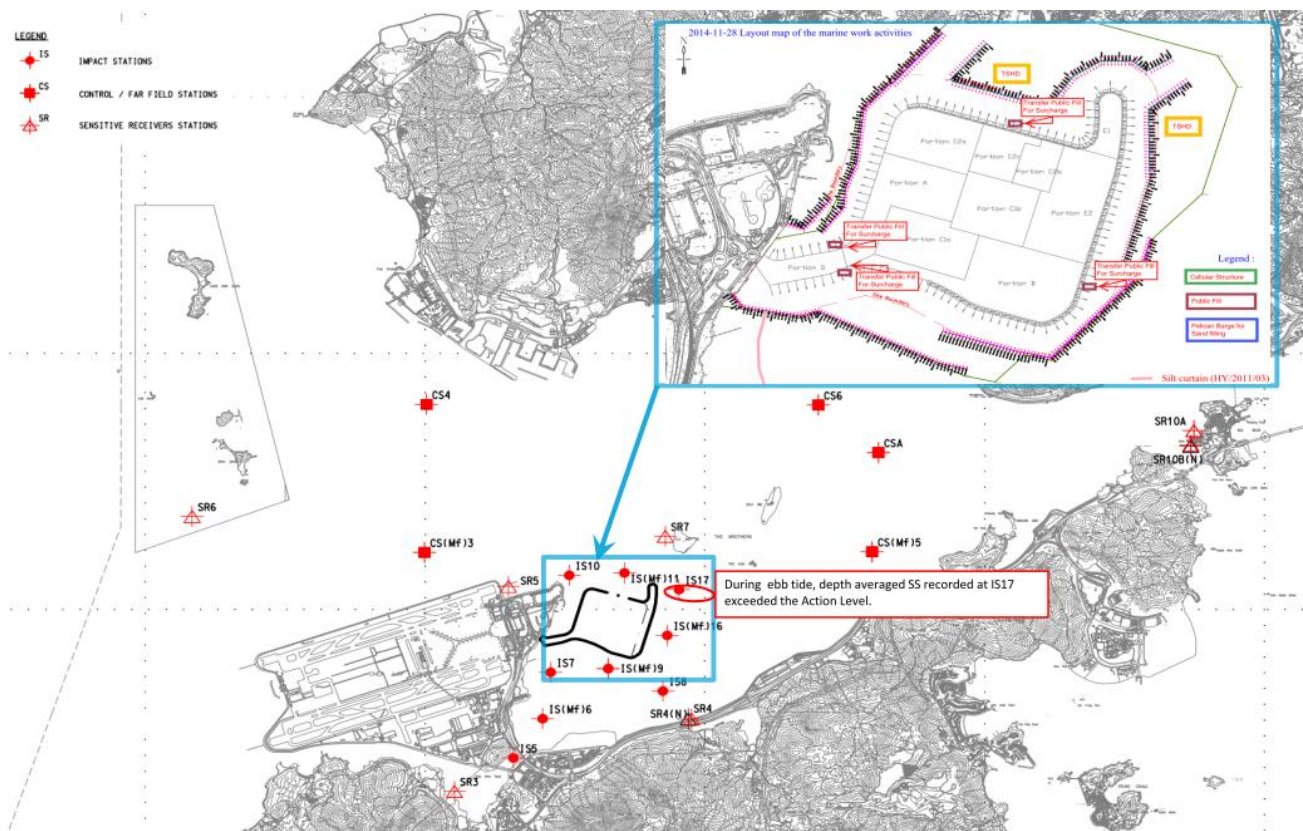
3.3.18.1 Layout map below shows active works conducted on 28 November 2014 during ebb tide.

3.3.18.3 With refer to monitoring record, appearance of water was relatively more turbid at IS17 when compared with the appearance of water at IS(Mf)11, IS10 and IS(Mf)16 during monitoring at ebb tide on 28 November 2014.

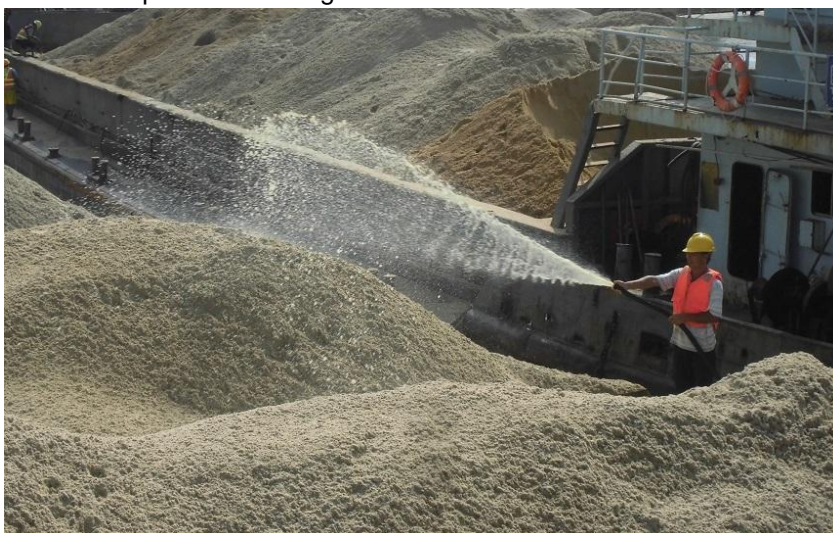
- As informed by the Contractor, the Contractor would continue to provide watering to stockpile of sand on sand delivery barges.
- Photo record below shows that sand barges were not covered but they are equipped with watering equipment and in order to prevent generation of fugitive dust, watering equipment was used to keep the sand filling material wet.

- In addition, site inspections were conducted jointly with RSS, IEC and the Contractor on 16 October 2014 and jointly with RSS and the Contractor on 23 October 2014, but no generation of fugitive dust was observed to be caused by barges loaded with filling material.
- Sand barges usually moor at around Sham Shui Kok anchorage area and the Contractor would continue to provide watering to stockpile of sand on sand delivery barges, therefore the potential impact to resident areas concerned by the complainant is low.
- The Contractor usually moor vessel at around Sham Shui Kok anchorage area (Except upon request by HK government and under this circumstances, then they will moor at Tuen Mun waters shortly for inspection.)

- 7.1.6.3 After investigation, there is no adequate information to conclude the observed impact is related to this Contract.
- 7.1.6.4 The Contractor was advised to ensure to continue the provision of fugitive dust mitigation measures to barges loaded with filling material such as watering to sand filling material on sand barges to keep the surface of stockpile of filling material wet.
