Contract No. HY/2010/02

## Hong Kong – Zhuhai – Macao Bridge Hong Kong Boundary Crossing Facilities – Reclamation Works

Quarterly EM&A Report for  
December 2014- February 2015

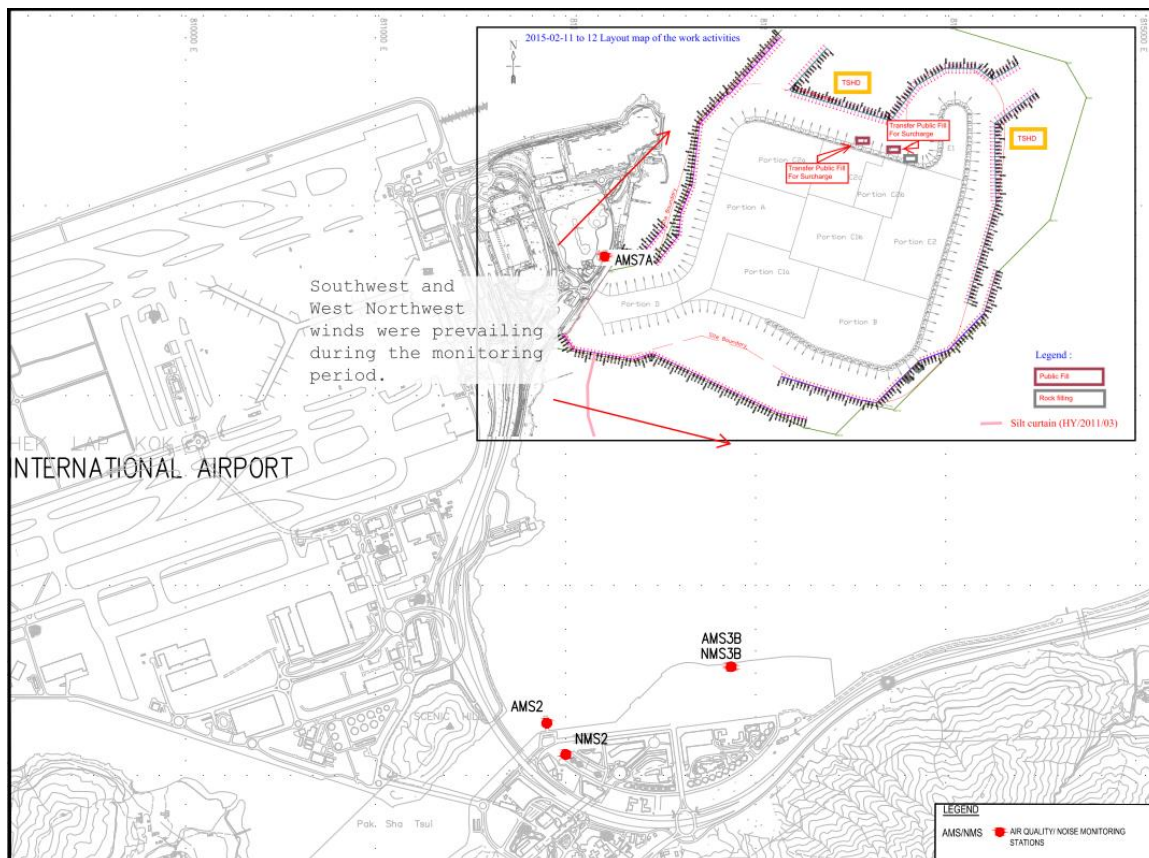
3.1.7.1 According to information provided by the Contractor, construction activities such as rock filling, transferring of public fill for surcharge and operation of TSHD for filling activity were undertaken at north of HKBCF reclamation works on 11 and 12 February 2015. Also refer to layout map below for location of works activities and monitoring stations AMS2, AMS3B and AMS7A on 11 and 12 February 2015.

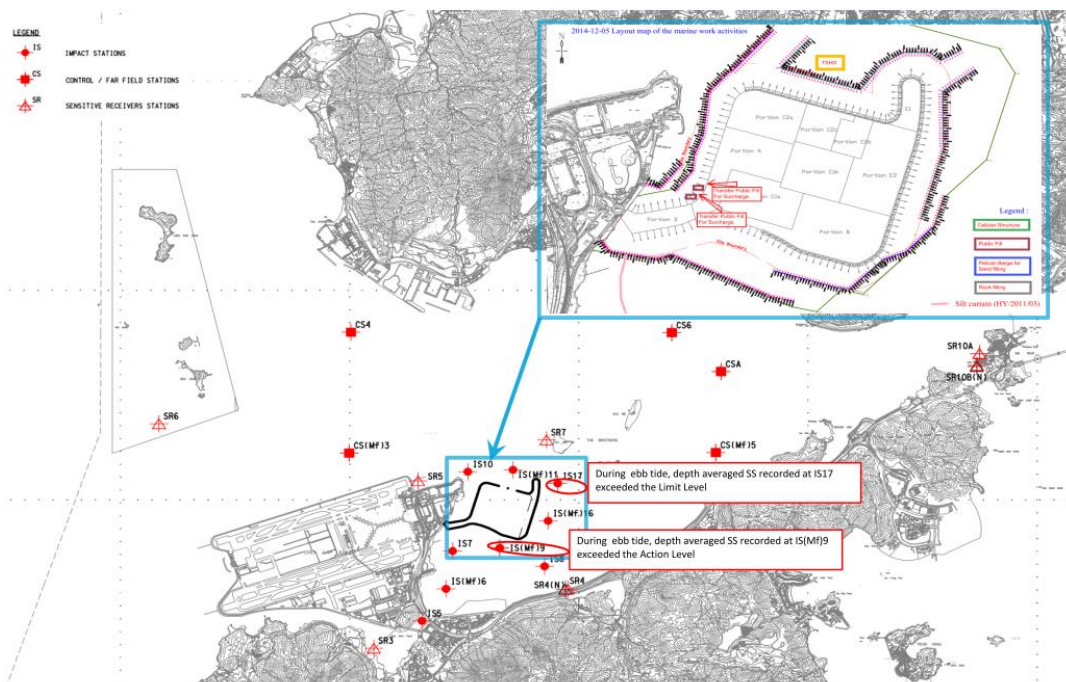
3.3.4.1 Layout map below shows active works conducted on 5 December 2014 during ebb tide.

3.3.4.2 Exceedances recorded at IS17 and IS(Mf)9 during ebb tide are unlikely due to marine based construction activities of the Project because:

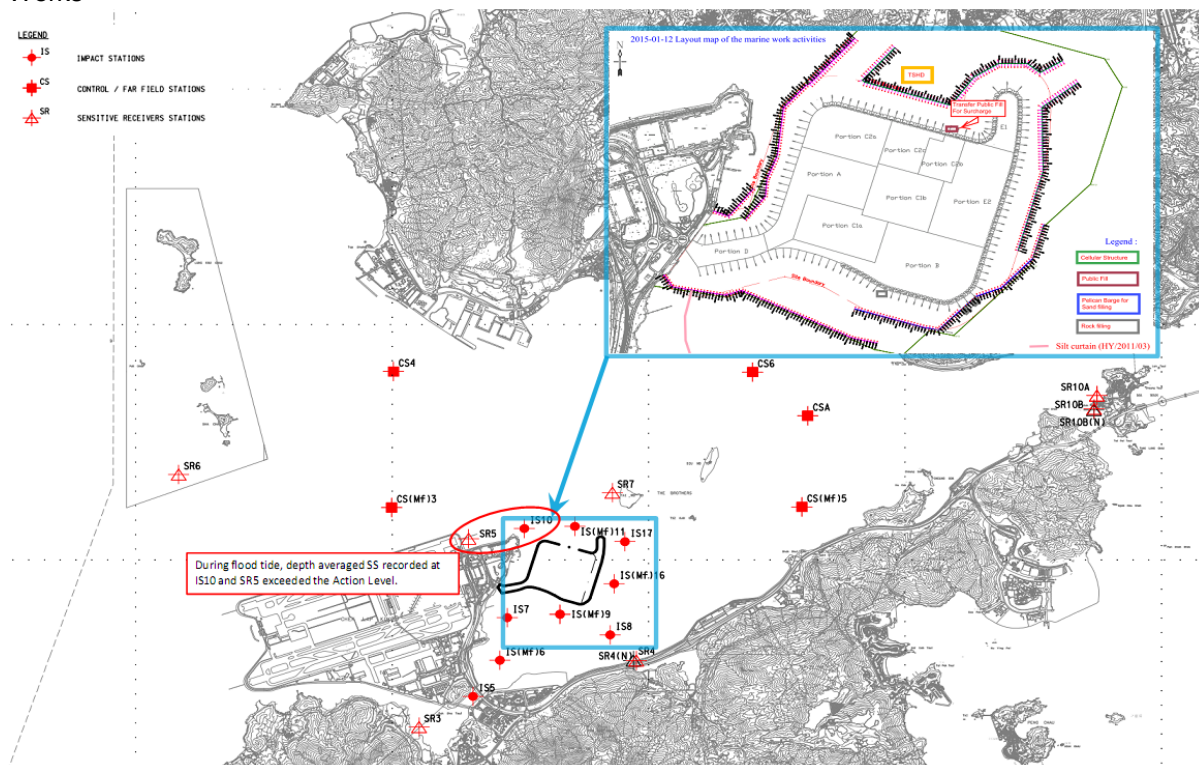
3.3.5.1 Attached layout map shows active works conducted on 12 January 2015. No marine based construction works such as filling were conducted at northwest part of the HKBCF Reclamation Works

3.3.5.2 Exceedance recorded at IS10 and SR5 during mid-flood tide are unlikely due to marine based construction activities of the Project because:

3.3.5.3 With reference to the silt curtain checking record, defects was not observed at northwest part of the perimeter silt curtain which are close to the IS10 and SR5.

3.3.5.11 Nevertheless, the Contractor was reminded to ensure provision of ongoing maintenance to the silt curtains and to carry out maintenance work once defects were found.

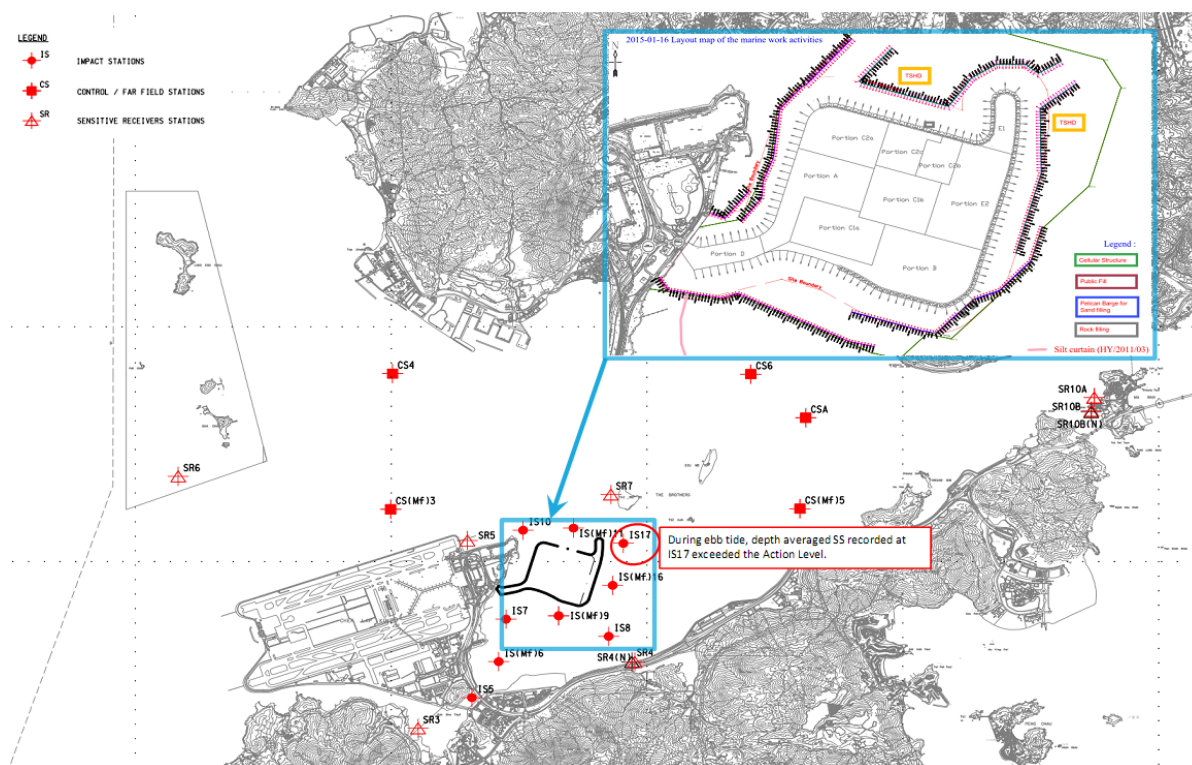
3.3.6.1 Attached layout map shows active works conducted on 16 January 2015. Marine based construction activities such as rock filling was conducted at north part of the HKBCF Reclamation Works.

3.3.6.4 With refer to the layout map attached, rock filling is the only marine based construction works conducted during ebb tide on 16 January 2015 at portion C2C which relatively far away from IS17, as such, it is unlikely to cause the exceedance of SS at IS17.

- 3.3.6.10 Nevertheless, the Contractor was reminded to ensure provision of ongoing maintenance to the silt curtains and to carry out maintenance work once defects were found.

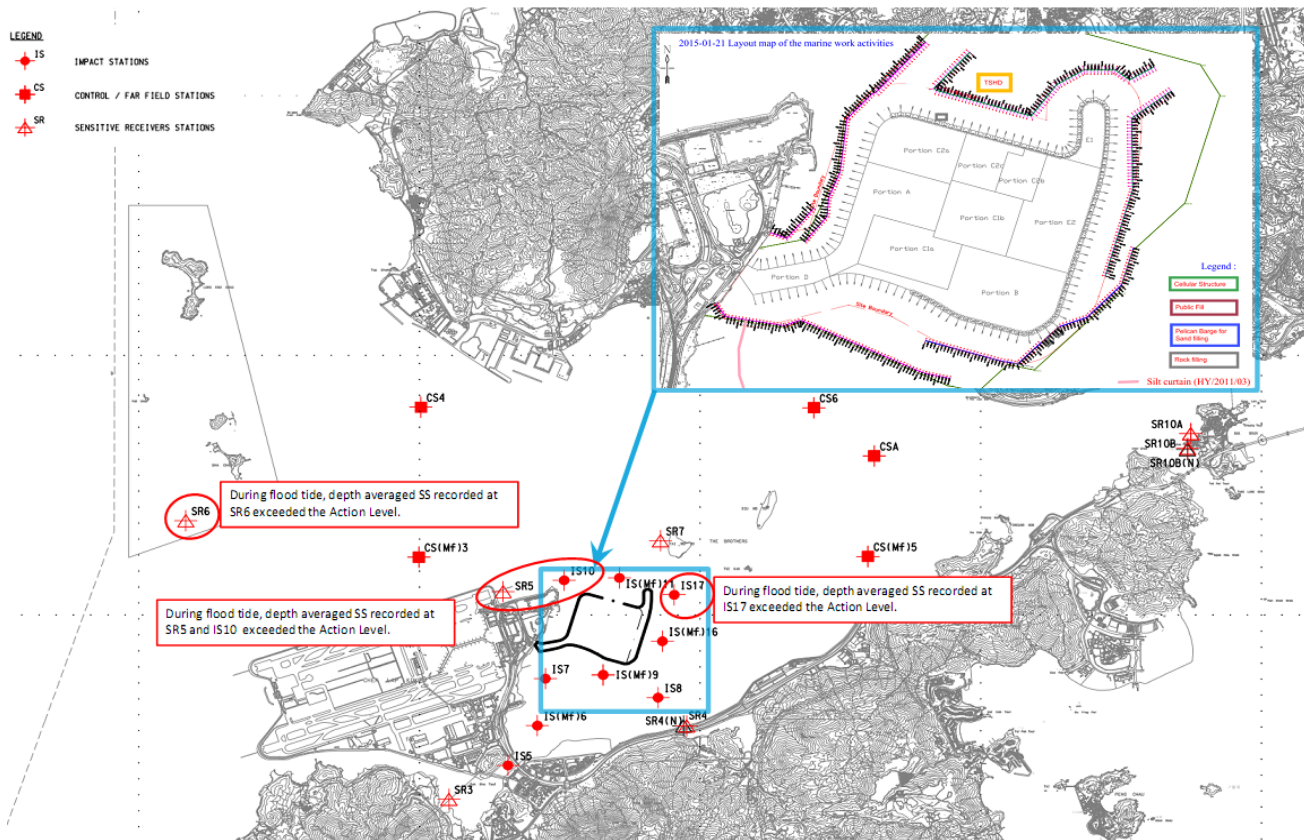
3.3.7.1 Attached layout map shows active works conducted on 21 January 2015. Construction works such as rock filling was conducted near portion C2a of the HKBCF Reclamation Works on 21 January 2015.

3.3.7.2 Exceedances recorded at IS10, SR5 and SR6 during mid-flood tide are unlikely due to marine based construction activities of the Project because:

3.3.7.3 With reference to the silt curtain checking record, defects were not observed at northwest part of the perimeter silt curtain which are close to the IS10 and SR5.

- 3.3.7.16 Nevertheless, the Contractor was reminded to ensure provision of ongoing maintenance to the silt curtains and to carry out maintenance work once defects were found.

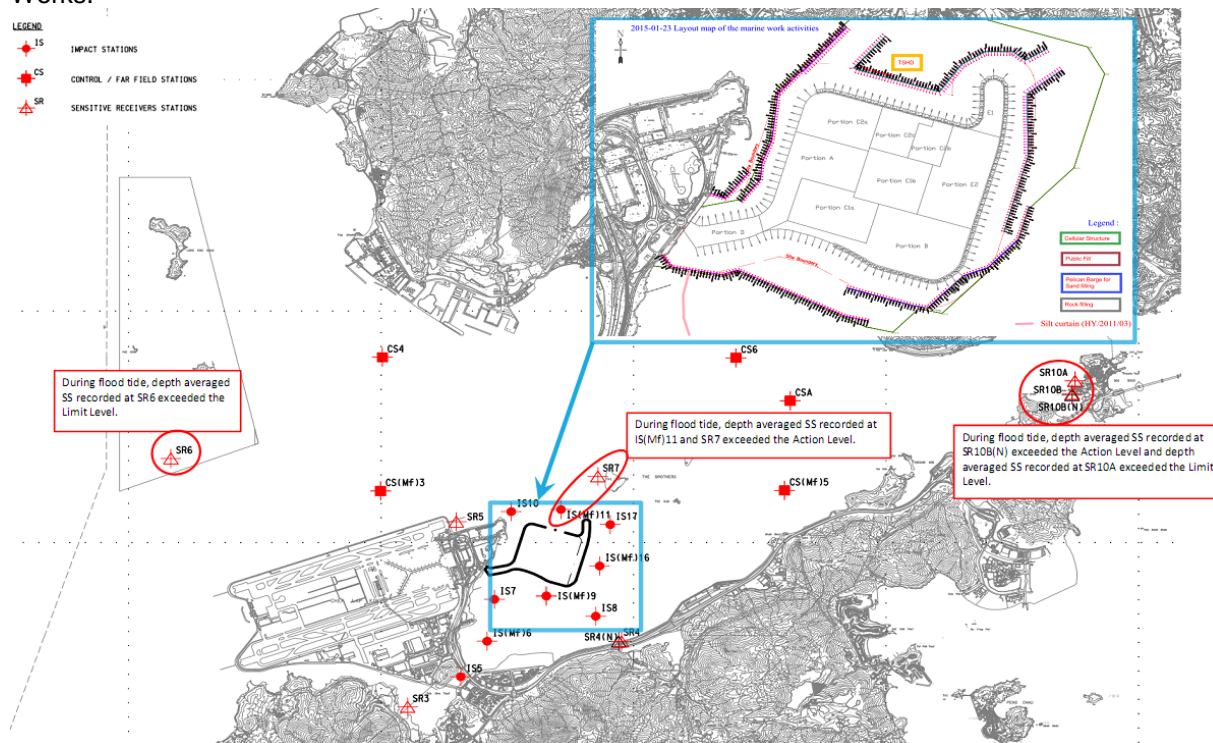
3.3.8.1 Attached layout map shows active works conducted on 23 January 2015. Marine based construction works such rock filling were conducted at southeast part of HKBCF Reclamation Works.

- 3.3.8.12 With referred to the attached layout map, marine based construction works such rock filling were conducted at southeast part of the site, however no silt plume was observed to flow from the inside of the perimeter silt curtain to the outside of the perimeter silt curtain when monitoring was conducted during flood tide. (Also see attached for sea condition observed on 23 January 2015 during flood tide.)

- 3.3.8.19 Nevertheless, the Contractor was reminded to ensure provision of ongoing maintenance to the silt curtains and to carry out maintenance work once defects were found.

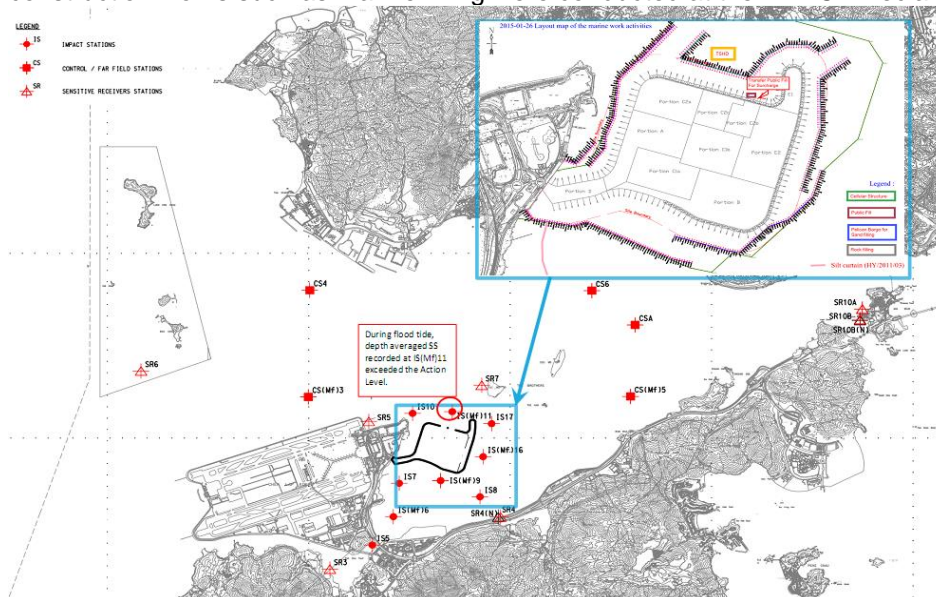
3.3.9.1 Attached layout map shows active works conducted on 26 January 2015. No marine based construction works such as marine filling were conducted at the HKBCF Reclamation Works.

3.3.9.3 With reference to the silt curtain checking record, defect was observed at north part of the perimeter silt curtain which are close to the IS(Mf)11.

- 3.3.9.10 Nevertheless, the Contractor was reminded to ensure provision of ongoing maintenance to the silt curtains and to carry out maintenance work once defects were found.

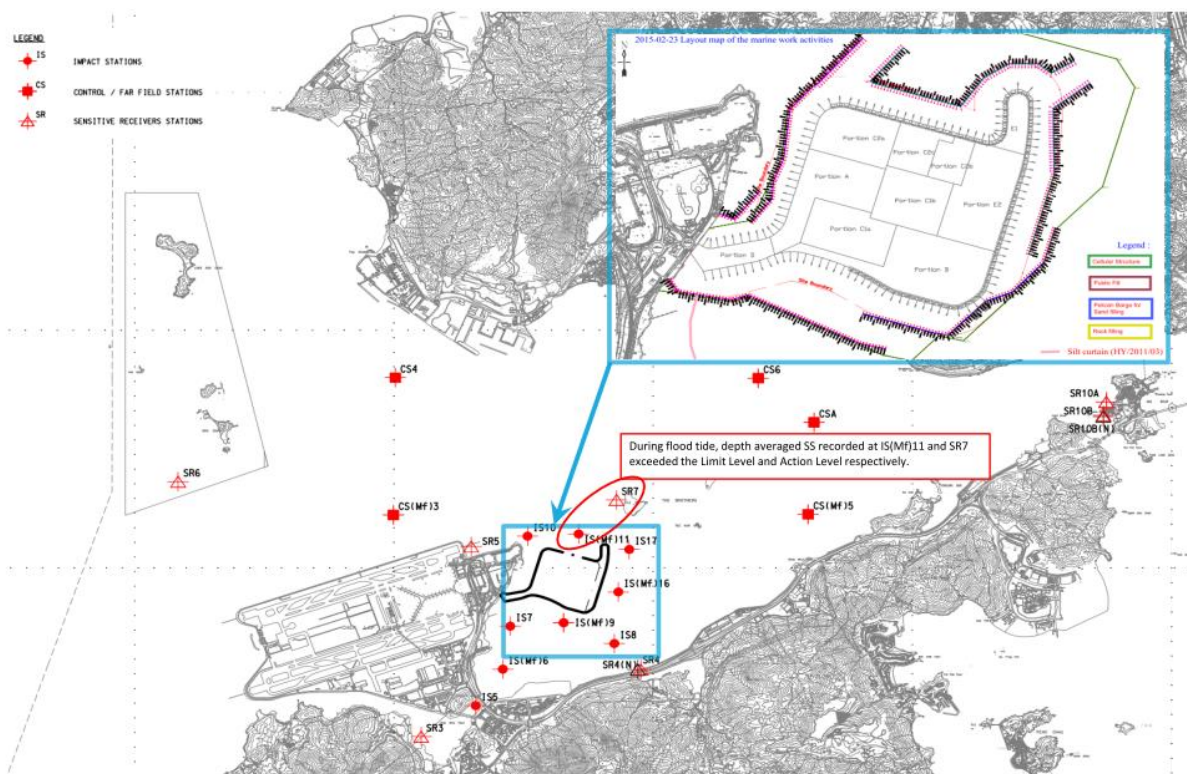
3.3.10.2 With reference to the silt curtain checking record, defects were observed at north and northwest part of the perimeter silt curtain which are close IS(Mf)11.

3.3.10.3 With referred to the layout map below, no marine based construction work was conducted on site on 23 February 2015 and no silt plume was observed to flow from the inside of the perimeter silt curtain to the outside of the perimeter silt curtain when monitoring was conducted during flood tide. (Also see below photo record for sea condition observed on 23 February 2015 during flood tide.

- 3.3.10.9 Nevertheless, the Contractor was reminded to ensure provision of ongoing maintenance to the silt curtains and to carry out maintenance work once defects were found.
