Contract No. HY/2010/02

**Hong Kong – Zhuhai – Macao Bridge
Hong Kong Boundary Crossing
Facilities –
Reclamation Works**

**Quarterly EM&A Report for
March 2015- May 2015**

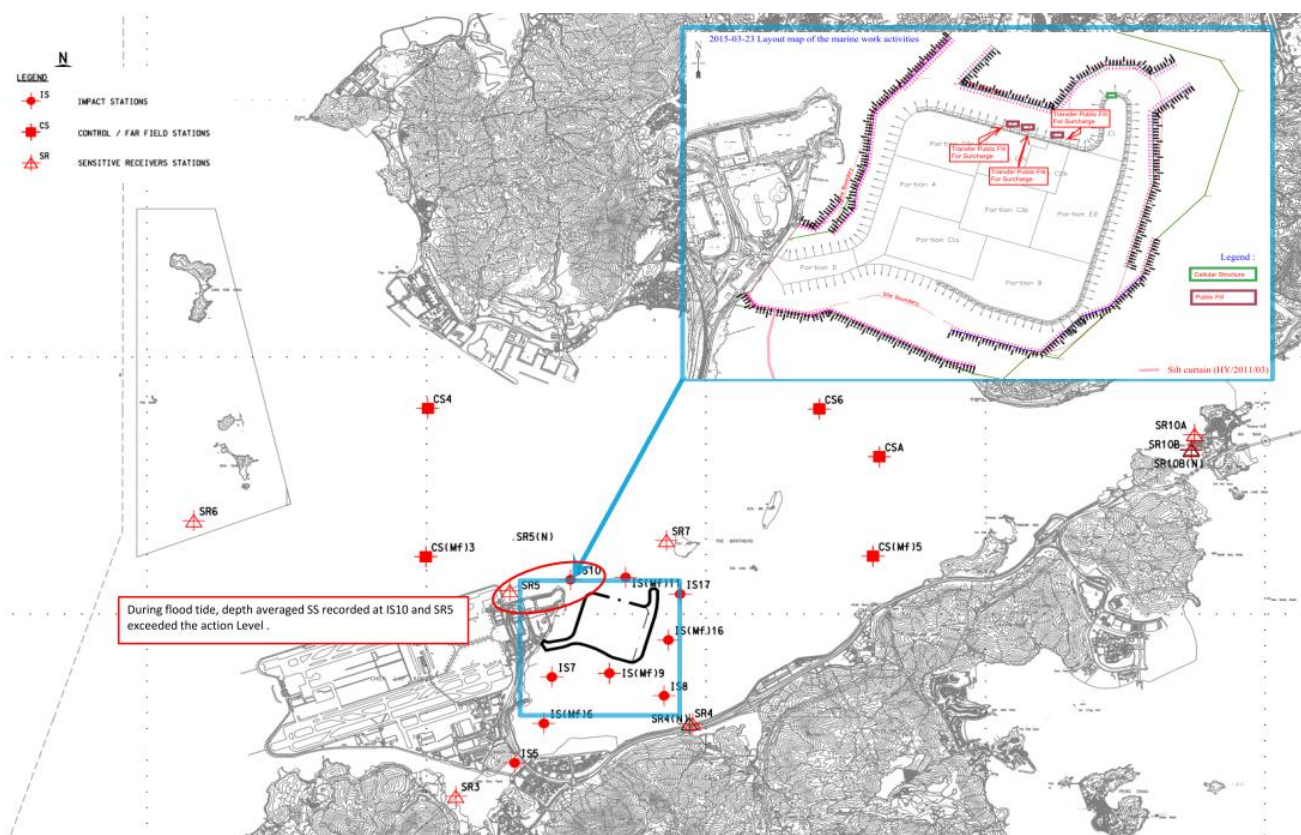
- 3.3.4.3 Photo record which shows the sea condition near IS10 at northwest part of the HKBCF during flood tide on 23 March 2015

- 3.3.4.5 With reference to the silt curtain checking record, defects such as disconnection of the silt curtain was not observed at northwest part of the perimeter silt curtain which are close to the IS10 and SR5.

- 3.3.4.8 Furthermore, no filling activities were observed in progress and no silt plume was observed to flow from the inside of the perimeter silt curtain to the outside of the perimeter silt curtain when monitoring was conducted at IS10 and SR5. (Also see attached for sea condition observed on 23 March 2015 during flood tide.)

- 3.3.4.13 Nevertheless, the Contractor was reminded to ensure provision of ongoing maintenance to the silt curtains and to carry out maintenance work once defects were found.

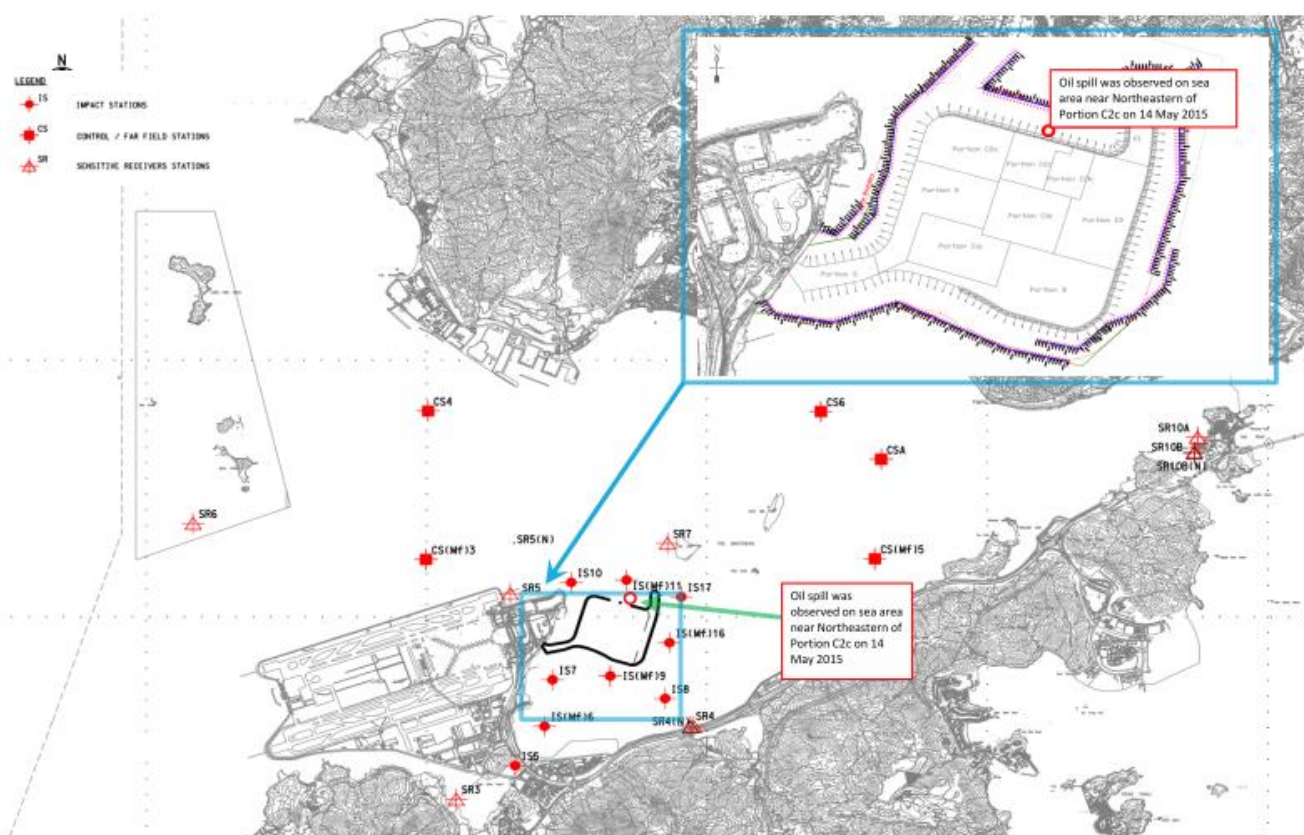
- 5.1.6 Oil spillage was observed on 14 May 2015 on sea area near Northeastern of Portion C2c (also refer to layout map below). There oil spillage incident including size, location, time of the spillage and Contractor’s actions taken in response to the spill incident have been reviewed and summarised as follow.

- The oil on sea was observed during inspection jointly conducted by Contractor, ET, ESS and the RSS on 14 March 2015.
- The Contractor organised manpower to identify the spill source, but the source of oil spill was not identified.
- The Contractor equipped people involved in the cleanup works with personal protective equipment such as gloves prior to the removal of any leaked chemical or chemical waste.
