Bi-Monthly Landscape and Visual Audit Checklist

Contract No. HY/2019/01

Hong Kong-Zhuhai-Macao Bridge Hong Kong Boundary Crossing Facilities –  
Phase 2 and Other Works

Establishment Inspection Checklist

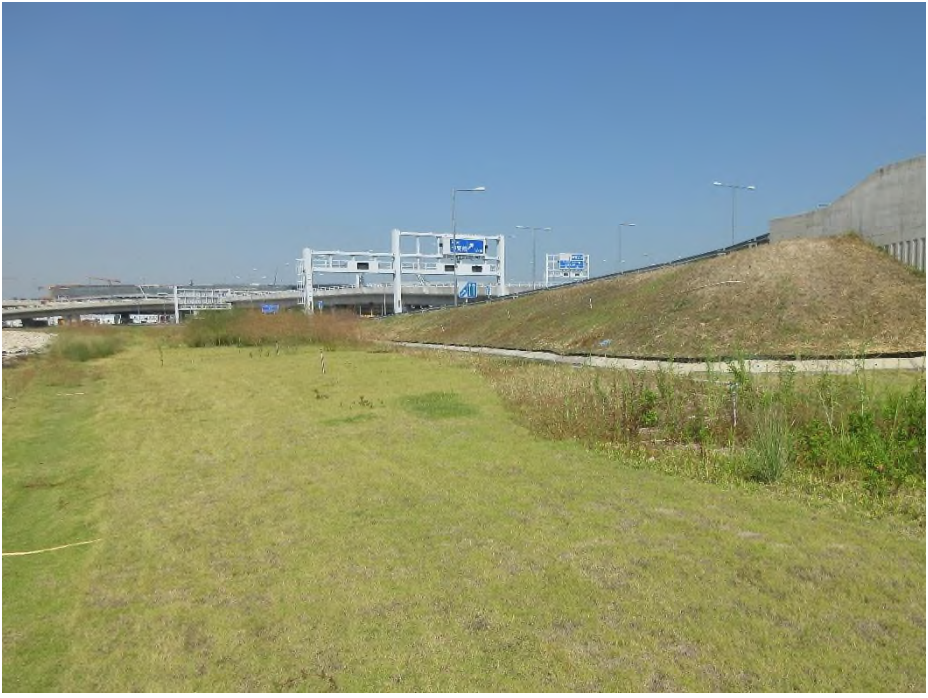
Location	Photo Record
<b>Portion A-1</b>

- TG45: 5 *Grevillea banksii* (GB) are proposed to be replaced due to poor conditions.
- TG47: 22 *Grevillea robusta* (GR) are proposed to be replaced due to poor conditions.
- TG49: 1 *Grevillea banksii* (GB) is proposed to be replaced due to poor conditions.

<p>TG45: 5 <i>Grevillea banksii</i> (GB) are replaced.</p>

<p>TG47: 22 <i>Grevillea robusta</i> (GR) are replaced.</p>

<p>TG49: 1 <i>Grevillea banksii</i> (GB) are replaced.</p>

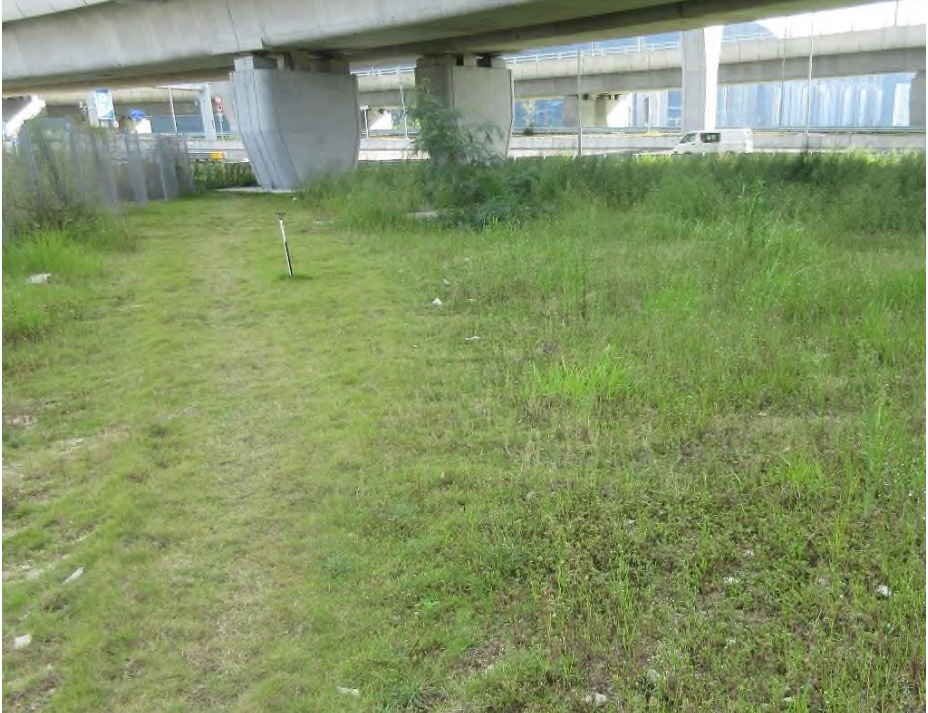
- Area C33 construction completed and handed over for disease control facilities. Other areas have no particular findings.

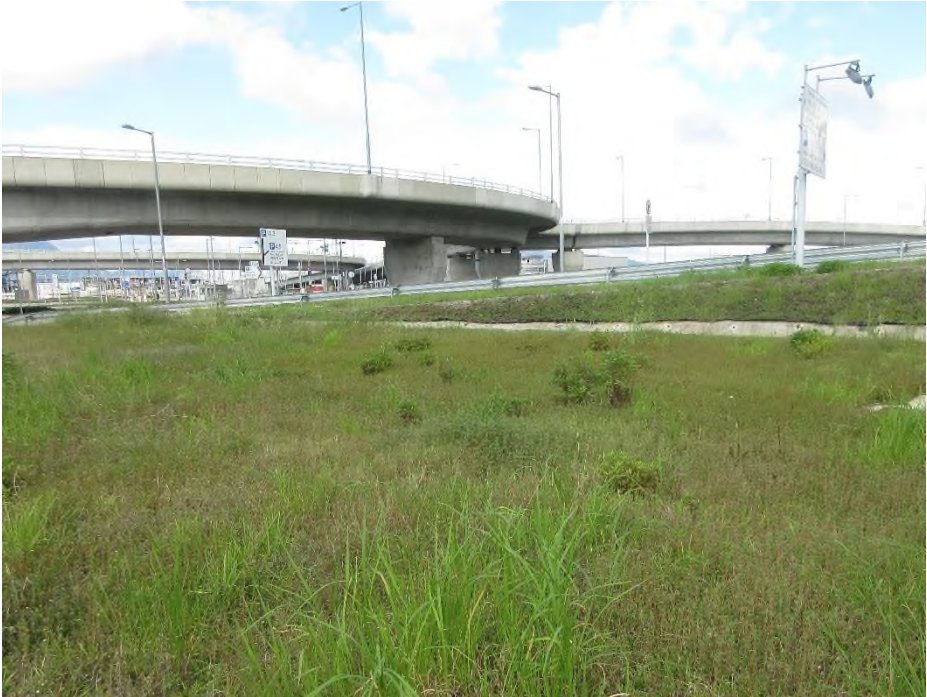
Location	Photo Record
<p><b>Portion A-3</b></p>

- No Particular findings.

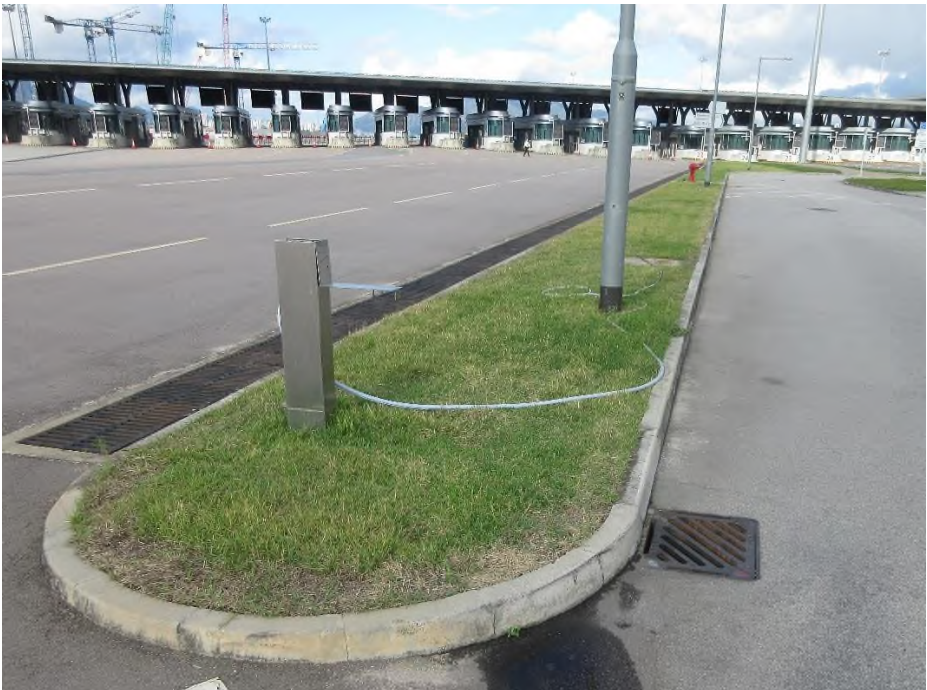
- No particular findings.
