Appendix N

Cumulative Statistics on
Exceedances, Complaints,
Notifications of Summons
and Successful Prosecutions

ENVIRONMENTAL COMPLAINT/ ENQUIRY FORM

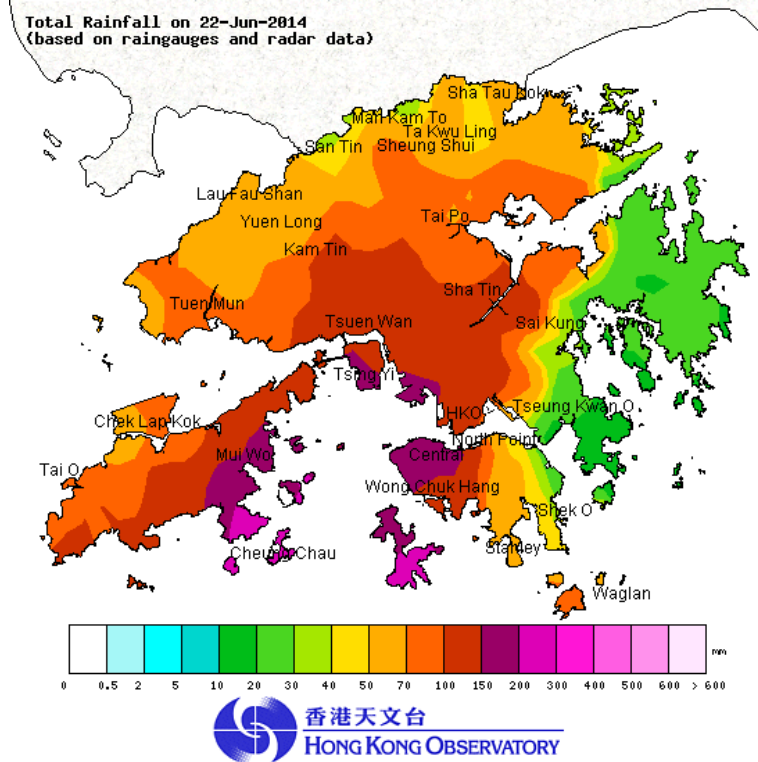
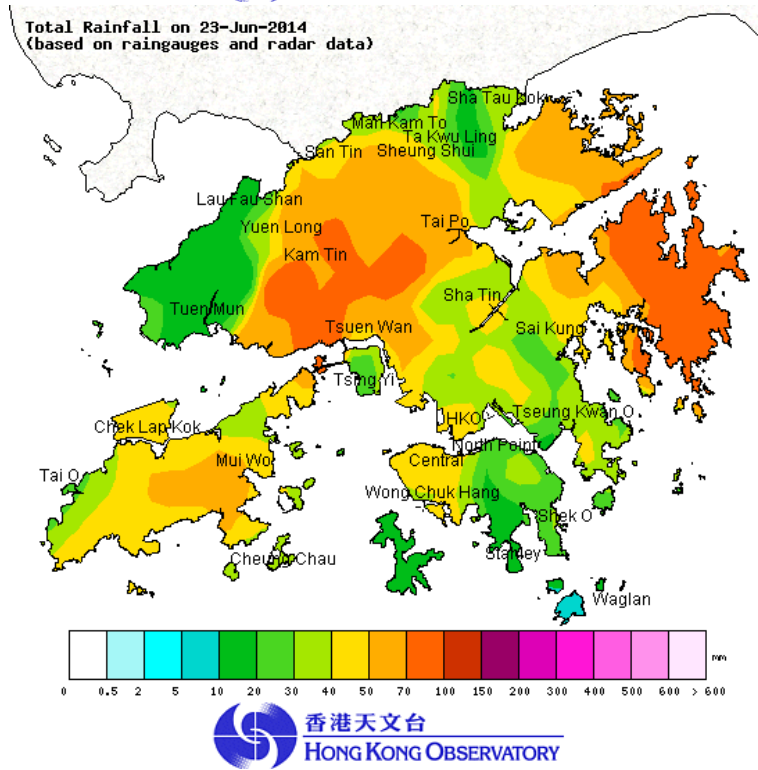
Figure 1.1 Rainfalls from 22 to 23 June 2014

An initial investigation was conducted on 25 June by ET with EPD, Contractor and SOR. Based on the weather information from the Hong Kong Observatory (HKO), heavy rain was recorded on 23 June 2014 (*Figure 1.1*). Rain water was found accumulating in the Site Access 9A (*Figure 1.2*) which was probably related to the heavy rain. Besides direct rainfall, the construction site was next to a slope which was partly unpaved. Soil was suspected to be flushed from the slope. However, there was no evidence that the accumulated muddy water was being discharged from the site.
