**Ref/Project number** Contract No. HY/2012/07  
Tuen Mun – Chek Lap Kok Link – Southern  
Connection Viaduct Section

**Subject** Notification of Exceedance for Marine Water  
Quality Impact Monitoring

TUEN MUN – CHEK LAP KOK LINK –  
SOUTHERN CONNECTION VIADUCT SECTION

Marine Water Quality Impact Monitoring

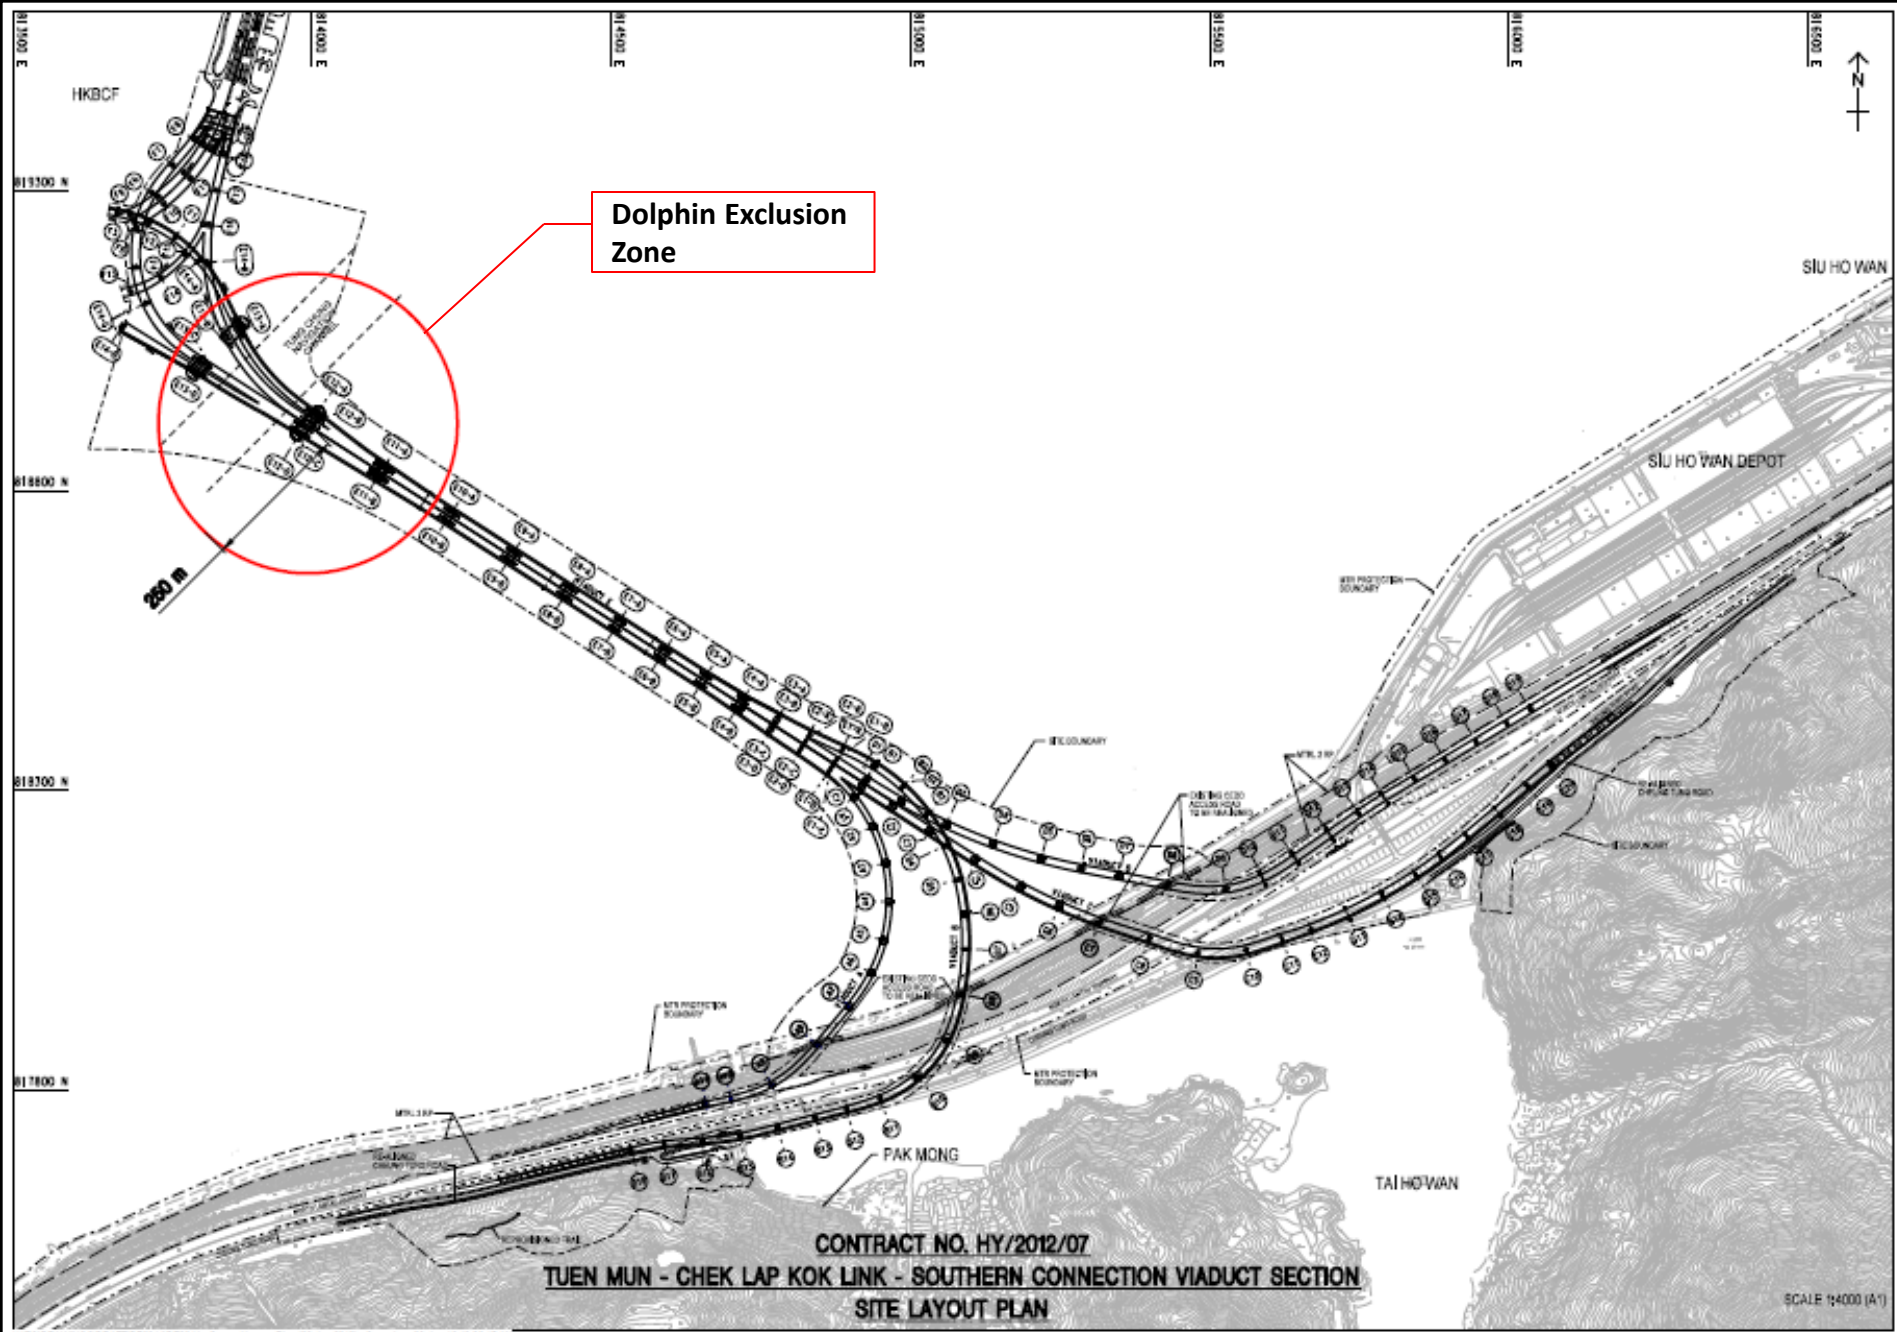
Figure 1

Work records of the concerned period were reviewed upon receiving the complaint. Based on the work records provided by the Contractor, works nearby Tai Ho Wan during the previous week of the complaint log date was mainly parapet installation at Viaduct B (Pier B6-B8) and Viaduct C (Pier C4-C6) (Figure 1). No record of falling objects from height was reported during the concerned period.

General Layout Plan of the Project
