Subject Notification of Exceedance for Air Quality
Impact Monitoring

CONTRACT NO. HY/2012/08
 TUEN MUN – CHEK LAP KOK LINK –
 NORTHERN CONNECTION SUB-SEA TUNNEL SECTION

Air Quality Impact Monitoring
 Notification of Exceedance

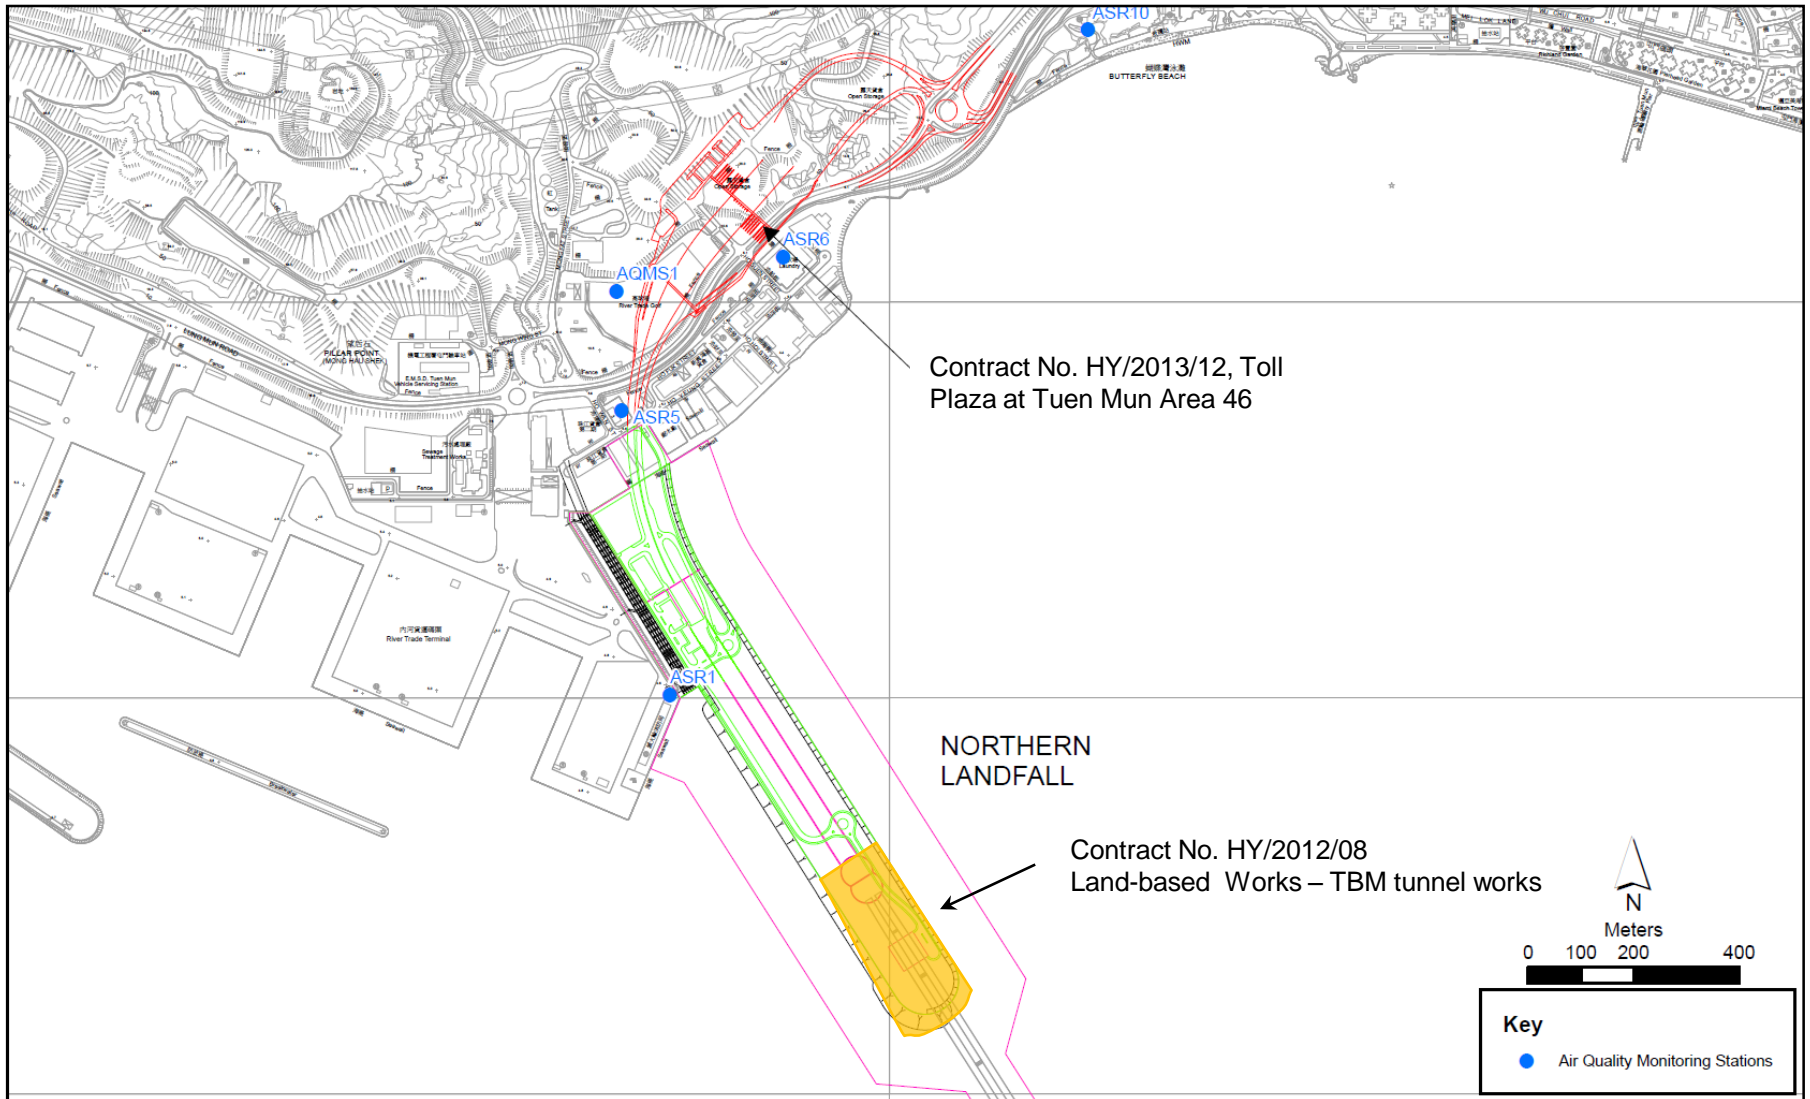
Figure 1

Actions Taken/ To Be Taken	<p>According to the construction information provided by the Contractor, no ground construction works were carried out on 7 September 2018. Water spraying was applied to prevent dust. Photos taken during AQM were provided in Annex A. No significant dust impact was observed at ASR1. Follow-up site inspection was carried out on 21 September 2018. Dust suppression measures were properly implemented during the site inspections. Photos are provided in Annex A. Based on the above, no additional action is required.</p> <p>The Contractor has been reminded to implement the required mitigation measures as per the EP, approved EIA and Updated EM&A Manual including watering to maintain all exposed road surfaces and dust sources wet, use of sprinklers for water spraying, covering the materials having the potential to create dust by clean tarpaulin, use of water truck and watering on all exposed soil within the Project site) throughout the construction period. The Contractor was also reminded to ensure all dust mitigation measures are provided at Portion N-A and Portion N-C, where the construction works are carried out.</p>

Indicative Construction Works Area on 7 September 2018
