Contract No. HY/2011/03 -

Hong Kong- Zhuhai- Macao Bridge

Hong Kong Link Road Section between Scenic Hill and Hong Kong Boundary Crossing Facilities

Notifications of Environmental Quality Limits Exceedances

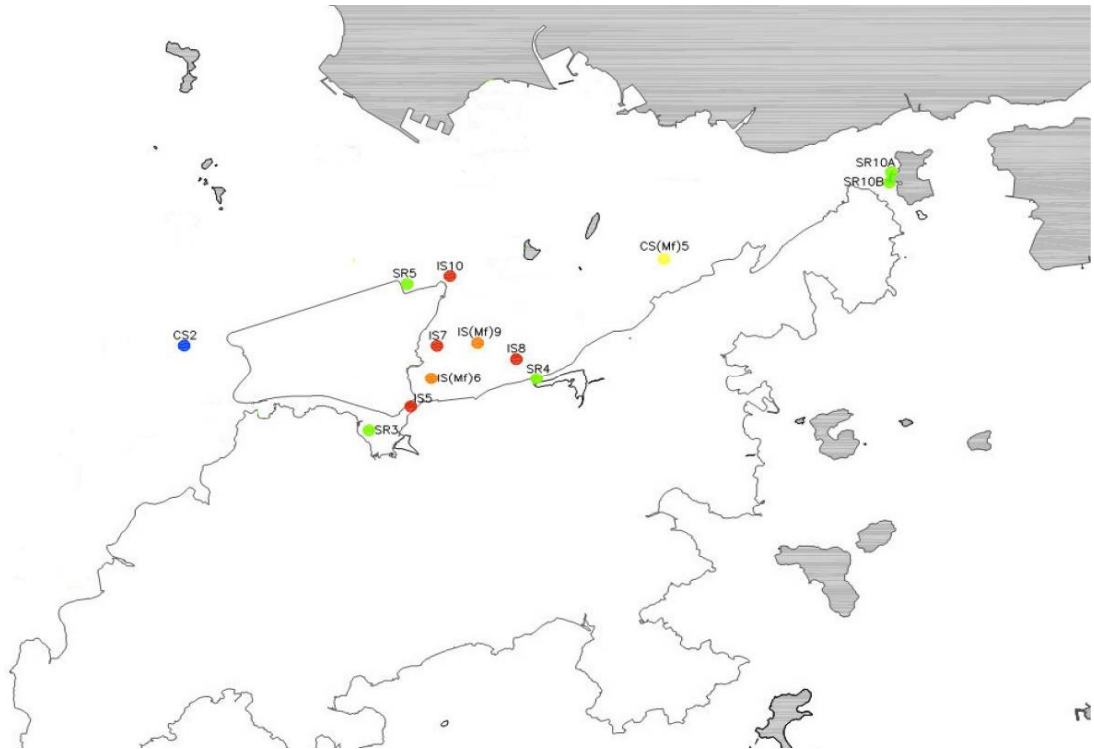
Location Plan:

1. Box culvert extension at Zone 1, construction of temporary drainage at Zone 2, seawall construction works at Zones 2 and 3A were carried out within silt curtain as recommended in the EIA Report.
2. The ranges of suspended solid at stations IS10 and SR5 during the baseline monitoring are shown as below:

The measured value at station SR5 was within the range of suspended solid during baseline monitoring for the mid-flood tide. The measured value at station IS10 was above the range of suspended solid during baseline monitoring for the mid-flood tide. However, there were no specific activities recorded during the monitoring period that would cause any significant impacts on the monitoring results.
