# **Dragages -China Harbour-VSL JV**

**Contract HY/2011/09**  
**Hong Kong-Zhuhai-Macao Bridge**  
**Hong Kong Link Road-Section between**  
**HKSAR Boundary and Scenic Hill**  
**Monthly EM&A Report**  
**August 2016**  
**(Version 1.0)**

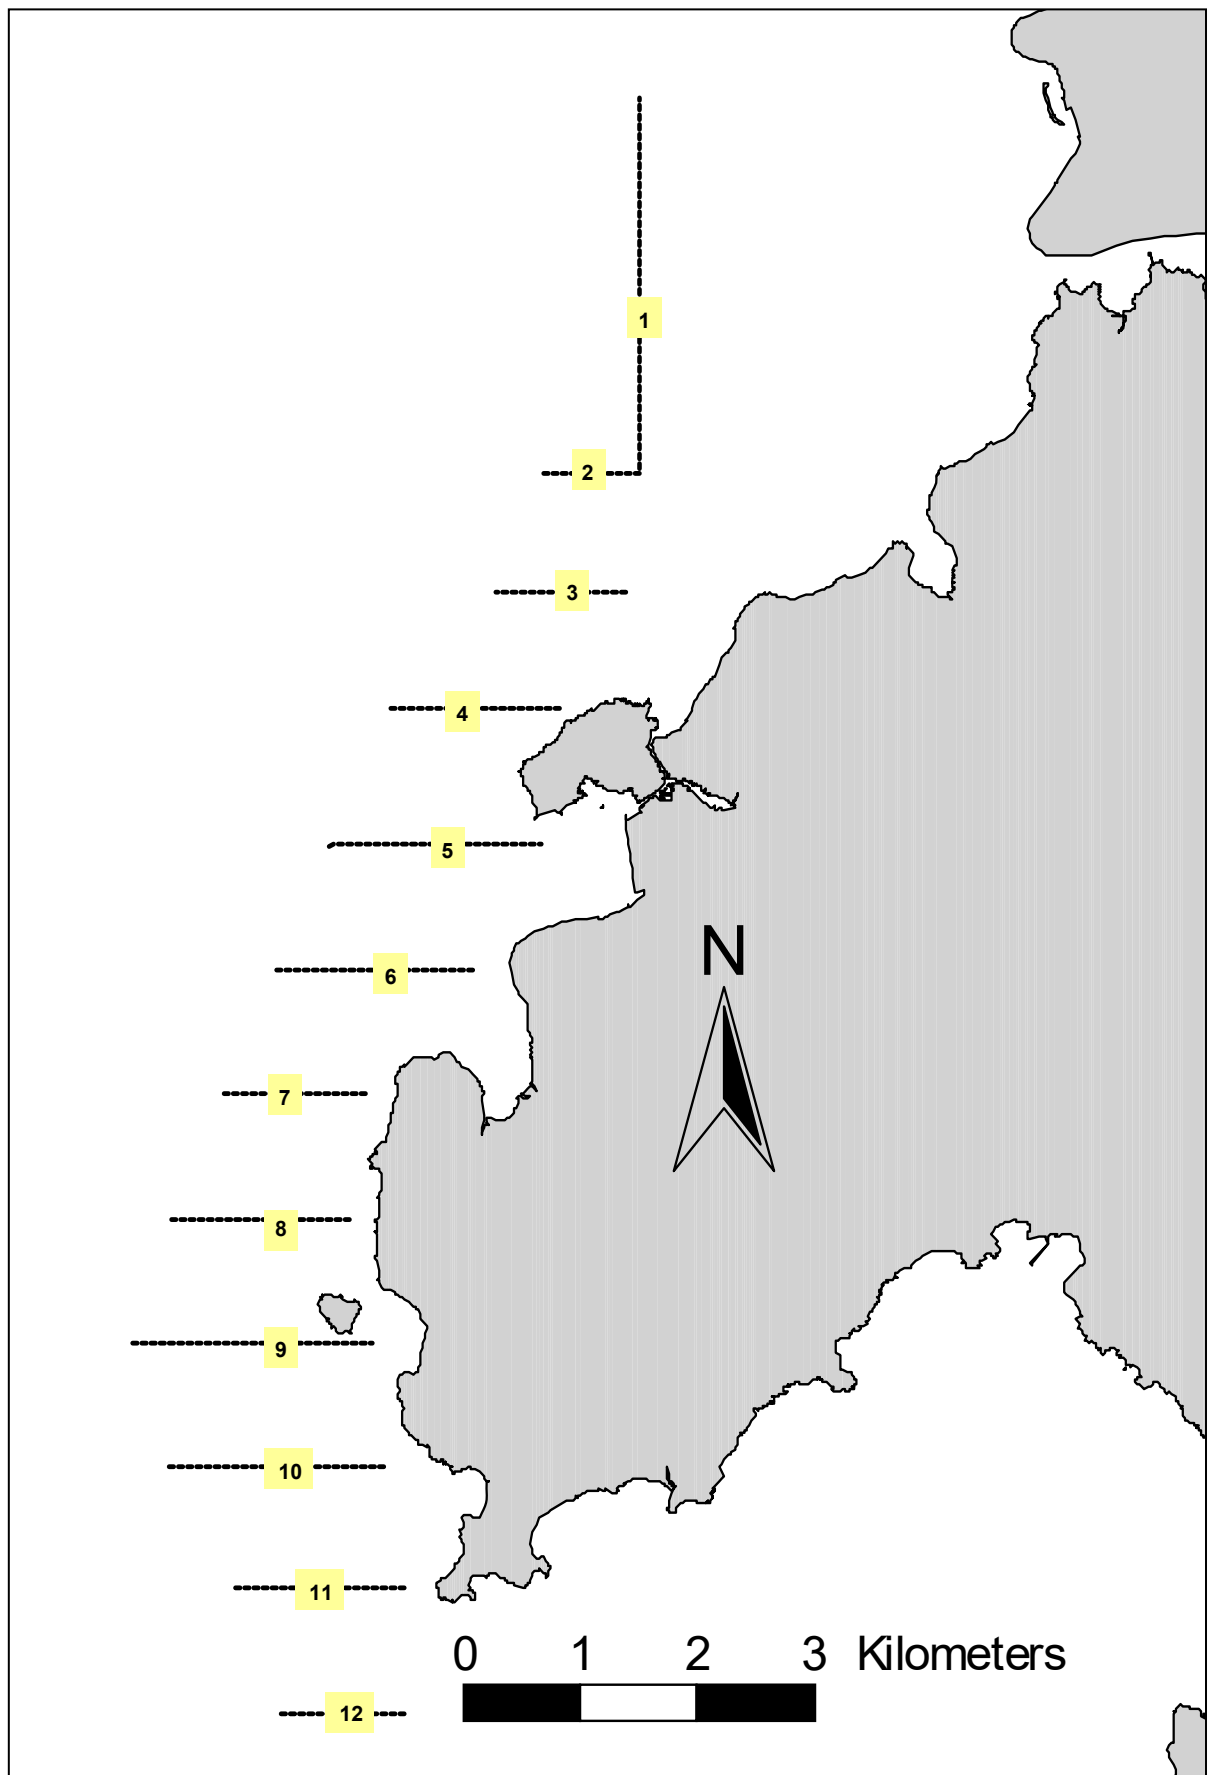
Figure 1. Transect Line Layout in West Lantau Survey Areas

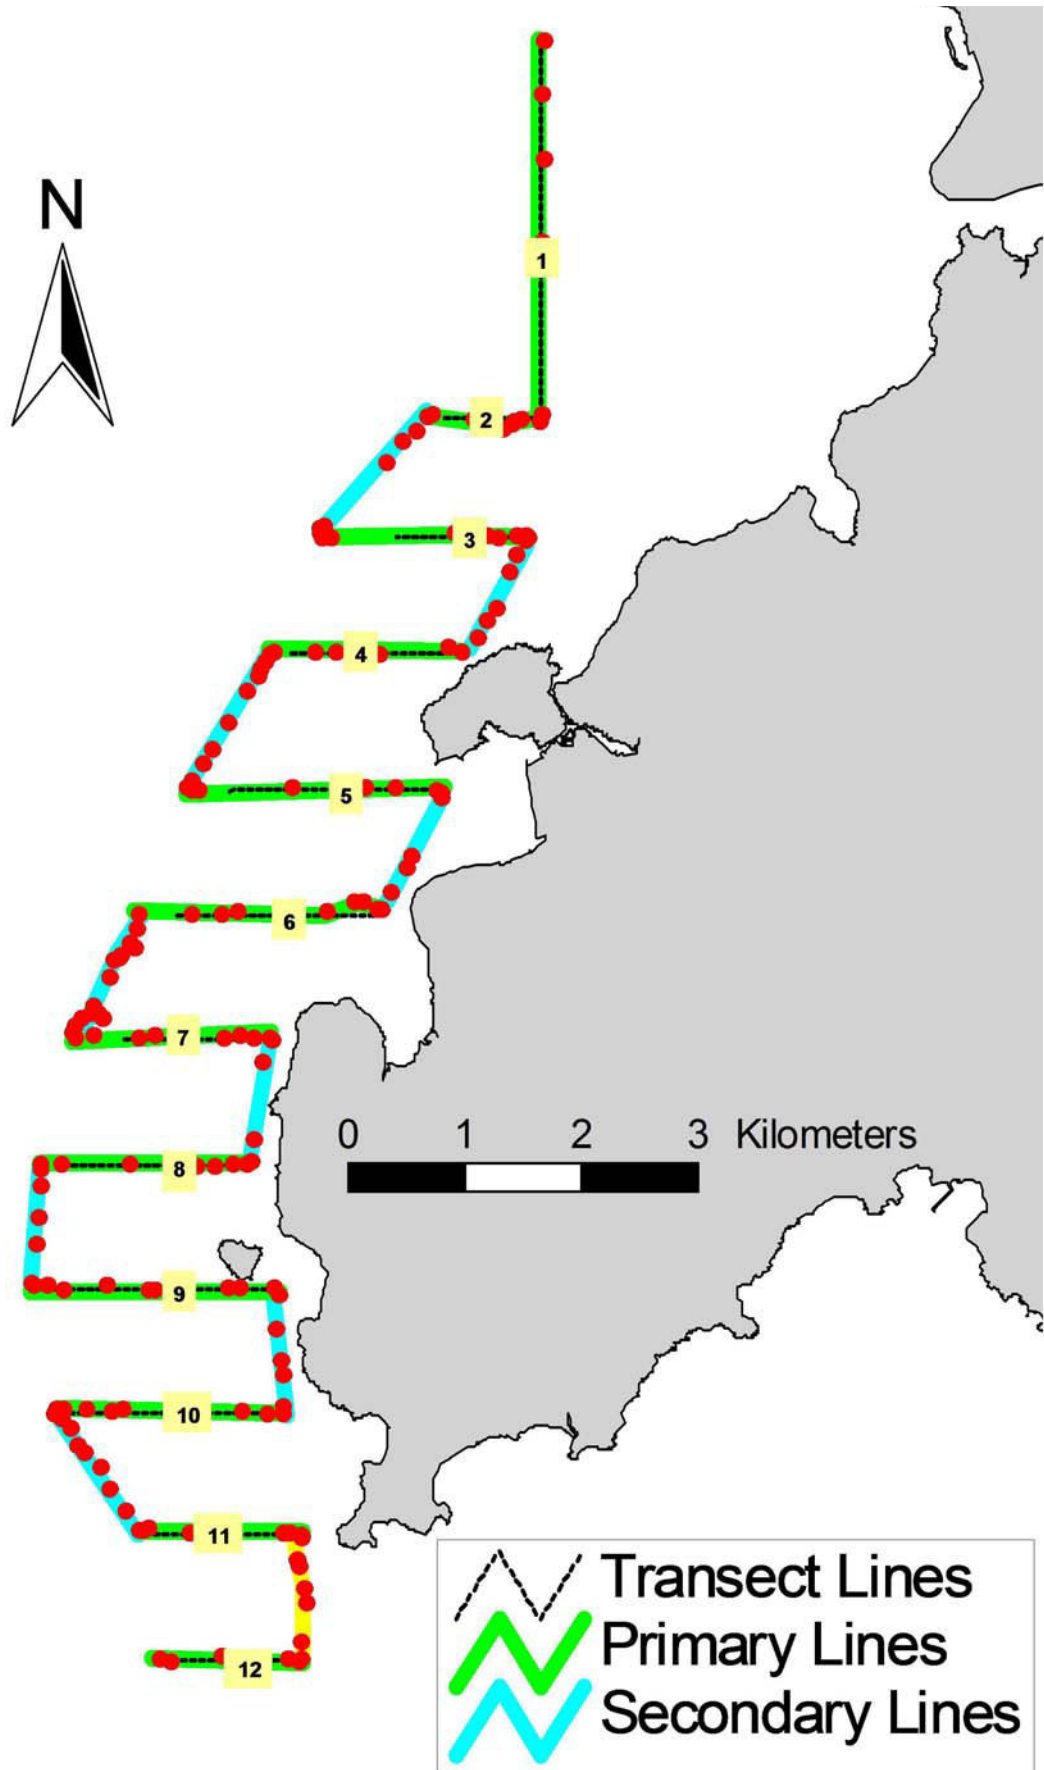
Figure 2. Survey Route on August 9<sup>th</sup>, 2016 (note: red dots represent the tracked positions of survey boat logged continuously by GPS throughout the course of the survey)

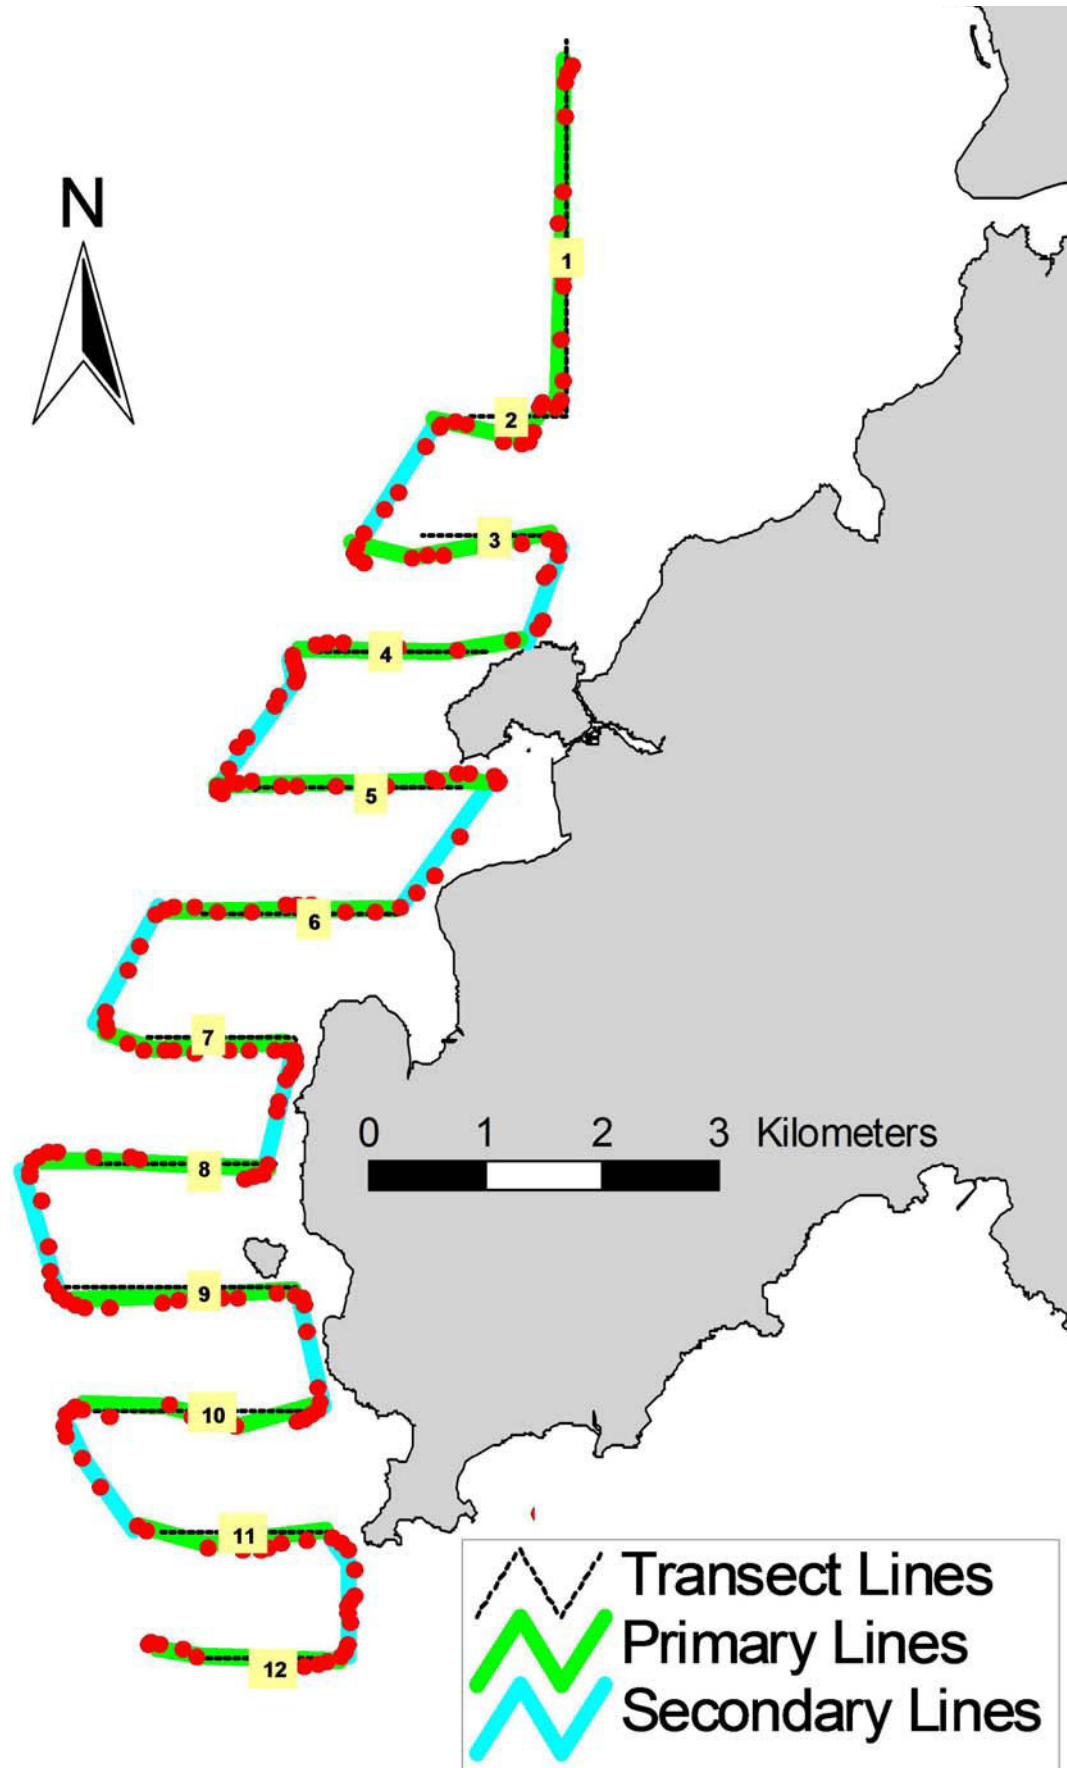
Figure 3. Survey Route on August 16<sup>th</sup>, 2016 (note: red dots represent the tracked positions of survey boat logged continuously by GPS throughout the course of the survey)

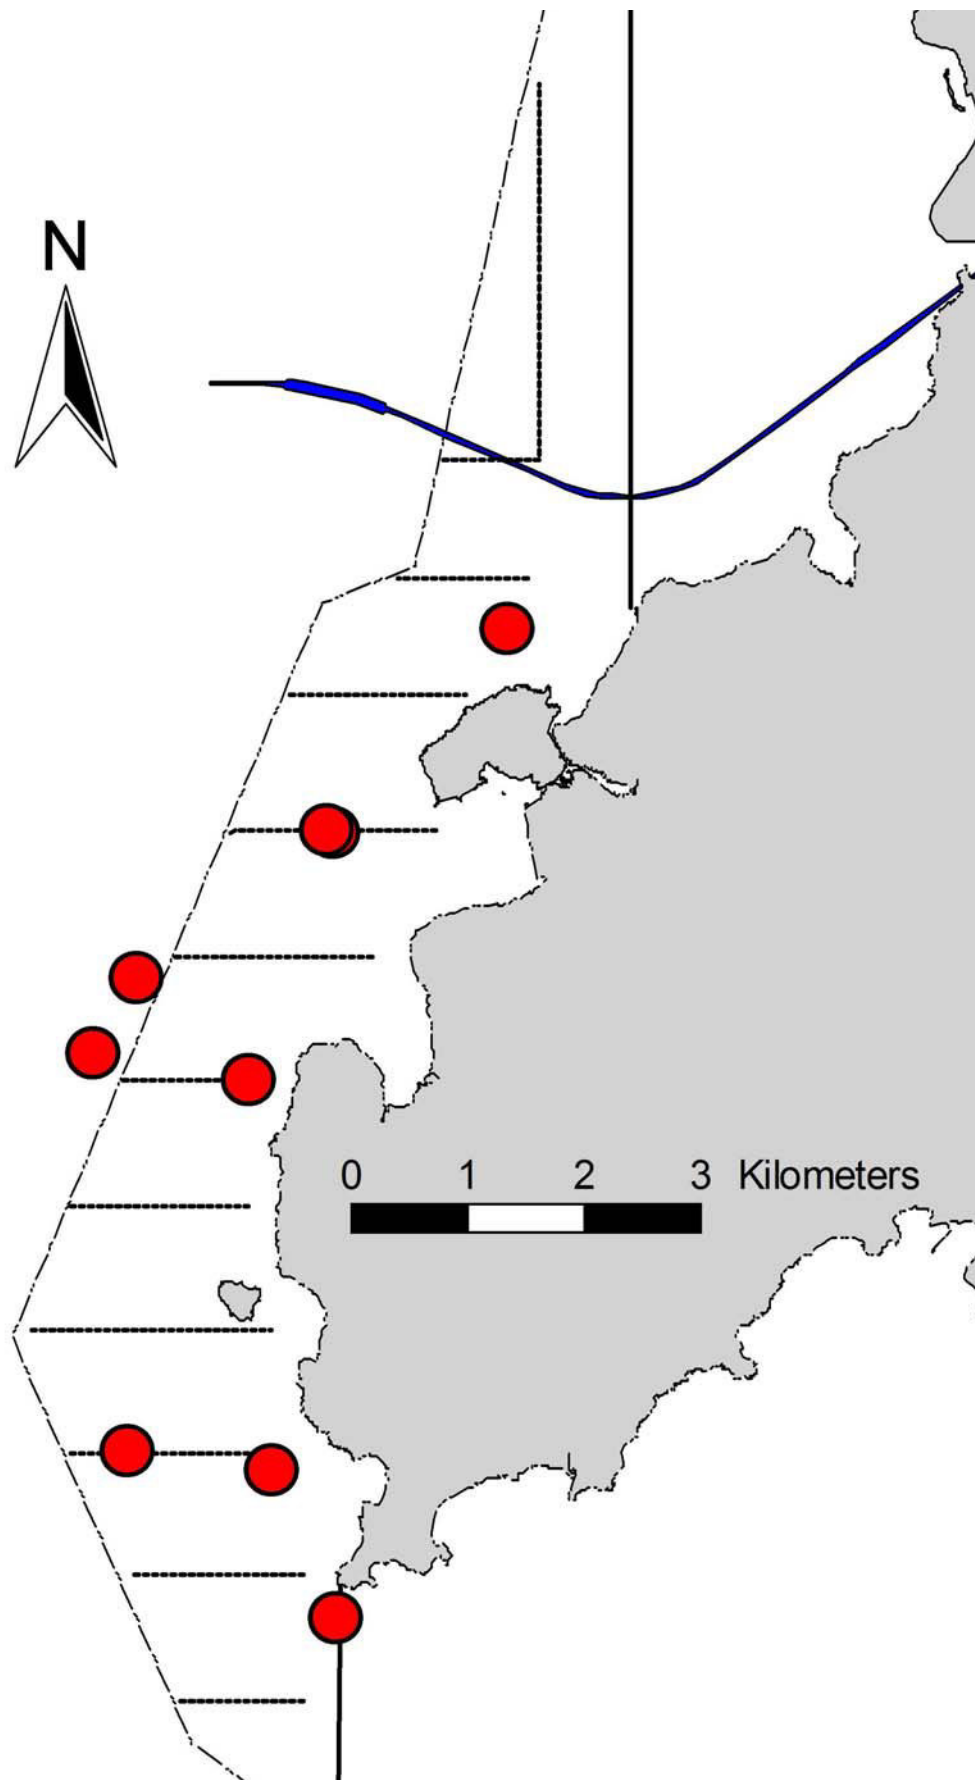
Figure 4. Distribution of Chinese White Dolphin Sighting during August 2016 HKLR09 Monitoring Surveys
